## Phase I - Environmental Site Assessment

201 Friel Street  
Ottawa, Ontario

Ottawa Community Housing Corporation

Report: PE4033-1

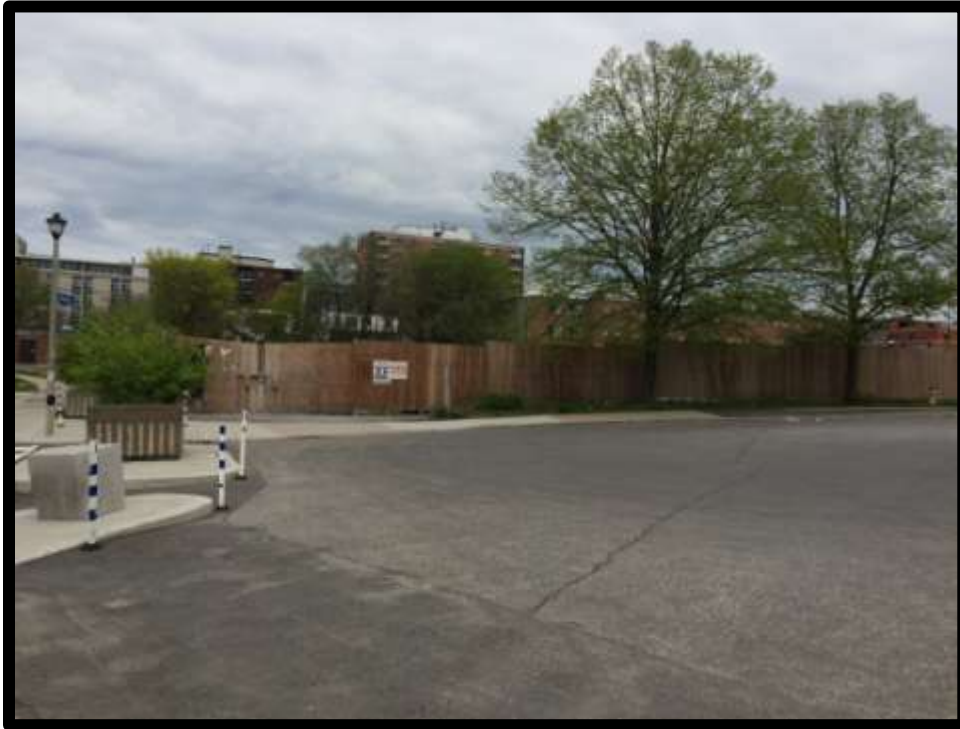
Photograph 5: View of neighbouring property to the west, across Chapel Street. The property is undergoing redevelopment.

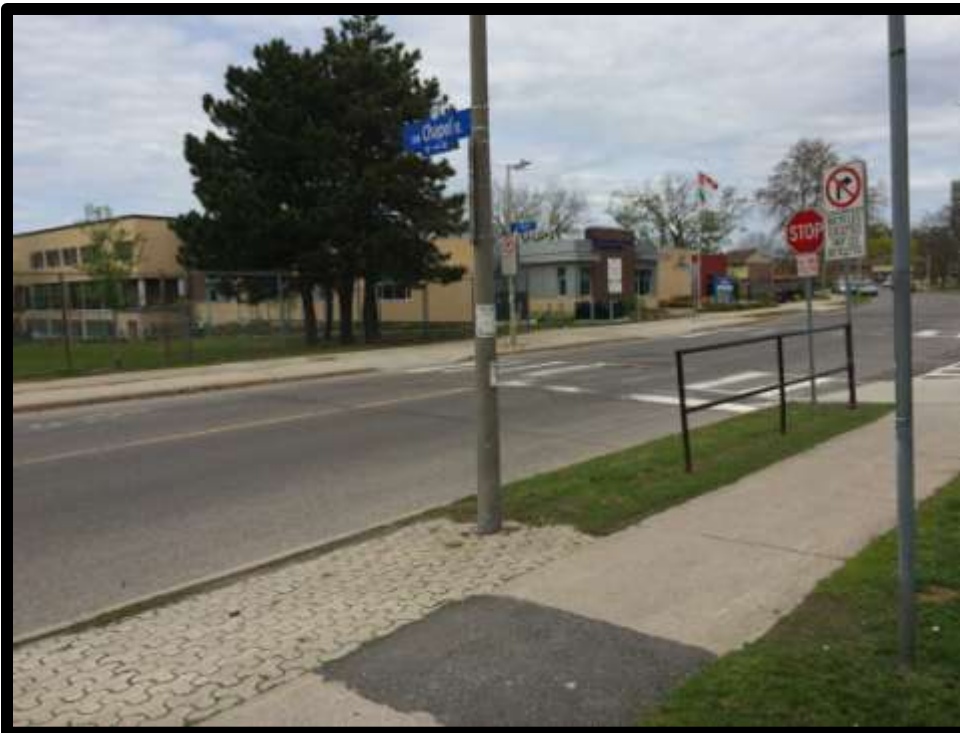
Photograph 6: View of neighbouring properties to the northeast, occupied by school buildings.

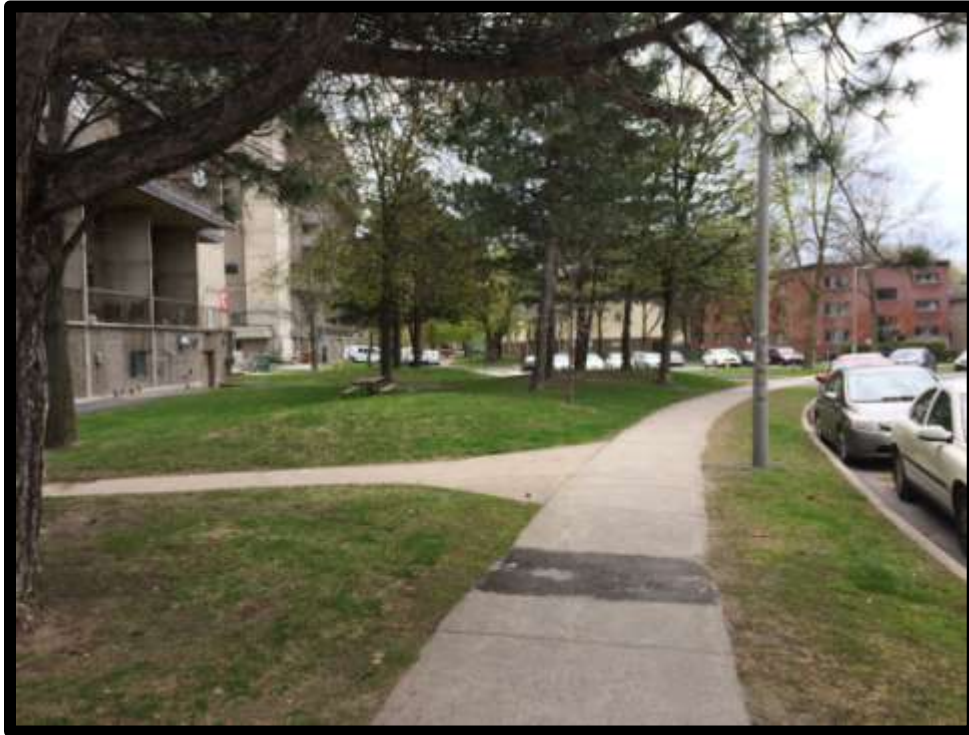
Photograph 7: View of neighbouring properties to the west, from the northwest corner of the property. Neighbouring properties are occupied by residential apartments and townhomes further to the northwest.

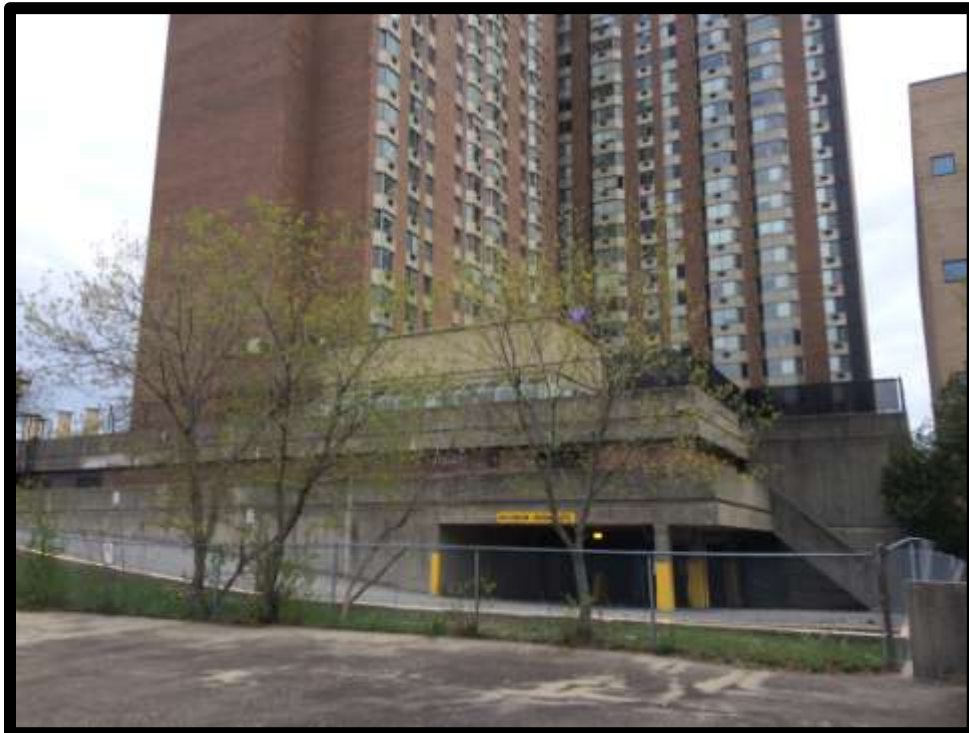
Photograph 8: View of neighbouring property to the south, occupied by a residential apartment tower with an underground parking structure.
