**Preliminary Geotechnical Investigation  
Report**

Proposed Development – 1495 Heron Road

Ottawa, Ontario

Project No. 160410368

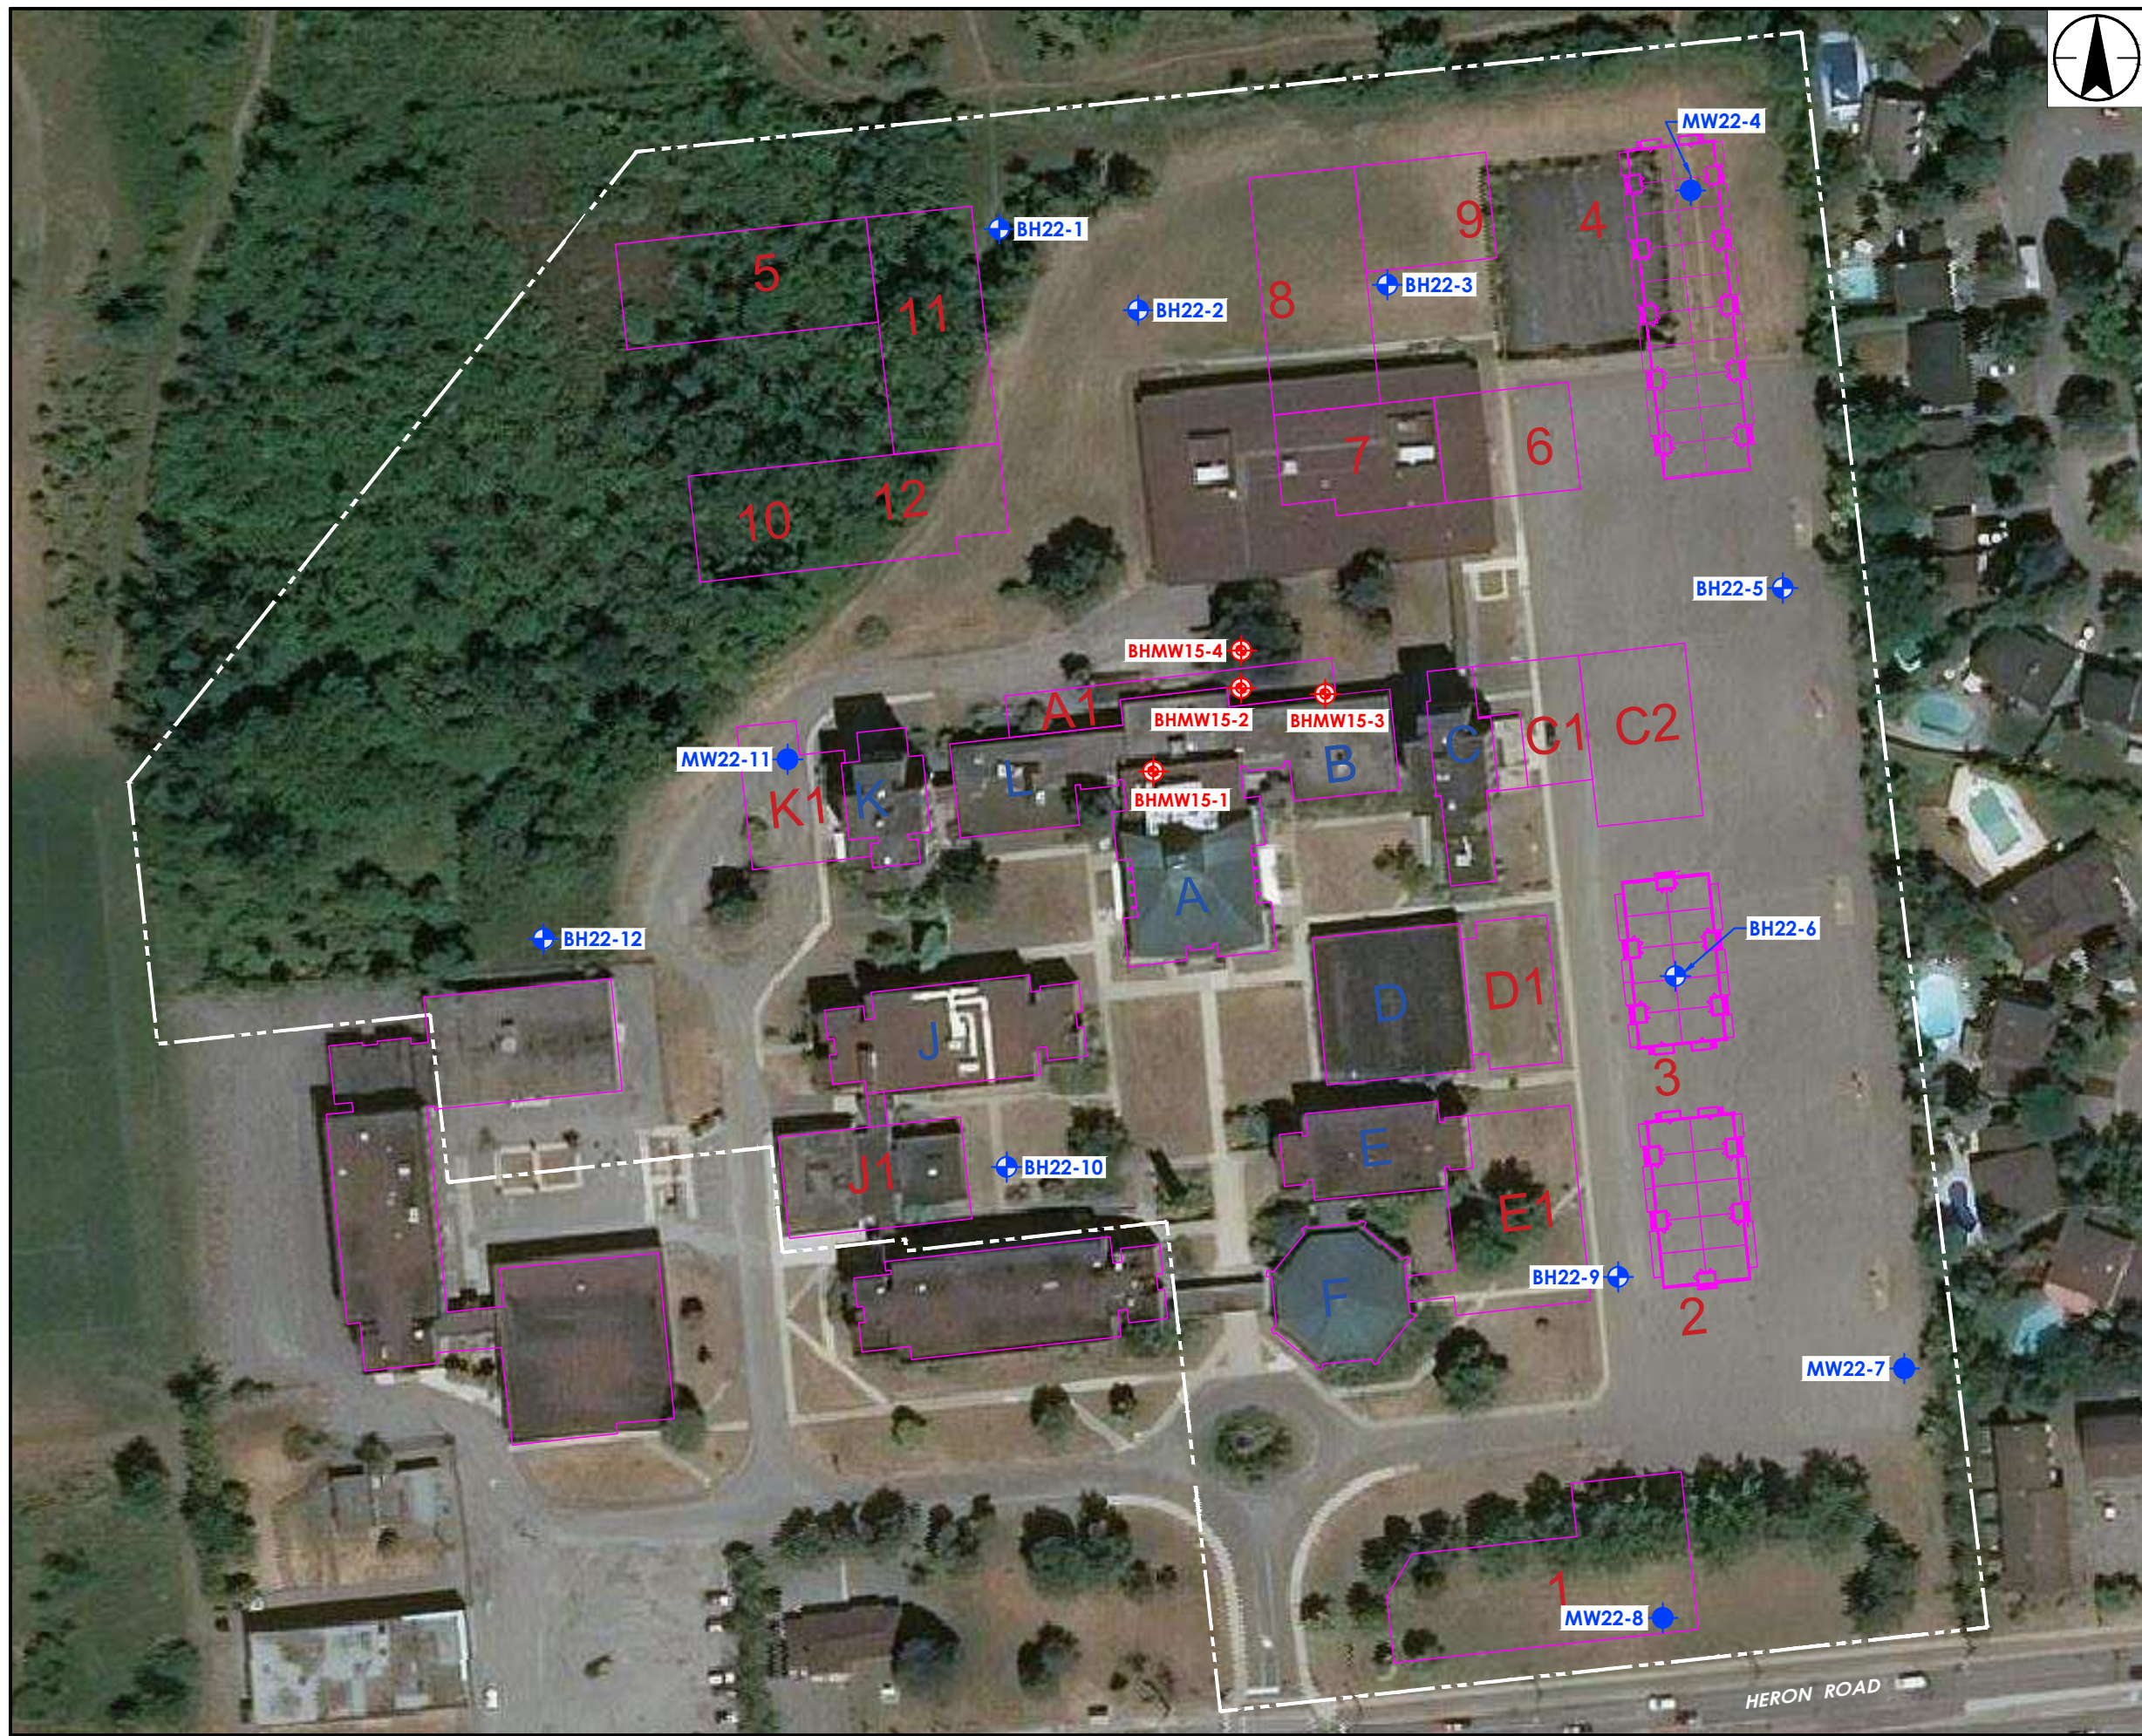
C:\CAD Drawings\Acad2019 Drawings\2022\160410368\160410368\_Boreholes Locations.dwg  
 2022/08/05 10:55 AM By: Briones, Gliceria

Borehole locations were surveyed using a Trimble GPS unit with decimeter accuracy. It is noted that accuracy may be affected by satellite coverage at the time of survey. Geodetic elevations at borehole locations are shown on the Borehole Records in Appendix C.

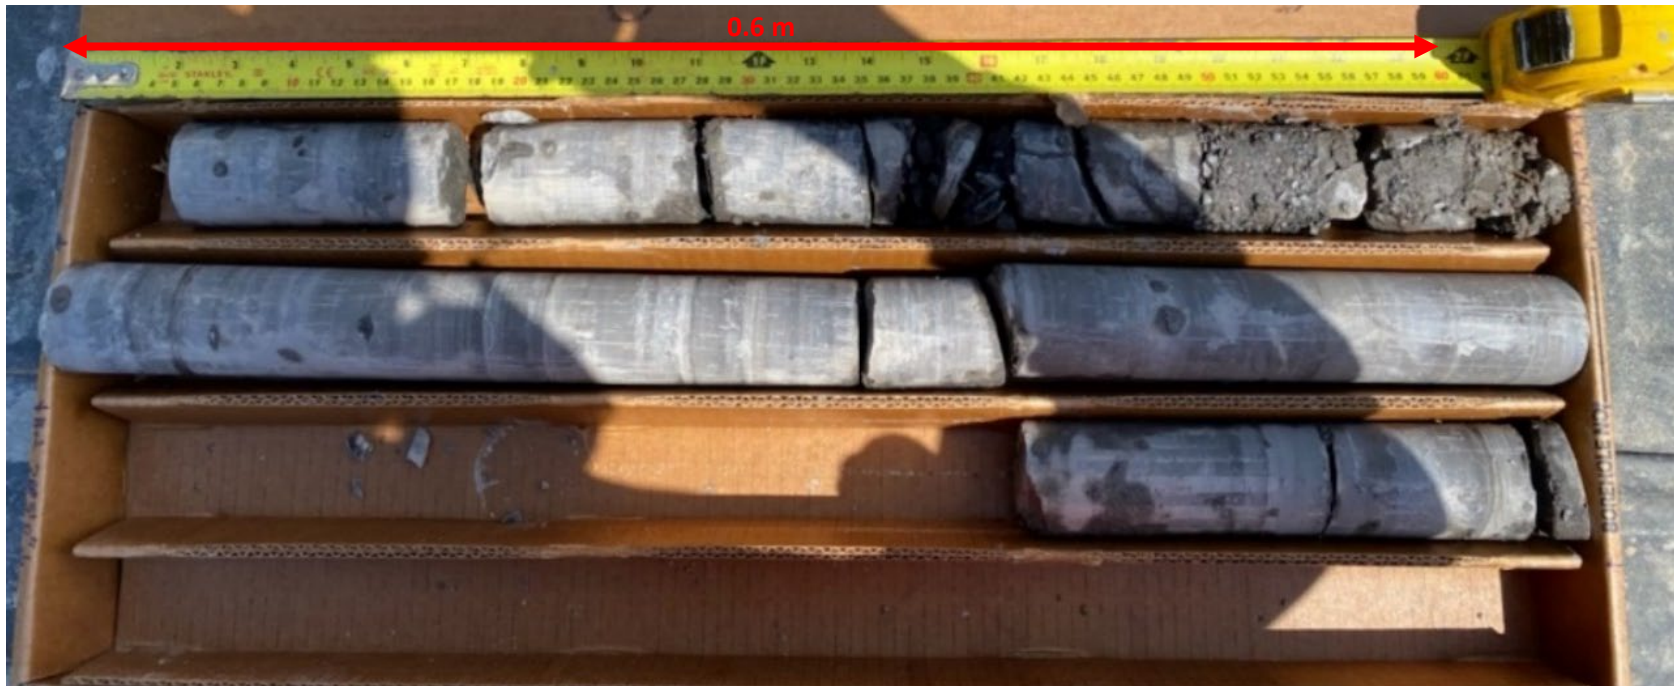
Rock Core Photo No.: 1

Borehole: BH22-1

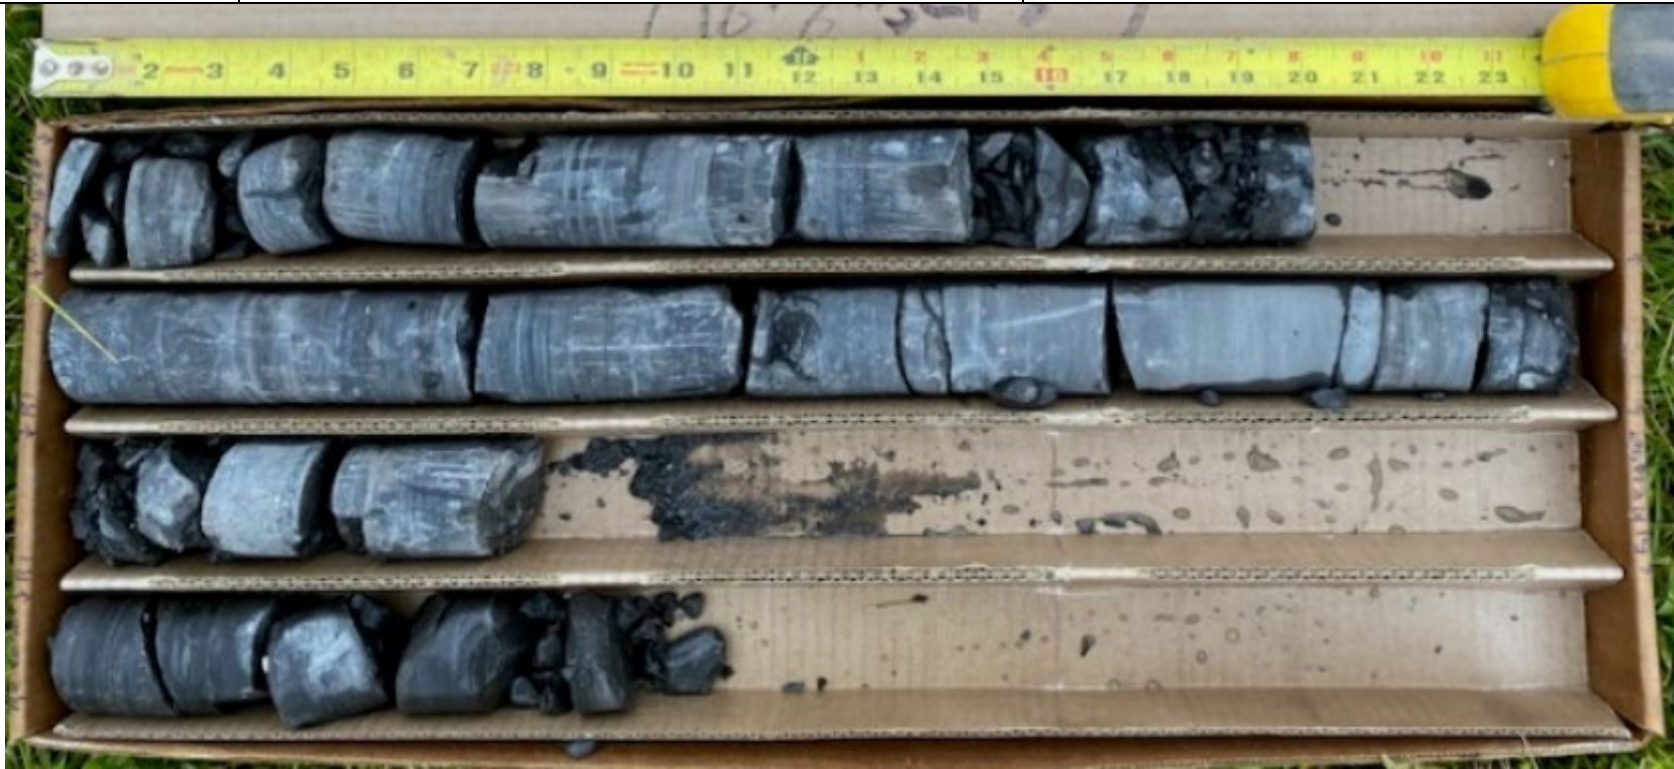
Rock Core Photo No.: 2

Borehole: BH22-3

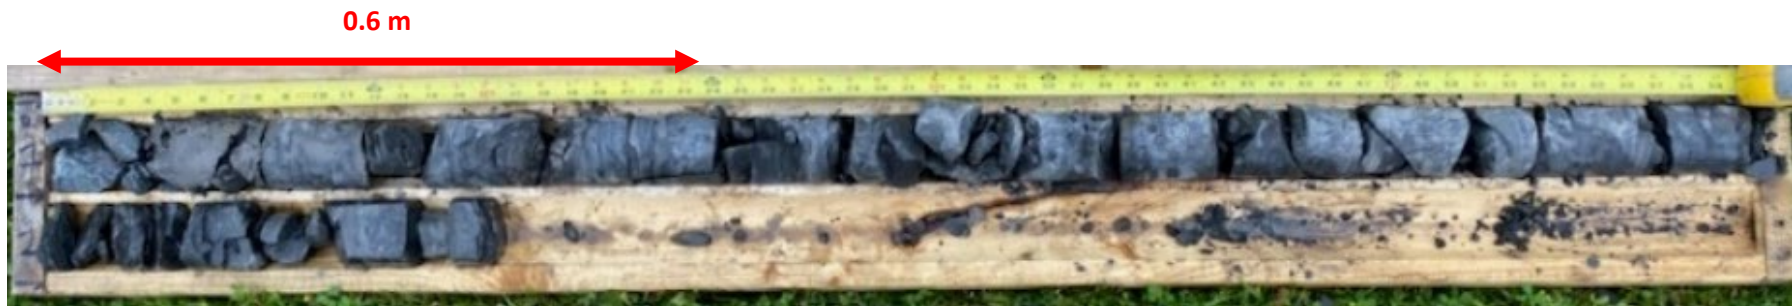
Rock Core Photo No.:	3	Borehole:	MW22-4	Depth:	4.6 m to 6.3 m
----------------------	---	-----------	--------	--------	----------------

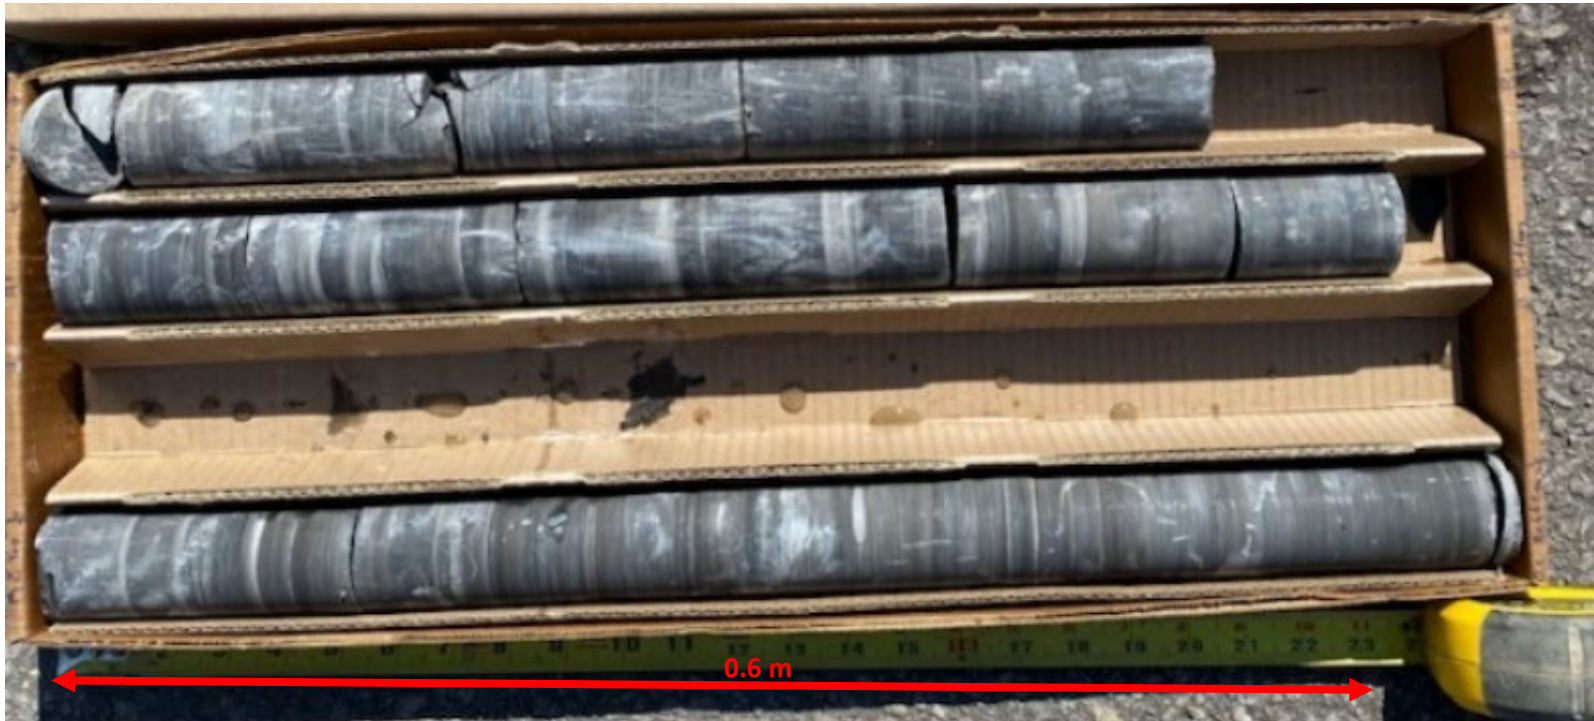
Rock Core Photo No.: 4

Borehole: BH22-6

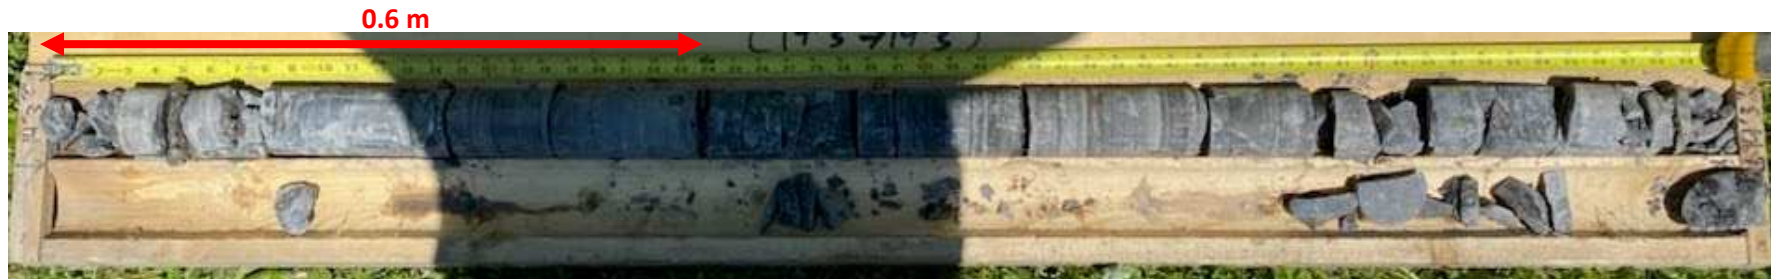
Rock Core Photo No.: 5

Borehole: MW22-8

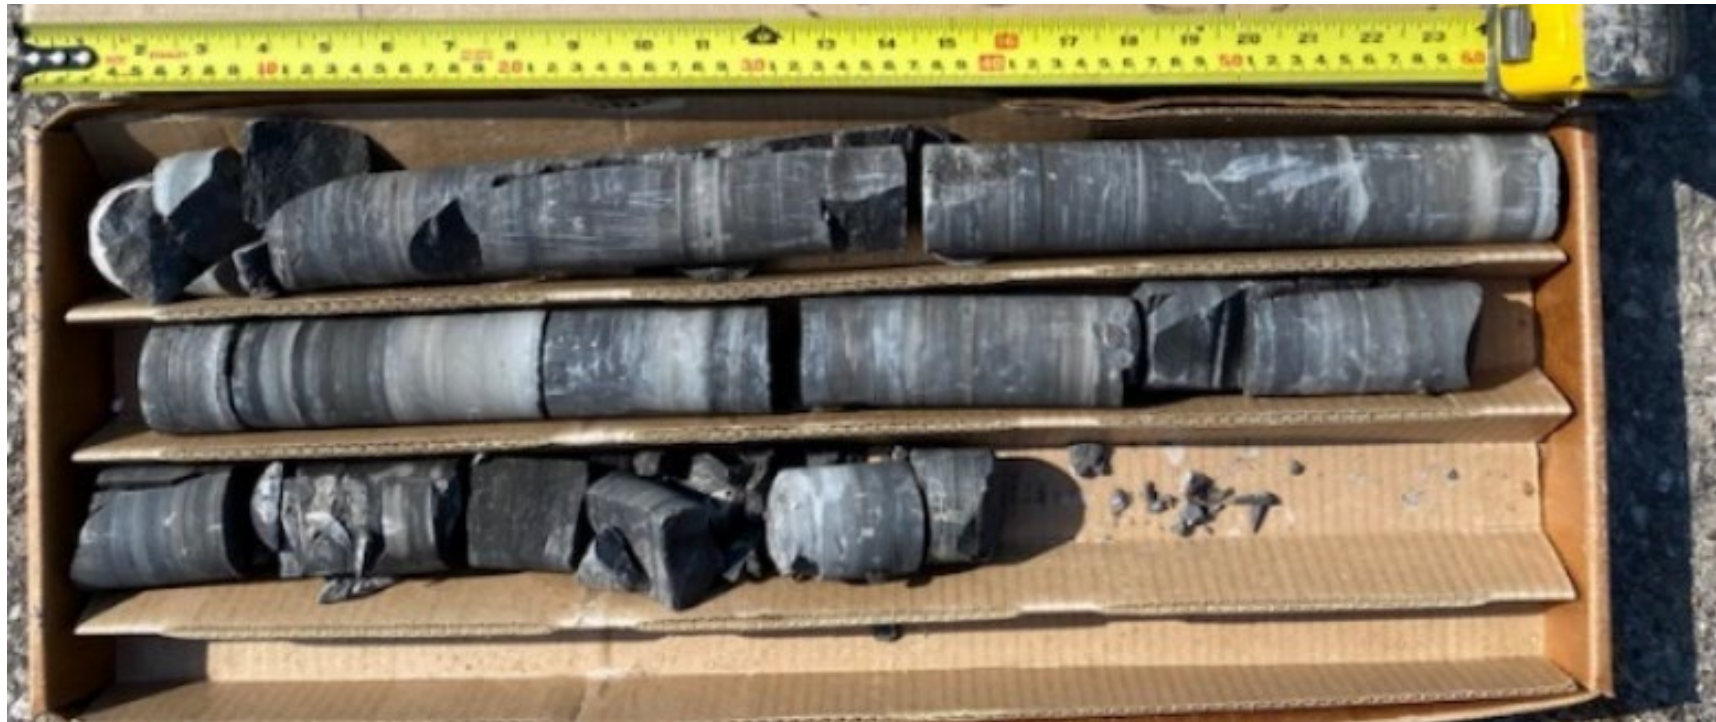
Rock Core Photo No.: 6

Borehole: BH22-9

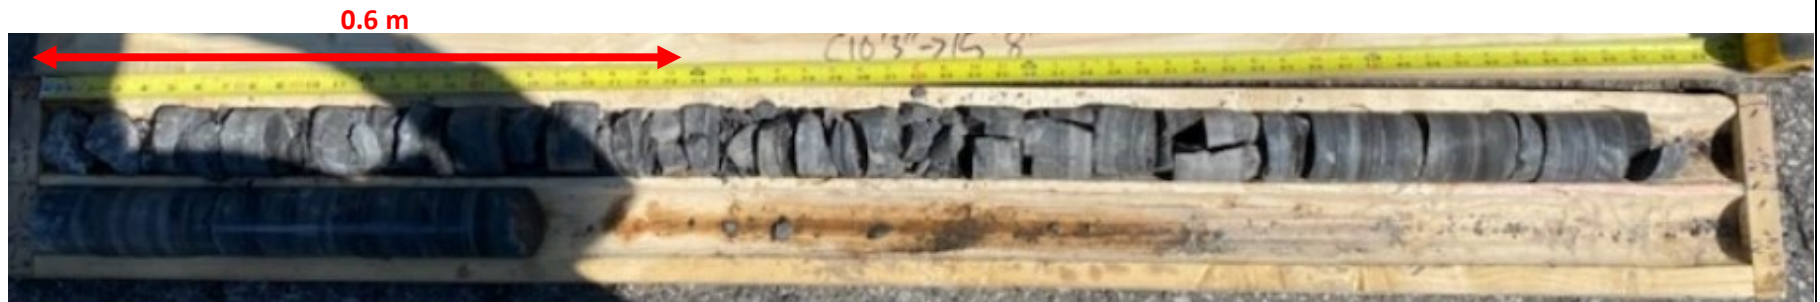
Rock Core Photo No.: 7

Borehole: MW22-11

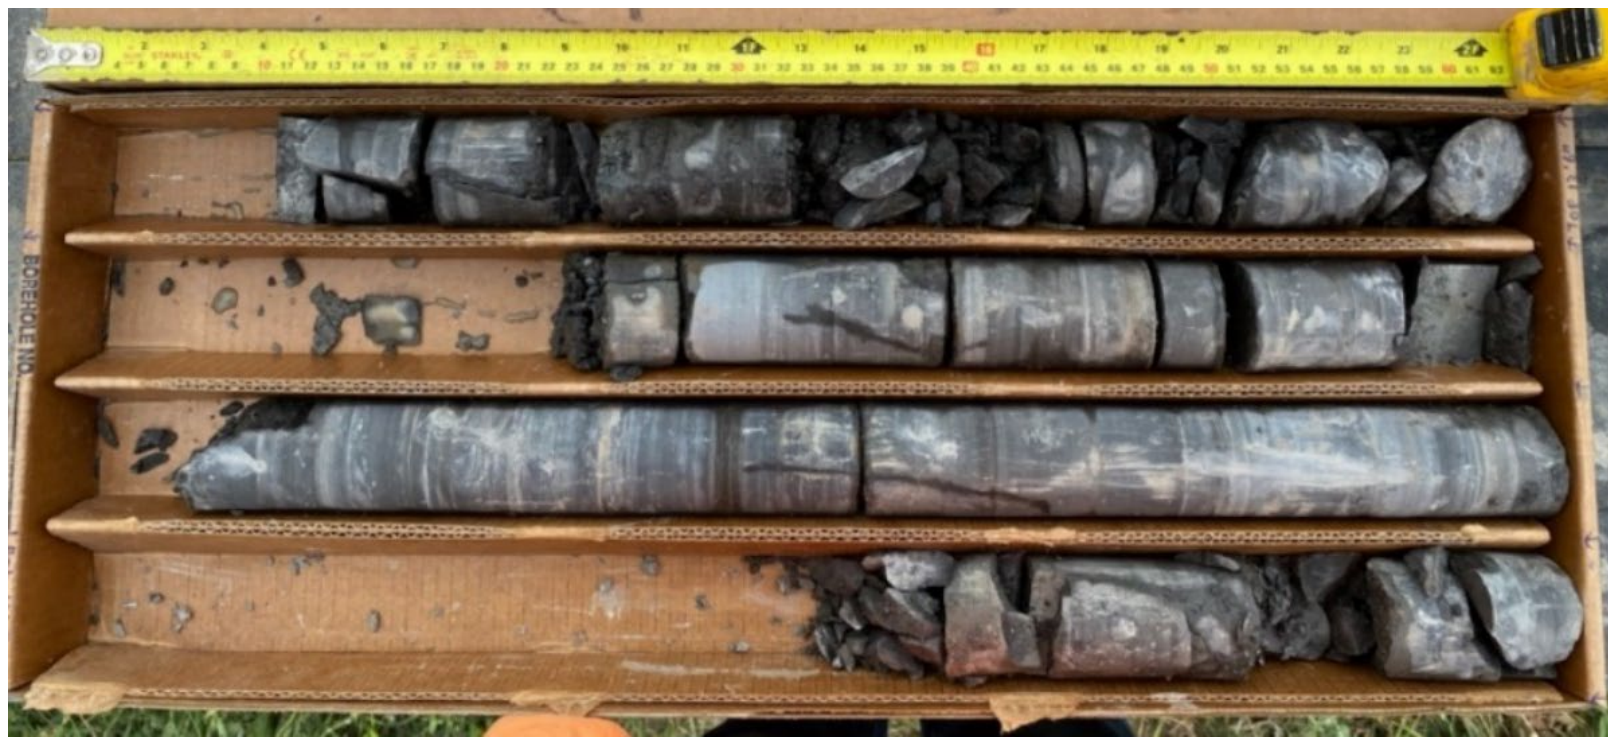
Rock Core Photo No.: 8

Borehole: BH22-12
