### 1184-1196 CUMMINGS AVENUE SERVICING AND STORMWATER MANAGEMENT REPORT

April 25, 2023

Prepared for: TCU Development Corporation

Prepared by: Stantec Consulting Ltd.

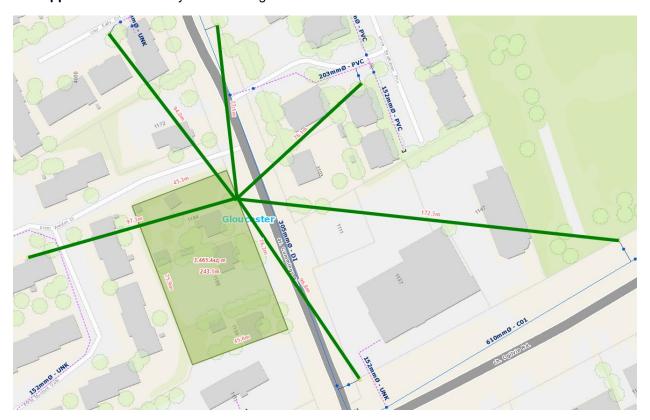
Figure 3-1: Existing Fire Hydrant Coverage Map

According to the NFPA 1 Table 18.5.4.3 in Appendix I of the City of Ottawa Technical Bulletin ISTB-2018-02, a hydrant situated less than 76 m away from a building can supply a maximum capacity of 5,678 L/min, while a hydrant situated between 76 m and 152 m away from a building can supply a maximum capacity of 3,785 L/min. Given the large fire flow demands from the site, it is proposed that a new fire hydrant be placed to be within 45 metres from the Siamese connection to reduce the number of fire hydrants needed to service the site's fire flow demand. It is suggested that the new hydrant be located to the east of Cummings Avenue within the road right of way as shown on **Drawing SSP-1** in **Appendix G**. See **Appendix A.5** for fire hydrant coverage table calculations and NFPA Table 18.5.4.3.
