# **Phase I Environmental Site Assessment**

1184, 1188 and 1196 Cummings Avenue  
Ottawa, Ontario

**Report: PE5990-1**

**Date: March 8, 2023**

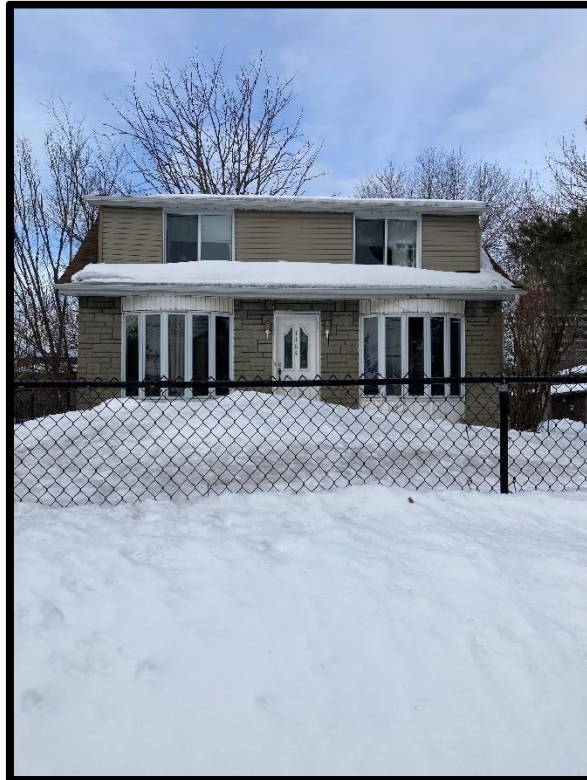
The two-storey residential duplex addressed 1184 Cummings Avenue is finished on the exterior with brick, and vinyl siding in addition to a sloped and shingled style roof. Constructed circa 1952, the building is constructed with a concrete foundation and is currently heated and cooled via a combination of natural gas-and electric means.

Photograph 1: View of the front of 1184 Cummings Avenue residential dwelling, facing west.

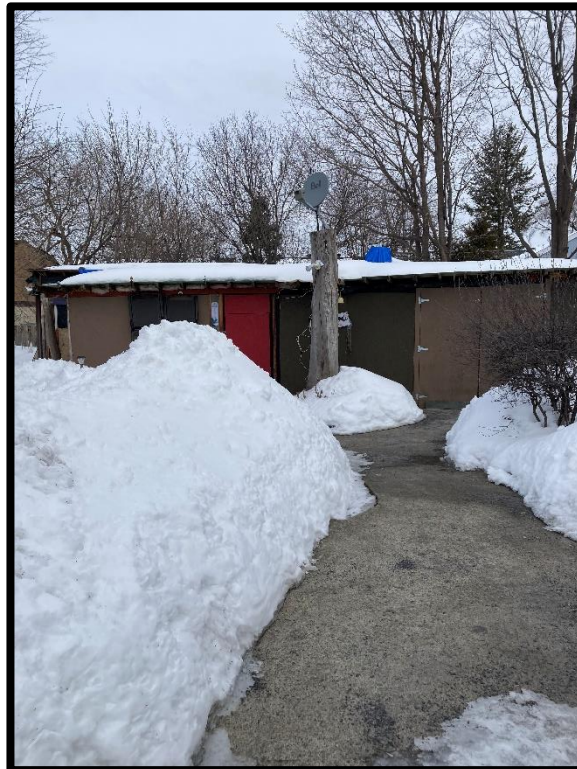
Photograph 2: View of the outbuilding on the 1184 Cummings Avenue property, facing north.

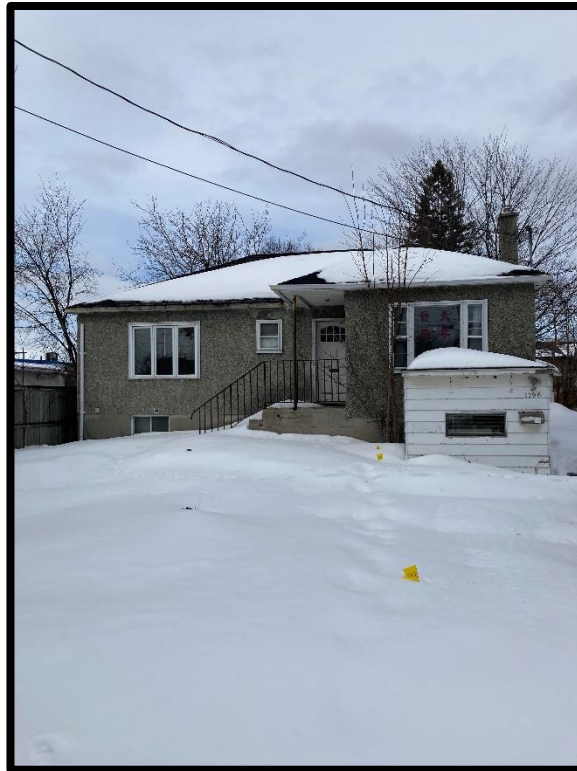
The vacant one-storey (with one basement level) residential dwelling addressed 1196 Cummings Avenue is finished on the exterior with vinyl siding and pebble stucco in addition to a sloped and shingled style roof. Constructed circa 1952, the building is constructed with a concrete foundation and is not currently serviced. However, natural gas services were noted to be present on the exterior of the subject building and assumed to be the most recent means of heating and cooling for the building.

Photograph 5: View of the front of 1196 Cummings Avenue residential dwelling, facing west.

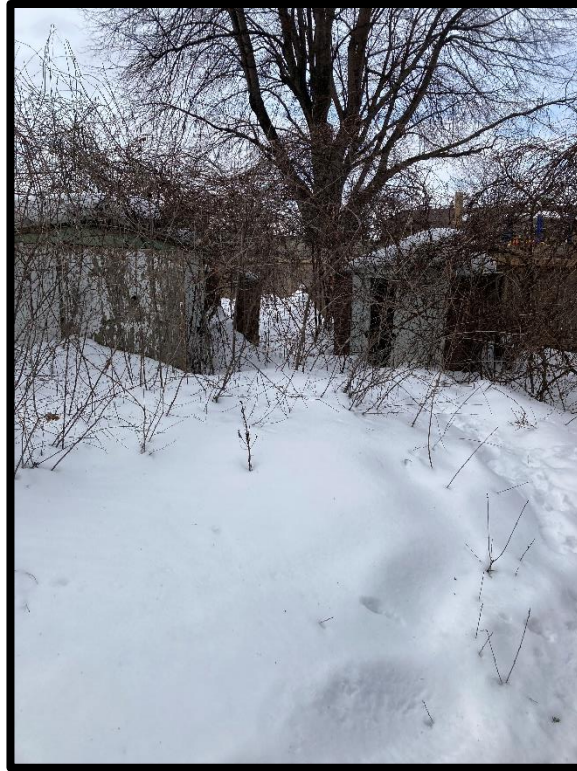
Photograph 7: View of the storage sheds on the 1196 Cummings Avenue property, facing south.

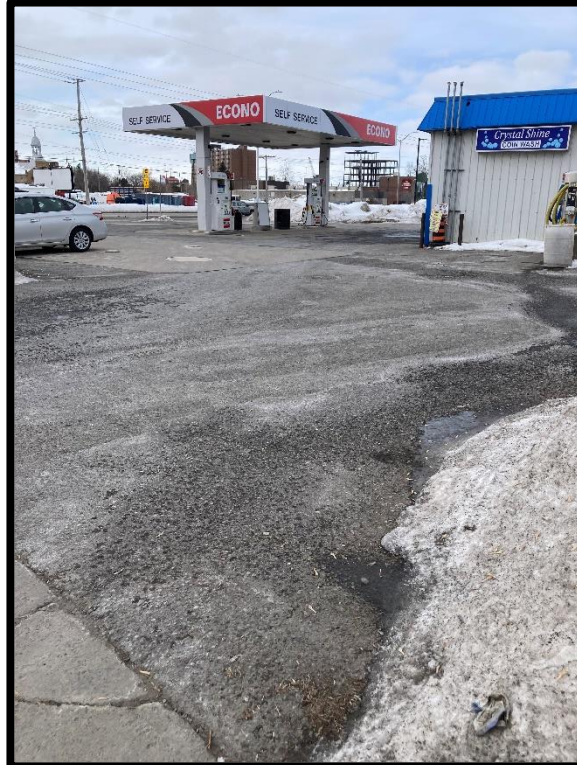
Photograph 8: View of the retail fuel outlet on the 1111 Ogilvie Road property from the southeast corner of the Phase I Property, facing northwest.
