**1184-1196 CUMMINGS AVENUE  
SERVICING AND STORMWATER  
MANAGEMENT REPORT**

January 11, 2024

Prepared for:  
TCU Development Corporation

Prepared by:  
Stantec Consulting Ltd.

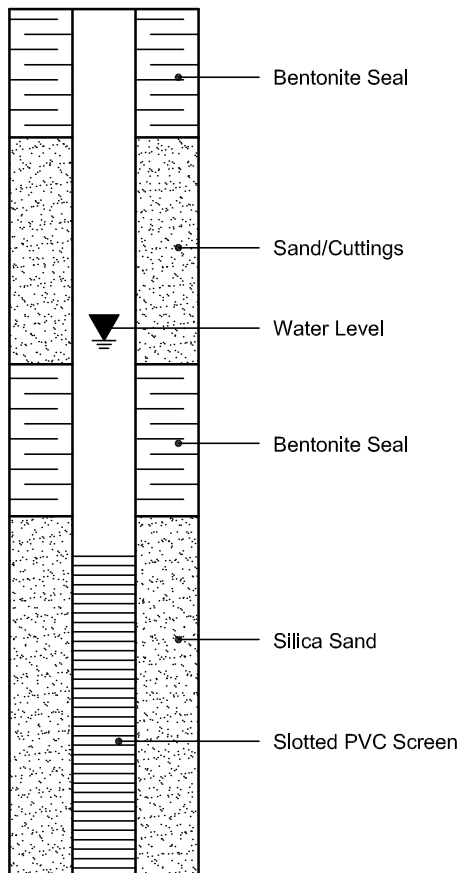
#### MONITORING WELL CONSTRUCTION

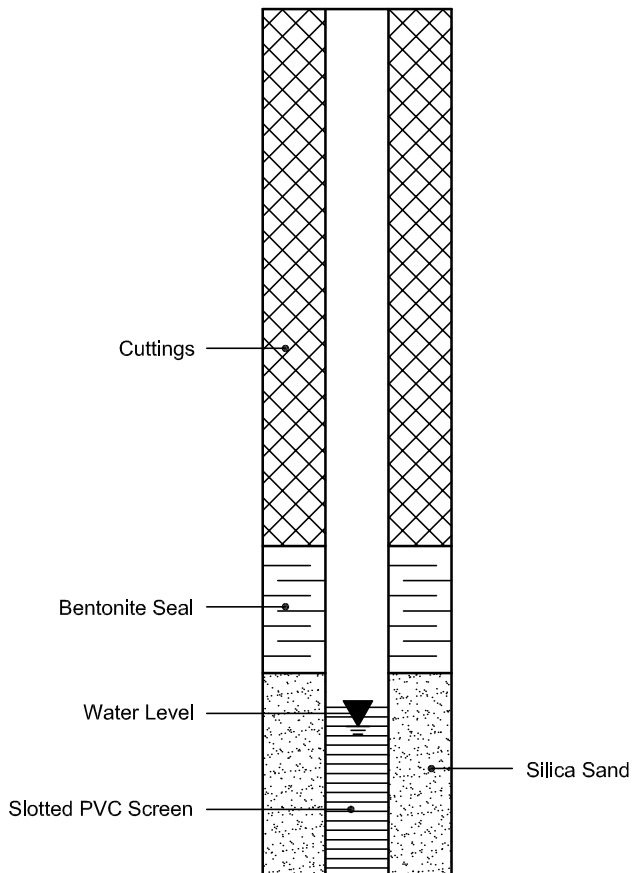
#### PIEZOMETER CONSTRUCTION
