Project Name: **Geotechnical Investigation – Slope Stability Analysis in Support of Zoning By-Law Amendment, 4380 Trail Road, Ottawa, Ontario**

EXP Project Number: **OTT-21023795-A0**

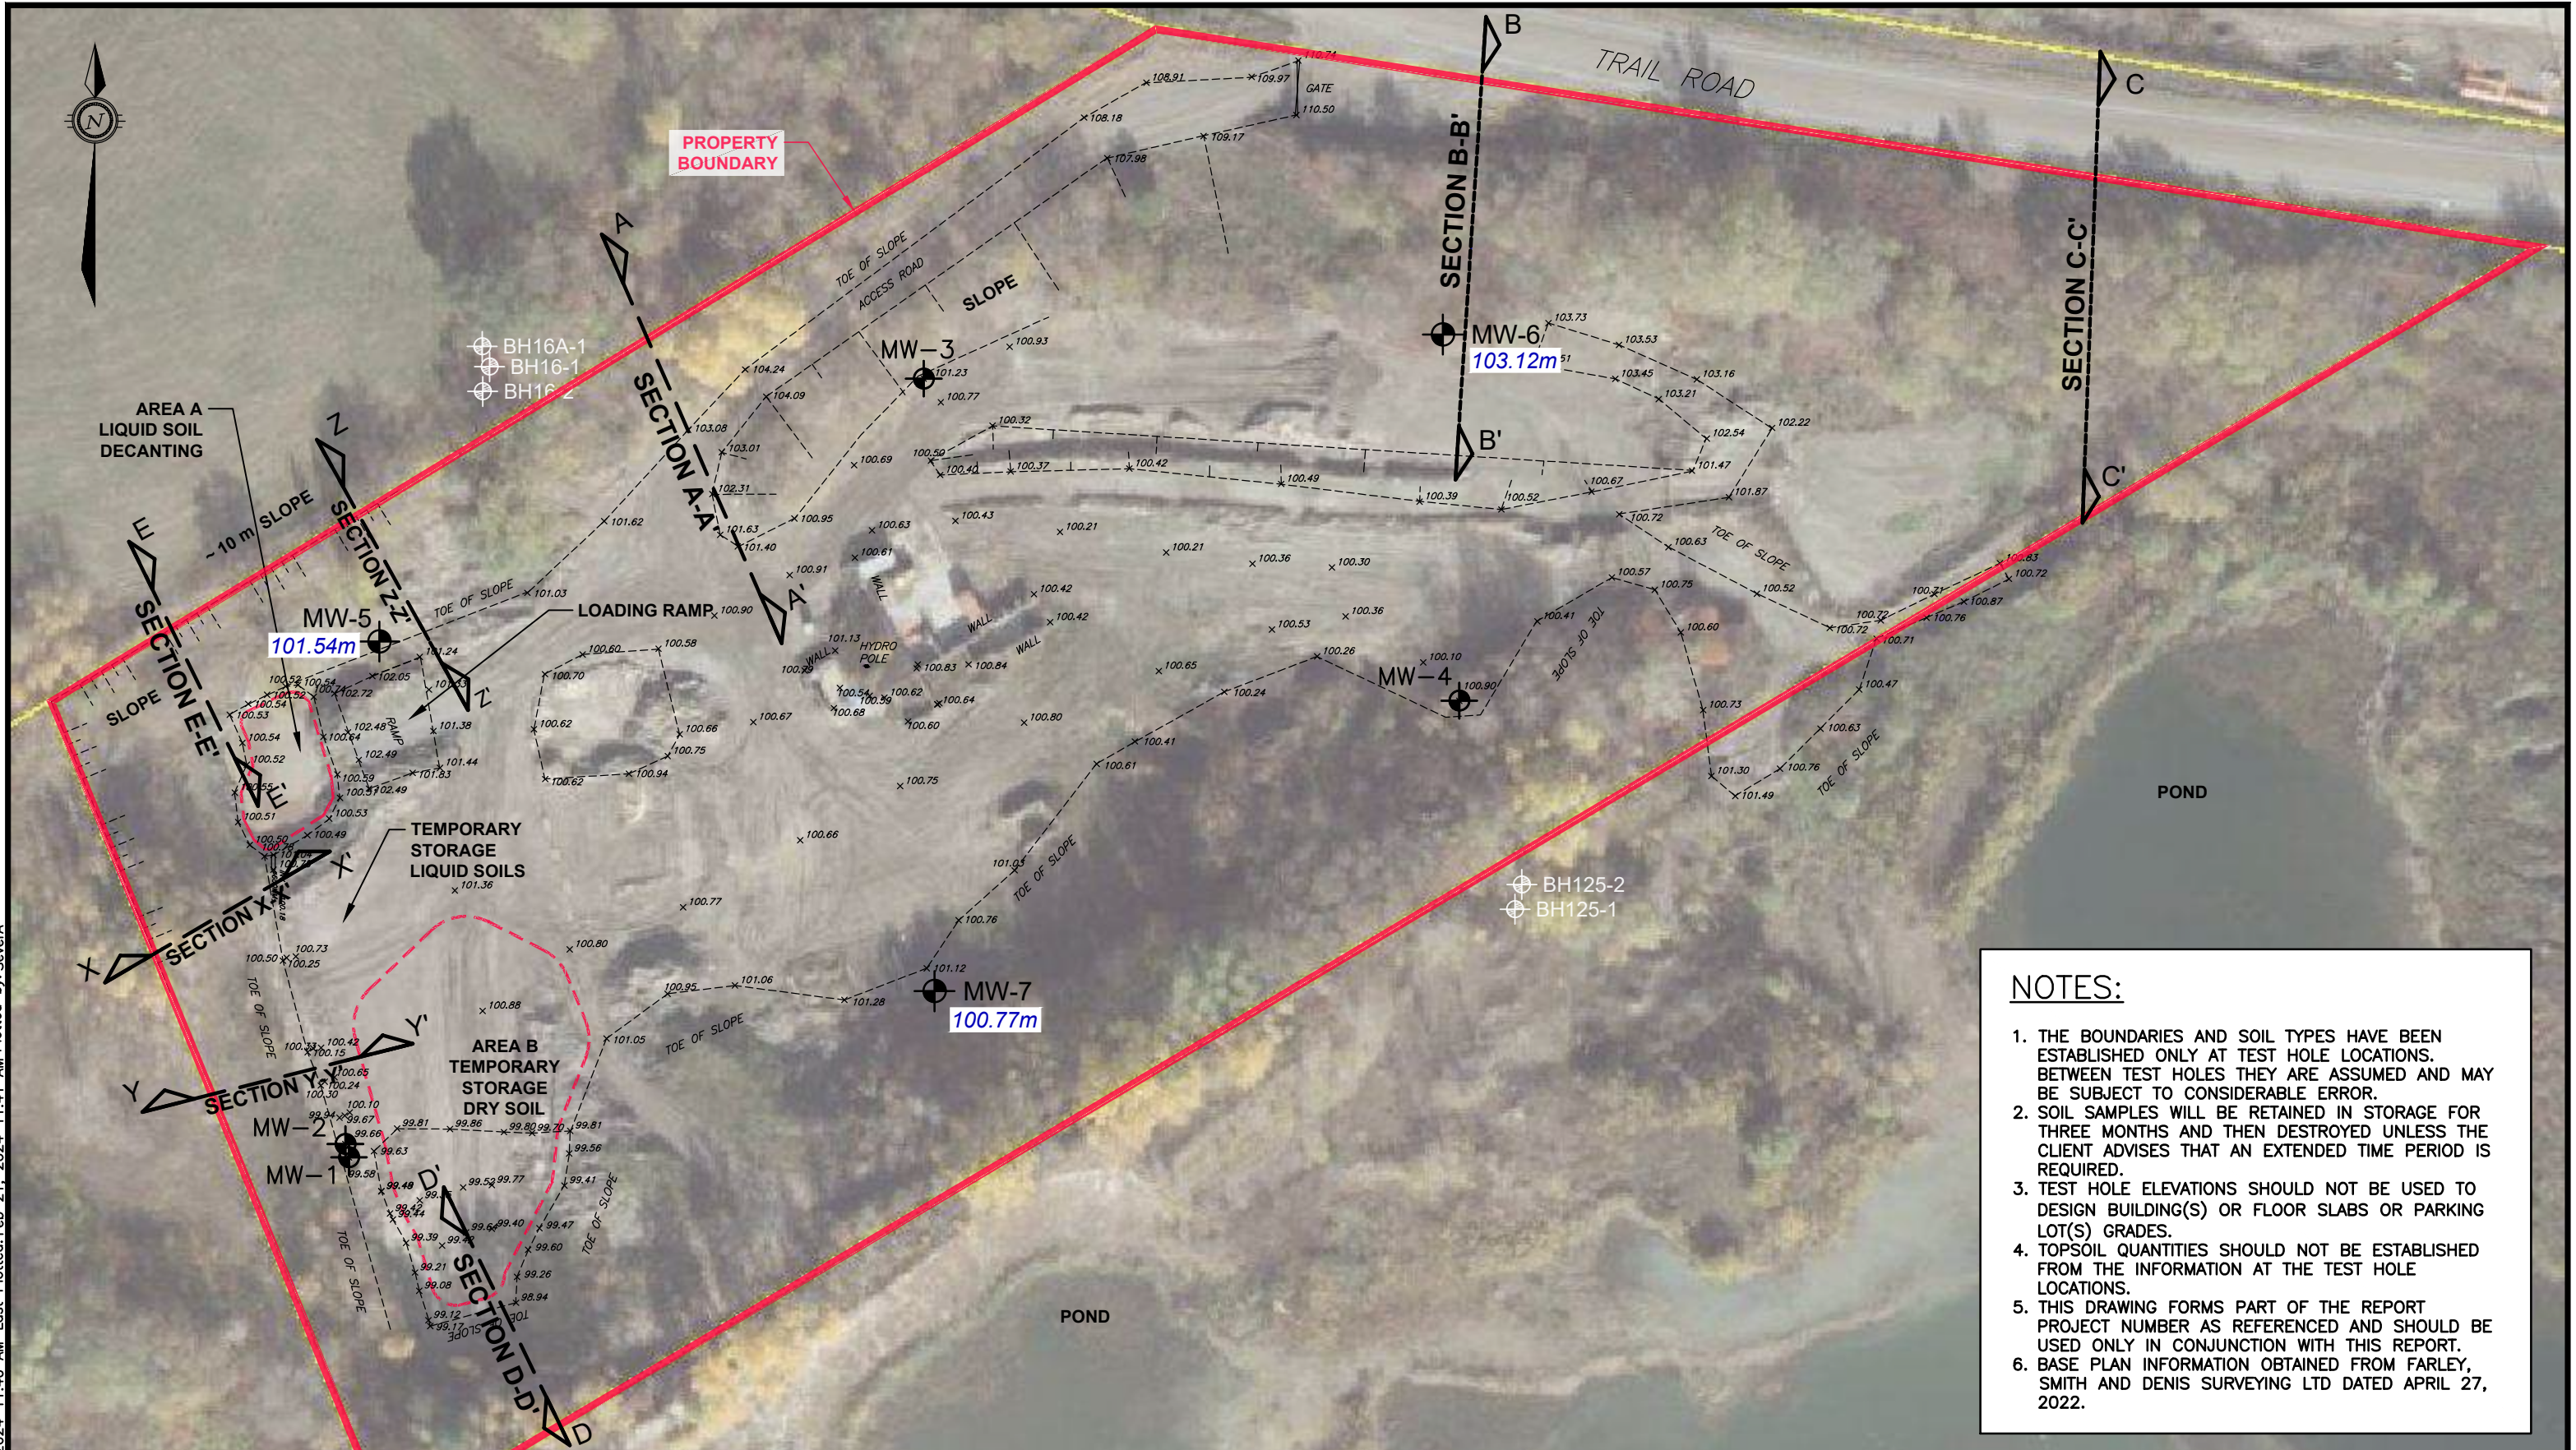
- NOTES:**
1. THE BOUNDARIES AND SOIL TYPES HAVE BEEN ESTABLISHED ONLY AT TEST HOLE LOCATIONS. BETWEEN TEST HOLES THEY ARE ASSUMED AND MAY BE SUBJECT TO CONSIDERABLE ERROR.
 2. SOIL SAMPLES WILL BE RETAINED IN STORAGE FOR THREE MONTHS AND THEN DESTROYED UNLESS THE CLIENT ADVISES THAT AN EXTENDED TIME PERIOD IS REQUIRED.
 3. TEST HOLE ELEVATIONS SHOULD NOT BE USED TO DESIGN BUILDING(S) OR FLOOR SLABS OR PARKING LOT(S) GRADES.
 4. TOPSOIL QUANTITIES SHOULD NOT BE ESTABLISHED FROM THE INFORMATION AT THE TEST HOLE LOCATIONS.
 5. THIS DRAWING FORMS PART OF THE REPORT PROJECT NUMBER AS REFERENCED AND SHOULD BE USED ONLY IN CONJUNCTION WITH THIS REPORT.
 6. BASE PLAN INFORMATION OBTAINED FROM FARLEY, SMITH AND DENIS SURVEYING LTD DATED APRIL 27, 2022.

Three additional cross sections in the vicinity of the west infiltration trenches (Sections X-X, Y-Y and Z-Z) were also analyzed and the locations of these cross sections are shown on Figure 2.

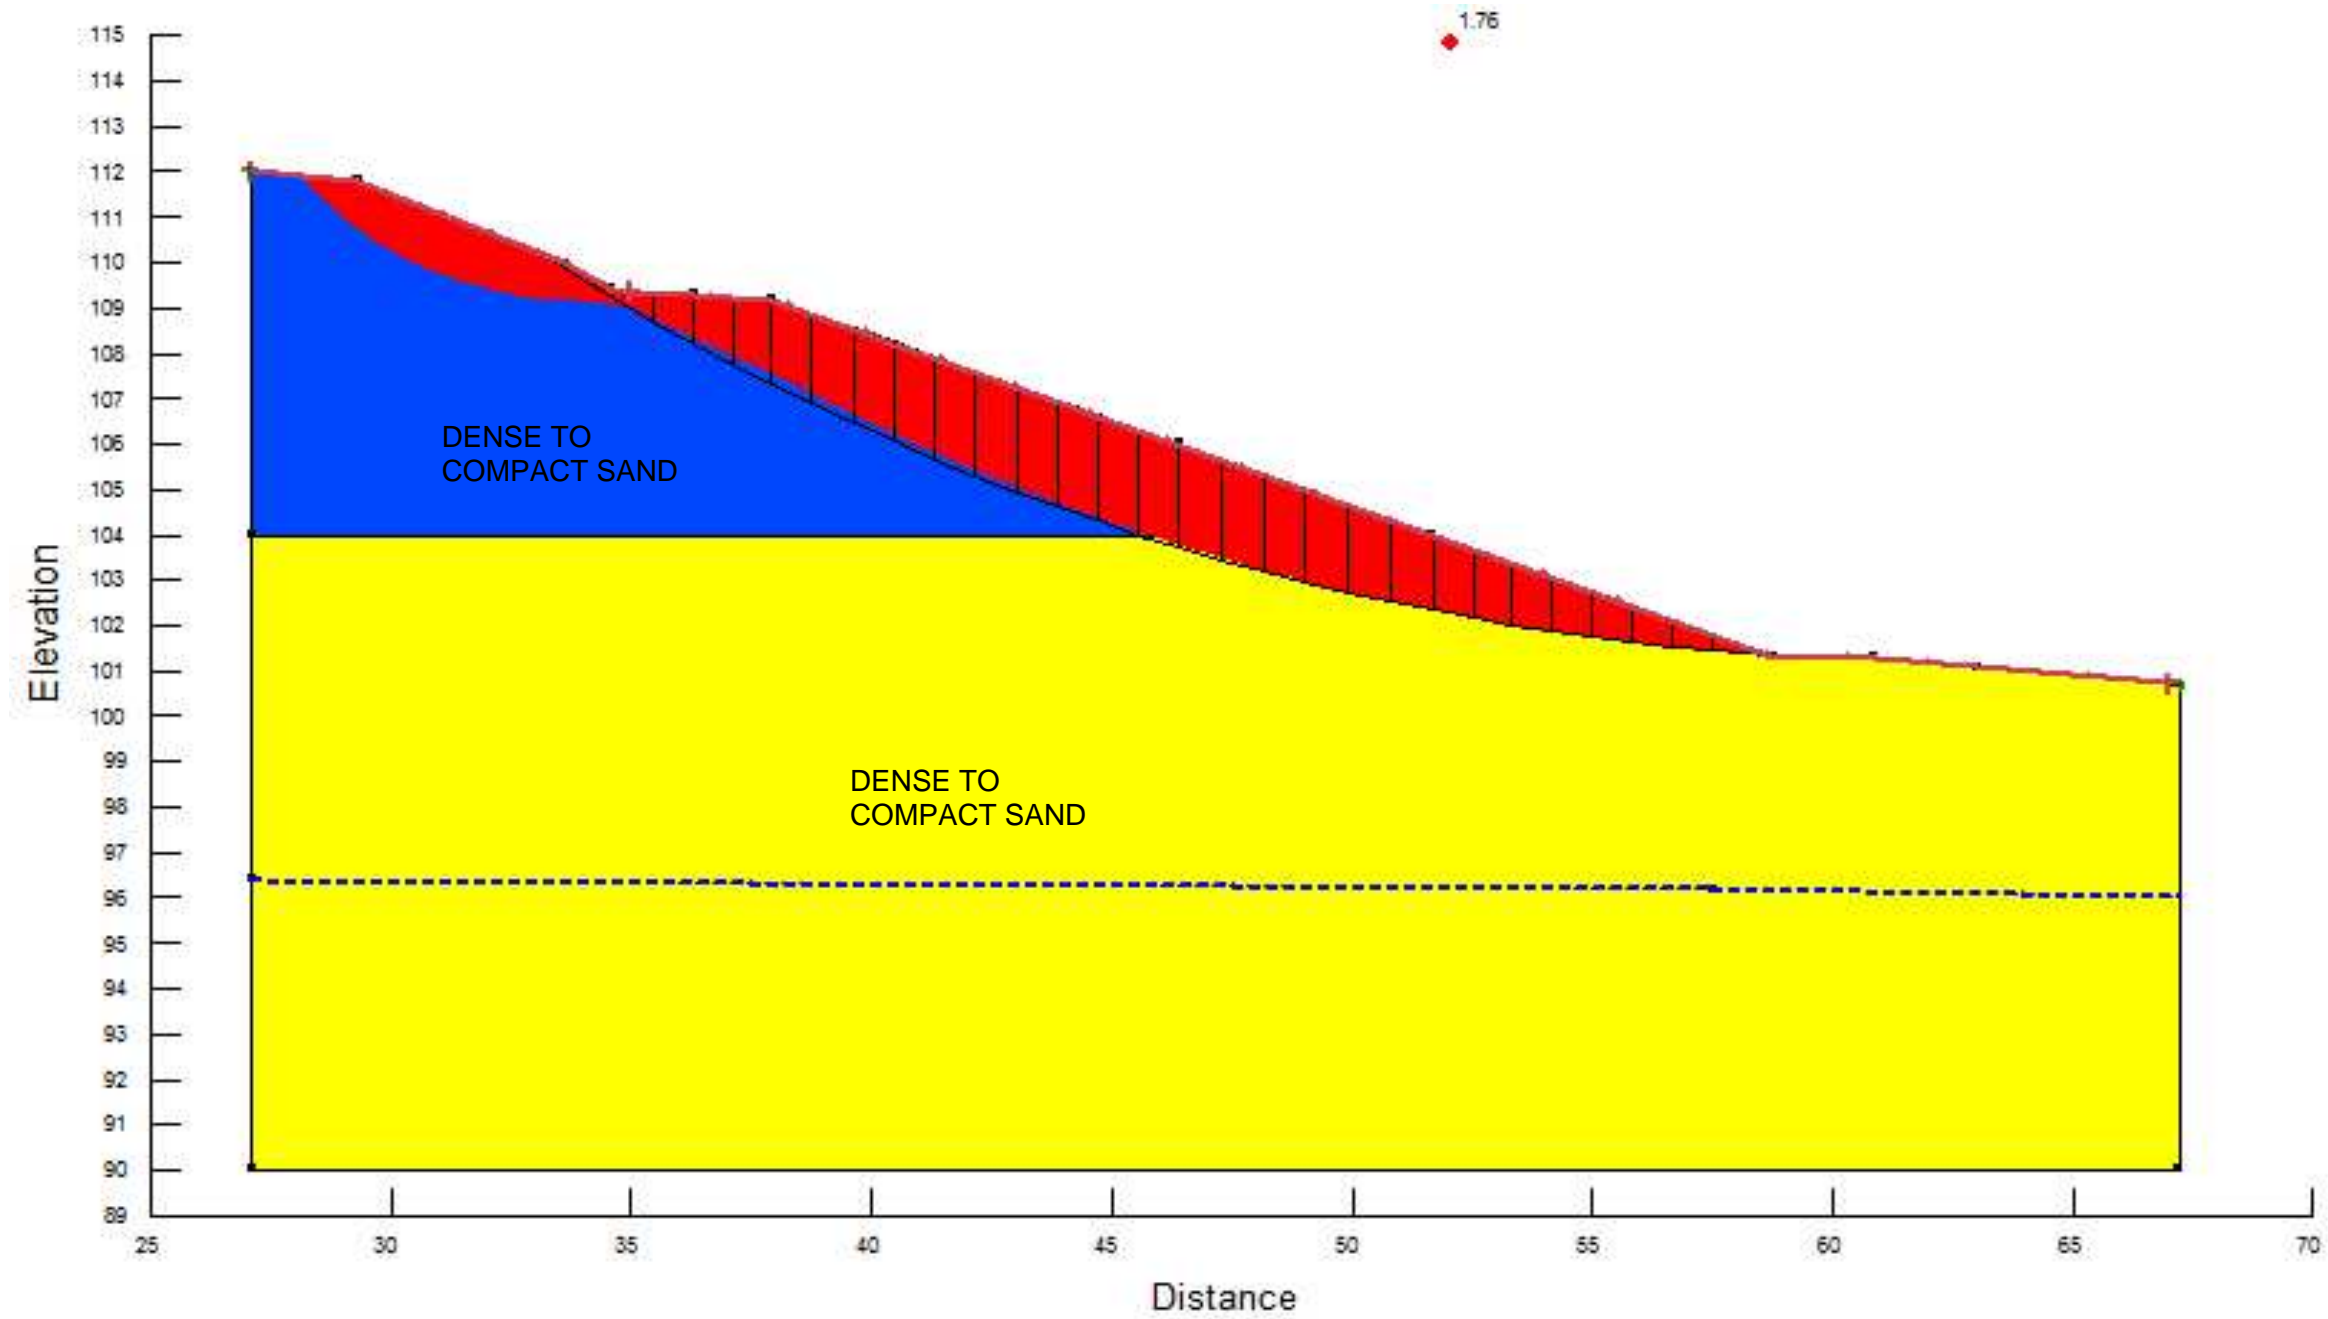
Figure 11A

Color	Name	Model	Unit Weight (kN/m ³)	Cohesion' (kPa)	Phi' (°)
■	Compact to dense sand	Mohr-Coulomb	19.7	0	31
■	Dense to compact sand	Mohr-Coulomb	19.7	0	31

Section A-A'

Table 6: Results of Slope Stability Analyses			
Section	Loading Condition	Factor of Safety	Figure No.
Section A-A	Effective Stress Analysis	1.76	11A
	Effective Stress Analysis with seismic loading	1.1	11B
Section B-B	Effective Stress Analysis	1.73	12A
	Effective Stress Analysis with seismic loading	1.1	12B
Section C-C	Effective Stress Analysis	1.38	13A
	Effective Stress Analysis with seismic loading	0.93	13B
Section D-D	Effective Stress Analysis	1.11	14A
	Effective Stress Analysis with seismic loading	0.76	14B
Section E-E	Effective Stress Analysis	1.42	15A
	Effective Stress Analysis with seismic loading	0.92	15B

Current practice in the industry and the City of Ottawa requires a factor of safety of 1.5 for static loading conditions (i.e., for effective stress and total stress analyses). The minimum acceptable factor of safety for seismic loading conditions is 1.1 (Mitchell 1983). A review of Table 6 indicates that the slope sections C-C, D-D, and E-E do not meet the City of Ottawa criteria for static loading conditions. Also, Sections C-C, D-D, and E-E do not meet the acceptable factor of safety for seismic loading conditions.

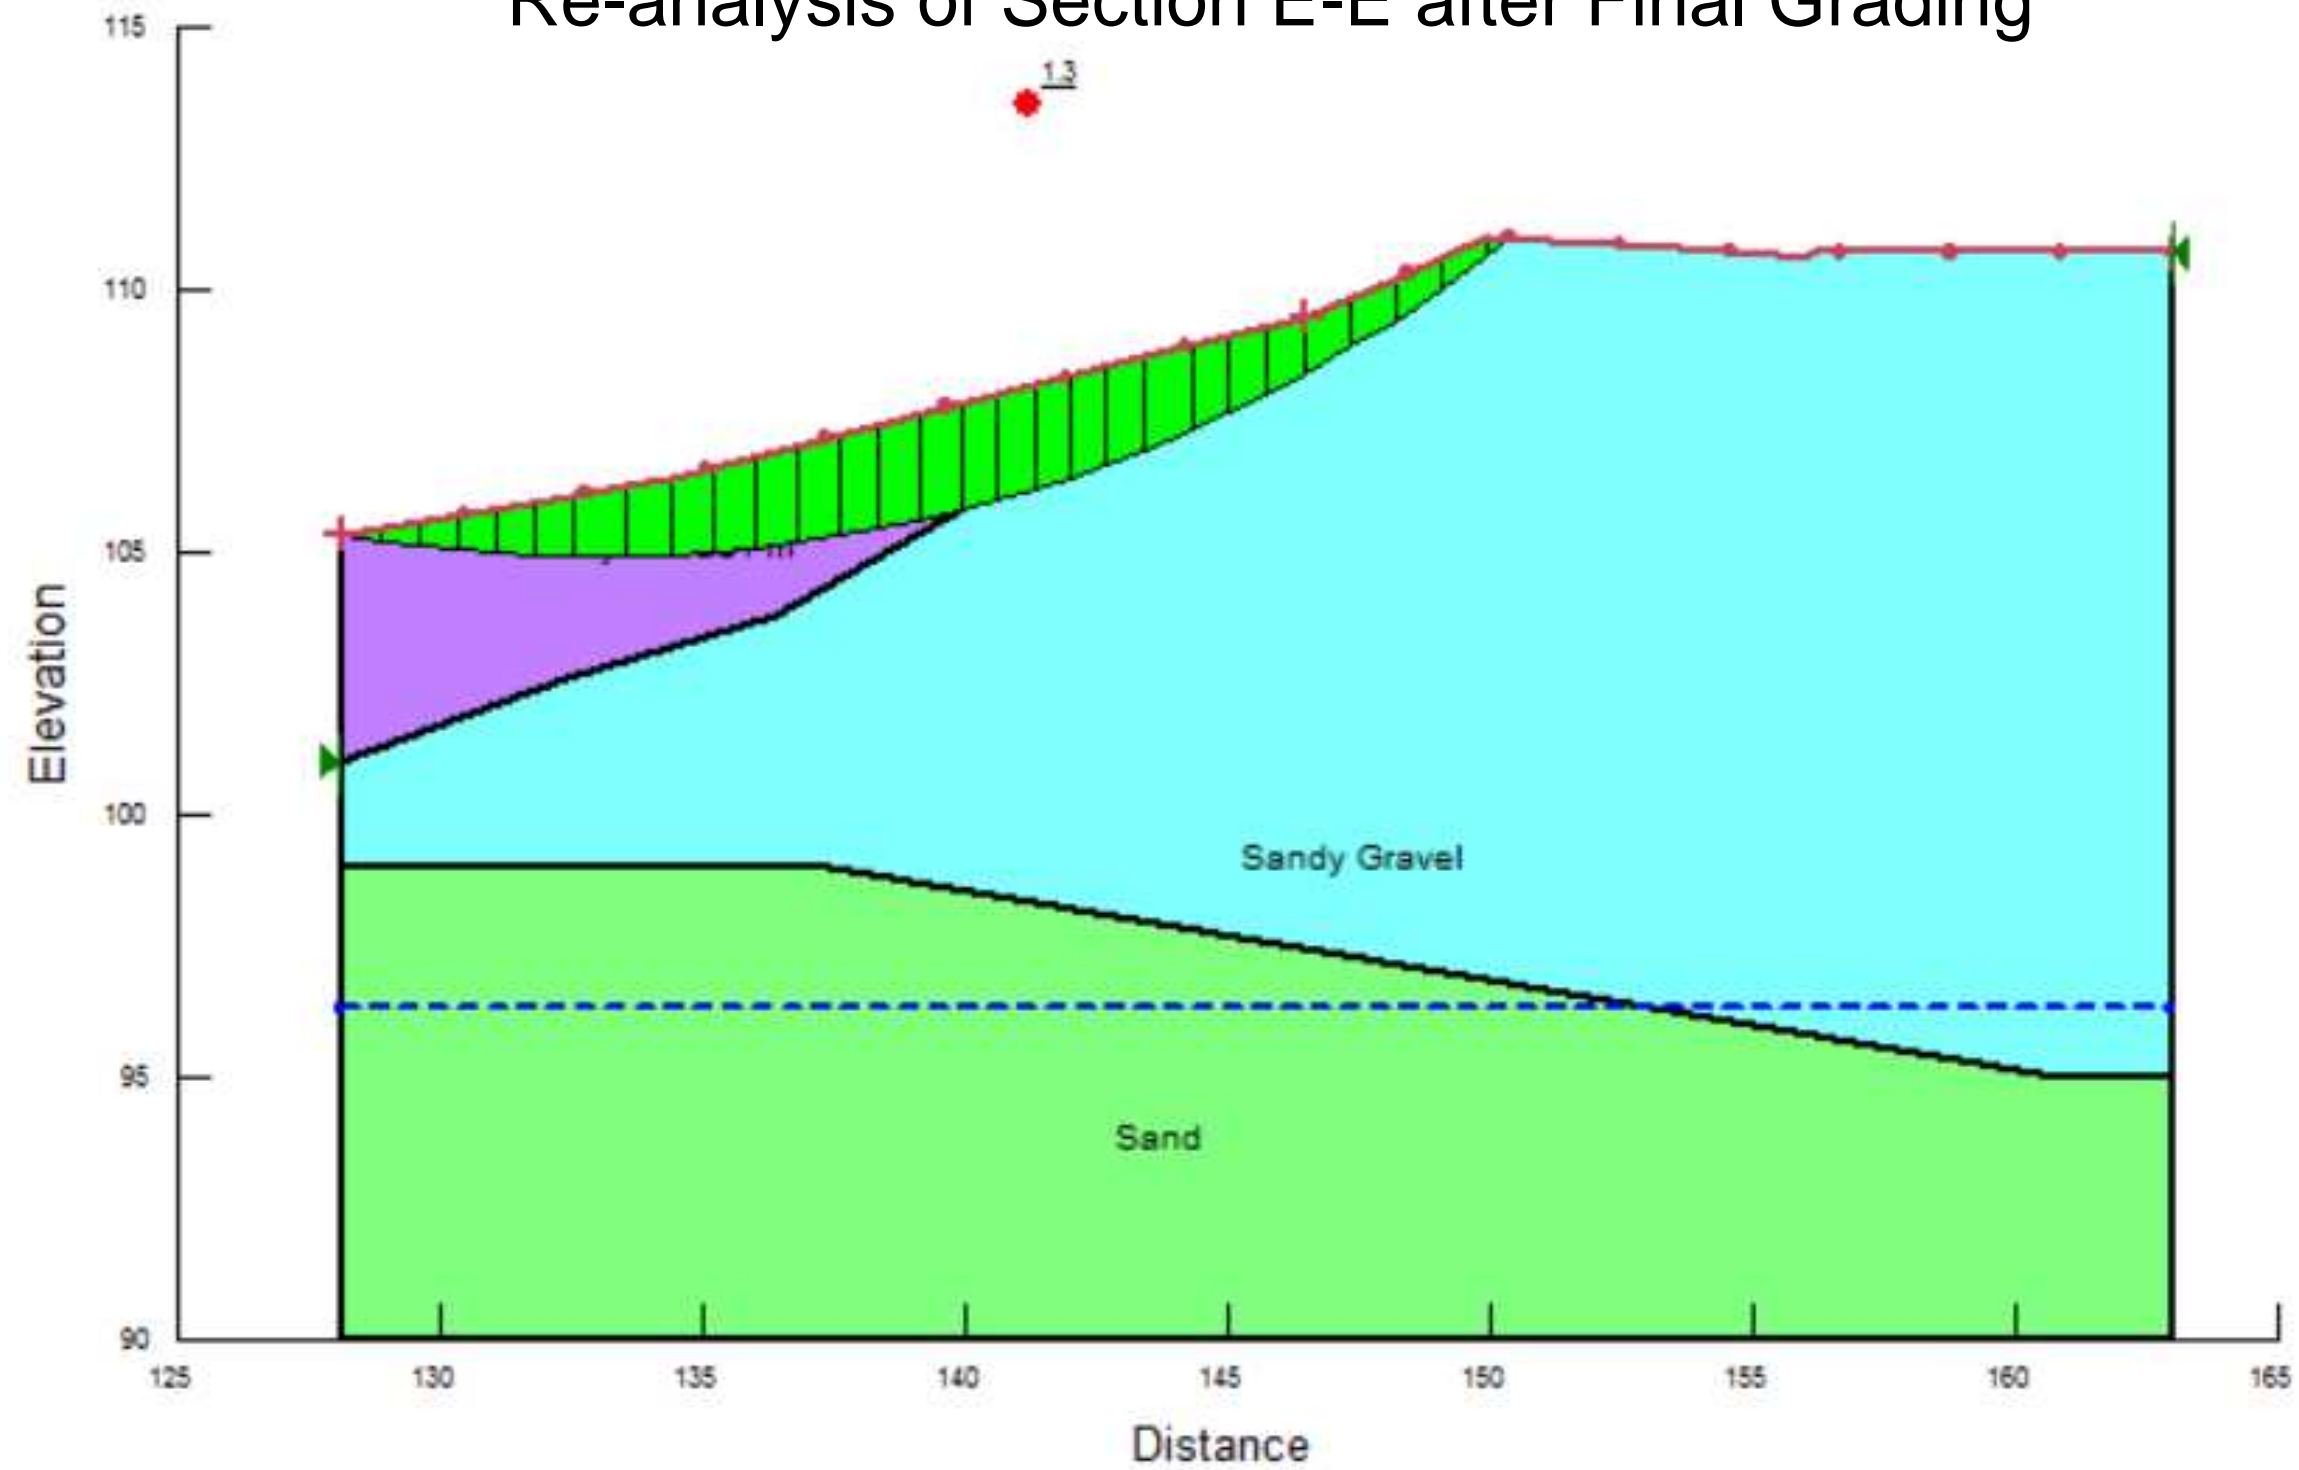
Re-analysis of Section E-E after Final Grading

Color	Name	Model	Unit Weight (kN/m ³)	Cohesion' (kPa)	Phi' (°)
Light Green	Compact to Dense Sand	Mohr-Coulomb	19.7	0	31
Purple	HydroVac Fill	Mohr-Coulomb	18	0	27
Green	Sand	Mohr-Coulomb	19.8	0	30

DATE	Aug 26, 2022	CLIENT:	DRAIN-ALL LTD.	project no.	OTT-21023795-A0
DESIGN	DW	CHECKED	SA	TITLE:	PSEUDO-STATIC SLOPE STABILITY ANALYSIS
DRAWN BY	DW	4380 Trail Road, Ottawa, Ontario		scale	Not to scale
					Figure 17B

Table 8: Results of Slope Stability Analyses of Proposed Slopes			
Section	Loading Condition	Factor of Safety	Figure No.
Section D-D	Effective Stress Analysis	3.0	16A
	Effective Stress Analysis with Seismic Loading	1.5	16B
Section E-E	Effective Stress Analysis	2.3	17A
	Effective Stress Analysis with Seismic Loading	1.3	17B
Section X-X	Effective Stress Analysis	1.8	18A
	Effective Stress Analysis with Seismic Loading	1.1	18B
Section Y-Y	Effective Stress Analysis	1.7	19A
	Effective Stress Analysis with Seismic Loading	1.1	19B
Section Z-Z	Effective Stress Analysis	1.7	20A
	Effective Stress Analysis with Seismic Loading	1.1	20B

The results of the analysis indicate the analyzed slopes will meet the required factor of safety of 1.5 for static loading conditions (i.e., for effective) and 1.1 for seismic loading conditions and the slopes are expected to be stable.

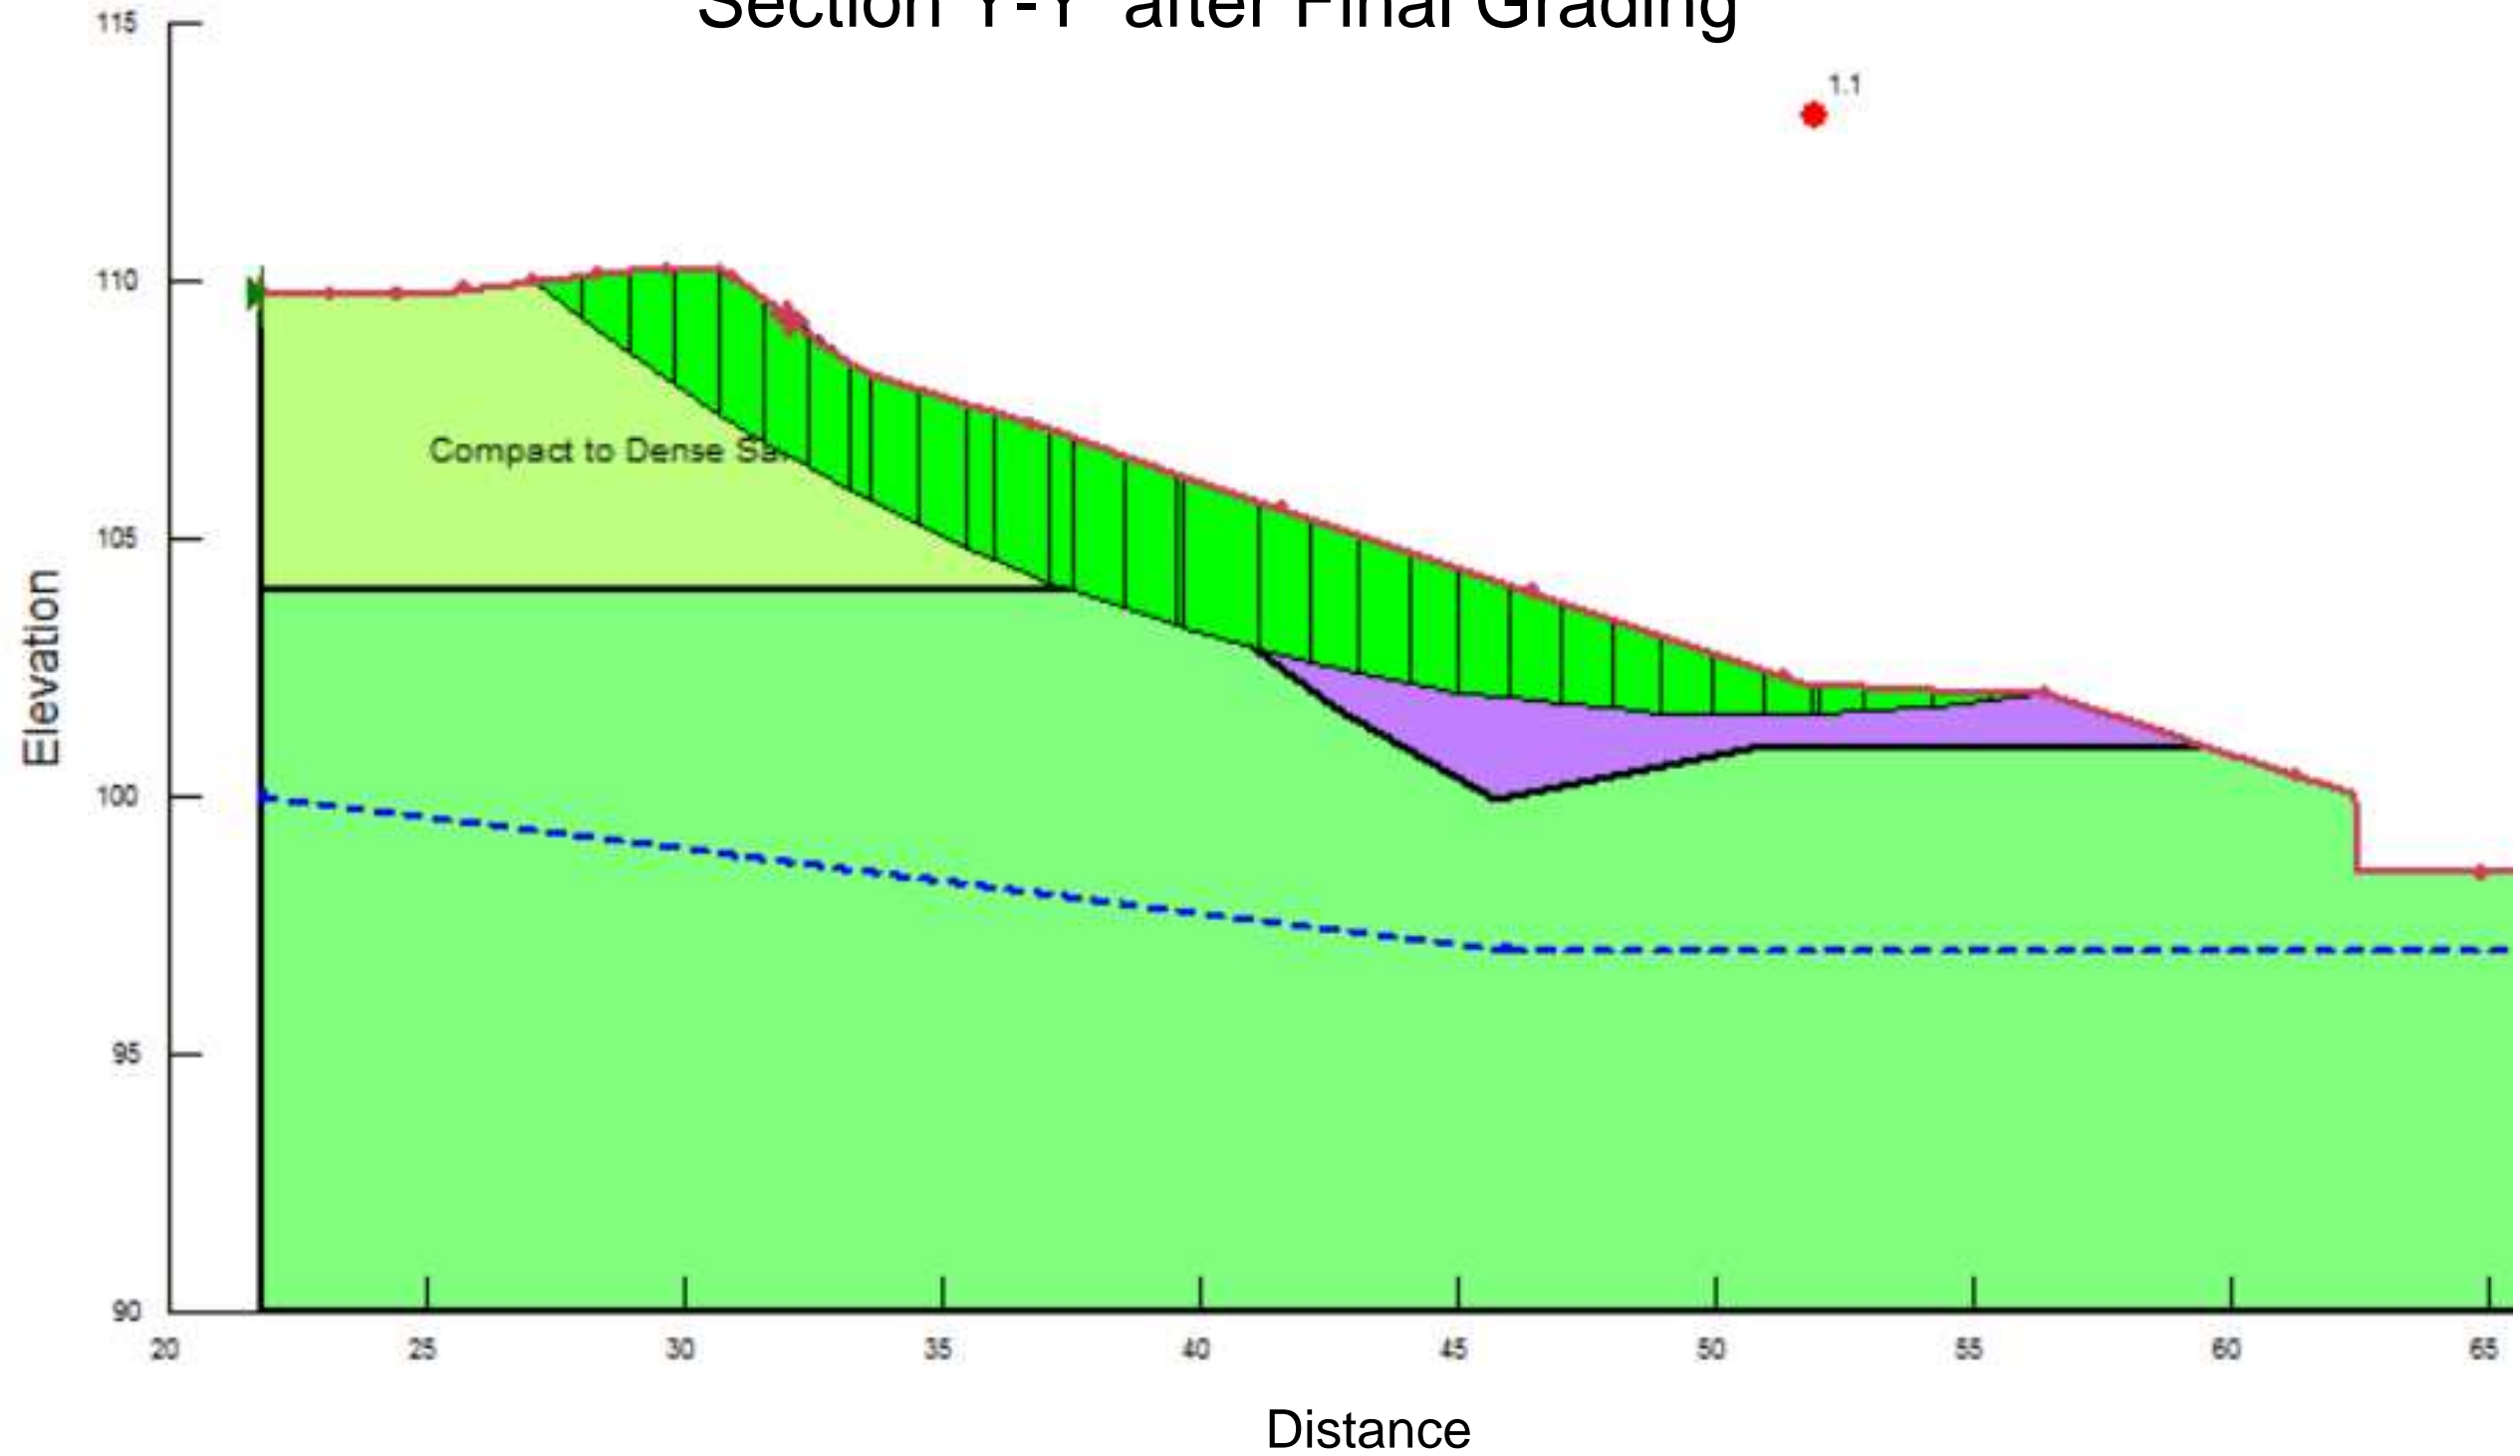
Section Y-Y' after Final Grading

Color	Name	Model	Unit Weight (kN/m ³)	Cohesion' (kPa)	Phi' (°)
Light Green	Compact to Dense Sand	Mohr-Coulomb	19.7	0	31
Purple	HydroVac Fill	Mohr-Coulomb	18	0	27
Green	Sand	Mohr-Coulomb	19.8	0	30
