**Phase One and Phase Two Environmental Site Assessment Update  
Proposed Residential Re-development  
265 Catherine Street, Ottawa, ON**

This letter outlines our background information, updated historical source information review, Site Inspection and findings for an update to the existing Phase One Environmental Site Assessment (ESA) and Phase Two ESA reports at the property Civically addressed as 265 Catherine Street, Ottawa, ON ("Site").

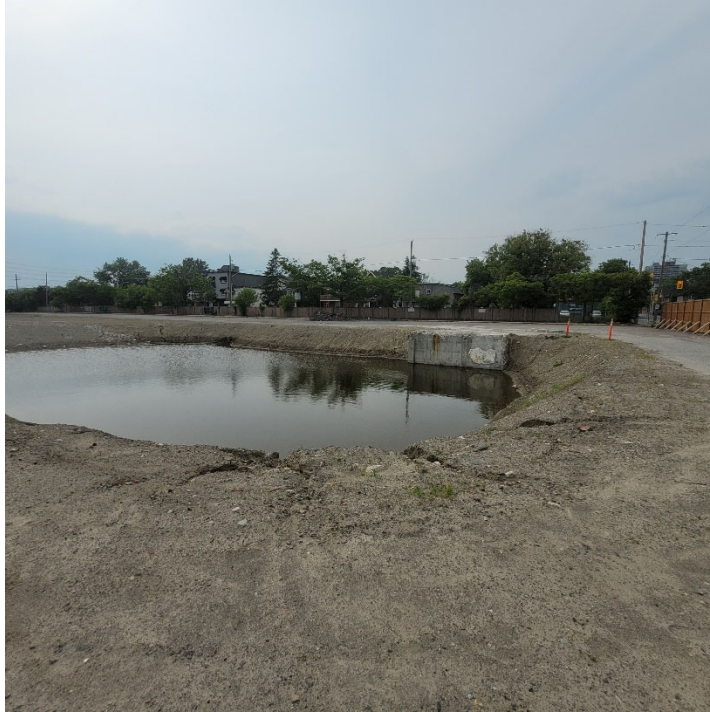
Photograph 1: View of excavation of the former building footprint which had filled with water. The foundation wall adjacent to the diesel UST was left in place. View is looking northwest.

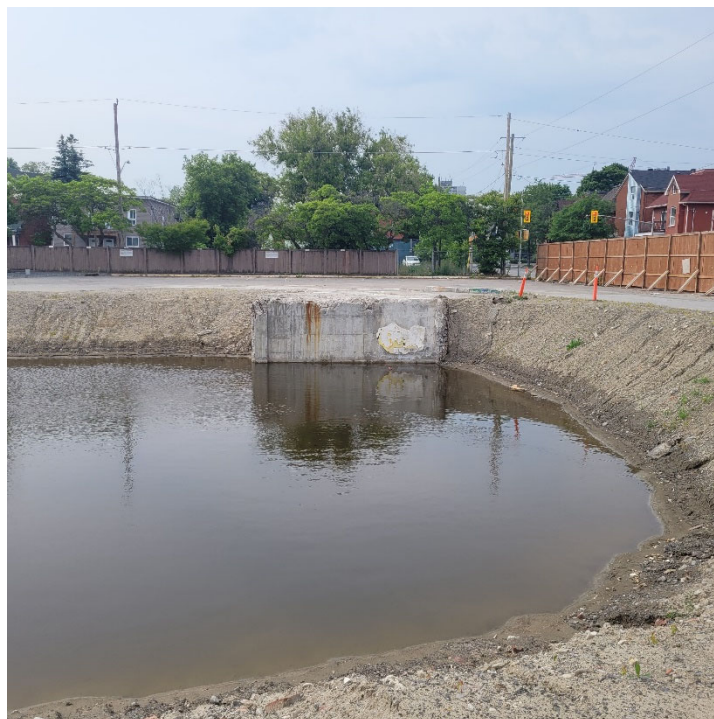
Photograph 2: View of excavation of the former building footprint which had filled with water. The foundation wall adjacent to the diesel UST was left in place. View is looking north.

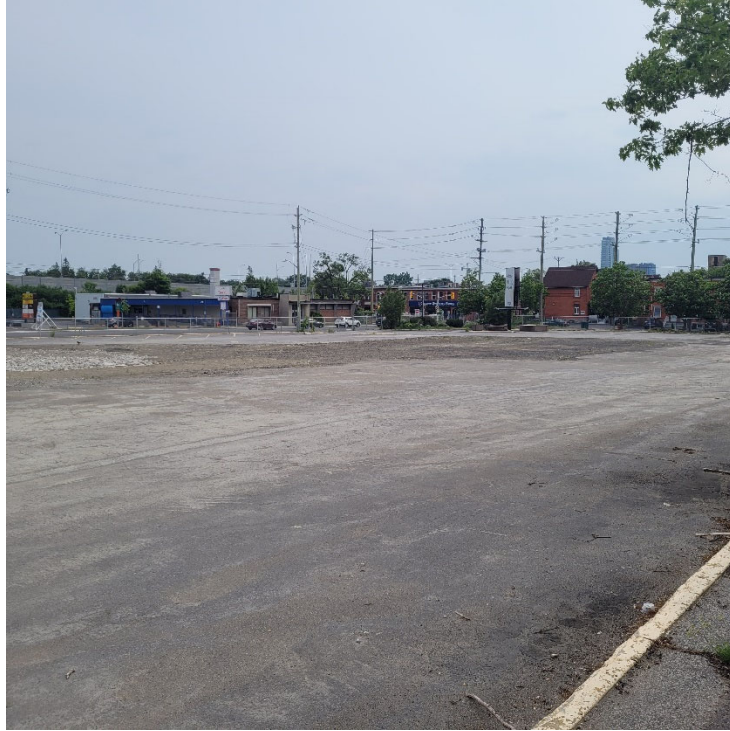
Photograph 3: View of Site (vacant) looking southwest from the northeast portion of the Property.

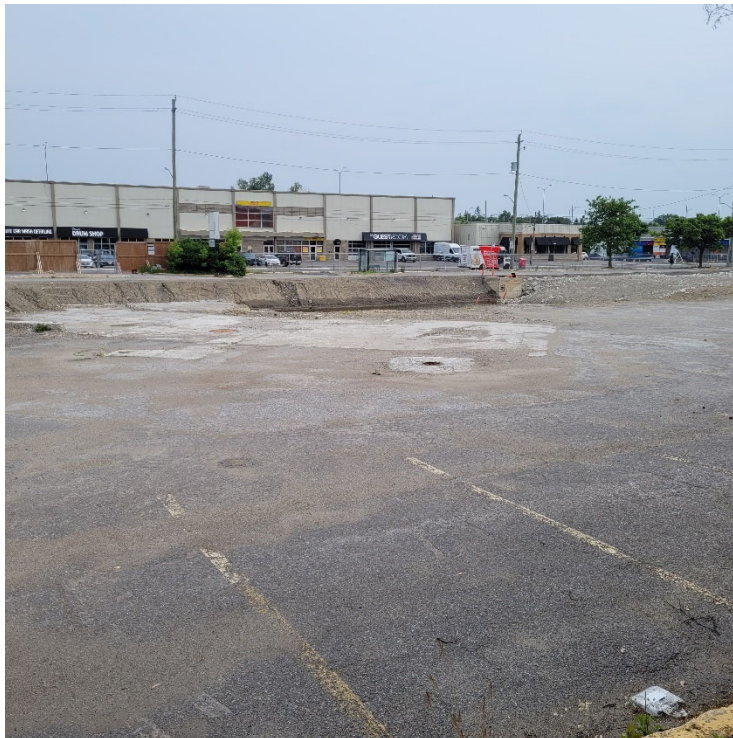
- 45,400 L Diesel UST, observed to have been emptied;
- 4,540 L Steel Waste Oil UST, observed to have previously contained an oily/water mixed, which was reportedly removed by Brigil's demolition contractor in October 2022; and,
- Septic Holding Tank, underground, contents unknown/uninvestigated.

Photograph 4: View of the fill caps for the diesel UST and septic holding tank on the northeast portion of the Site. View is looking south.

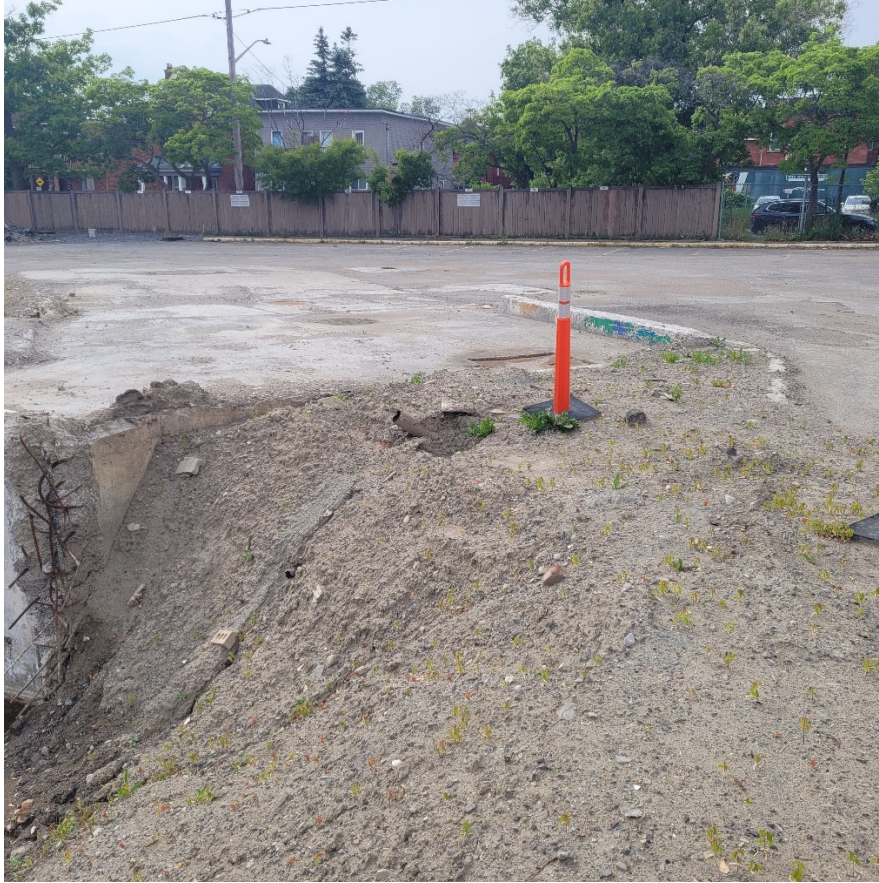
Photograph 5: View of the existing Waste Oil UST, which was emptied and had its contents disposed of off-Site in October 2022.
