Phase One Environmental Site Assessment

265 Catherine Street
Ottawa, Ontario

Prepared for:
11034936 Canada Inc.

LOP21-018A

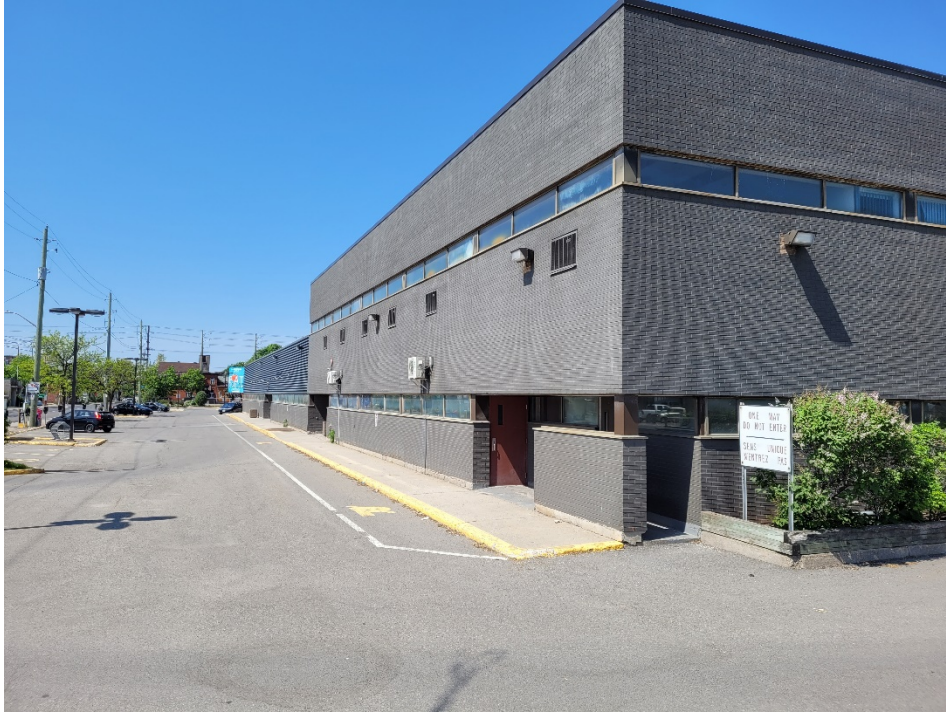
Photograph 1: View of Phase One Property looking west on the southeast portion of the Property. View shows the south side (front) of the commercial building at the Property.

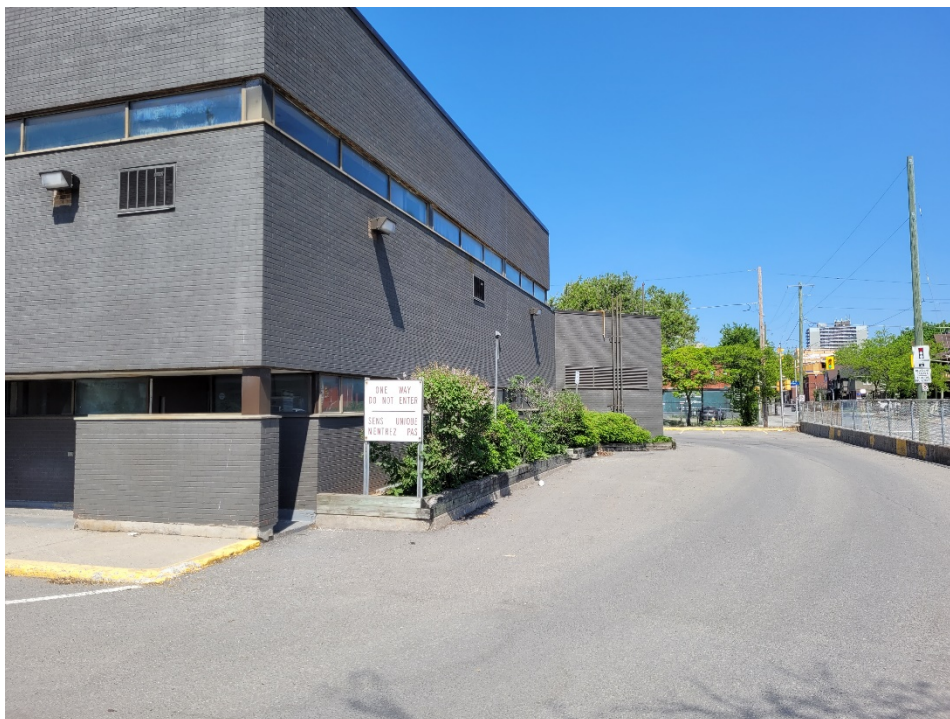
Photograph 2: View of Phase One Property looking north from the southeast corner of the Property. View shows the vent pipes associate with a former aboveground fuel storage tank and an underground waste oil storage tank, associated with the service garage on the east portion of the Property.

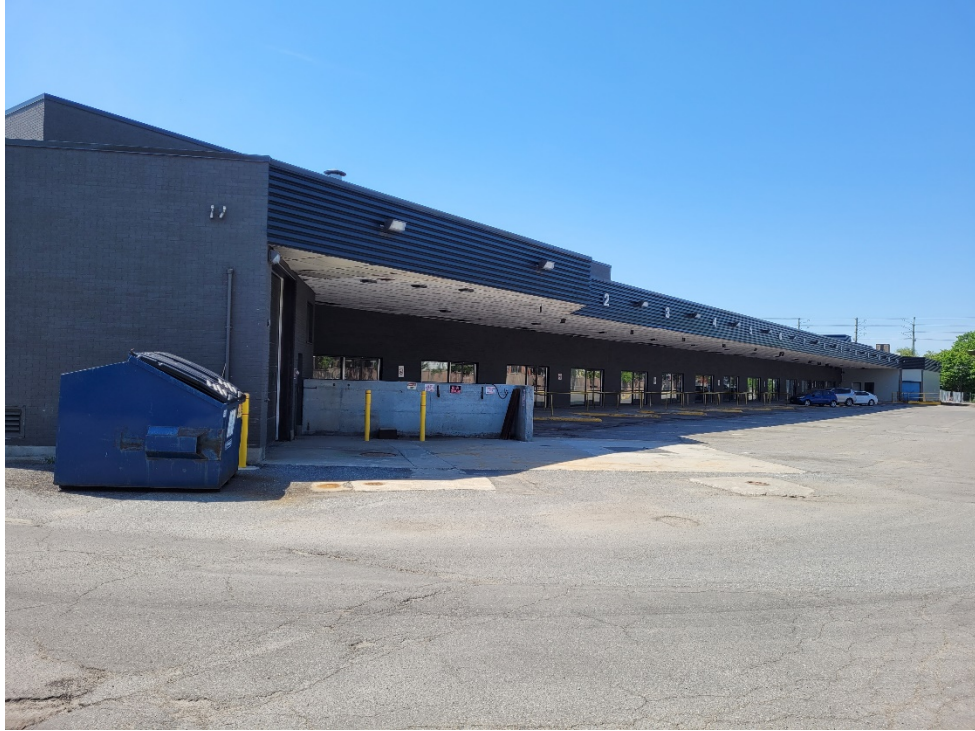
Photograph 3: View of the north side of the Phase One Property looking west. View shows the terminals for the former central bus station. The diesel underground storage tank and former fueling area is visible in this photograph.
