Tree Conservation Report

5646/5650 Manotick Main St.
Manotick, ON K4M 1B3

May 4, 2023

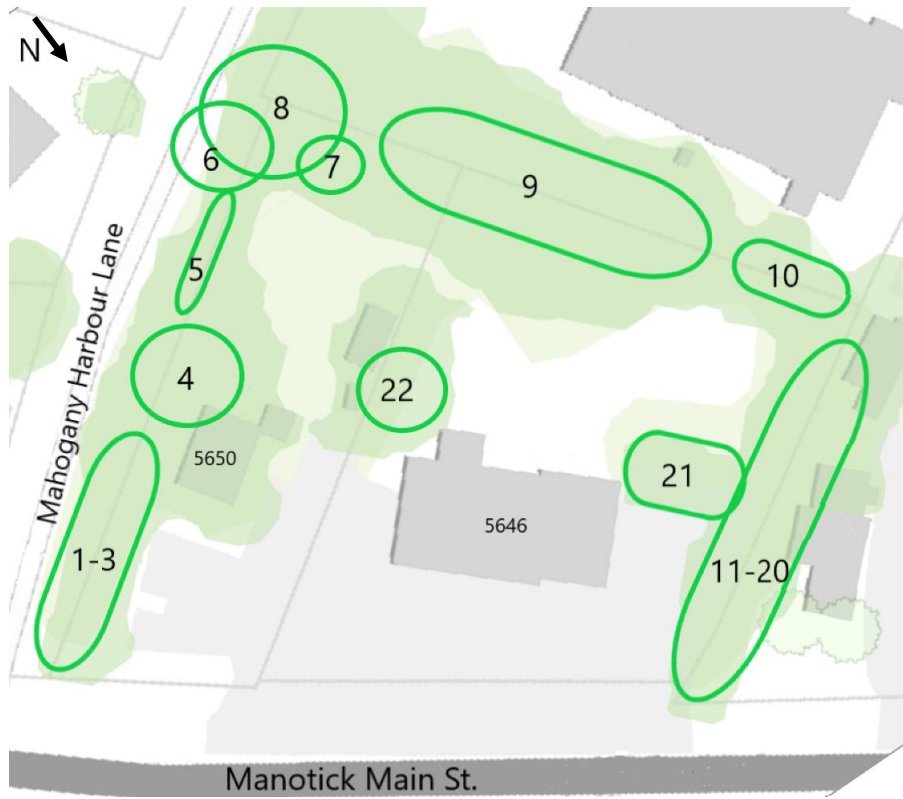
Map #1: Existing vegetation

All trees in the tables below are labelled on Map#1 with the allocated number.

Indicates existing trees or clusters of trees

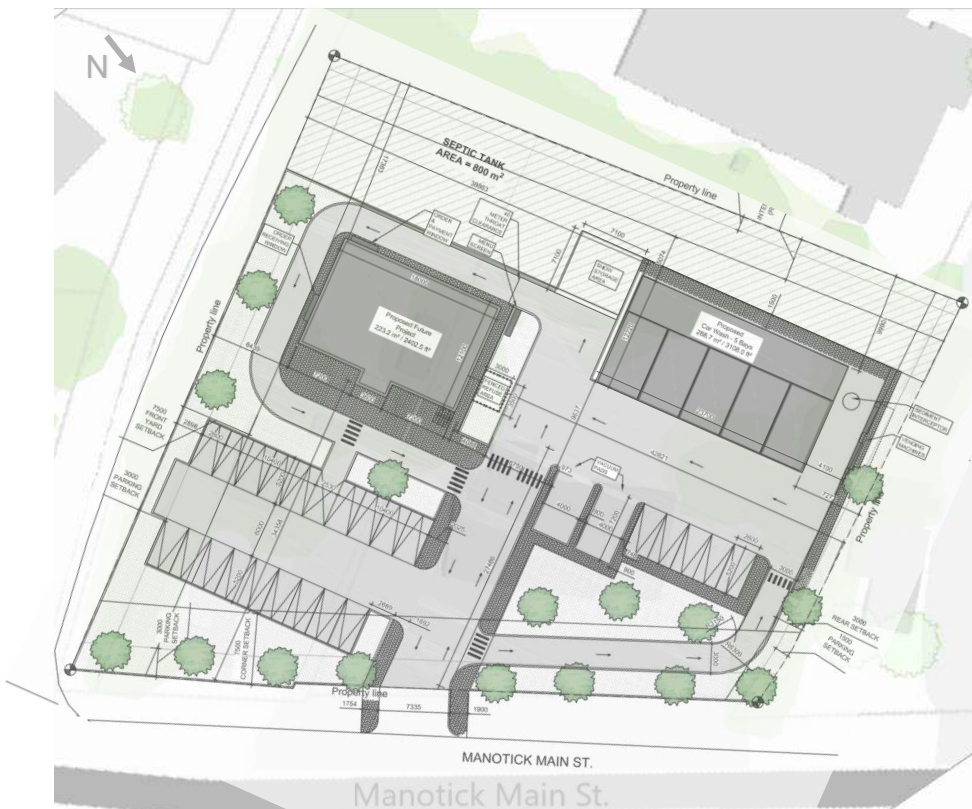
Map #2: Overlay of development plans onto area map.

Trees to be planted

As a significant amount of canopy and screening between the commercial property and existing residential properties is to be removed, trees should be planted as replacement in these areas particularly, as well as in front of the property.
