December 16, 2022  
CO884.00

Ms. Jade Hawkins  
595831 Ontario Inc.  
650 Eagleson Road  
Kanata, Ontario  
K2M 1H4

**Re: Designated Substances Survey  
5646 Manotick Main Street, Ottawa, Ontario**

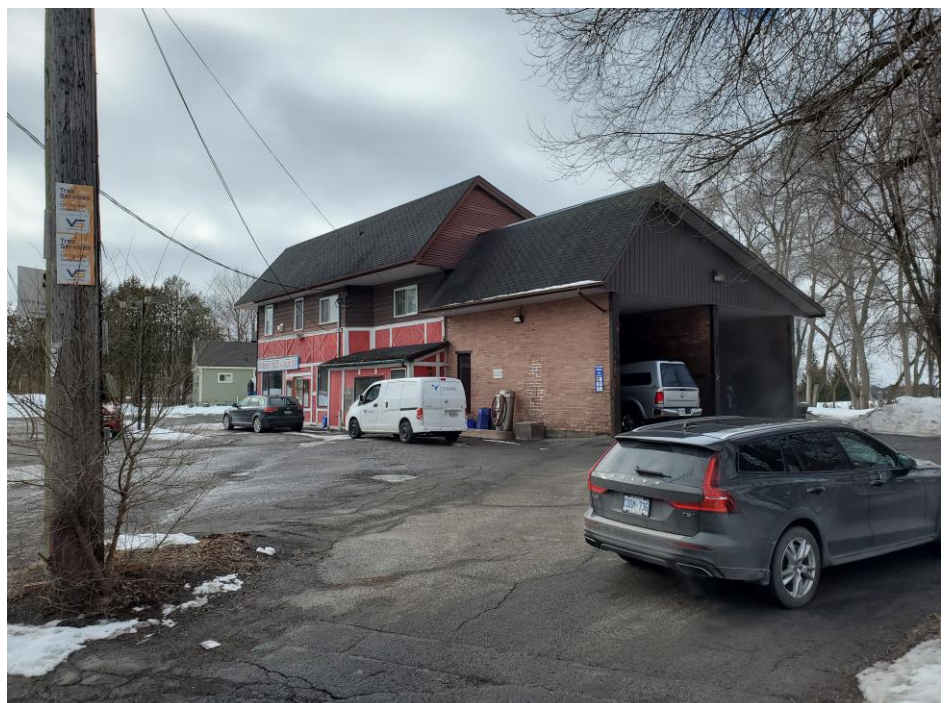
**Photo No:** 2

View of the Site from the northeastern portion of the Site. The two-bay car wash is visible in the foreground.

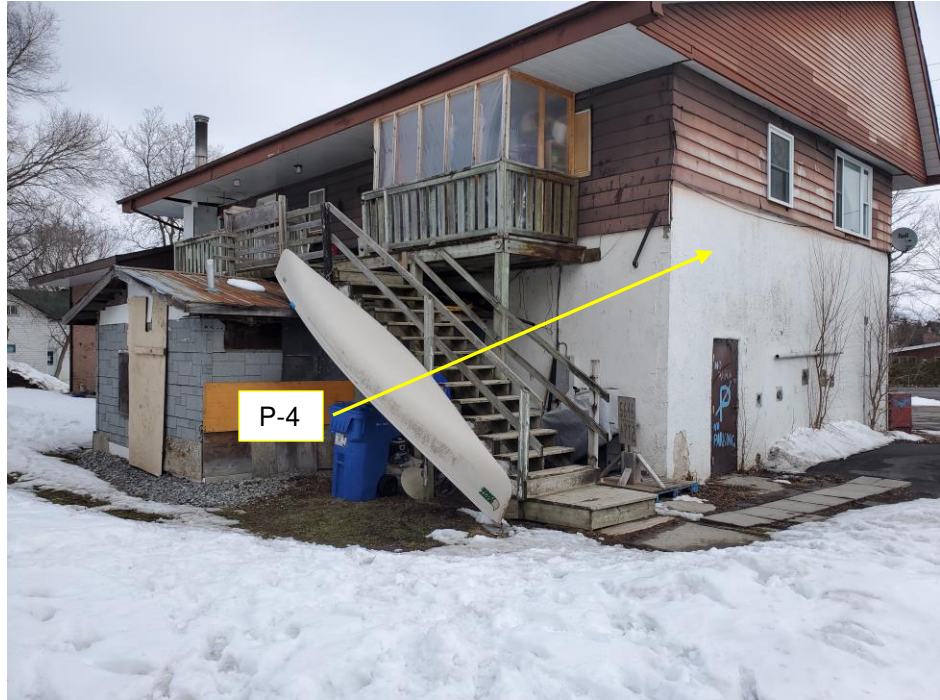
- the white paint (P-4) located on the exterior at the southern and western sides of the exterior;
- beige-brown paint (P-5) located on the first floor of the building;
- grey paint (P-6) located on first floor
- green paint (P-7) located on first floor
- yellow-green paint (P-9) located on first floor
- white paint (P-11) located on wood siding on exterior of building.

A view of exterior and side of the building. The white paint is where paint sample P-4 was collected.

Demolition and renovation contractors should ensure the use of appropriate personal protective equipment and proper dust control measures to protect themselves and the public from potential exposure by inhalation of silica dust or paint dust or chips.

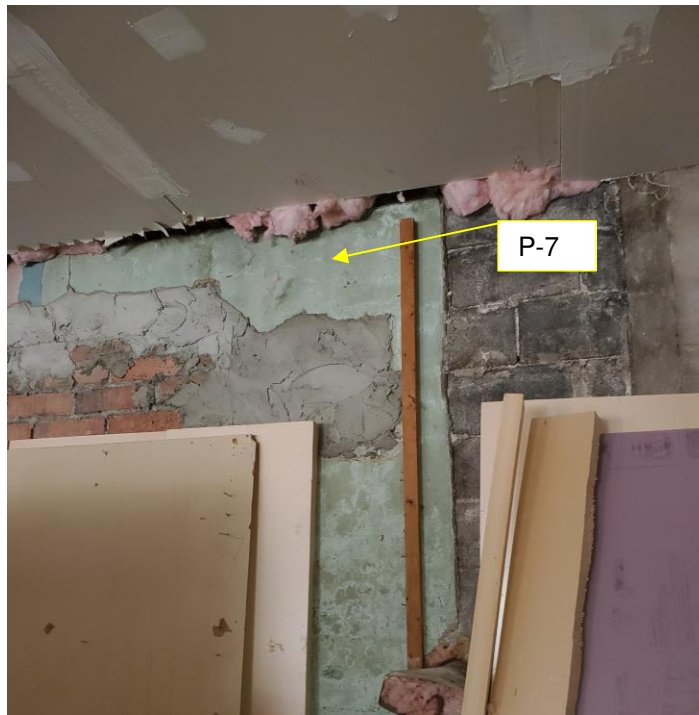
Photo No: 8

A view of the green paint (P-7) located in the first floor of the building.

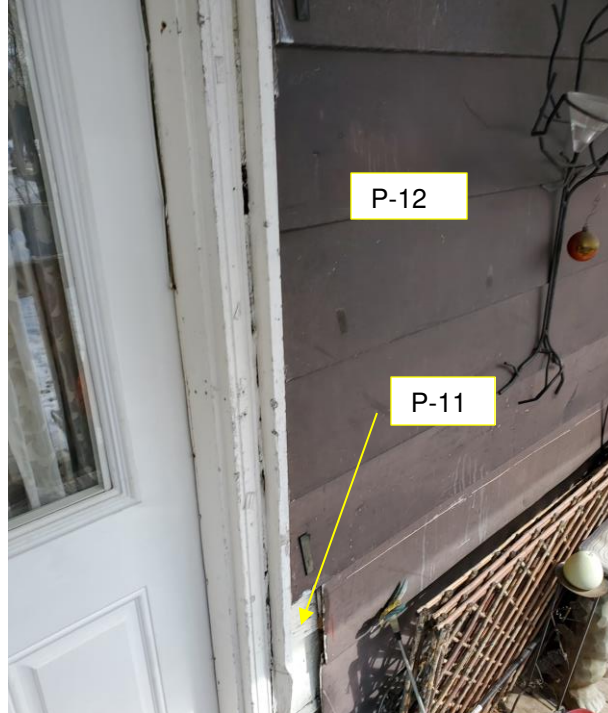
A view of white paint (P-11) and brown paint (P-12) collected from the exterior of the second story of the building.
