Phase Two Environmental Site Assessment 56 Capilano Drive, Ottawa, Ontario

Phase Two Environmental Site Assessment

OTT-22003851-A0

*McDonald Brothers Consulting Inc.
Phase Two Environmental Site Assessment
56 Capilano Drive, Ottawa, Ontario
OTT-22003851-A0
May 27, 2022*

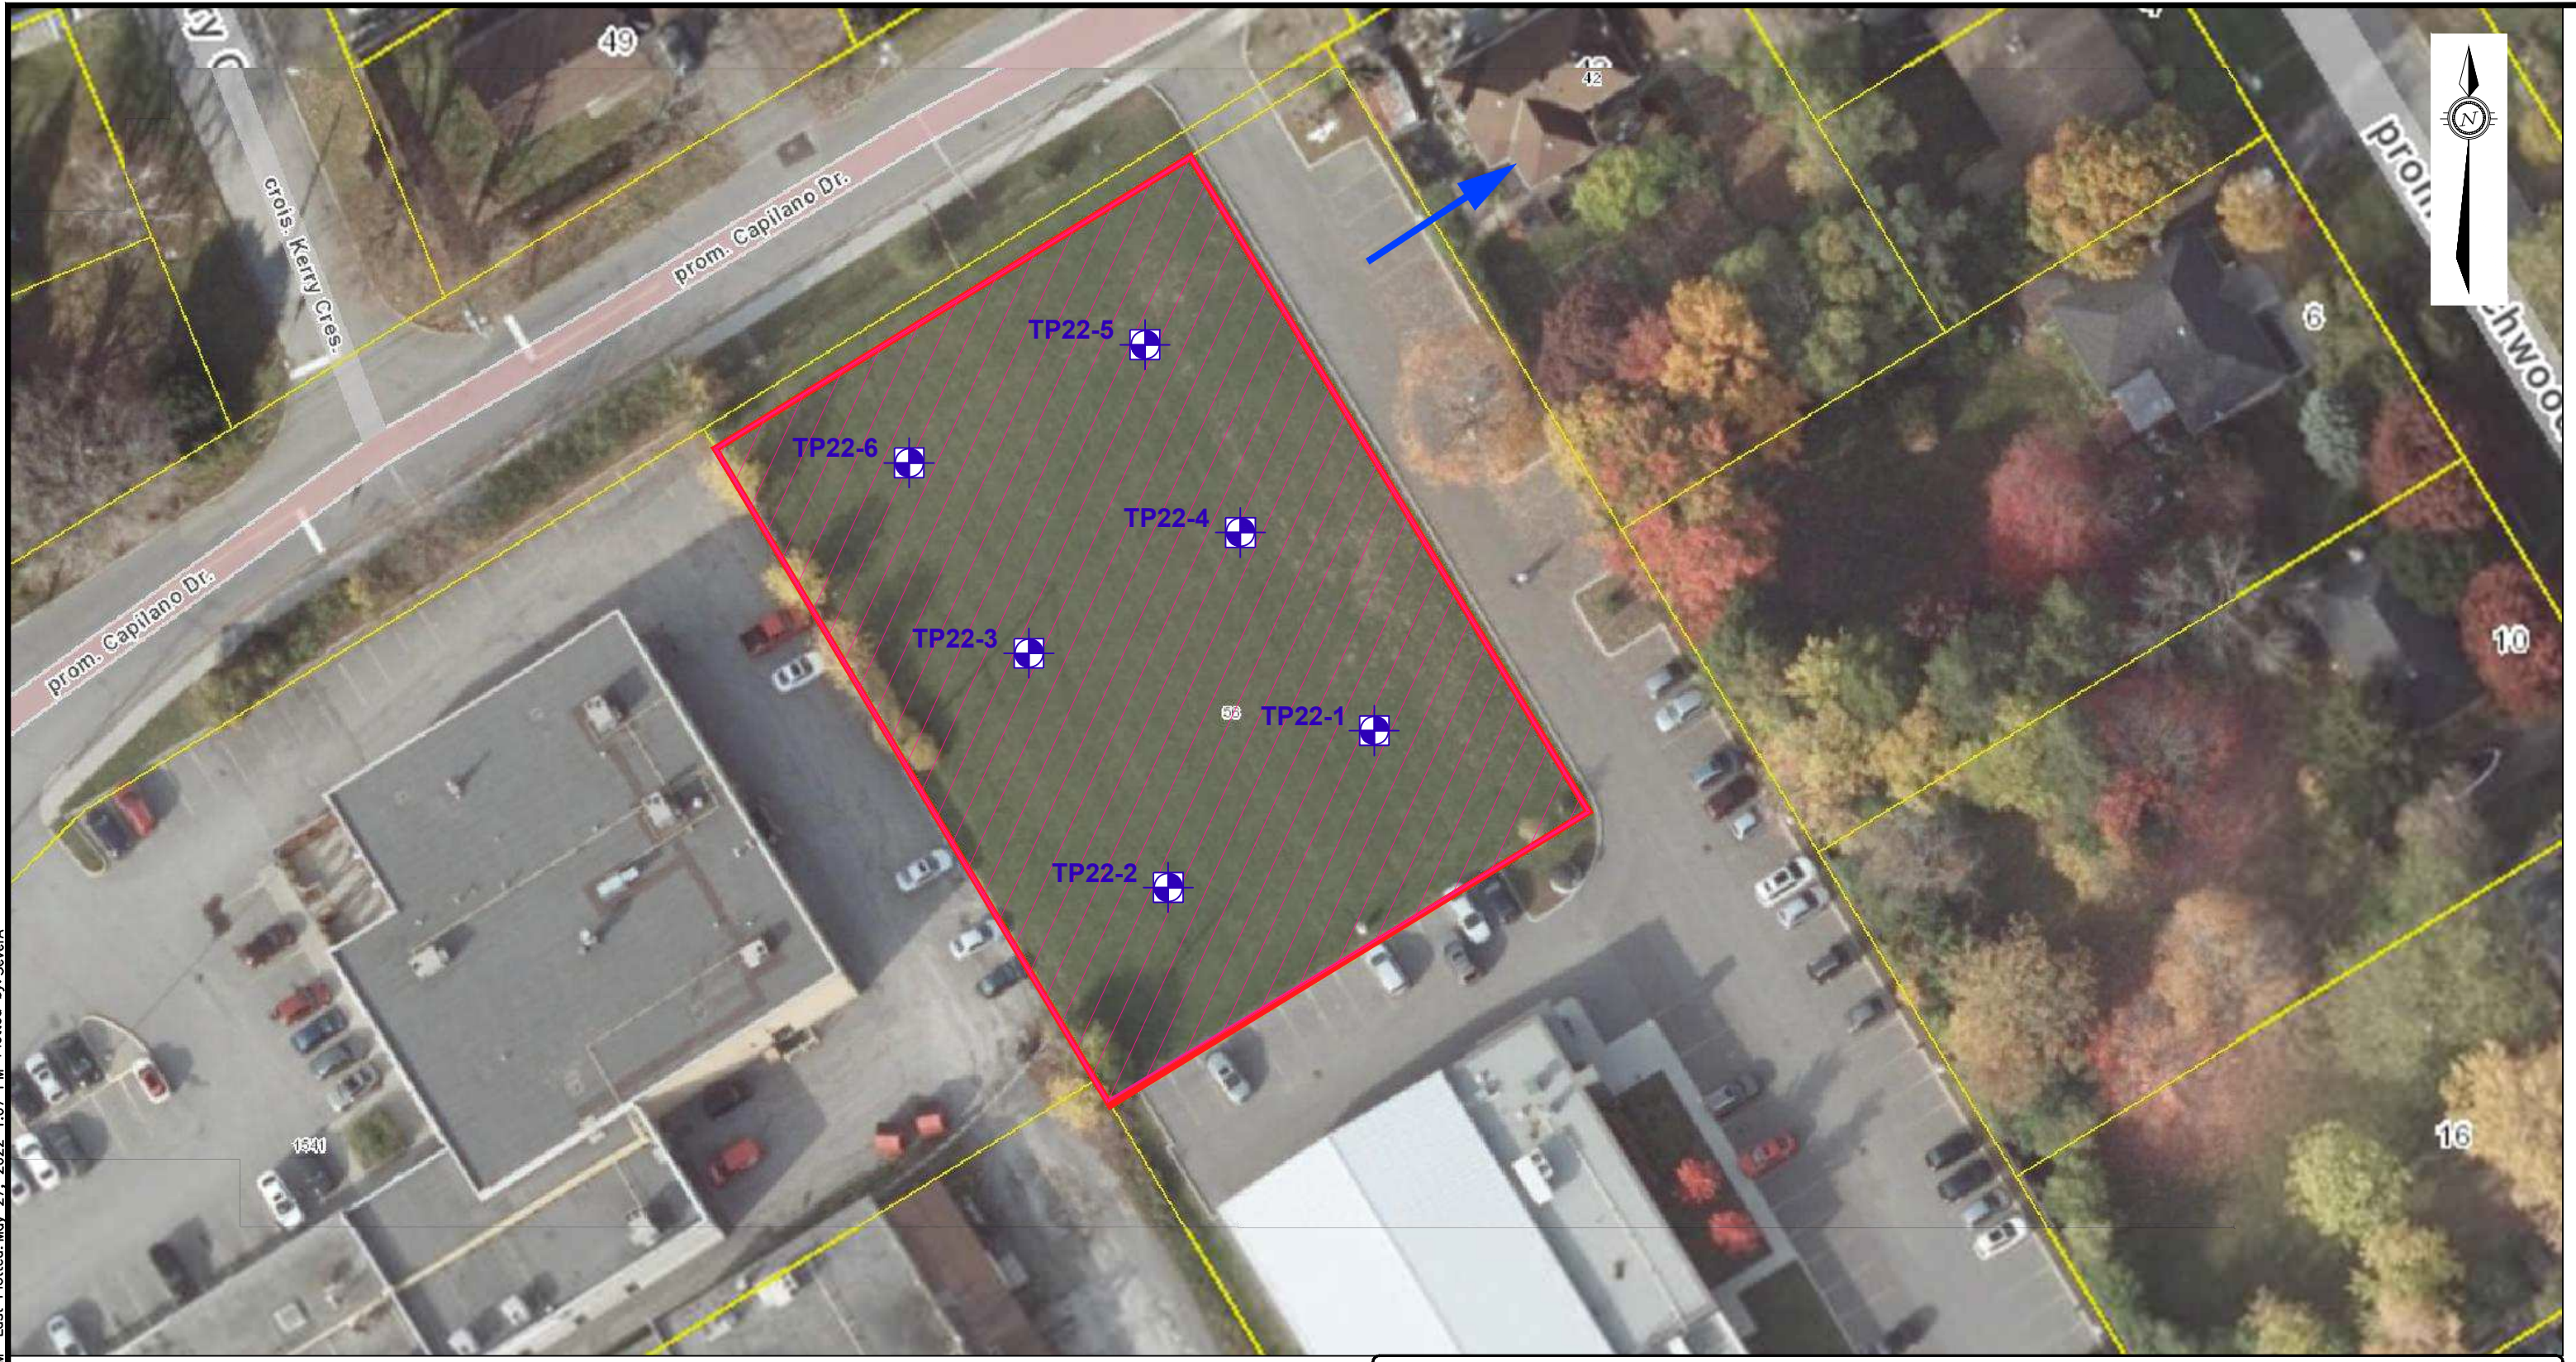
DATE MAY 2022	PHASE TWO ENVIRONMENTAL SITE ASSESSMENT	project no. OTT-22003851-A0
DESIGN LW		scale 1:500
CHECKED MM		
DRAWN BY AS	TITLE: TEST PIT LOCATION PLAN 56 CAPILANO DRIVE, OTTAWA, ONTARIO	FIG 2

On May 16, 2022, six test pits (TP22-1 to TP22-6) were advanced at the Phase Two property by Lacroix Equipment Rentals Ltd. (Lacroix) under the full-time supervision of EXP staff. Test pits were excavated to refusal on bedrock surface. Dedicated nitrile gloves (one pair per sample) were used during sample handling. No petroleum-based greases or solvents were used during excavation activities. EXP staff continuously monitored the excavating activities to log the stratigraphy observed from the pits, to record the depth of the samples, to record total depths of excavation, and to screen the samples by recording visual or olfactory observations of potential impacts and measuring petroleum vapours.

Soil at the Phase Two property generally consisted of sandy clay and gravel fill material overlying silty clay and glacial till. Small amounts of debris material (bricks, concrete, rubber debris) were present in the fill material in TP22-5 and TP22-6. There were no odours or staining observed in the fill or native material in any of the test-pits. Refusal was met in all the test pits at depths ranging between 2.0 m to 2.4 m.
