## Phase I - Environmental Site Assessment

Vacant Property  
1034 McGarry Terrace and 1117 Longfields Drive  
Ottawa, Ontario

Report: PE2830-2

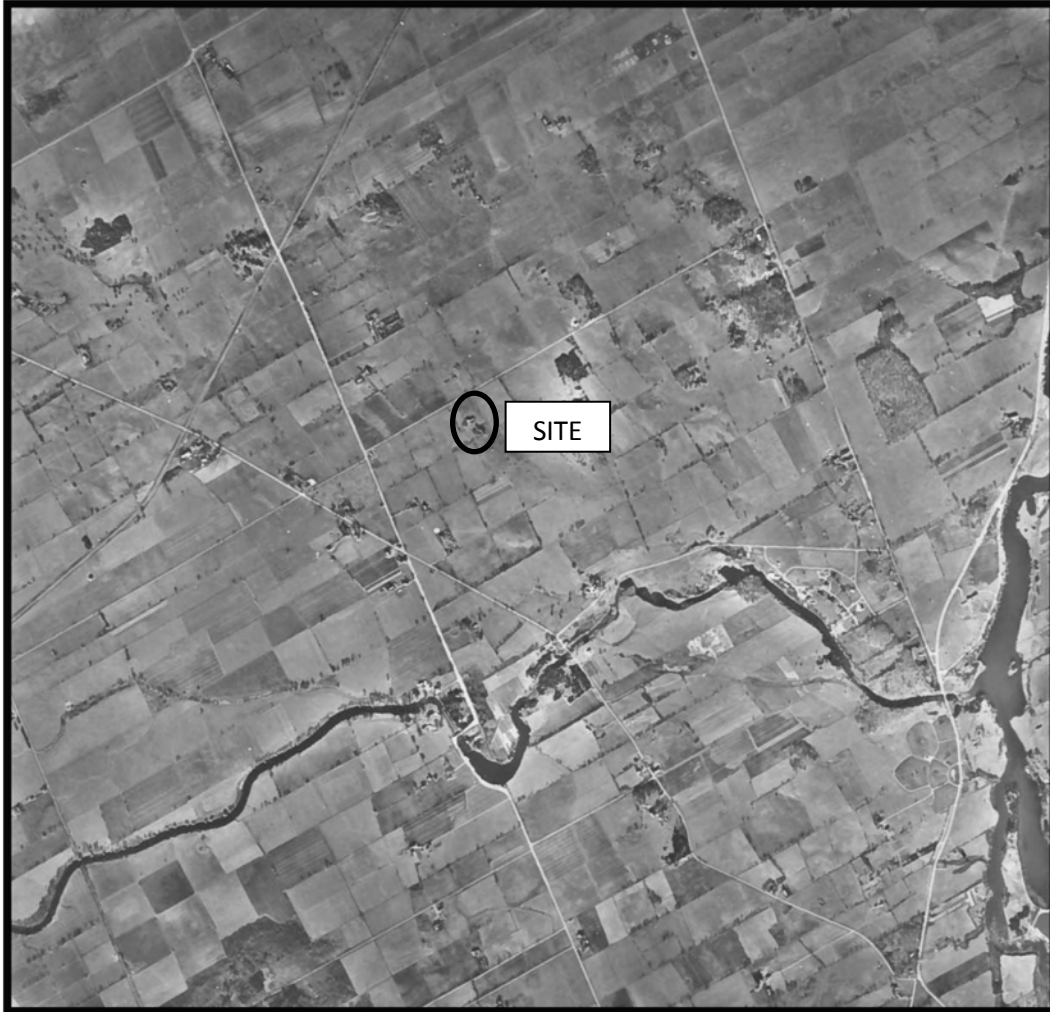
AERIAL PHOTOGRAPH  
1960

| 1960 | No significant changes appear to have been made to the subject property, or neighbouring properties. |

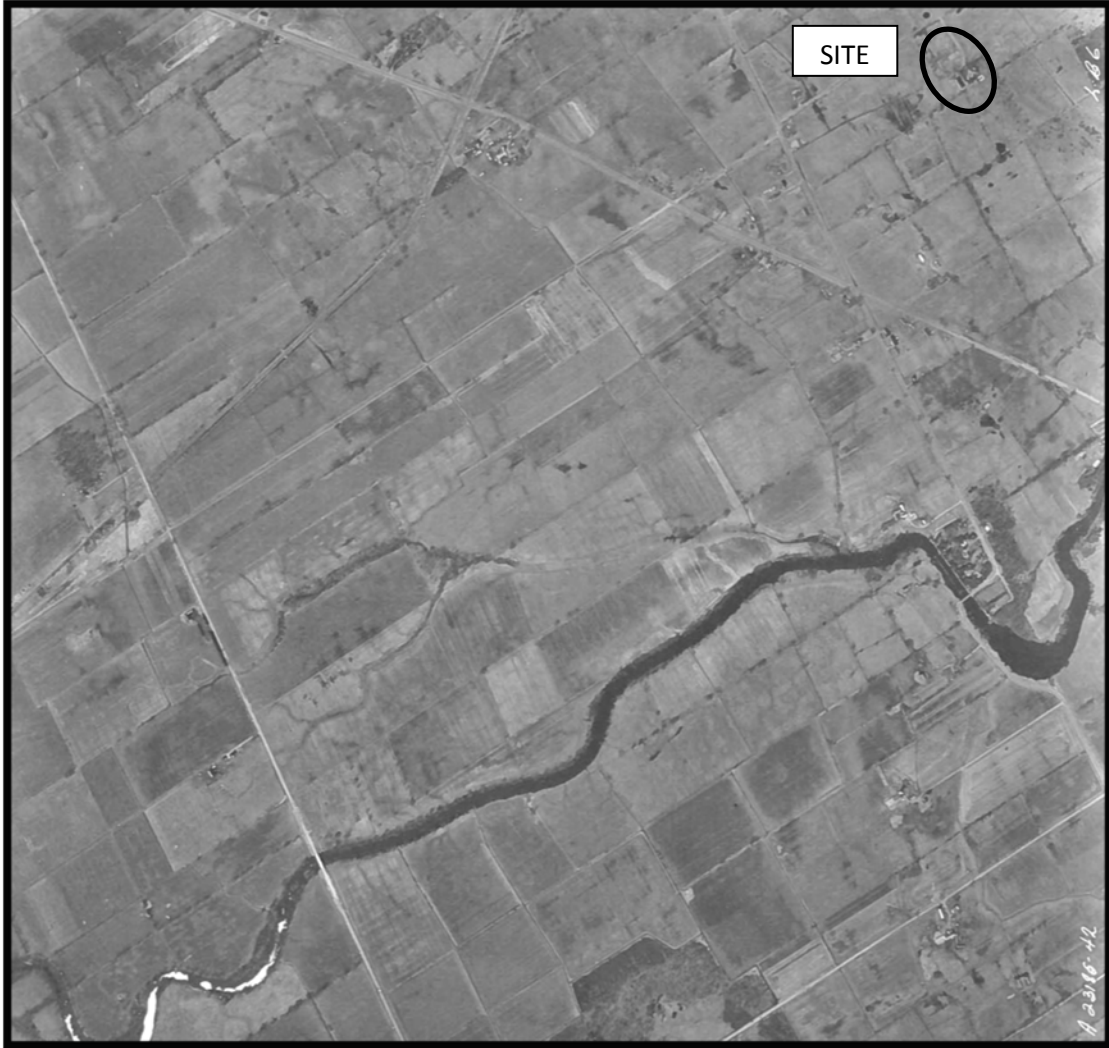
AERIAL PHOTOGRAPH  
1973

| 1973 | At least one of the garage structures appears to have been constructed on the subject property. Neighbouring properties appear to be used for agriculture. |

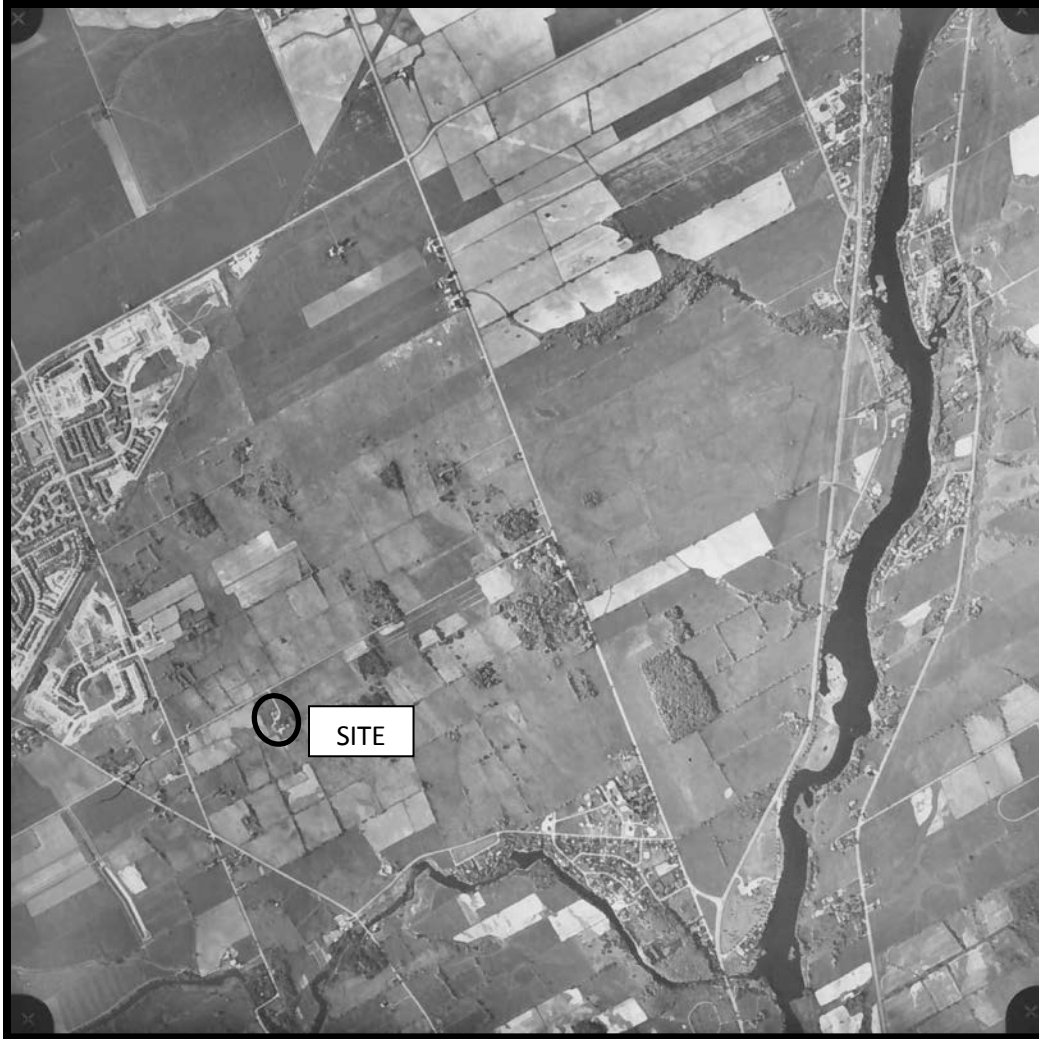
AERIAL PHOTOGRAPH  
1979

| 1979 | No changes appear to have been made to the subject site or neighbouring properties. |

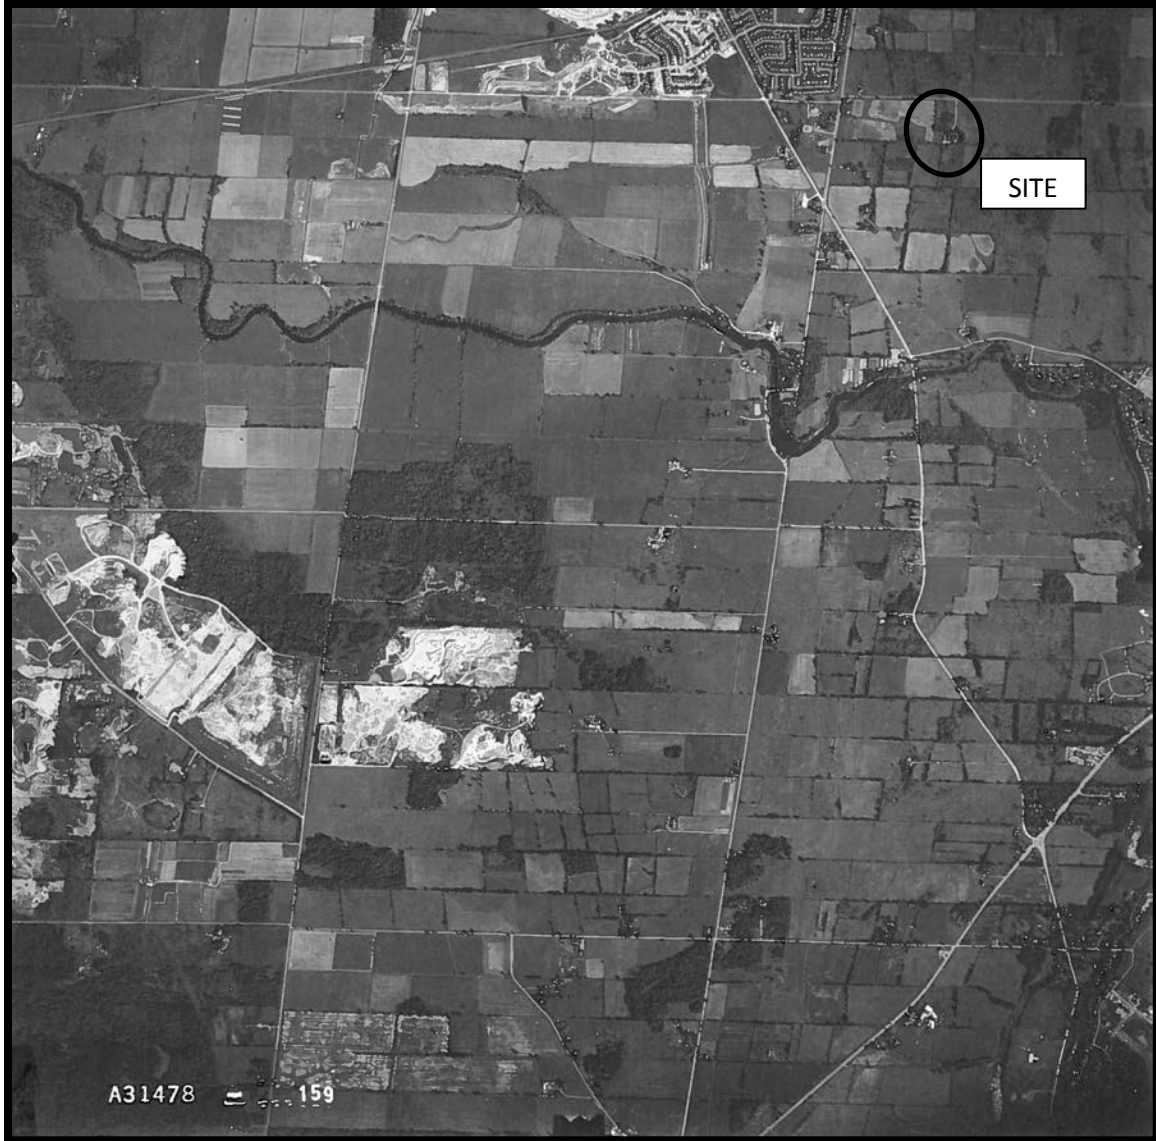
AERIAL PHOTOGRAPH  
1987

| 1987 | No changes appear to have been made to the subject site or neighbouring properties. |
