April 25, 2024  
File: PE2830-LET.07

Subject: **Phase I Environmental Site Assessment Update  
Vacant Land  
1034 McGarry Terrace  
Ottawa, Ontario**

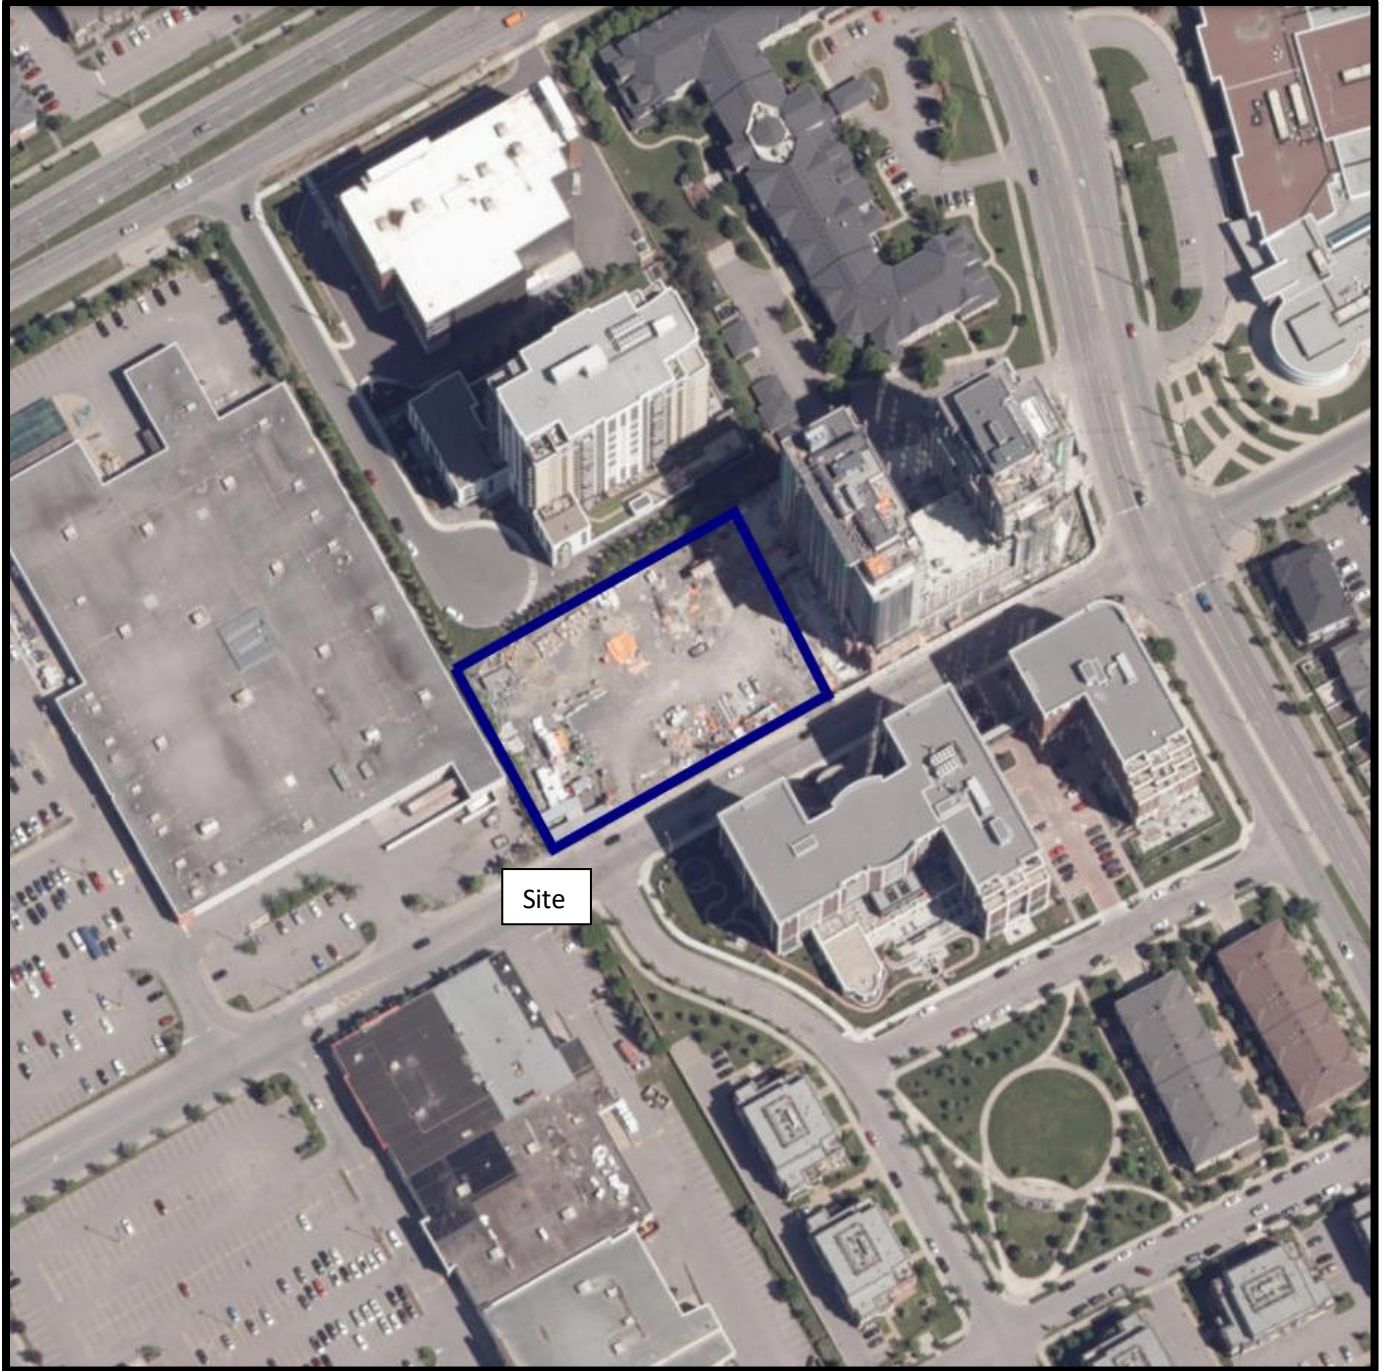
AERIAL PHOTOGRAPH  
2022

significant changes were observed in the 2022 photograph to the subject site. Two residential buildings and a self-storage building have been constructed east and north of the subject site.
