Phase II Environmental Site Assessment Update

Vacant Property –
Proposed Residential Development
1034 McGarry Terrace and 1117 Longfields Drive
Ottawa, Ontario

Paterson Group Inc.

Report: PE2830-3

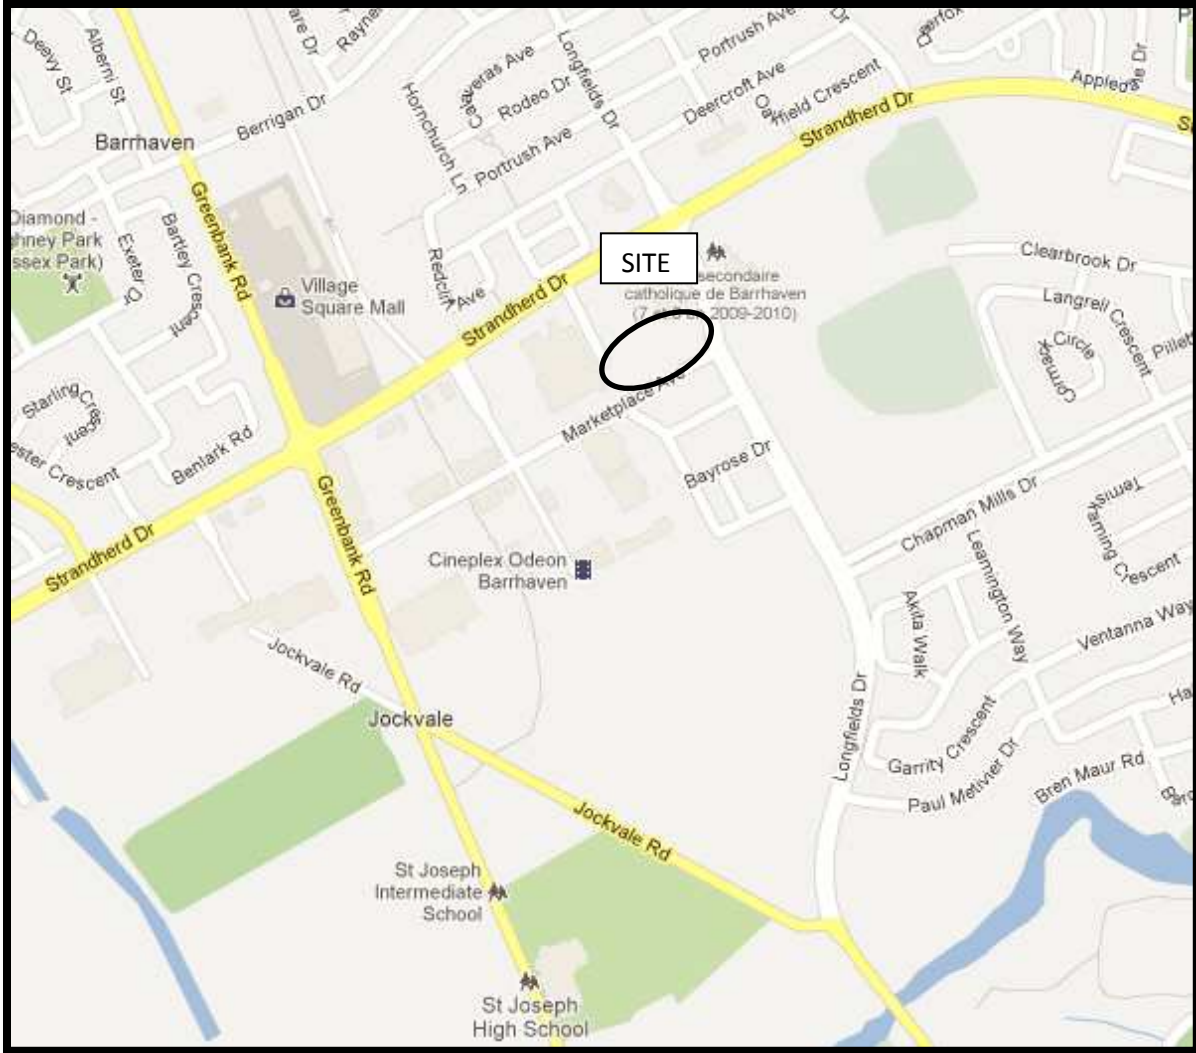
FIGURE 1
KEYPLAN

Location: The subject site is located at the intersection of Longfields Drive and Marketplace Avenue, and can be accessed by the McGarry Terrace cul-de-sac, in the City of Ottawa, Ontario. The subject site is shown on Figure 1 - Key Plan following the body of this report.

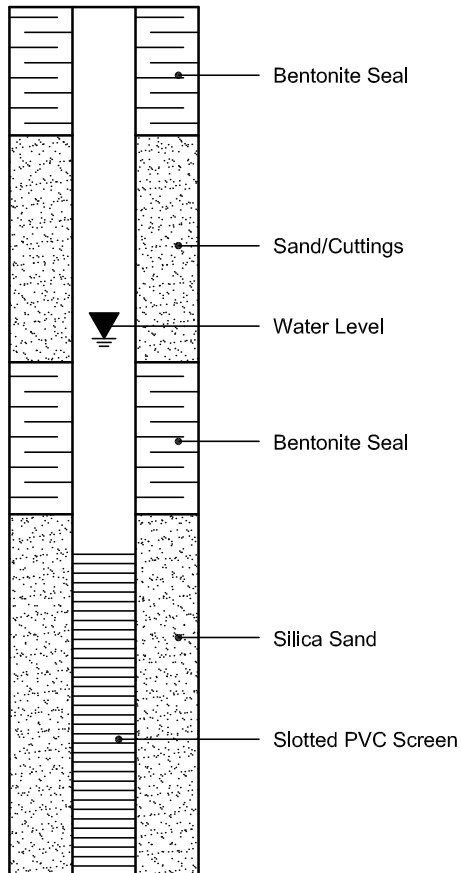
MONITORING WELL CONSTRUCTION

MONITORING WELL AND PIEZOMETER CONSTRUCTION
