**Hydrogeological Investigation,
Terrain Analysis, and Groundwater
Impact Assessment
Zoning Amendment
6158 Rideau Valley Drive
Ottawa, Ontario**

September 4, 2024

File: 100011.082

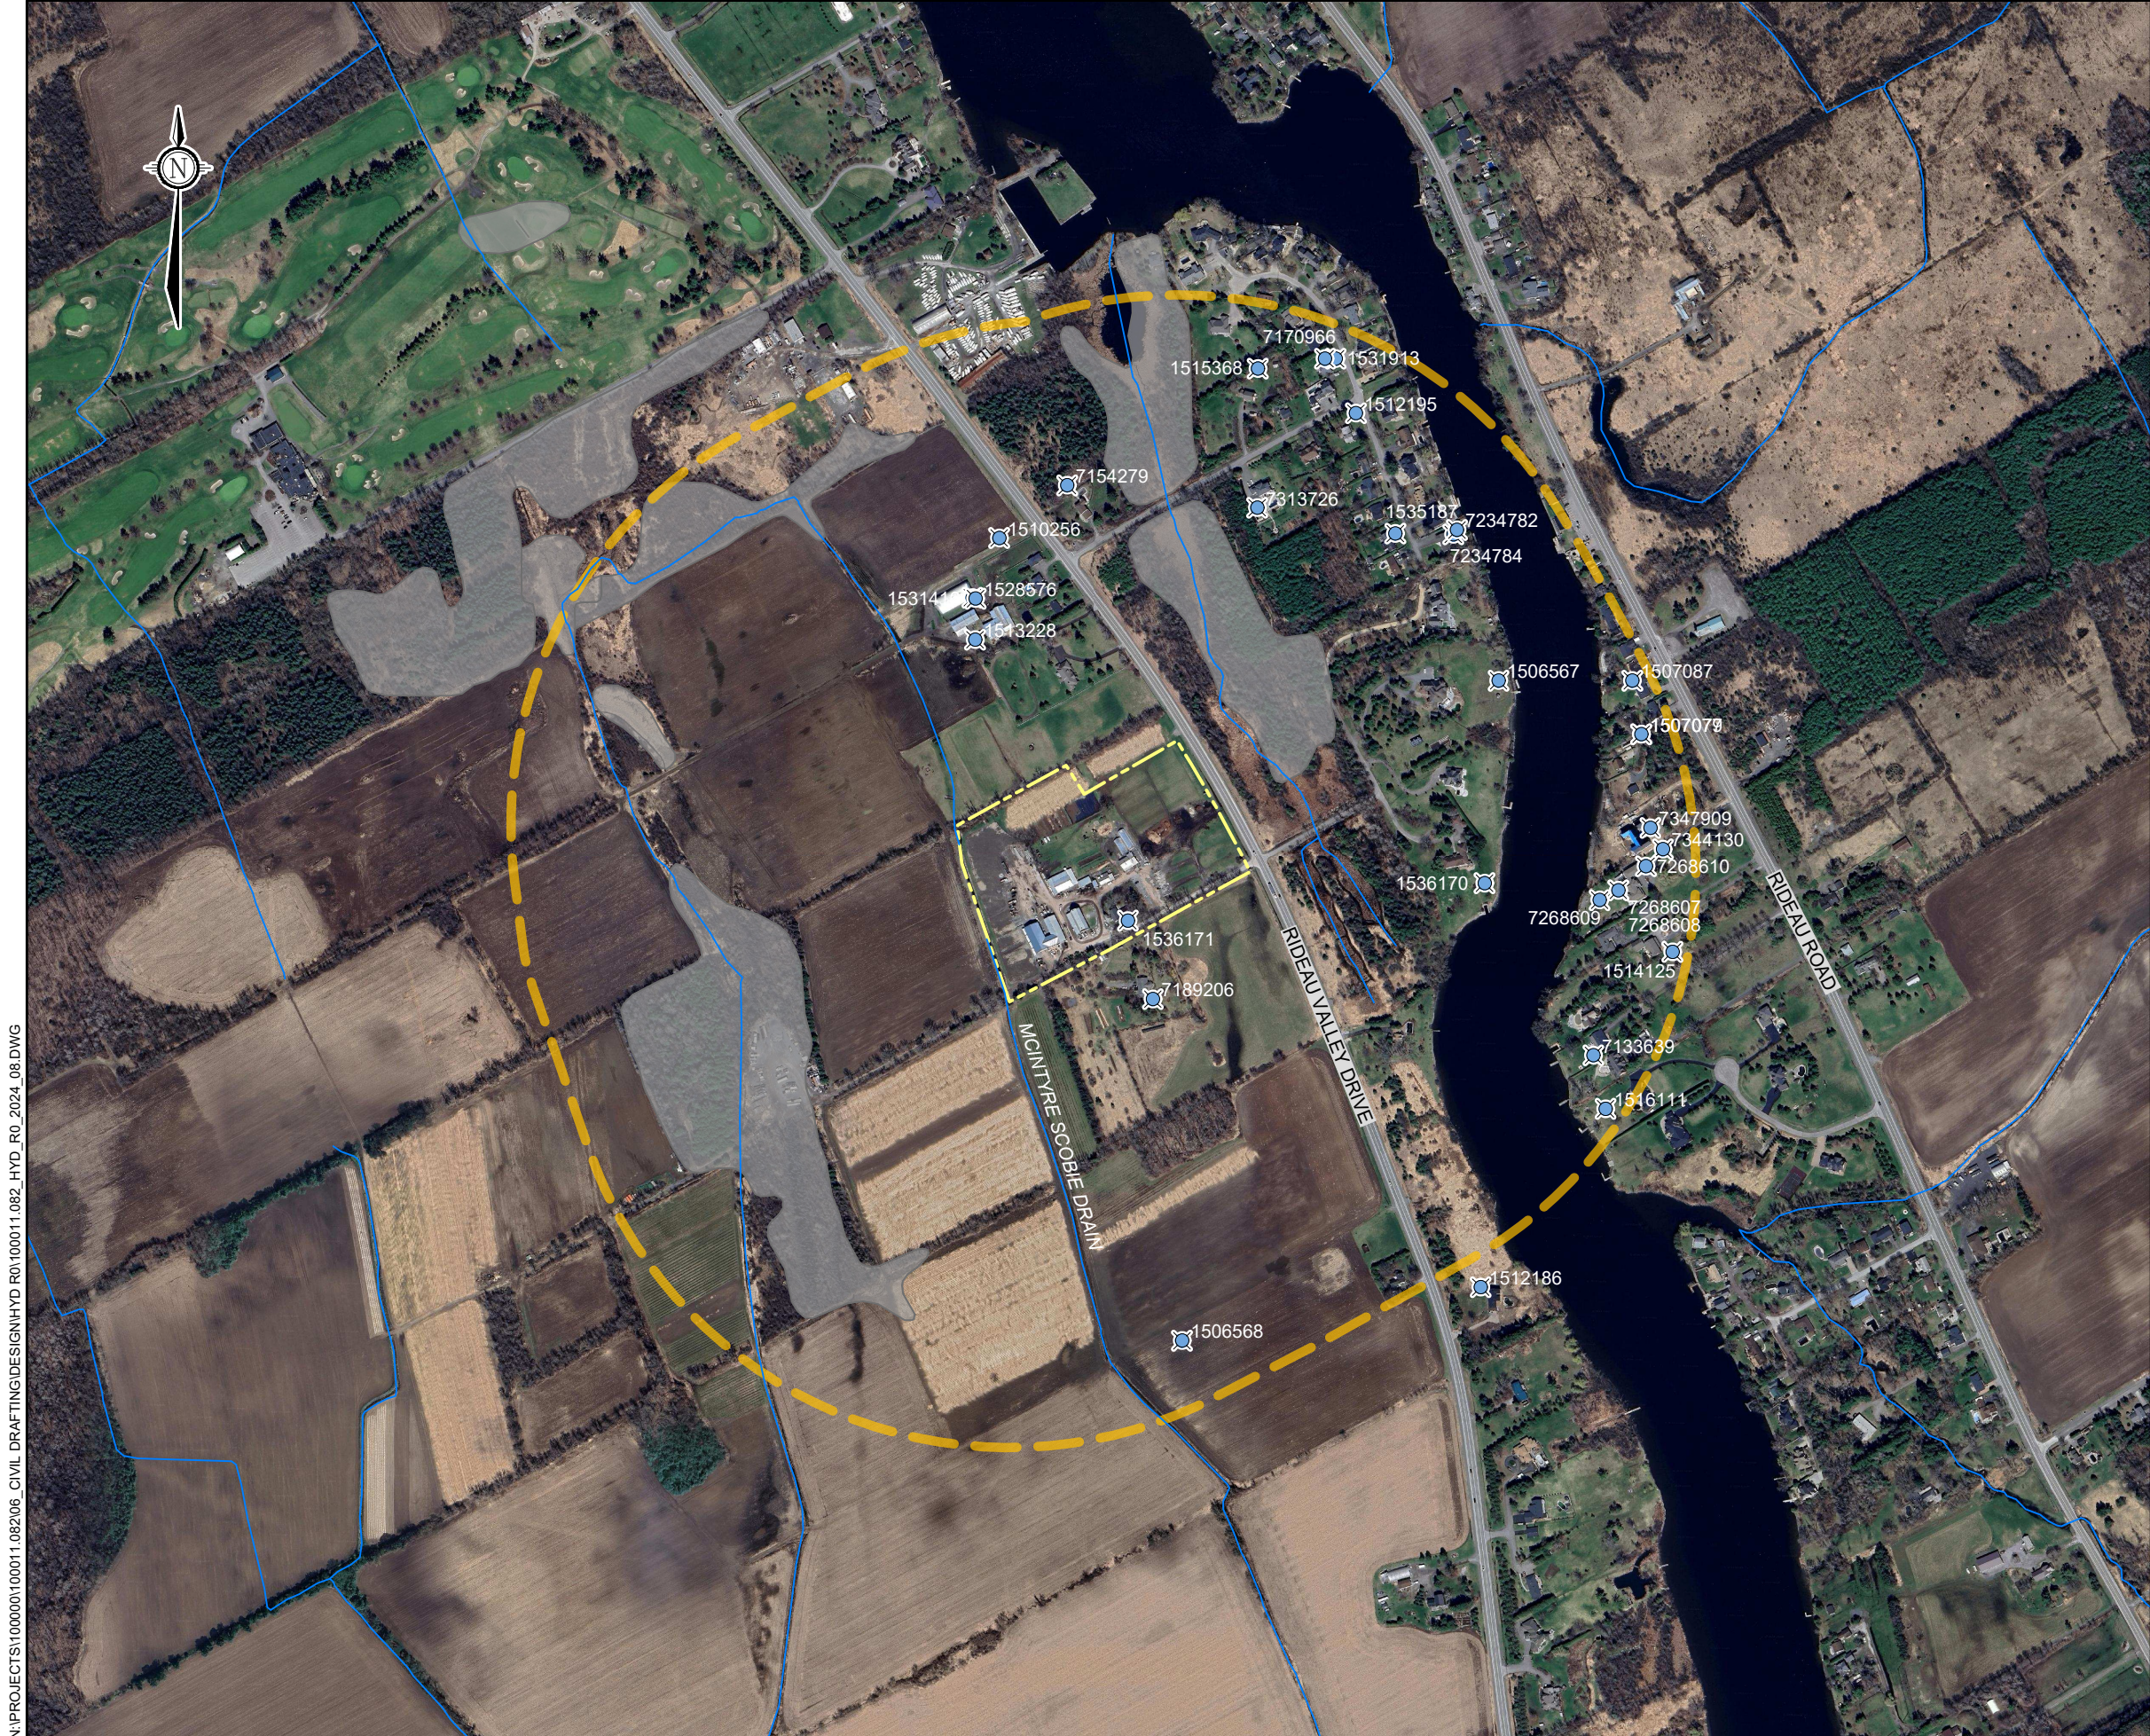
- APPROXIMATE SITE BOUNDARY
- STUDY AREA
(500 RADIUS AROUND THE SITE BOUNDARY)
- WATERCOURSE
- WETLAND UNEVALUATED
- MECP PUBLIC WELL RECORDS

A search of the Ministry of Environment, Conservation and Parks (MECP) water well records (<https://www.ontario.ca/environment-and-energy/map-well-records>) returned 32 water well records within 500 metres of the Site (Figure 1). Of the 32 wells, 21 were domestic supply wells, 2 were monitoring or test wells, and 9 were unidentified. A summary of the water well record data is provided in Appendix C.

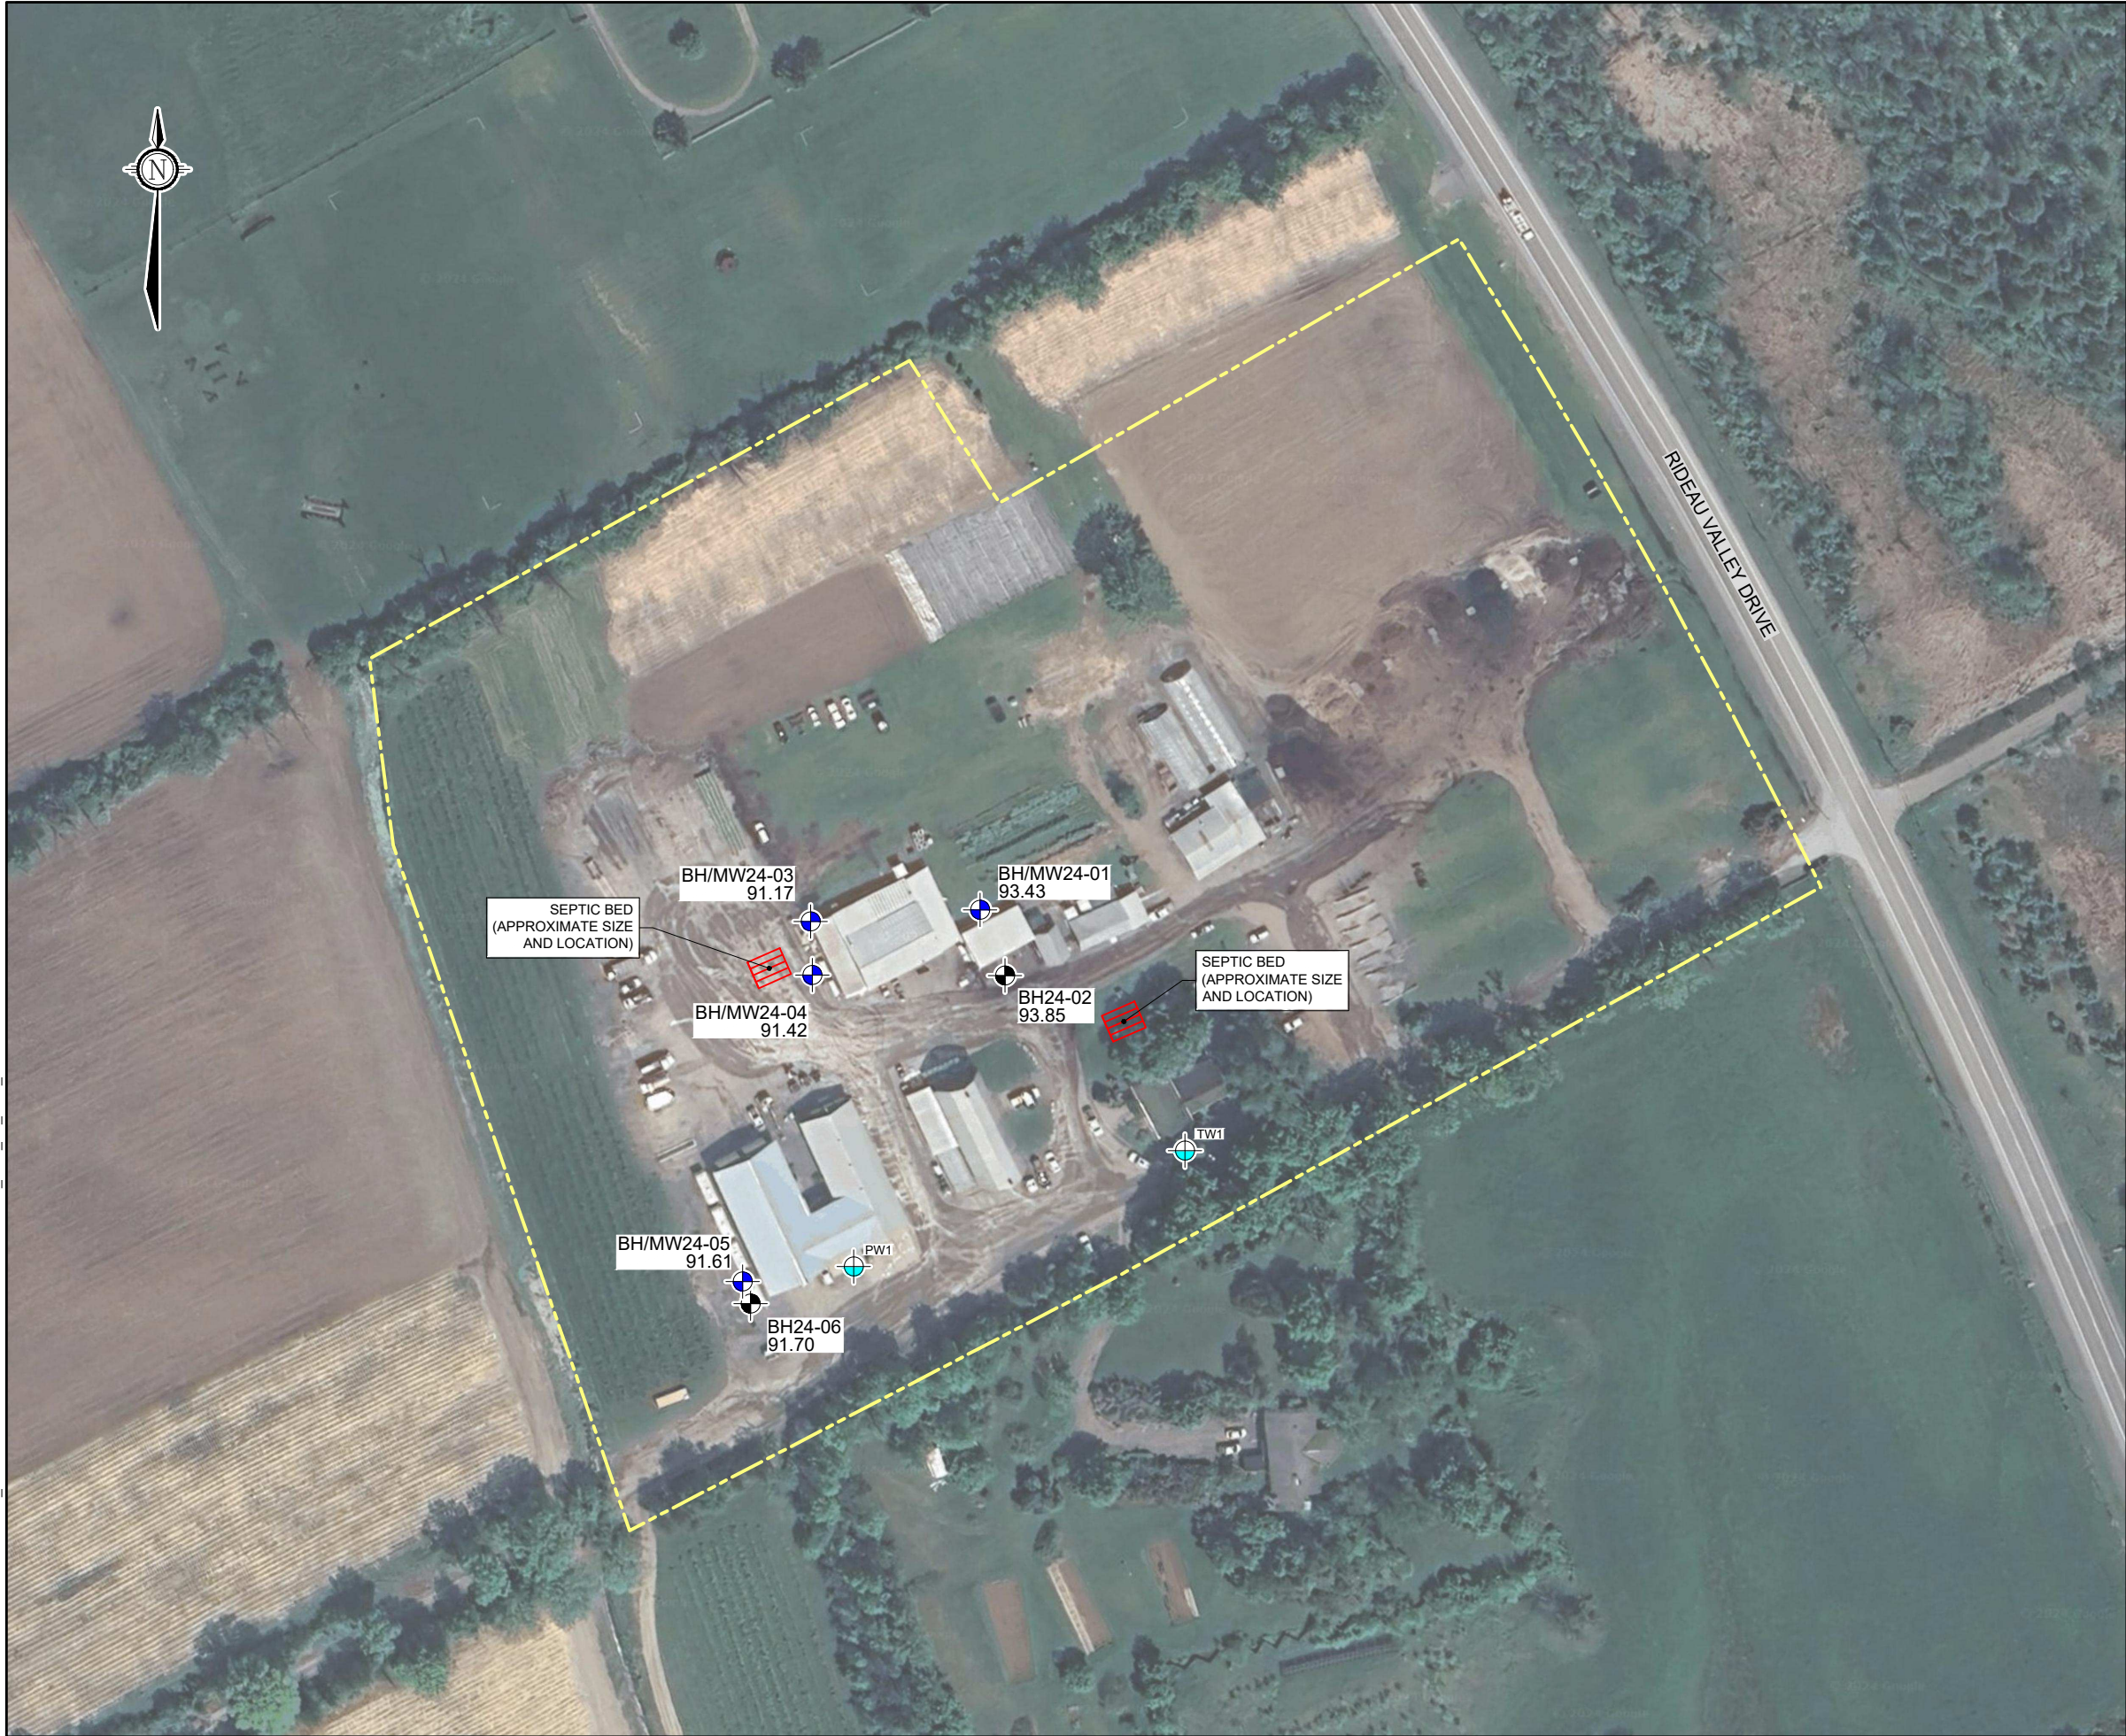
BH/ MW # — BOREHOLE/ MONITORING WELL ID
XX.XX — GROUND SURFACE ELEVATION, IN METRES

The location of these monitoring wells is shown in Figure 2, Appendix A. The details of these monitoring wells are provided in Table 1.

Two existing wells located on the Site were reviewed as part of the hydrogeological investigation, herein referred to as ‘TW1’ and ‘PW1’. The MECP water well record for TW1 is provided in Appendix D and the construction details are summarized in Table 3, below. The water well record was unavailable for PW1 at the time of this investigation. The approximate locations of the water wells are provided on the Detailed Site Plan, Figure 2.
