**Phase One Environmental Site Assessment
Zoning By-Law Amendment Application
6158 Rideau Valley Drive
Ottawa, Ontario**

June 12, 2024
Project: 100011.082

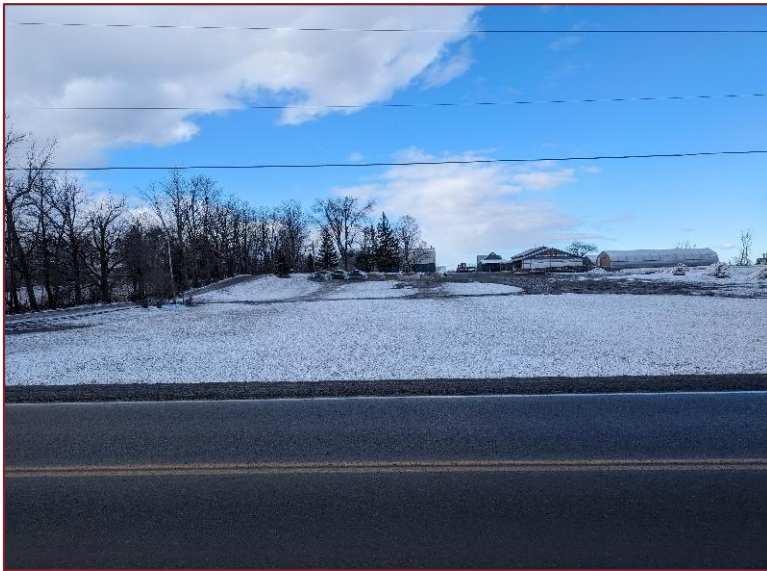
Photograph L1 – Looking west. View of the Site from Rideau Valley Drive. All the structures at the Site can be seen on the photo in the background and landscaping operations can be seen in the front.

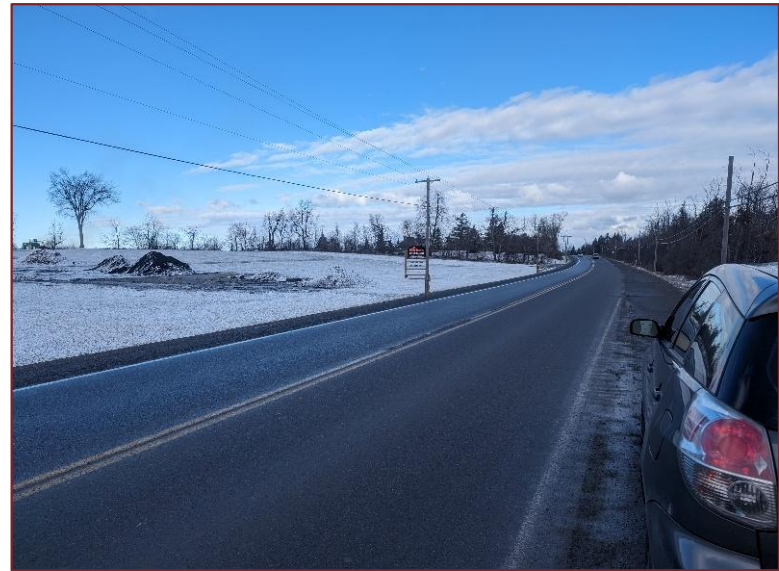
Photograph L2 – Looking north along the Rideau Valley Drive. The Site is to the left of the Rideau Valley Drive. Roadside drainage ditches are located on both sides of the Rideau Valley Drive.

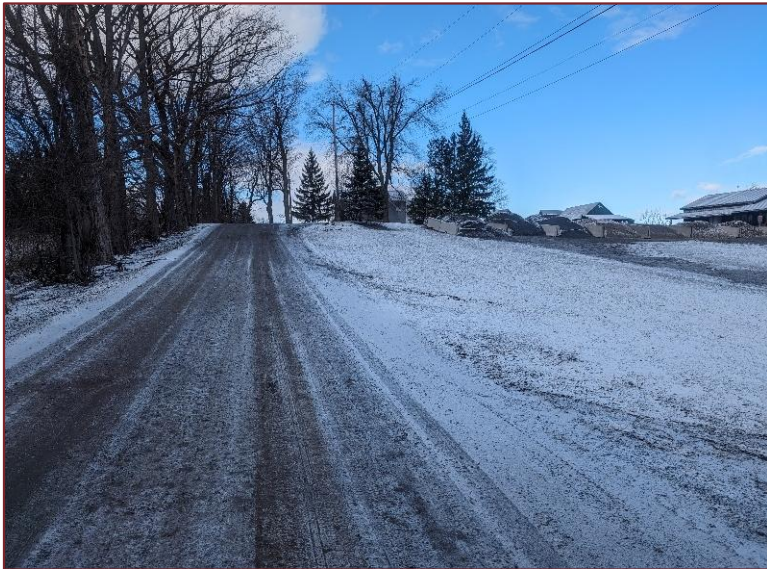
Photograph L3 – Looking west along the gravel graded roadway/driveway leading into the Site. Structure 2 (Office Building) can be seen behind the trees.

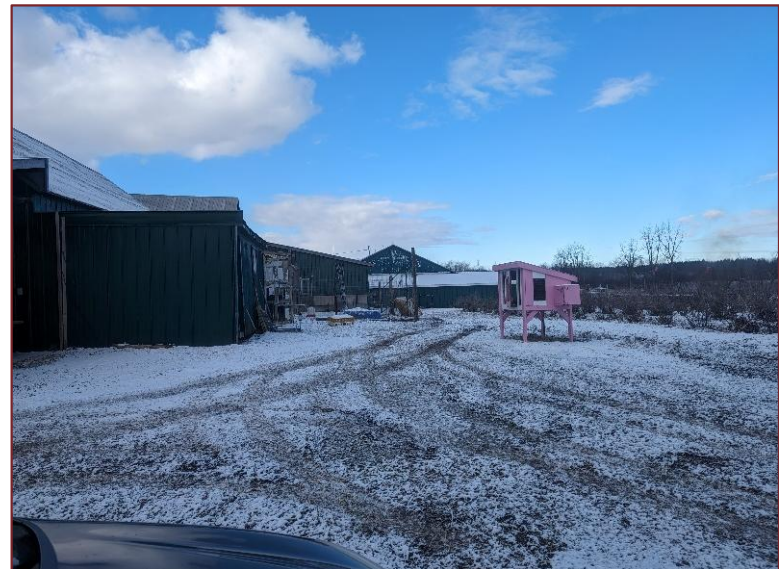
Photograph L4 – Looking west. Chicken coops and the area behind Structure 4 (Material Storage), Structure 5 (Material Storage), Structure 9 (Salt Storage) and Structure 3 (Material Storage in the background).

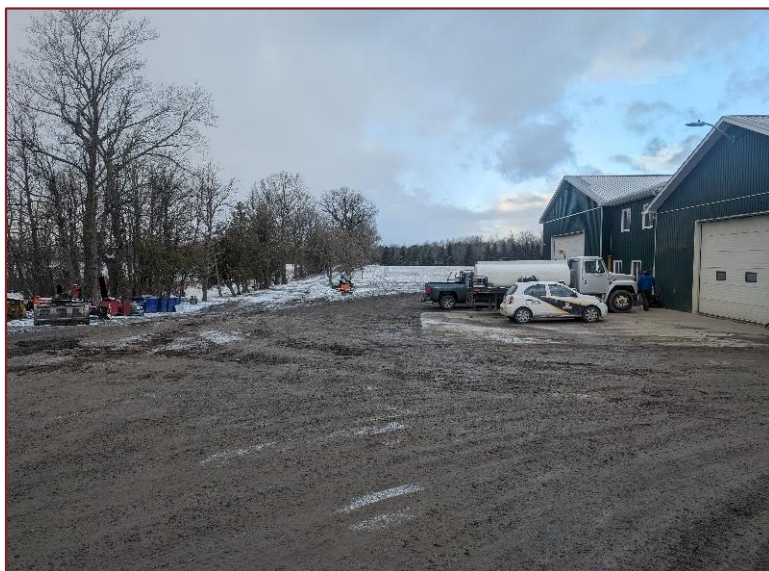
Photograph L7 – Looking west. Structure 7 (Building Workshop) with the bay doors can be seen to the right.

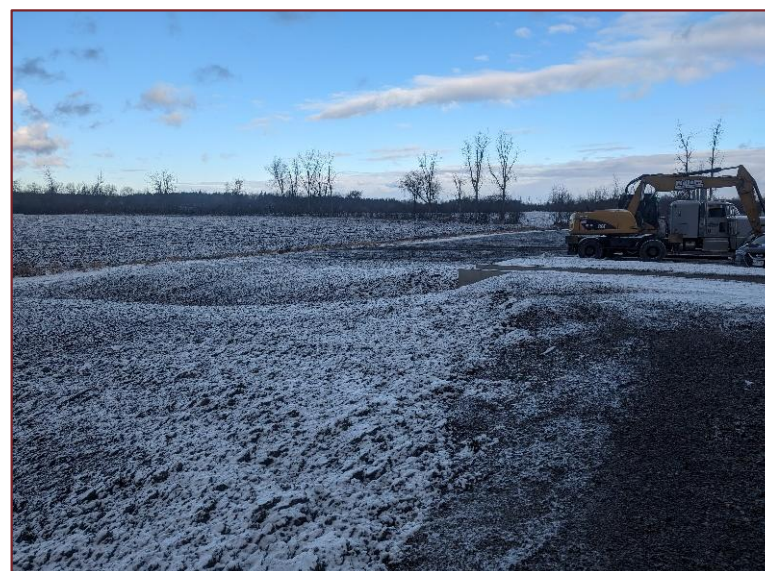
Photograph L8 – Looking north along the area where the imported soil was placed. Tractor wash area can be seen on the right and McIntyre Scobie Drain can be seen on the left.

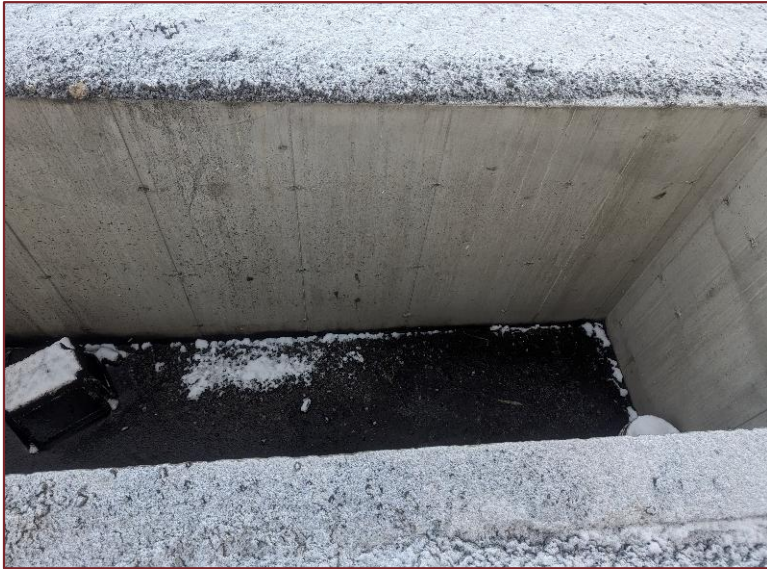
Photograph L9 – Looking north and a view of the tractor wash area. No signs of spills, staining or odors were noted at this location.

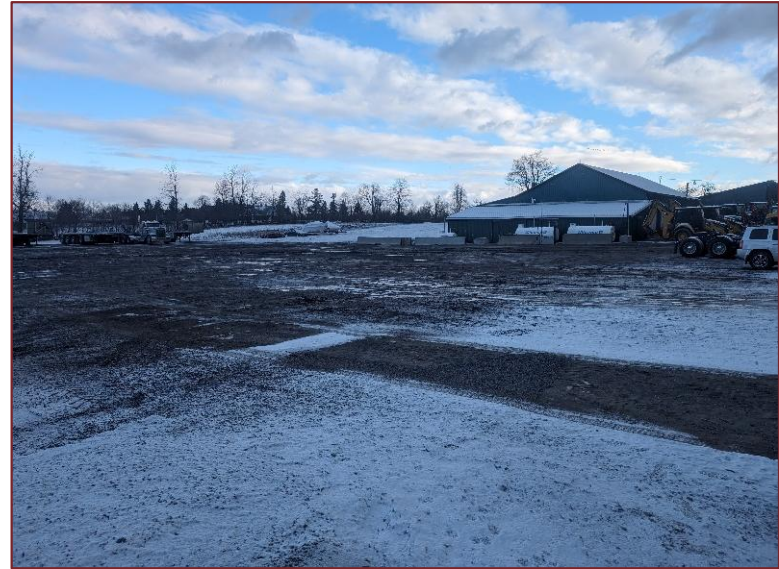
Photograph L10 – Looking north and a view of the gravel graded parking area and ASTs. ASTs are located along the west building line of Structure 3 (Material Storage). The Structure 9 (Salt Storage) can be seen in the background on the right.

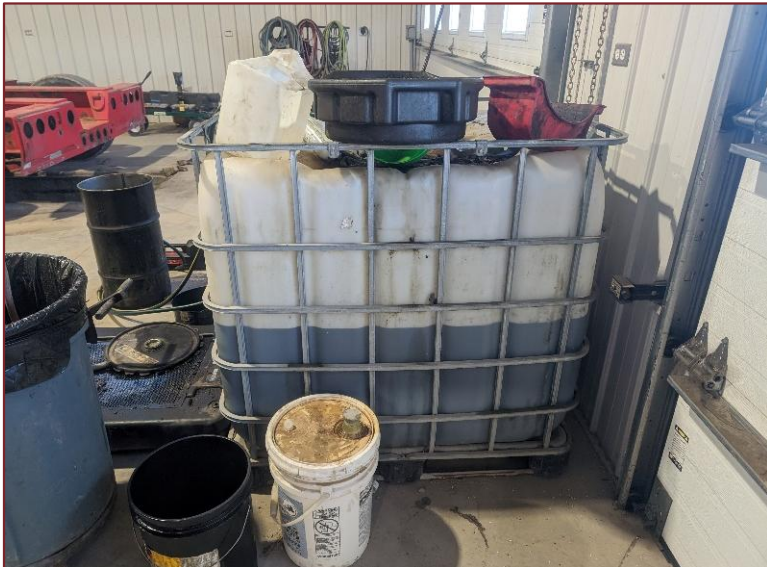
Photograph L11 – Looking east inside the Structure 7 (Building Workshop). An oil tote was present inside the Structure 7. No signs of spills, staining or odors were noted at this location.

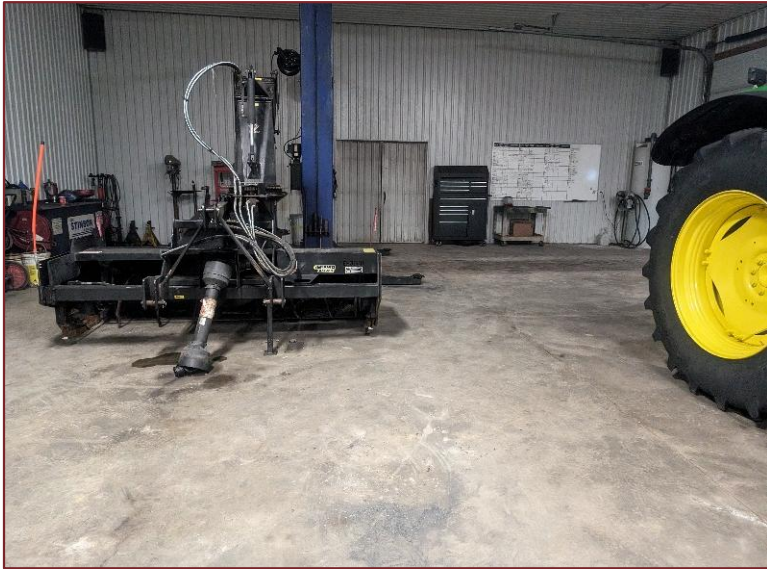
Photograph L13 – Looking west inside the Structure 7 (Building Workshop). A photo of the hydraulic lift.

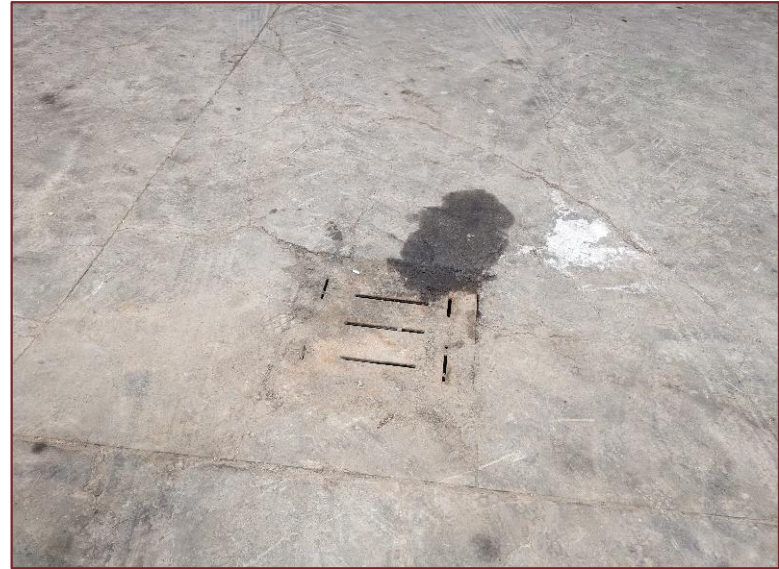
Photograph L14 – Looking west inside the Structure 7 (Building Workshop). A photo of the drain.

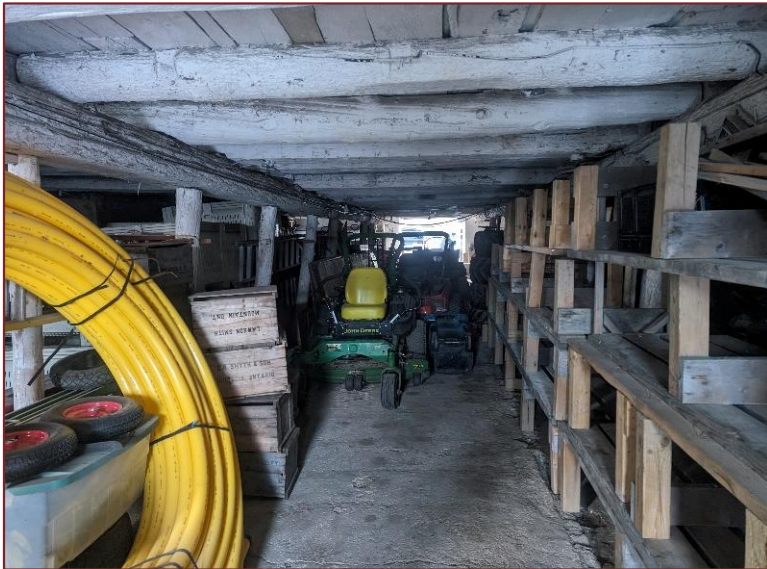
Photograph L15 – Looking north inside the Structure 3 (Material Storage). Concrete flooring was in a good shape with minimal cracking. No signs of spills, staining or odors were noted at this location.

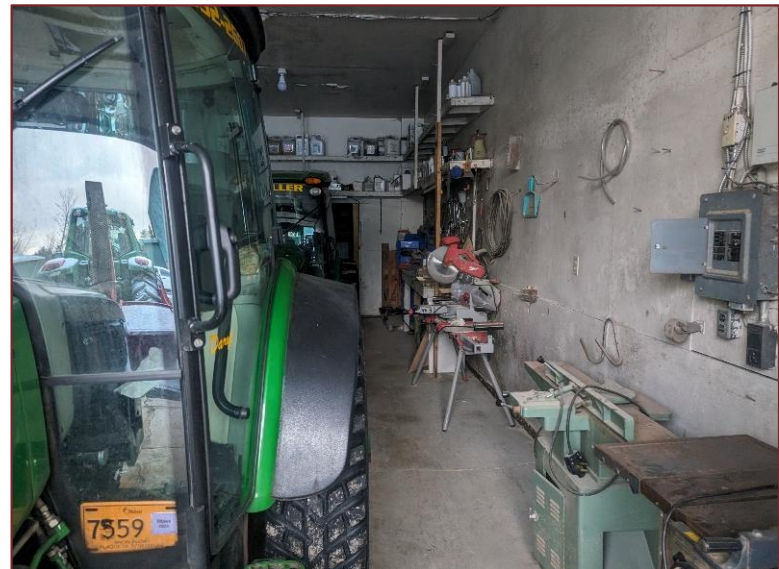
Photograph L16 – Looking north inside the Structure 3 (Material Storage). Concrete flooring was in a good shape with minimal cracking. No signs of spills, staining or odors were noted at this location.

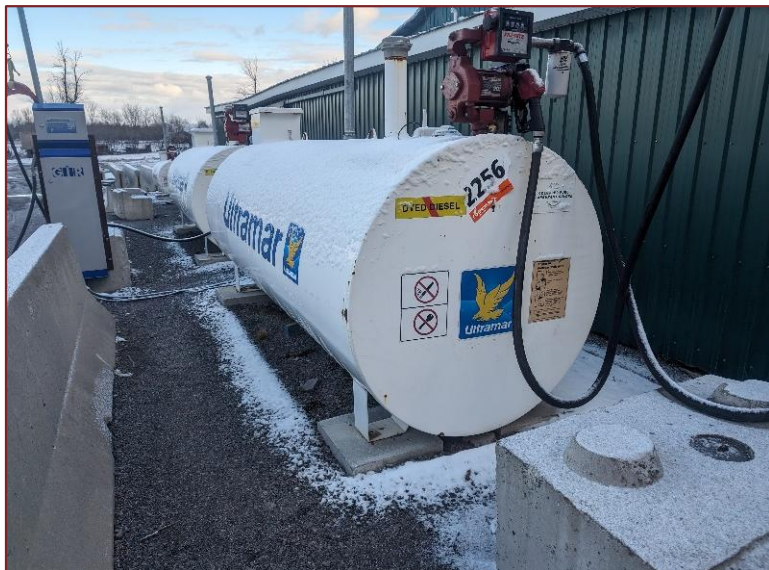
Three ASTs are used for refuelling farm equipment. These ASTs are located to the west of the building line of Storage Shed (Structure 3). The ASTs appeared to be in a good working condition with no staining and spills on the ground. The ASTs were protected by concrete barriers.

Through the review of information (aerial photographs and Site reconnaissance), the Site has three ASTs. No evidence of staining, spills or odours were noted at the time of the Site reconnaissance. This APEC is limited to the western building line of Storage Shed (Structure 3). The COPCs are PHC F1-F4, PAHs, and BTEX in soil and groundwater.

Photograph L17 – Looking north at the ASTs along the west building line of Structure 3 (Material Storage). The ASTs were in good working condition and there were no signs of spills, staining or odors were noted at this location.

Based on the identification of three APECs on the Site, it is recommended that a subsurface investigation be carried out to adequately characterize soil and groundwater conditions in support of the proposed works in accordance with O.Reg 153/04, as amended.

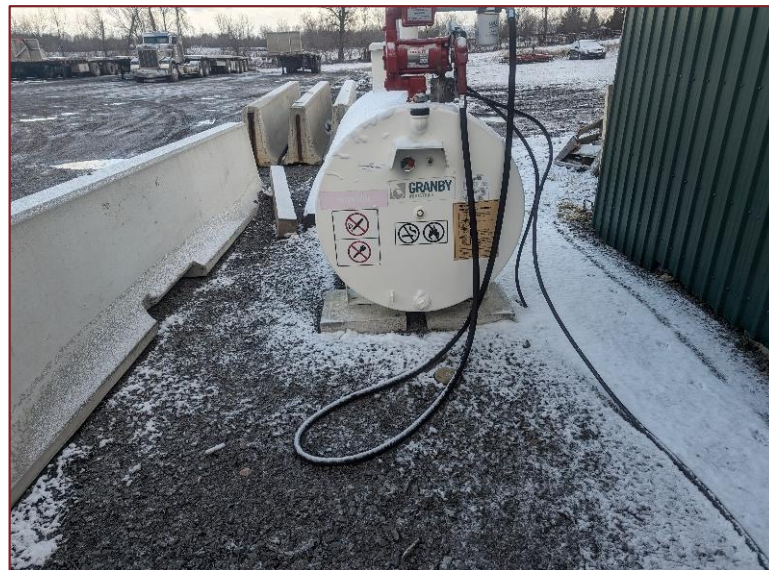
Photograph L18 – Looking north at one of the ASTs along the west building line of Structure 3 (Material Storage). The ASTs were in good working condition and there were no signs of spills, staining or odors were noted at this location.

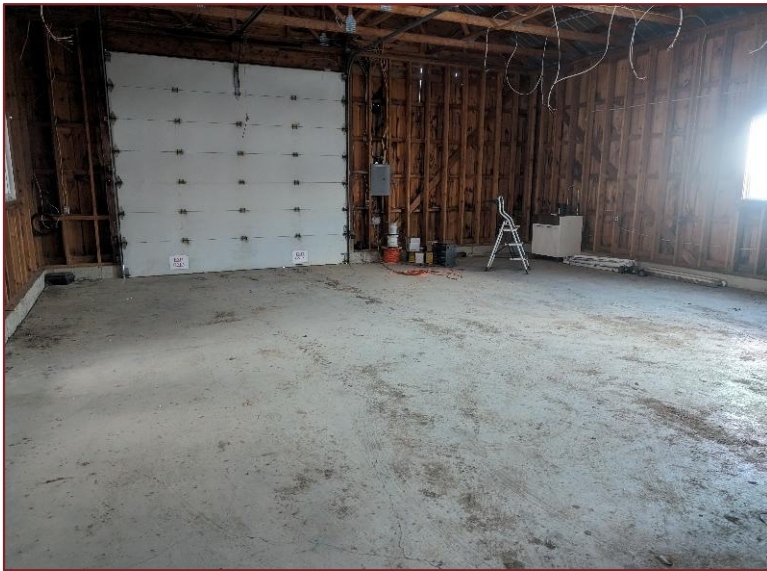
Photograph L21 – Looking north inside Structure 6 (Sales Shop). Concrete flooring was in a good shape with minimal cracking.

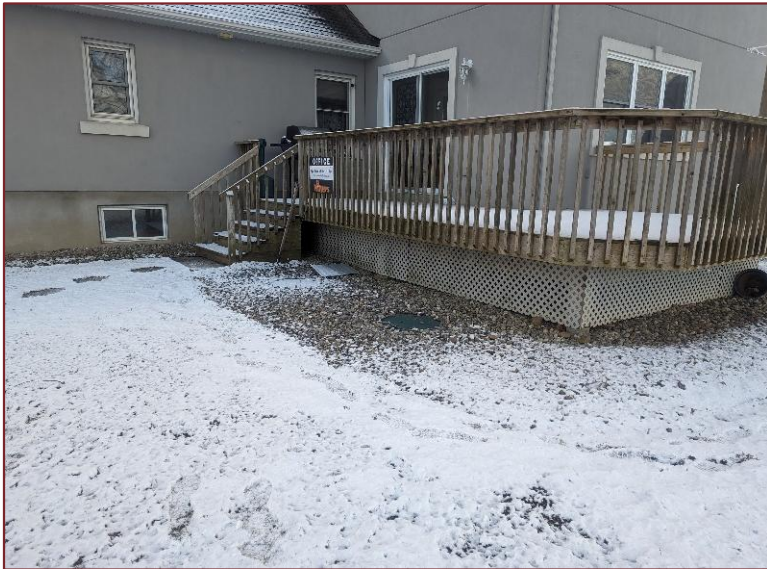
Photograph L23 – Looking south towards Structure 2 (Office Building). A septic tank can be seen in front of the Office Building.
