# **Phase One Environmental Assessment Update**

2095 Dilworth Road, Ottawa, Ontario

**Dilworth Development Inc.**  
Final Report

May 17, 2024  
02402048.000

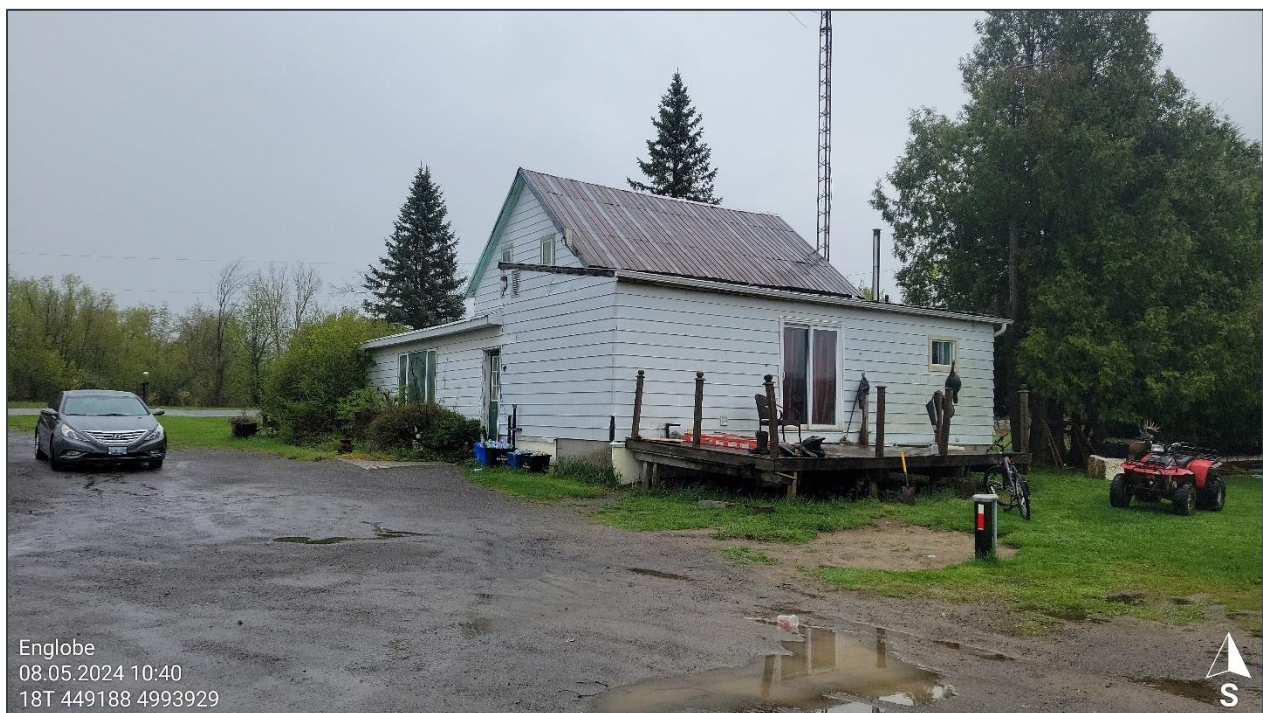
Photograph 2: Residential house

The residential house is a two-storey building, located near the east most entrance to the Site in the southeast portion of the property, constructed with vinyl siding, a concrete block foundation, and a peaked metal roof. The building has an approximate footprint of 160 m<sup>2</sup>, one basement level, and was constructed prior to 1920. Potable water is provided to the building from the north-adjacent domestic supply well; electricity is provided via overhead lines; the building does not appear to be serviced with gas; heating is provided via underground lines from an exterior wood burning stove located approximately 15 m northwest of the building; and although a septic tank access port could not be located, it is inferred that sewage is serviced via an underground septic tank system located to the west of the house on-site (DST, 2021).

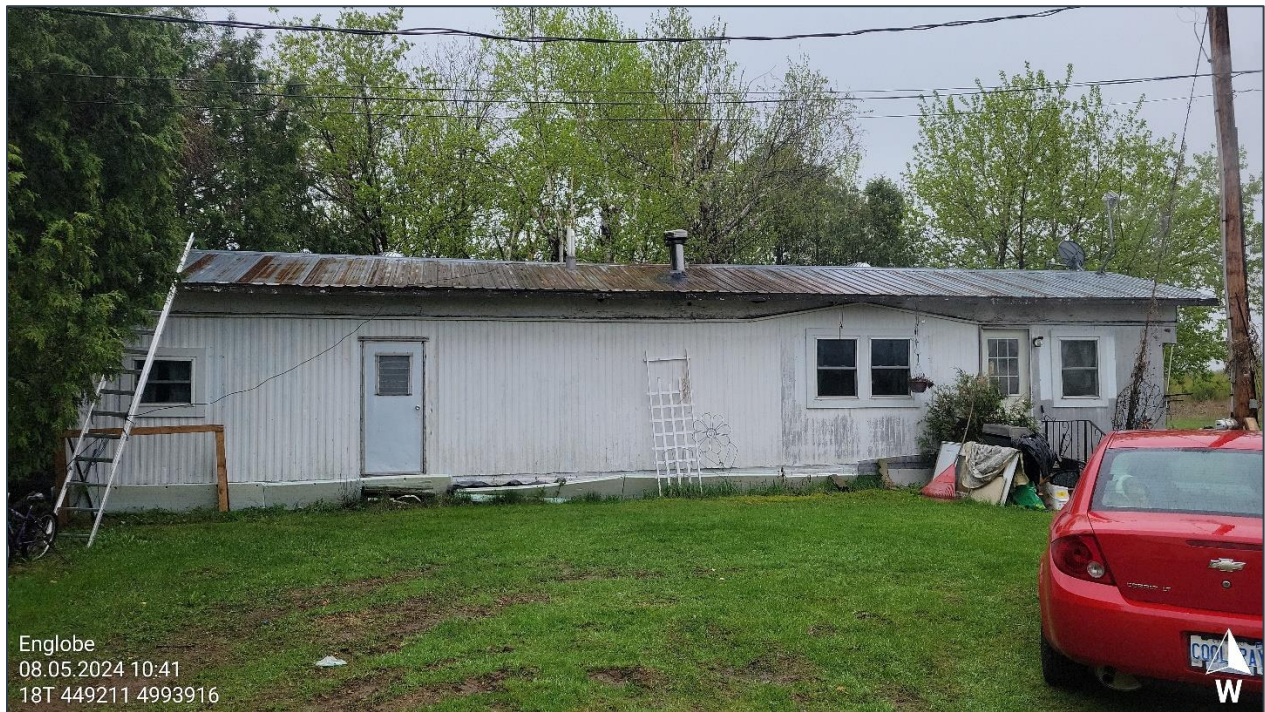
Photograph 3: Residential trailer home

The residential trailer home is a one-storey building, located west of the residential house, constructed with vinyl siding, a concrete slab-on-grade foundation, and a peaked metal roof. The building has an approximate footprint of 85 m<sup>2</sup> and was constructed in 1976. Potable water is provided to the building from the on-Site domestic supply well; electricity is inferred to be provided via underground lines from the residential house; propane is provided from a west-adjacent propane AST.

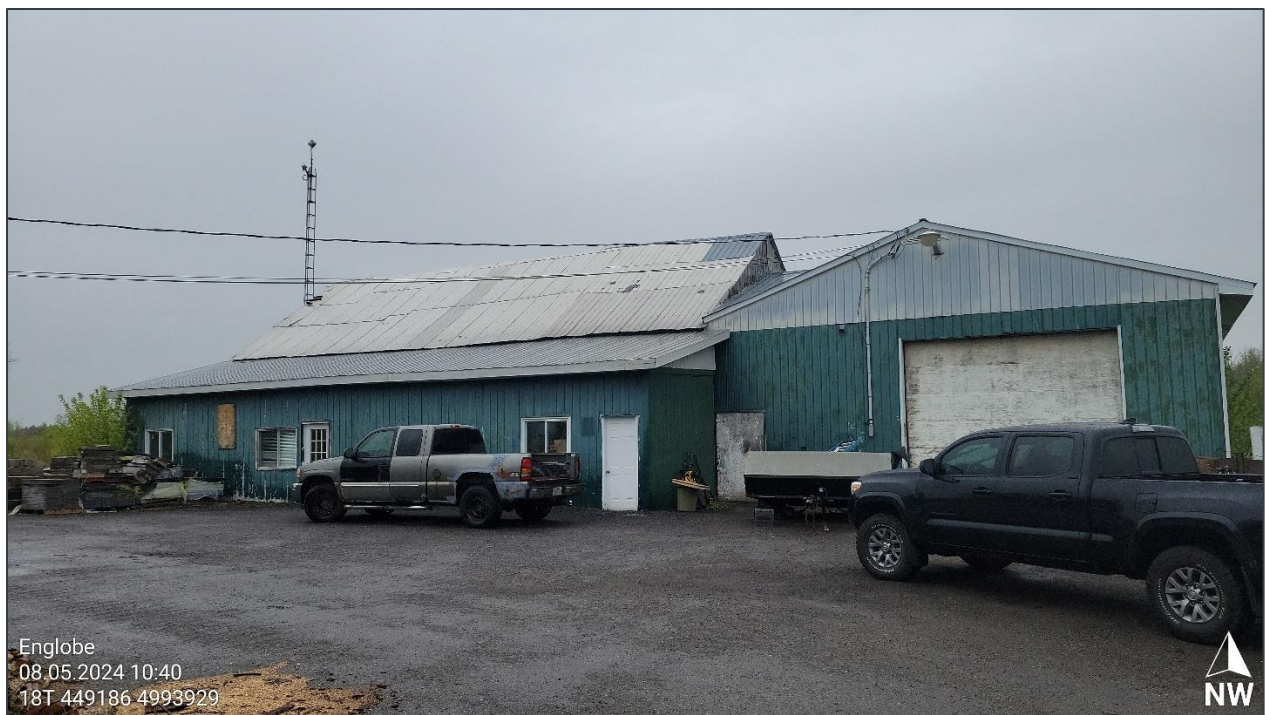
Photograph 4: Commercial service garage

The commercial service garage is a one-story building, located approximately 20 meters north of the residential trailer home, constructed with metal siding, a concrete slab-on-grade foundation, and a peaked metal roof. The building has an approximate footprint of 625 m<sup>2</sup> and was constructed prior to 1920. Electricity is provided via overhead lines; the building does not appear to be serviced with gas; heating is provided by the exterior wood burning stove, via underground lines; and it is unclear if the building is serviced with water or sewage services.

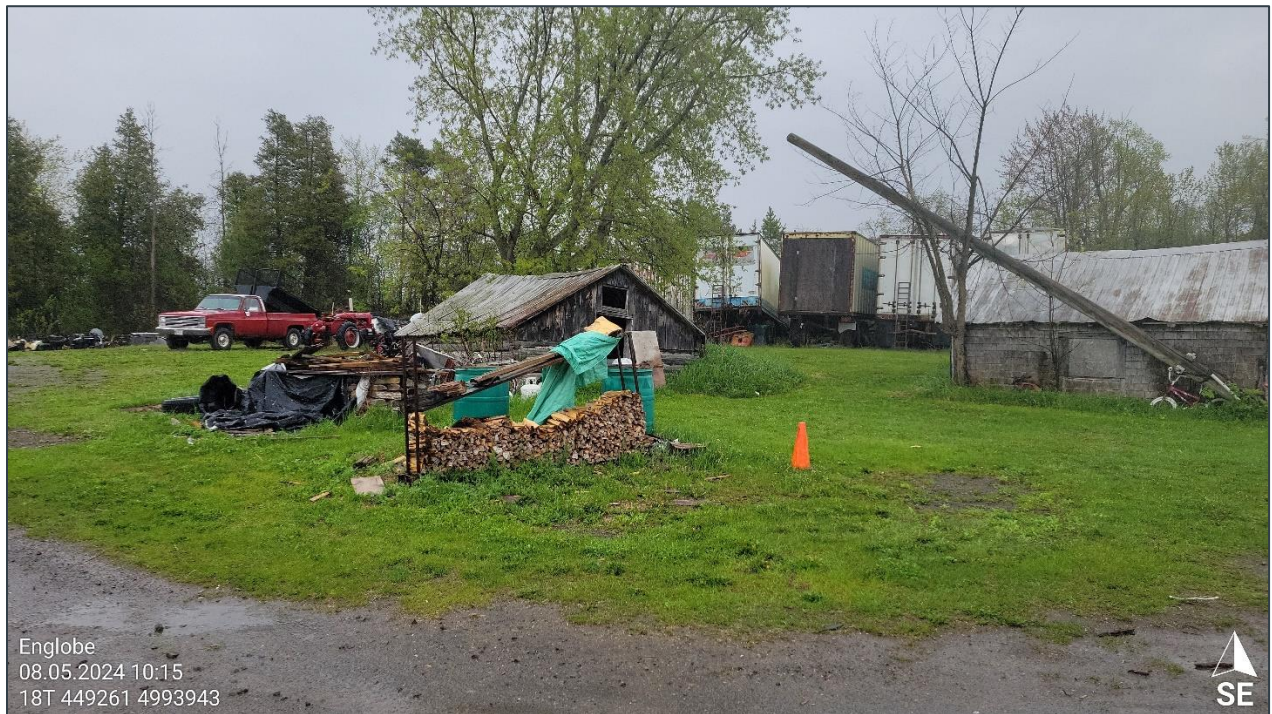
Photograph 5: Wooden storage sheds

The two wooden storage sheds are one-storey structures located approximately to the northeast of the residential house, constructed of wood, with no foundations, and peaked metal roofs. Each storage shed has an approximate footprint of 15 m<sup>2</sup> and was constructed prior to 1976. The storage sheds are not serviced with water, electricity, gas, or sewage.

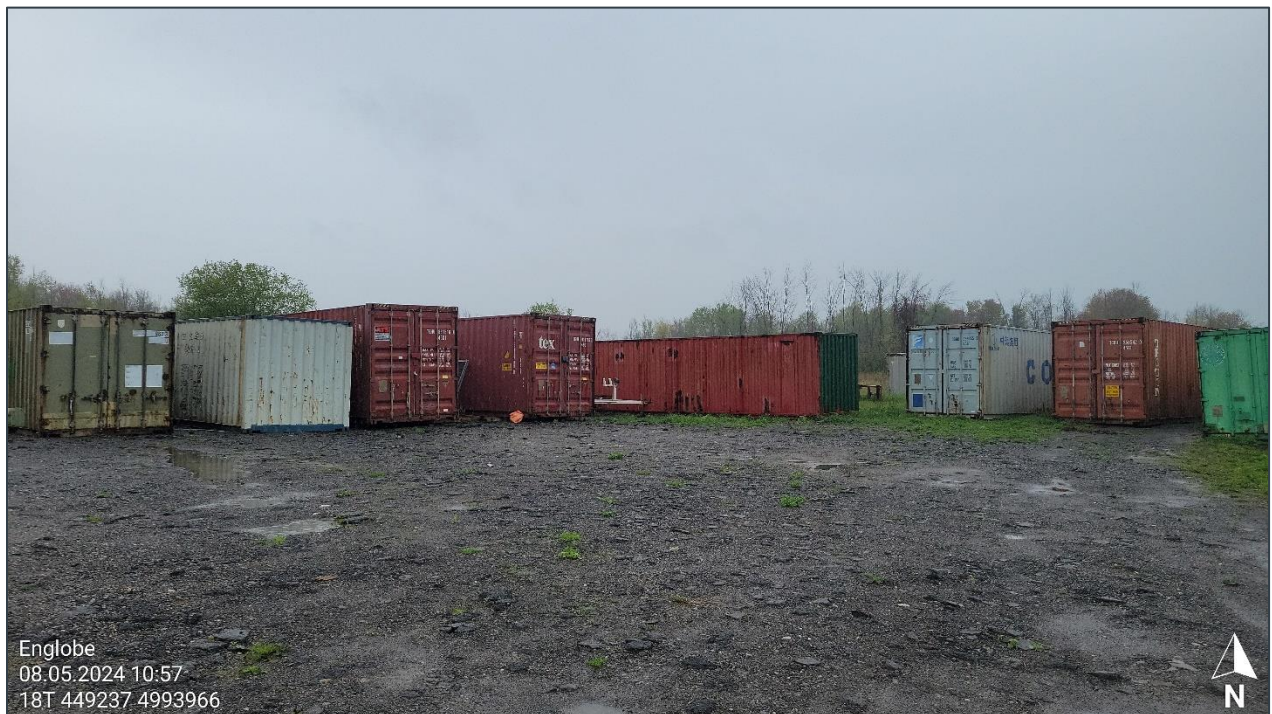
Photograph 6: Metal shipping containers

Additionally, 13 metal shipping containers, and five semi trailers were observed near the residential dwellings.

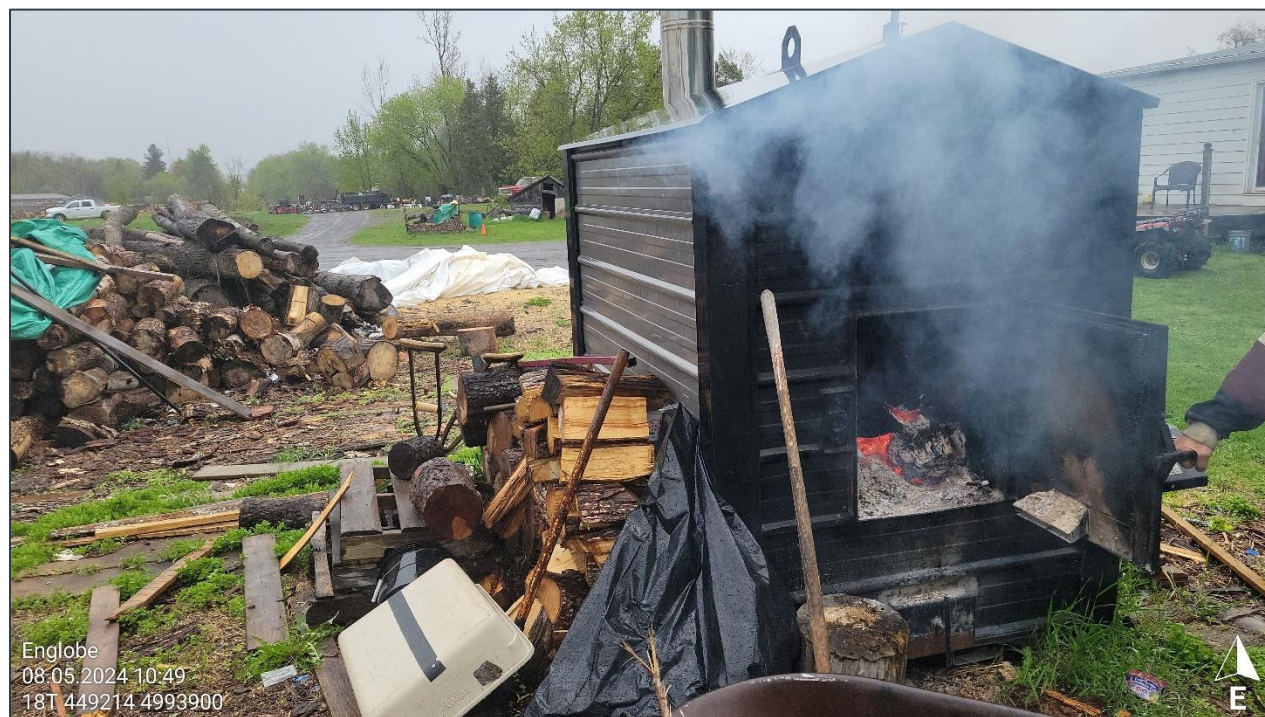
Photograph 8: Exterior wood burning stove

During the Site reconnaissance, Englobe observed one external wood stove, approximately 15 m northwest of the residential house, one air conditioning unit west-adjacent to the residential house, and one window-mounted air conditioning unit on the west side of the residential trailer home.

- PCA 1: Undefined No 1 - Exterior wood burning stove: large exterior wood burning stove used to heat the residential house and the service garage observed approximately 15 m northwest of the residential house.

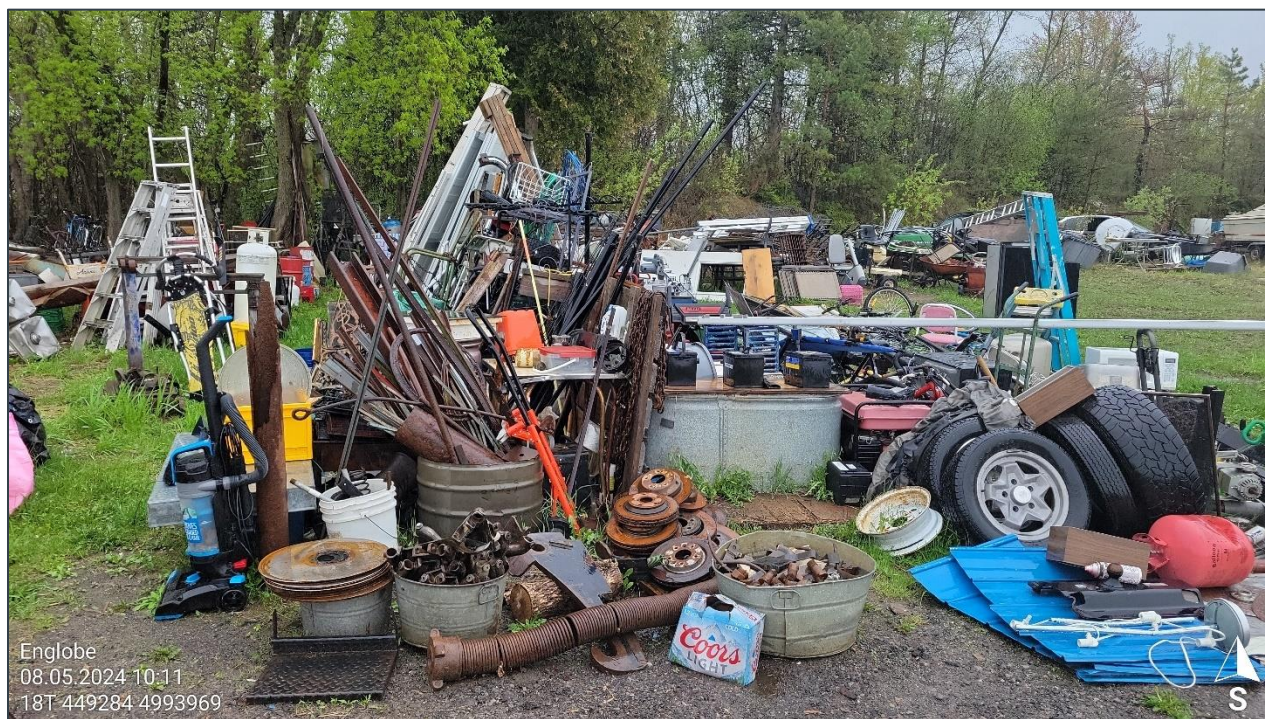
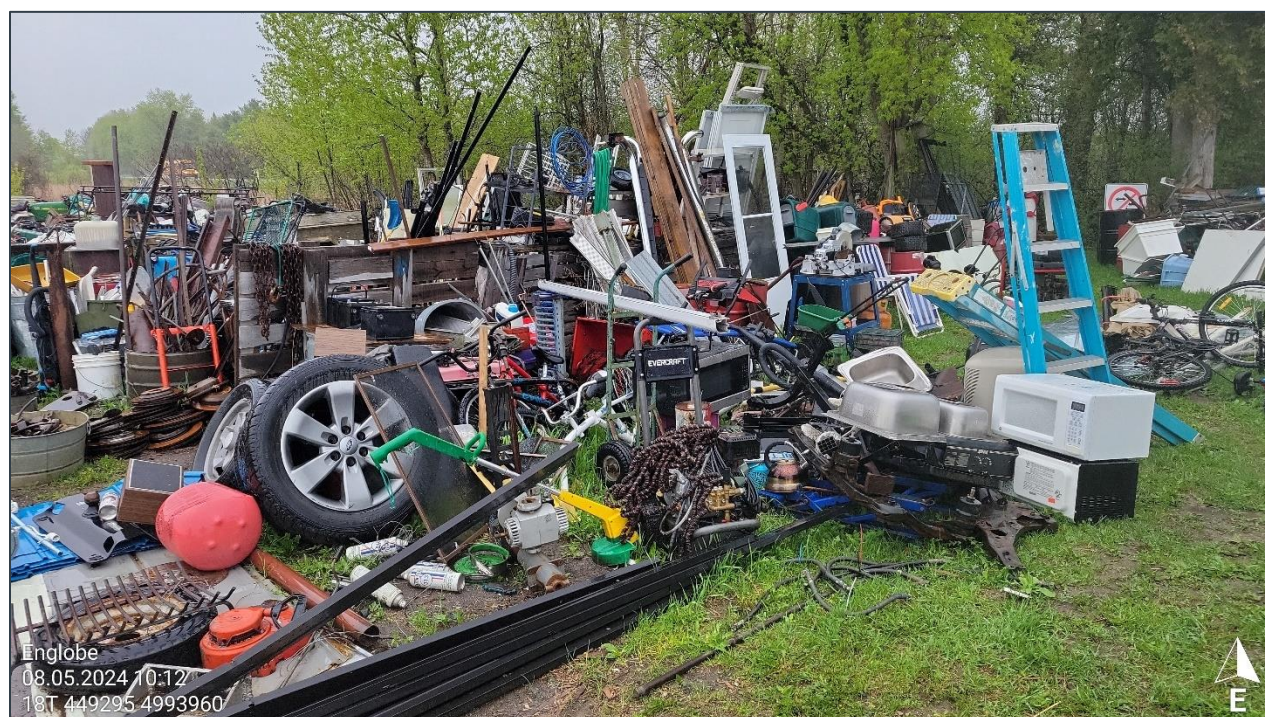
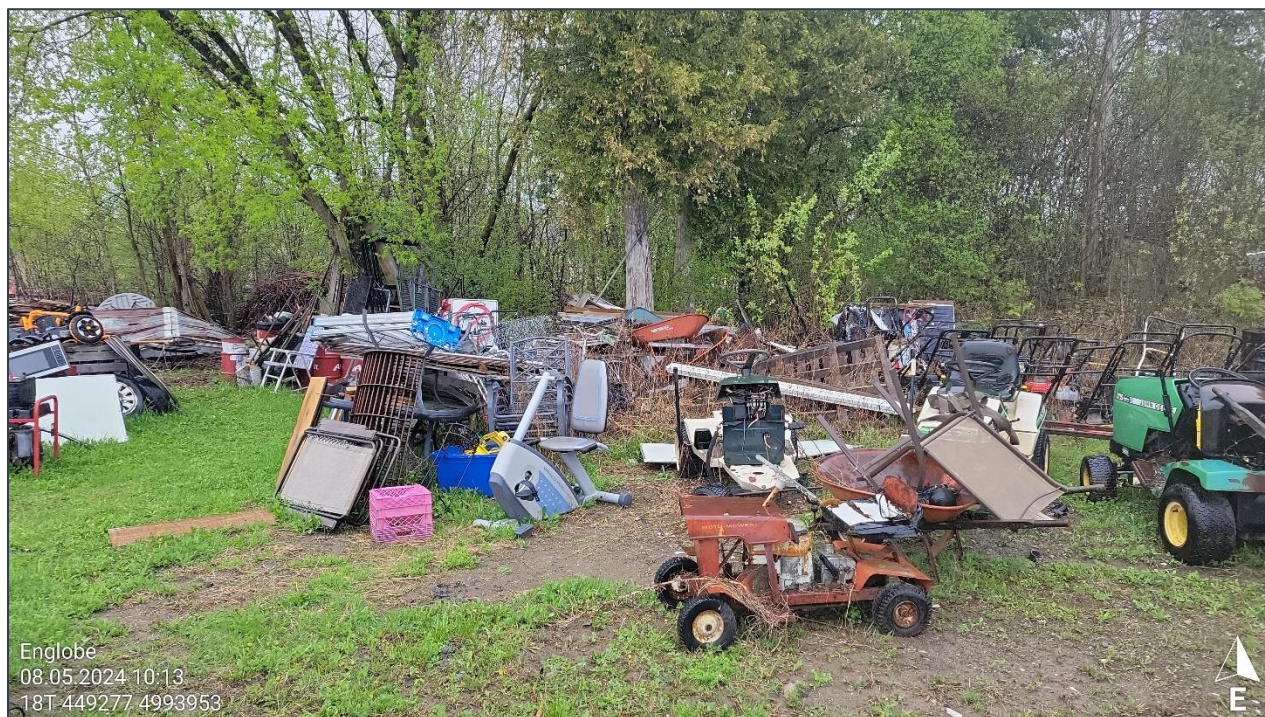
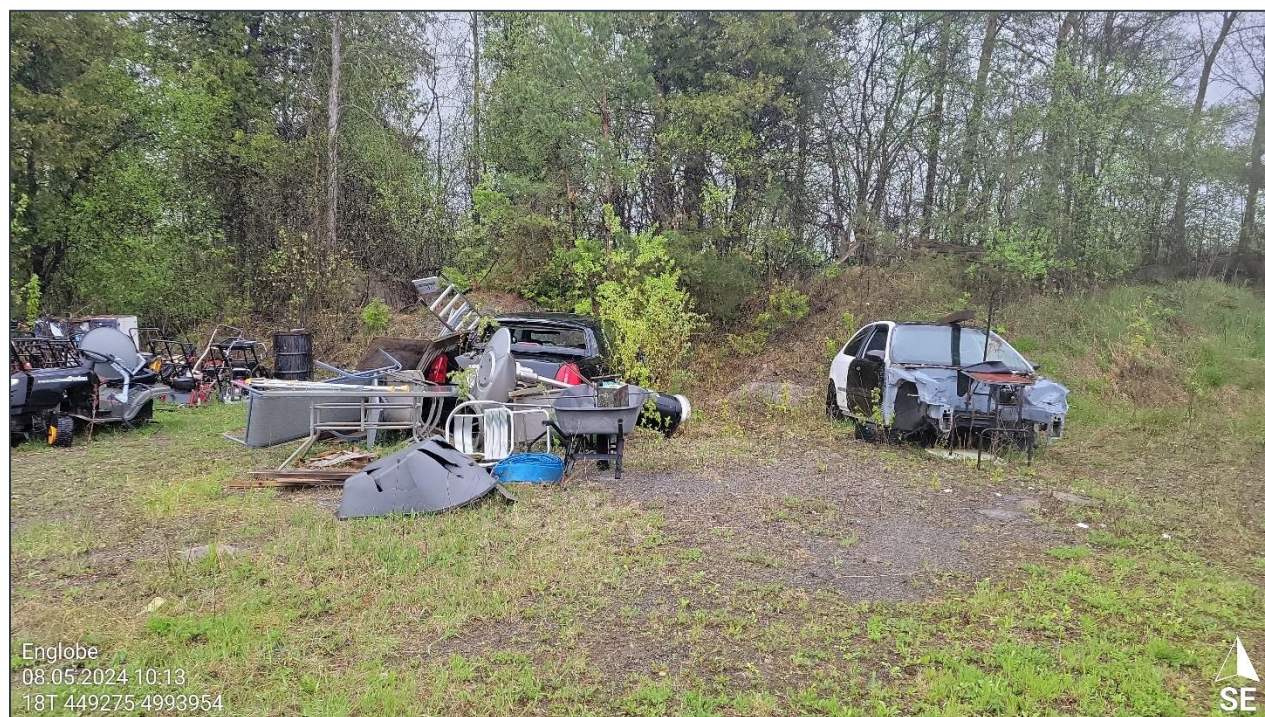
During the Site reconnaissance, Englobe observed a significant quantity of metal debris, old metal storage containers, lawn mowers, tires, snow blowers, wood piles, and old farm equipment located approximately 70 m northeast of the residential house.

Photograph 9: Debris stored on-Site
