Phase One Environmental Site Assessment

2095 Dilworth Road

Kars, Ontario

April 2021

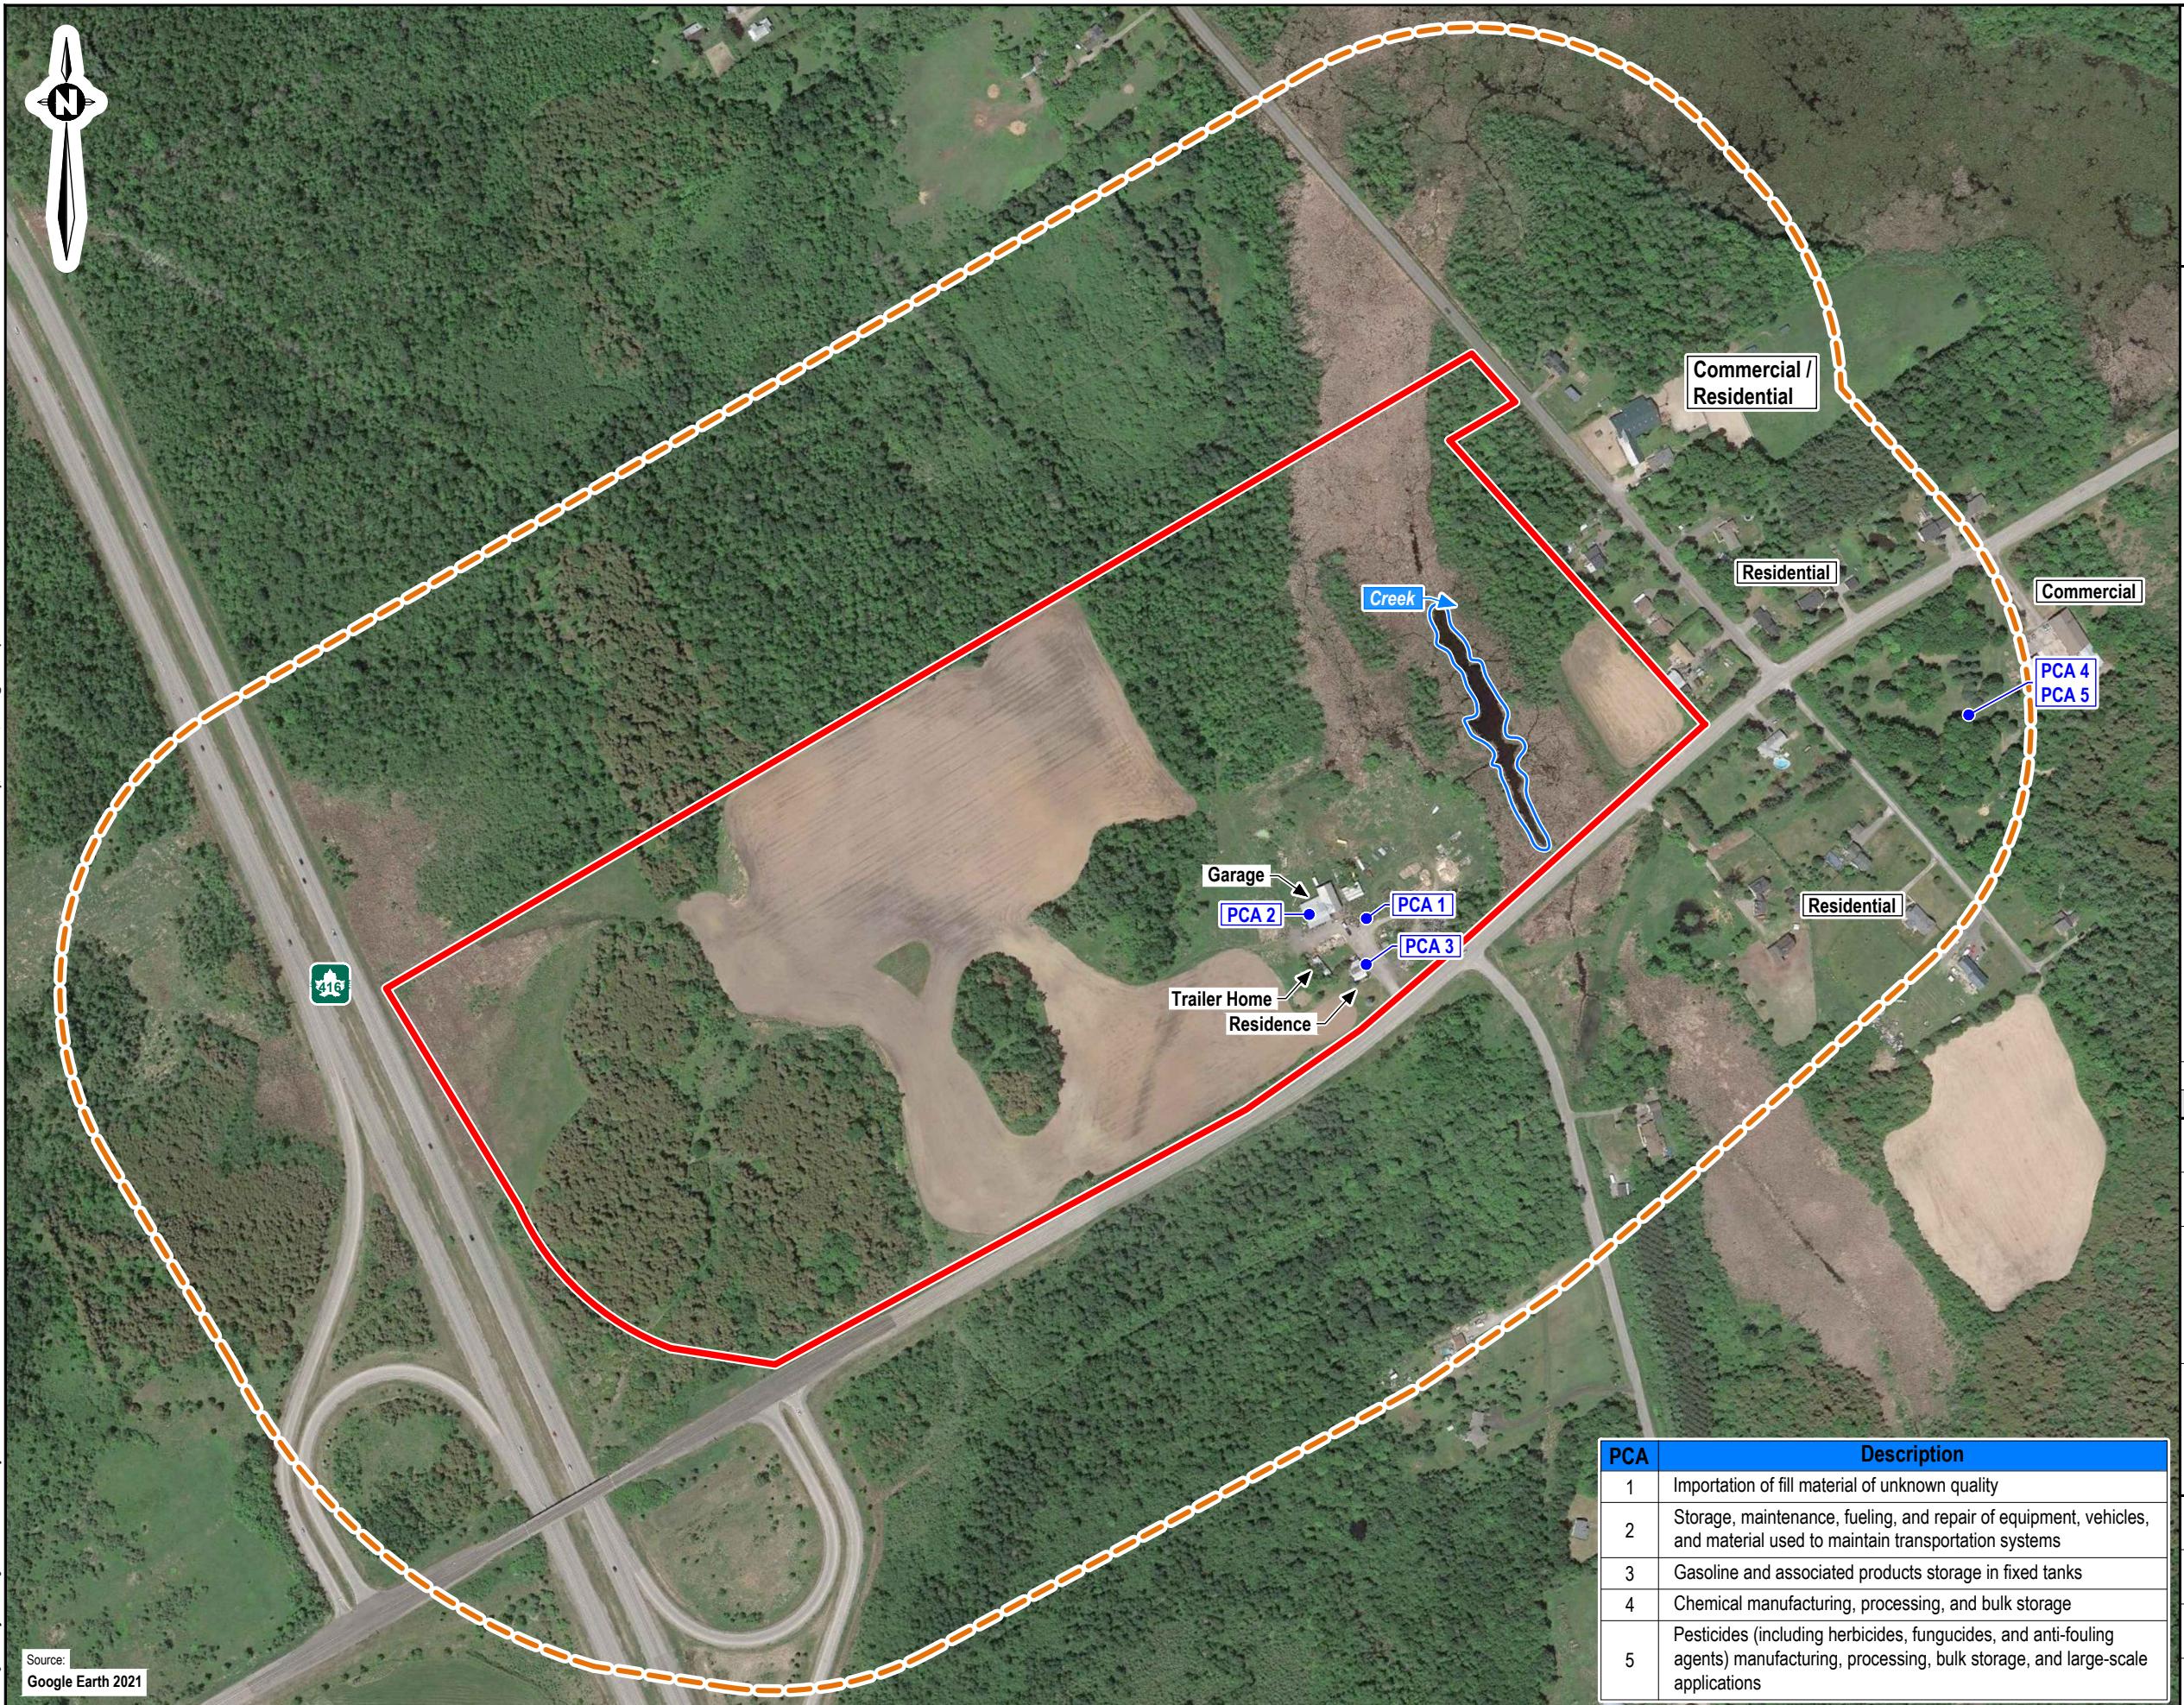
Study Area and Potentially Contaminating Activities (PCAs)

Through observation and records review of the properties surrounding the Site during the Site reconnaissance, and review of records and aerial photographs, the following PCAs were observed at other properties within the Phase One Study Area, as shown on Figure 2 in Appendix A:

In accordance with the definitions within O. Reg. 153/04 (as amended) Schedule D (Table 2, Phase One ESAs) and through review of the database record, DST noted the PCAs summarized in the table below within the Phase One Study Area, as shown on Figure 2 in Appendix A and described in detail in Section 6.2.2.

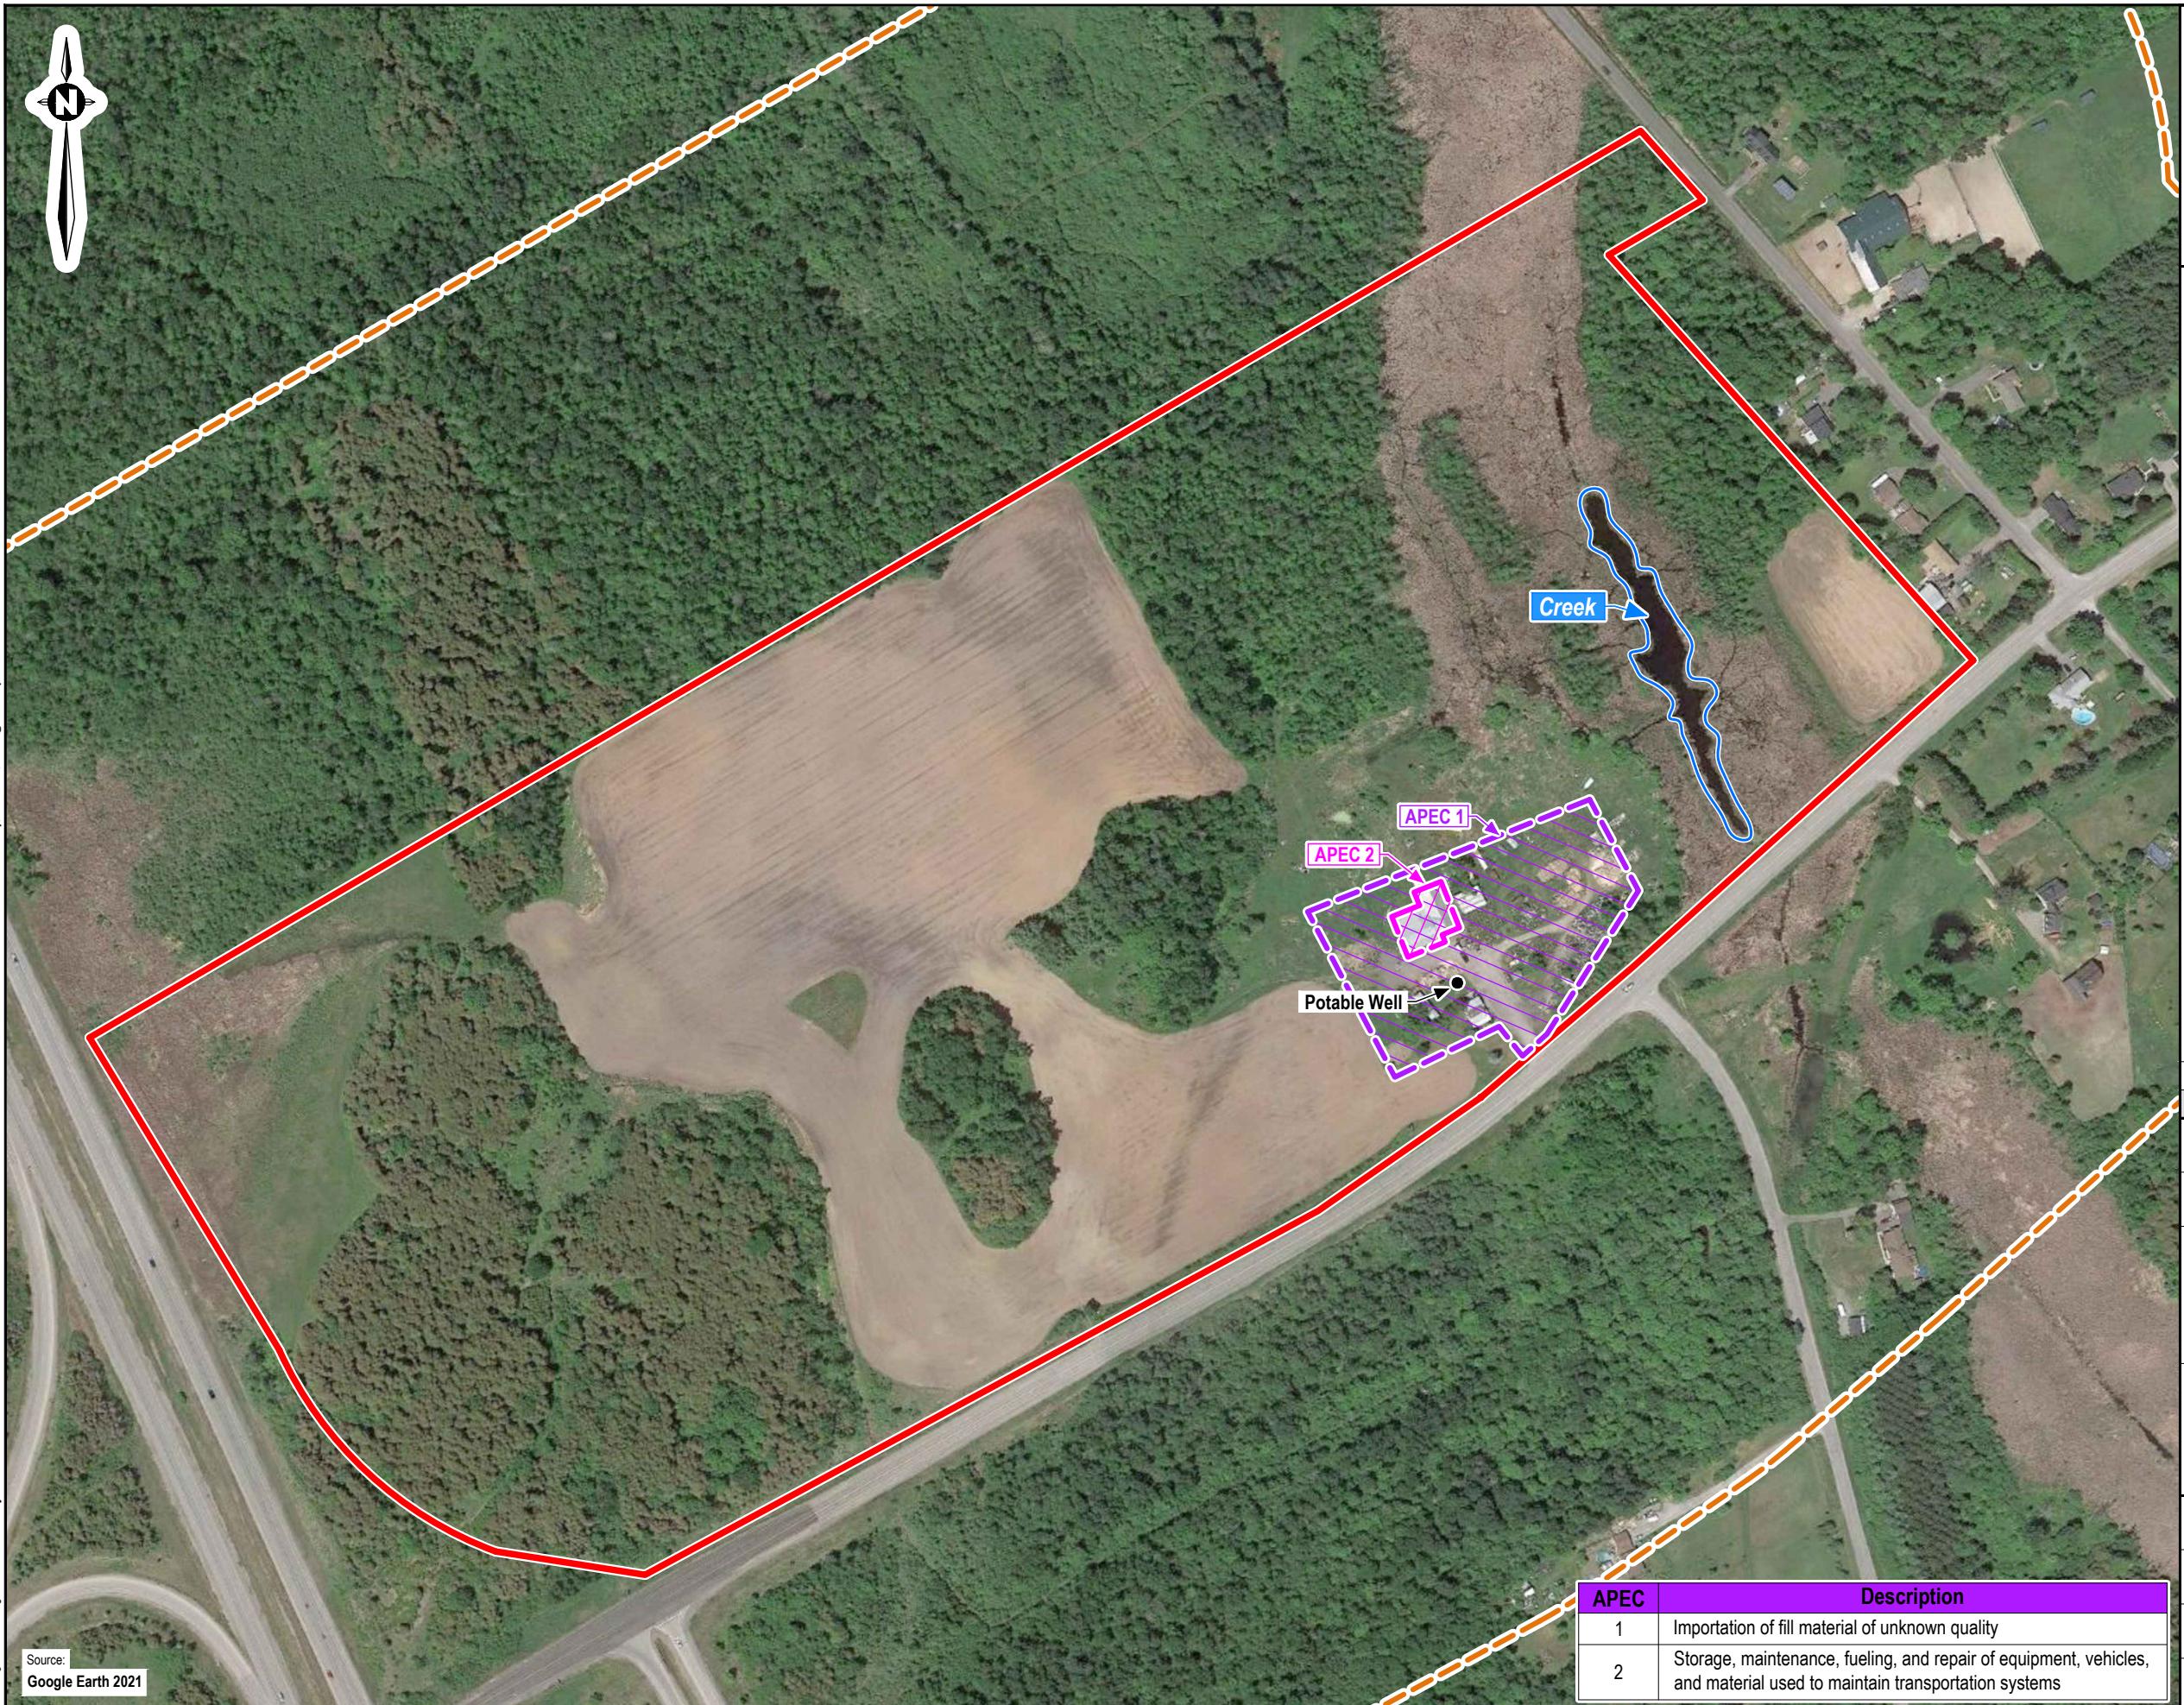
One potable water supply well was observed on Site during the Site reconnaissance, located to the north of the two-storey residence. The approximate location of the subject well is shown on Figure 3, in Appendix A.

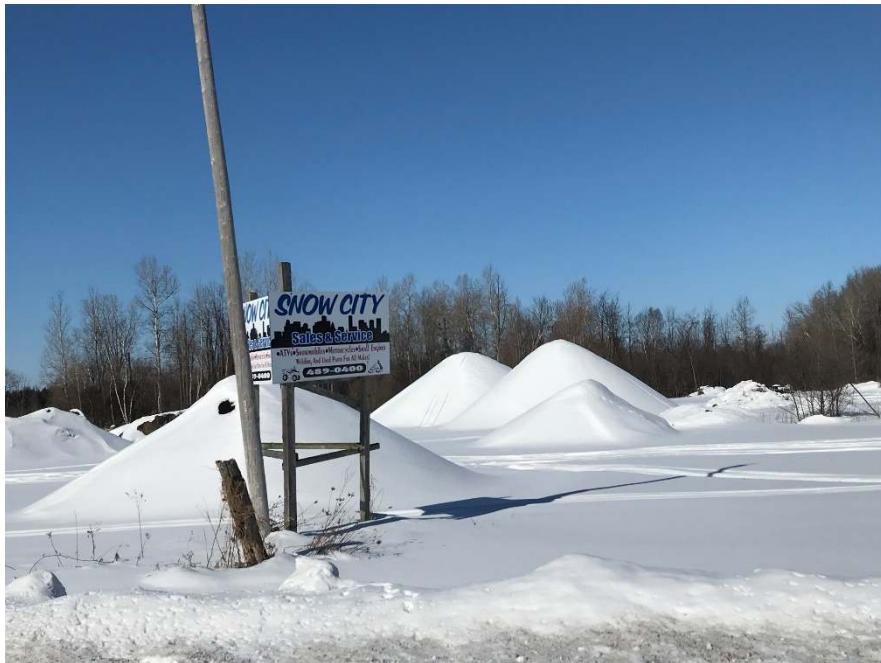
The presence of structures on Site indicates the presence of fill material of an unknown origin in the developed portion of the Phase One Property. Also, various stockpiles of topsoil were observed to the west of the garage at the time of the Site reconnaissance.

Photograph 15: Stockpiled material southwest of main house

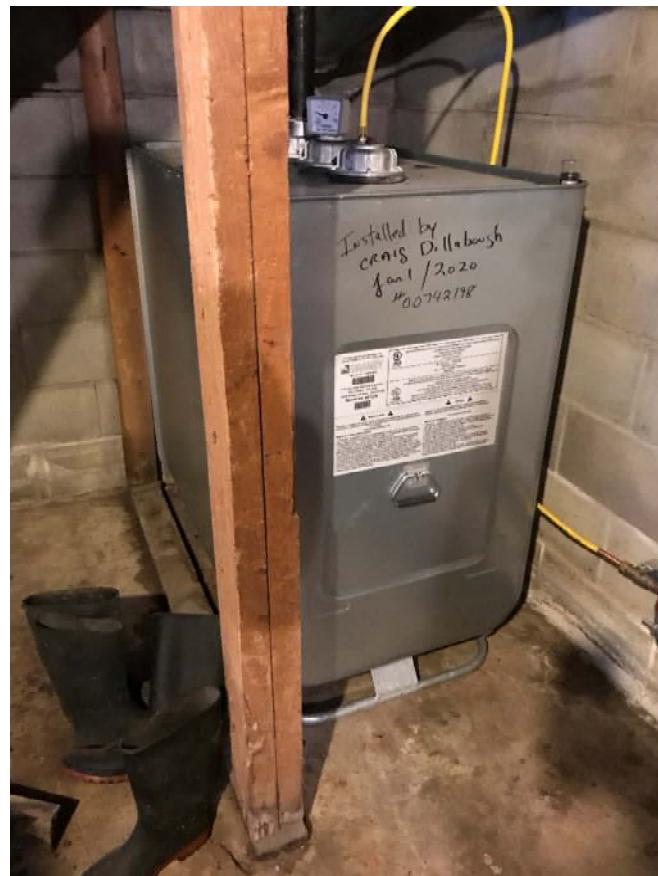
An aboveground storage tank (AST) containing heating oil was observed in the basement of the two-storey residence at the time of the Site reconnaissance. DST was informed by Mr. Cureston that a previous oil tank was installed in 2004 and removed and replaced with the existing tank in January 2020. No evidence of leaks or corrosion of the existing tank was observed by DST. Also, no staining was observed in the basement of the residence.

Photograph 28: Main house basement, heating oil tank

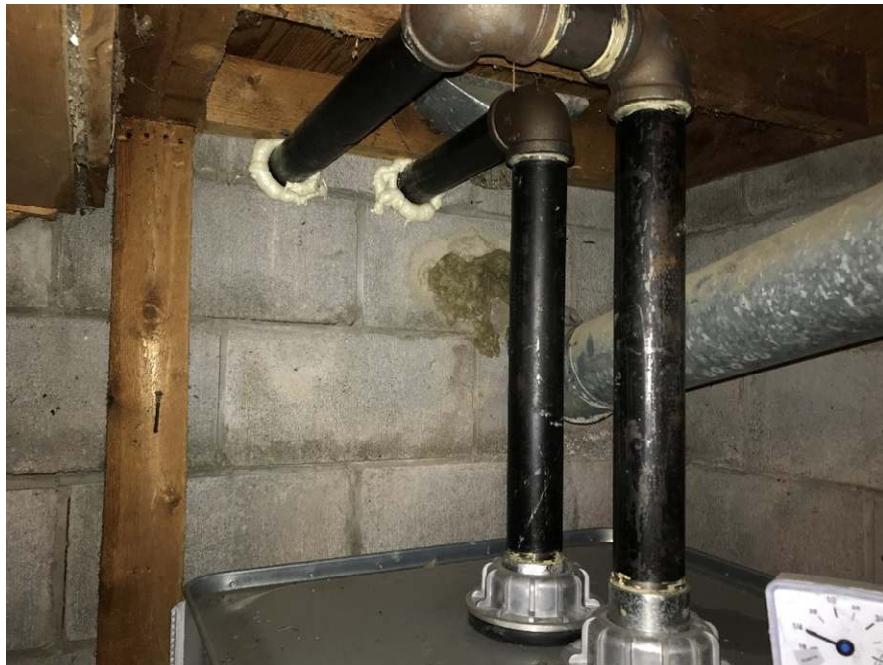
Photograph 29: Heating oil tank, fill and vent lines

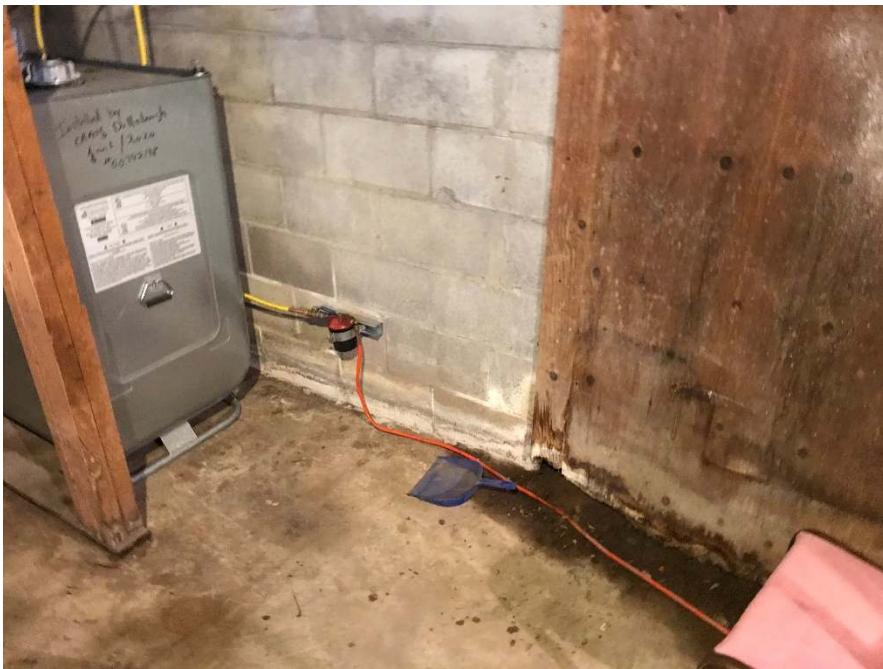
Photograph 30: Main house basement, heating oil tank

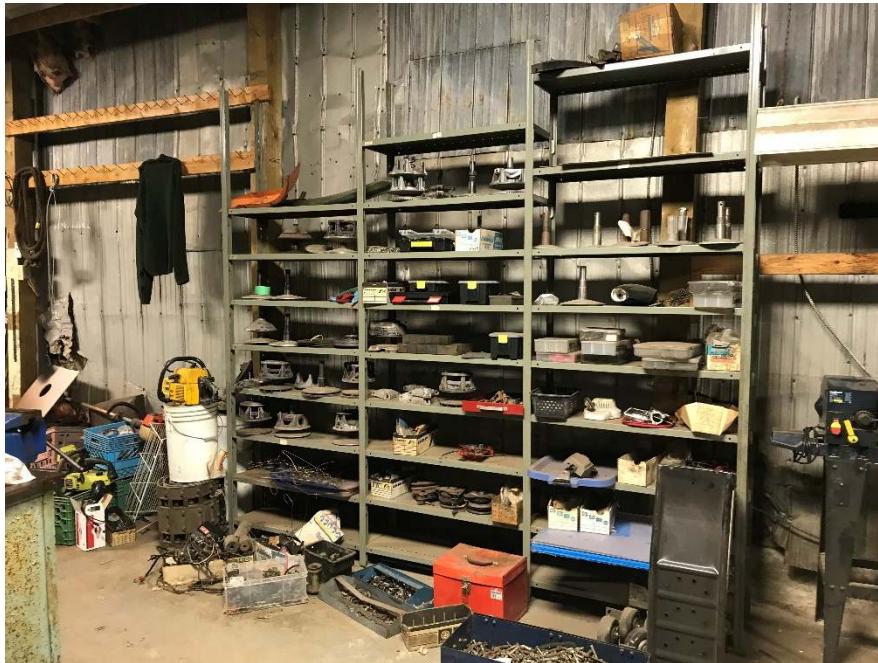
Various small containers of chemicals were observed within the commercial garage on Site associated with maintenance and repair of snowmobile and small engines (gas/diesel, oil, lubricants, etc.)

Photograph 38: Garage interior storage shelves

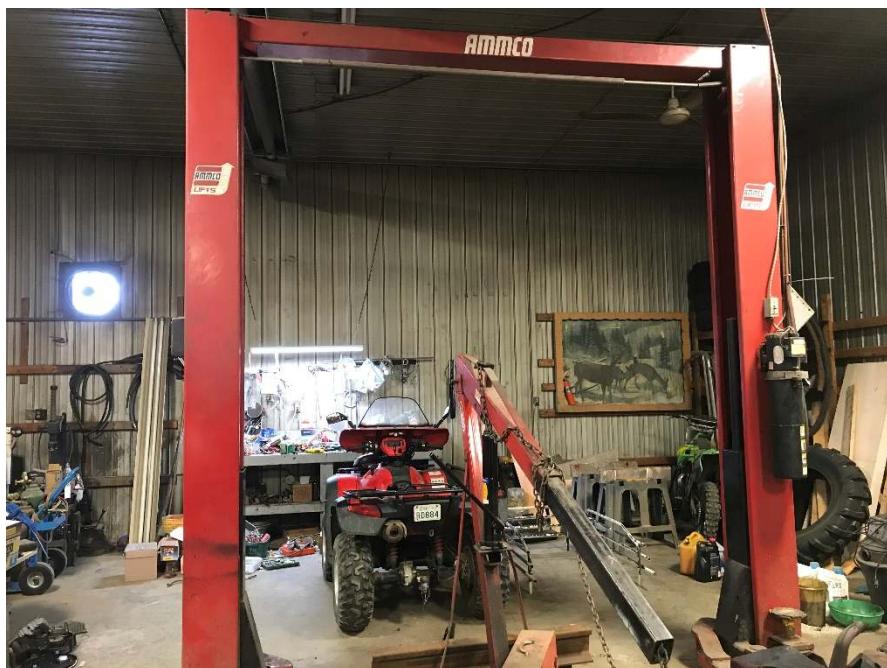
- PCA Item #28 – *Gasoline and Associated Products Storage in Fixed Tanks* – The former heating oil storage tank in
- PCA Item #30 – *Importation of Fill Material of Unknown Quality* – Possible fill materials imported during the construction of the on-Site structures.
- PCA Item #52 – *Storage, maintenance, fuelling and repair of equipment, vehicles, and material used to maintain transportation systems* – The on-Site garage used for storing and repair of snowmobiles, farm equipment and other small engines. There is also a hoist present in the garage.

Photograph 50: Garage interior, Hoist

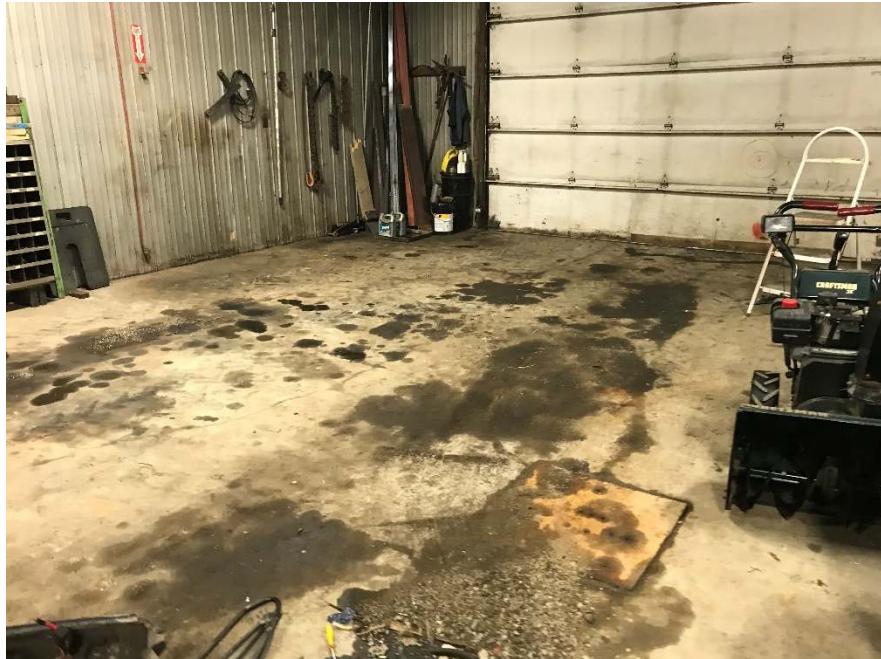
There was staining observed in various areas on the concrete floors within the garage, likely due to fluids leaking or spilling during the repair and maintenance of the snowmobiles and small engines performed in the garage. It should be noted, however, that the concrete floor slab within the garage was observed to be in good condition.

Photograph 51: Garage interior staining

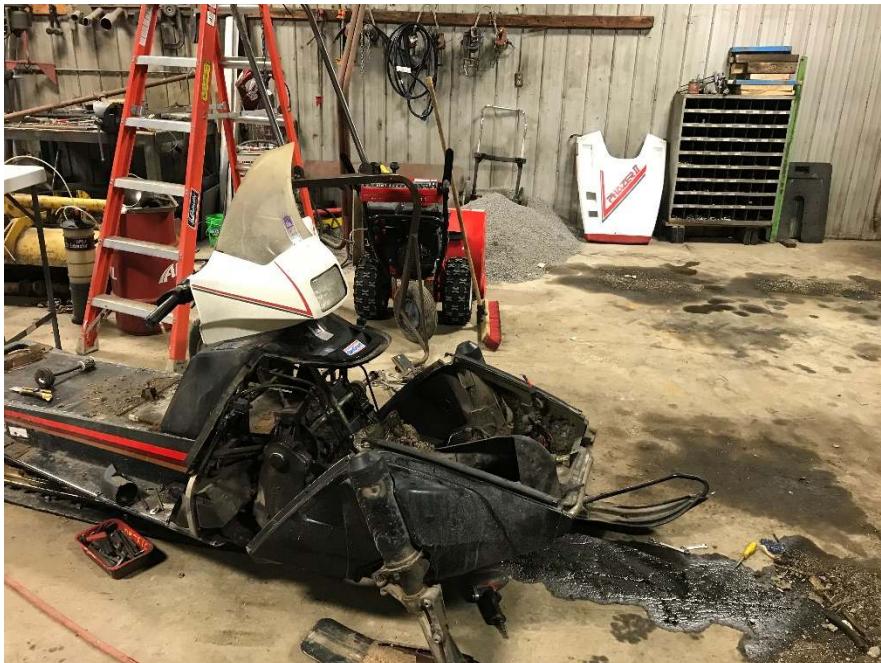
Photograph 52: Garage interior spill and staining
