Phase One Environmental Assessment Update

2095 Dilworth Road, Ottawa, Ontario

Dilworth Development Inc.
Final Report

May 17, 2024
02402048.000

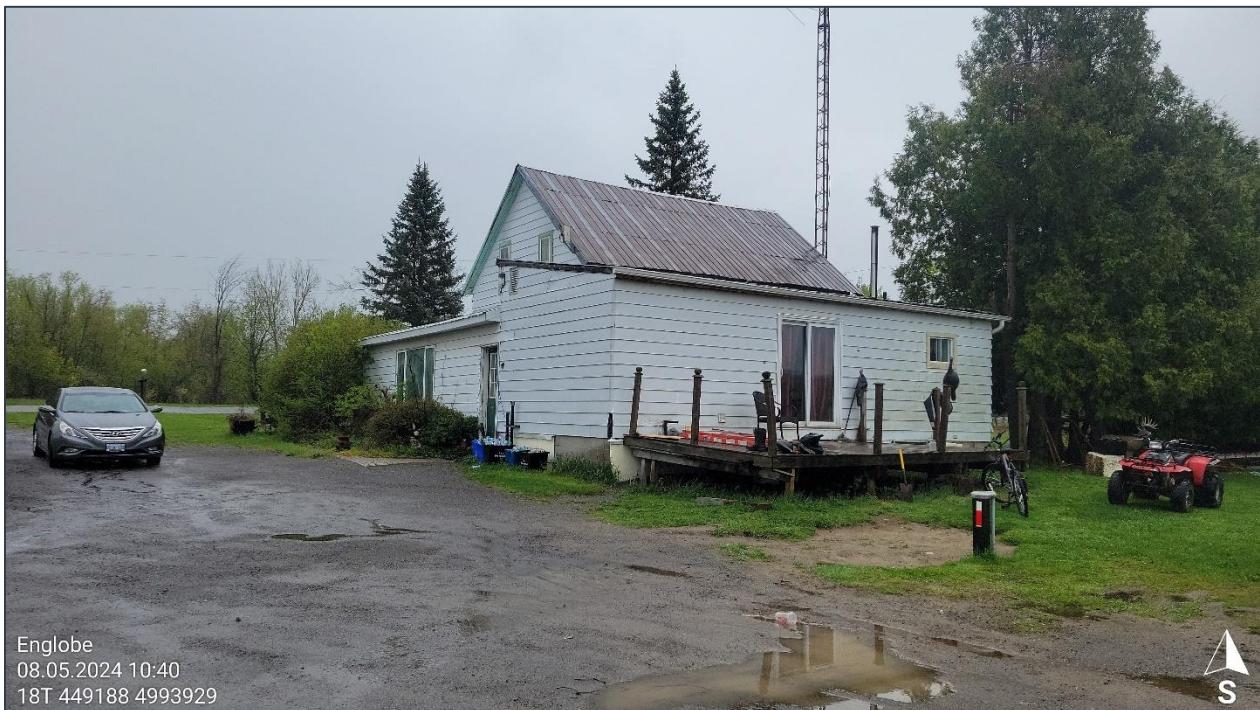
Photograph 2: Residential house

The residential house is a two-storey building, located near the east most entrance to the Site in the southeast portion of the property, constructed with vinyl siding, a concrete block foundation, and a peaked metal roof. The building has an approximate footprint of 160 m², one basement level, and was constructed prior to 1920. Potable water is provided to the building from the north-adjacent domestic supply well; electricity is provided via overhead lines; the building does not appear to be serviced with gas; heating is provided via underground lines from an exterior wood burning stove located approximately 15 m northwest of the building; and although a septic tank access port could not be located, it is inferred that sewage is serviced via an underground septic tank system located to the west of the house on-site (DST, 2021).

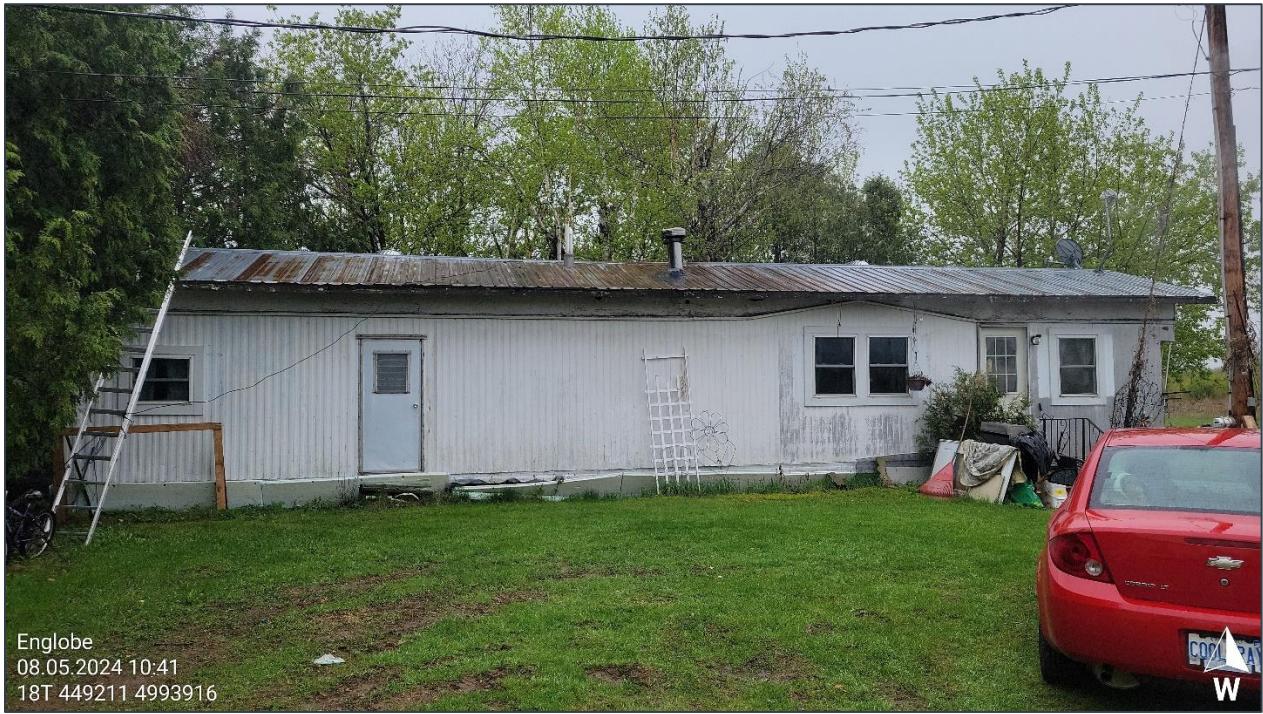
Photograph 3: Residential trailer home

The residential trailer home is a one-storey building, located west of the residential house, constructed with vinyl siding, a concrete slab-on-grade foundation, and a peaked metal roof. The building has an approximate footprint of 85 m² and was constructed in 1976. Potable water is provided to the building from the on-Site domestic supply well; electricity is inferred to be provided via underground lines from the residential house; propane is provided from a west-adjacent propane AST.

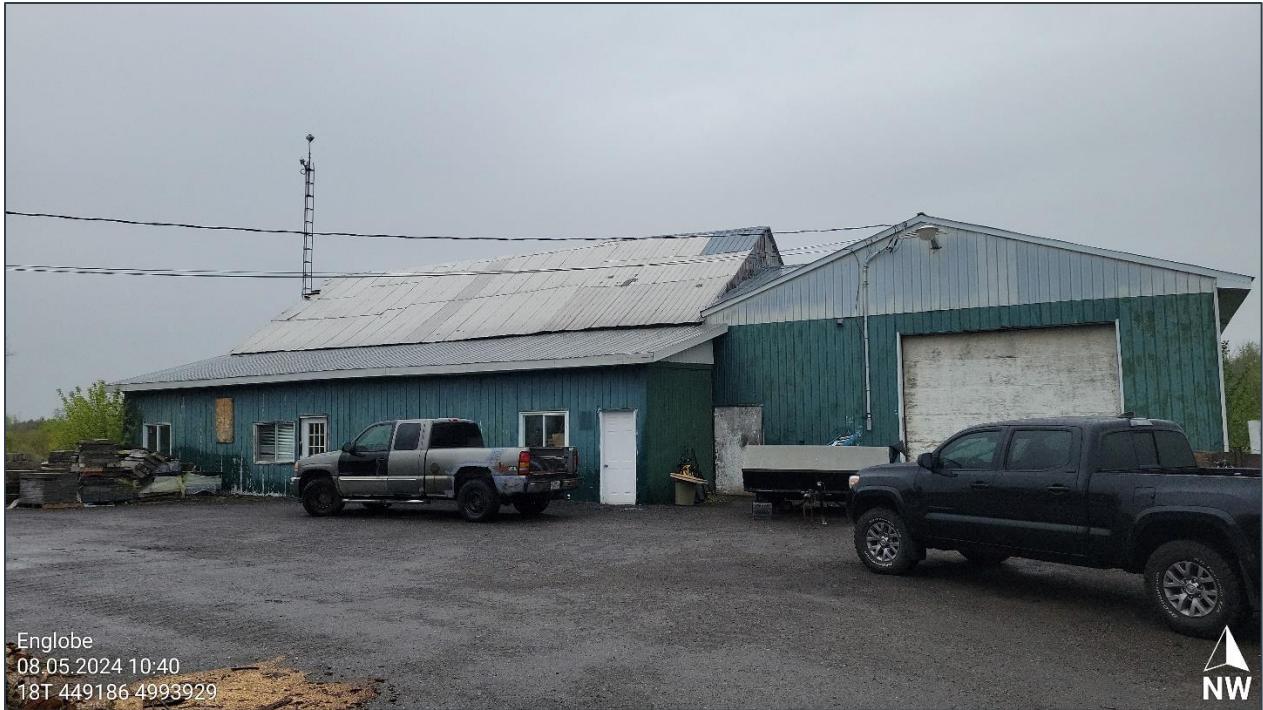
Photograph 4: Commercial service garage

The commercial service garage is a one-story building, located approximately 20 meters north of the residential trailer home, constructed with metal siding, a concrete slab-on-grade foundation, and a peaked metal roof. The building has an approximate footprint of 625 m² and was constructed prior to 1920. Electricity is provided via overhead lines; the building does not appear to be serviced with gas; heating is provided by the exterior wood burning stove, via underground lines; and it is unclear if the building is serviced with water or sewage services.

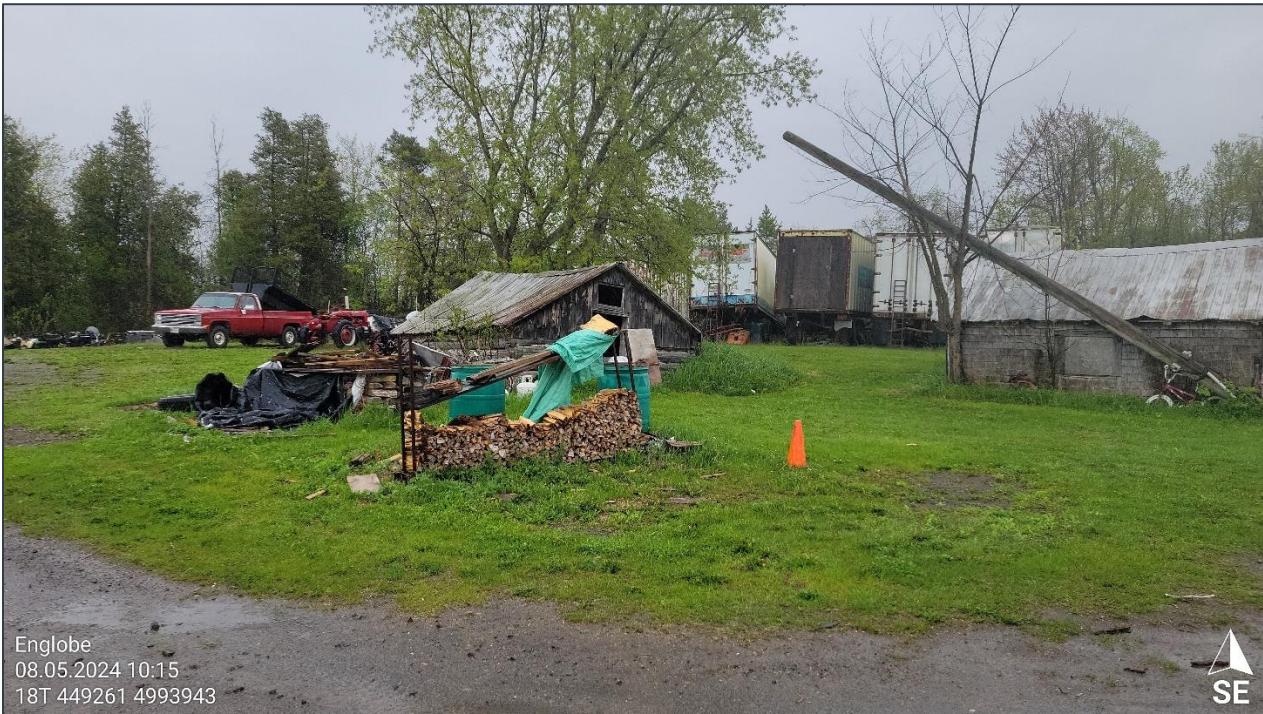
Photograph 5: Wooden storage sheds

The two wooden storage sheds are one-storey structures located approximately to the northeast of the residential house, constructed of wood, with no foundations, and peaked metal roofs. Each storage shed has an approximate footprint of 15 m² and was constructed prior to 1976. The storage sheds are not serviced with water, electricity, gas, or sewage.

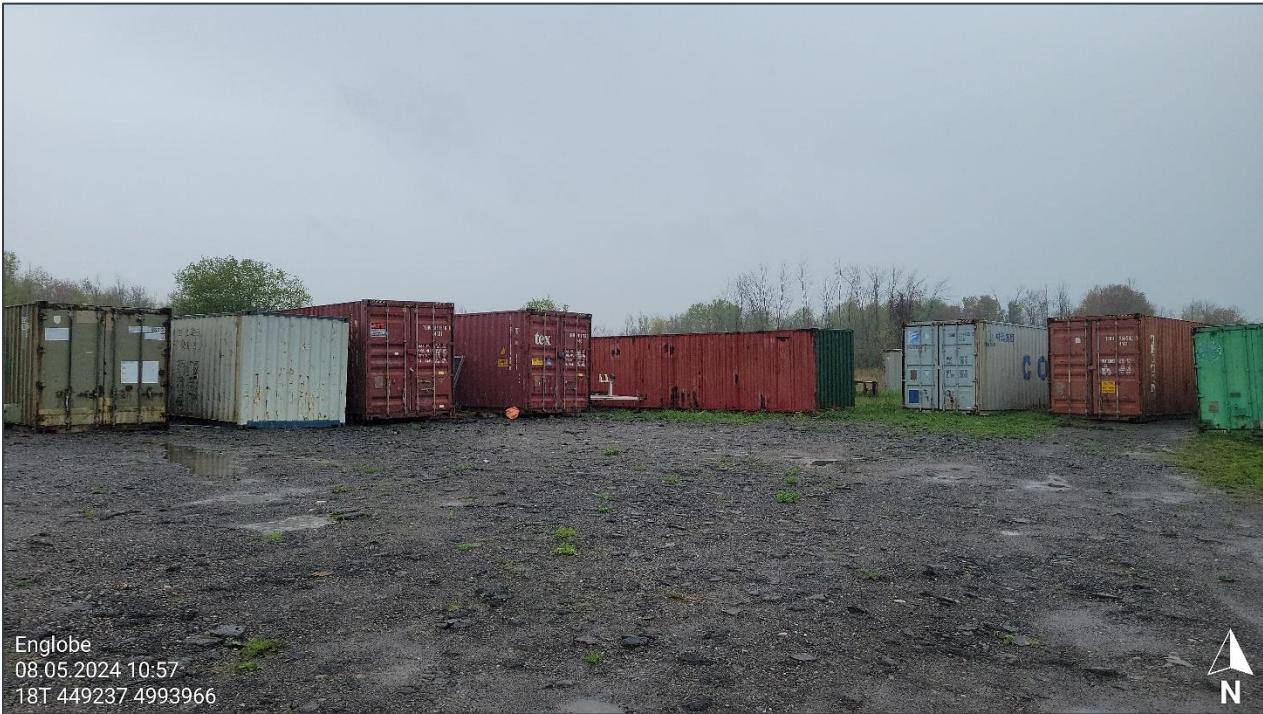
Photograph 6: Metal shipping containers

Additionally, 13 metal shipping containers, and five semi trailers were observed near the residential dwellings.

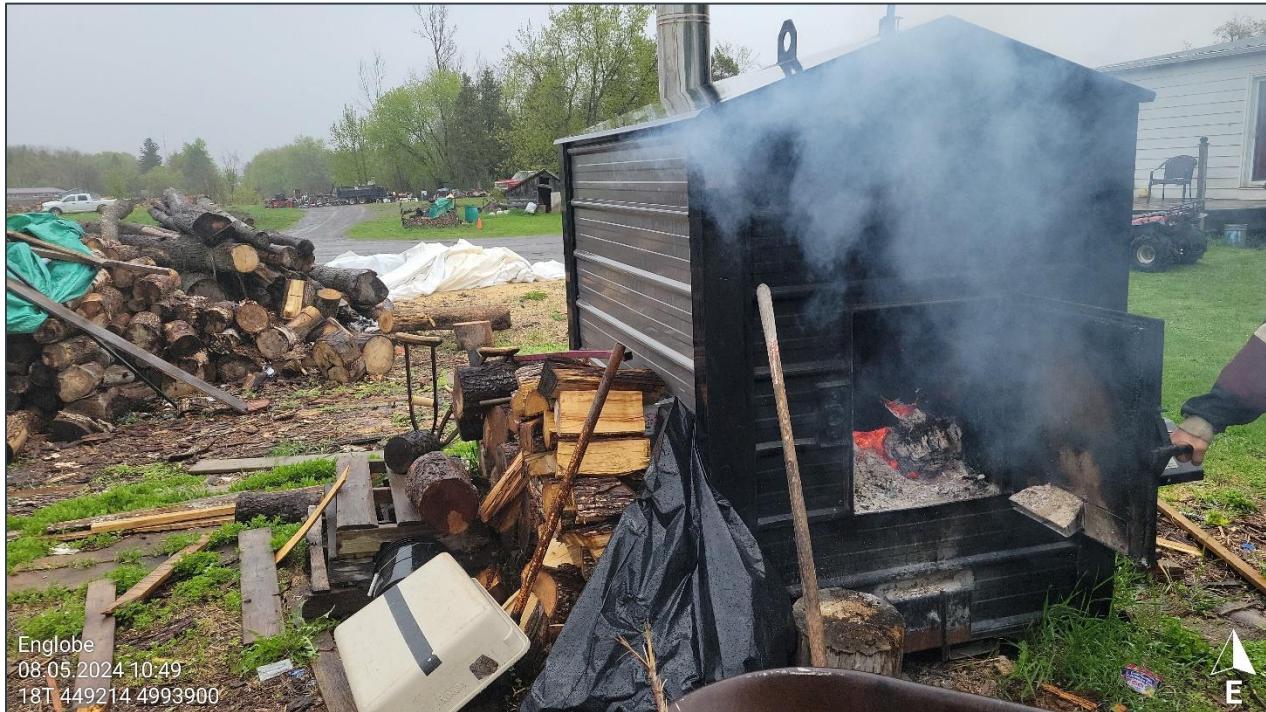
Photograph 8: Exterior wood burning stove

During the Site reconnaissance, Englobe observed one external wood stove, approximately 15 m northwest of the residential house, one air conditioning unit west-adjacent to the residential house, and one window-mounted air conditioning unit on the west side of the residential trailer home.

- PCA 1: Undefined No 1 - Exterior wood burning stove: large exterior wood burning stove used to heat the residential house and the service garage observed approximately 15 m northwest of the residential house.

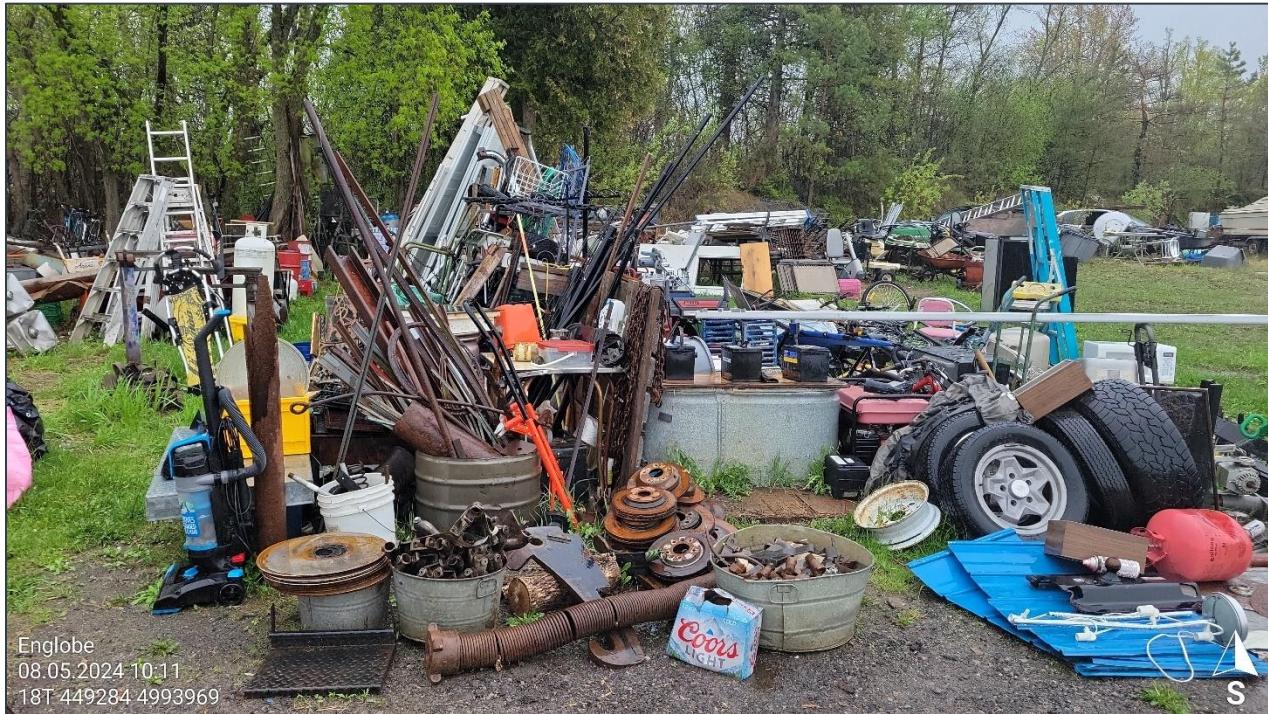
Photograph 9: Debris stored on-Site

During the Site reconnaissance, Englobe observed a significant quantity of metal debris, old metal storage containers, lawn mowers, tires, snow blowers, wood piles, and old farm equipment located approximately 70 m northeast of the residential house.
