# Hydrogeological Study Report

2095 Dilworth Road

Kars, Ontario

Englobe Ref No: 02101208.000

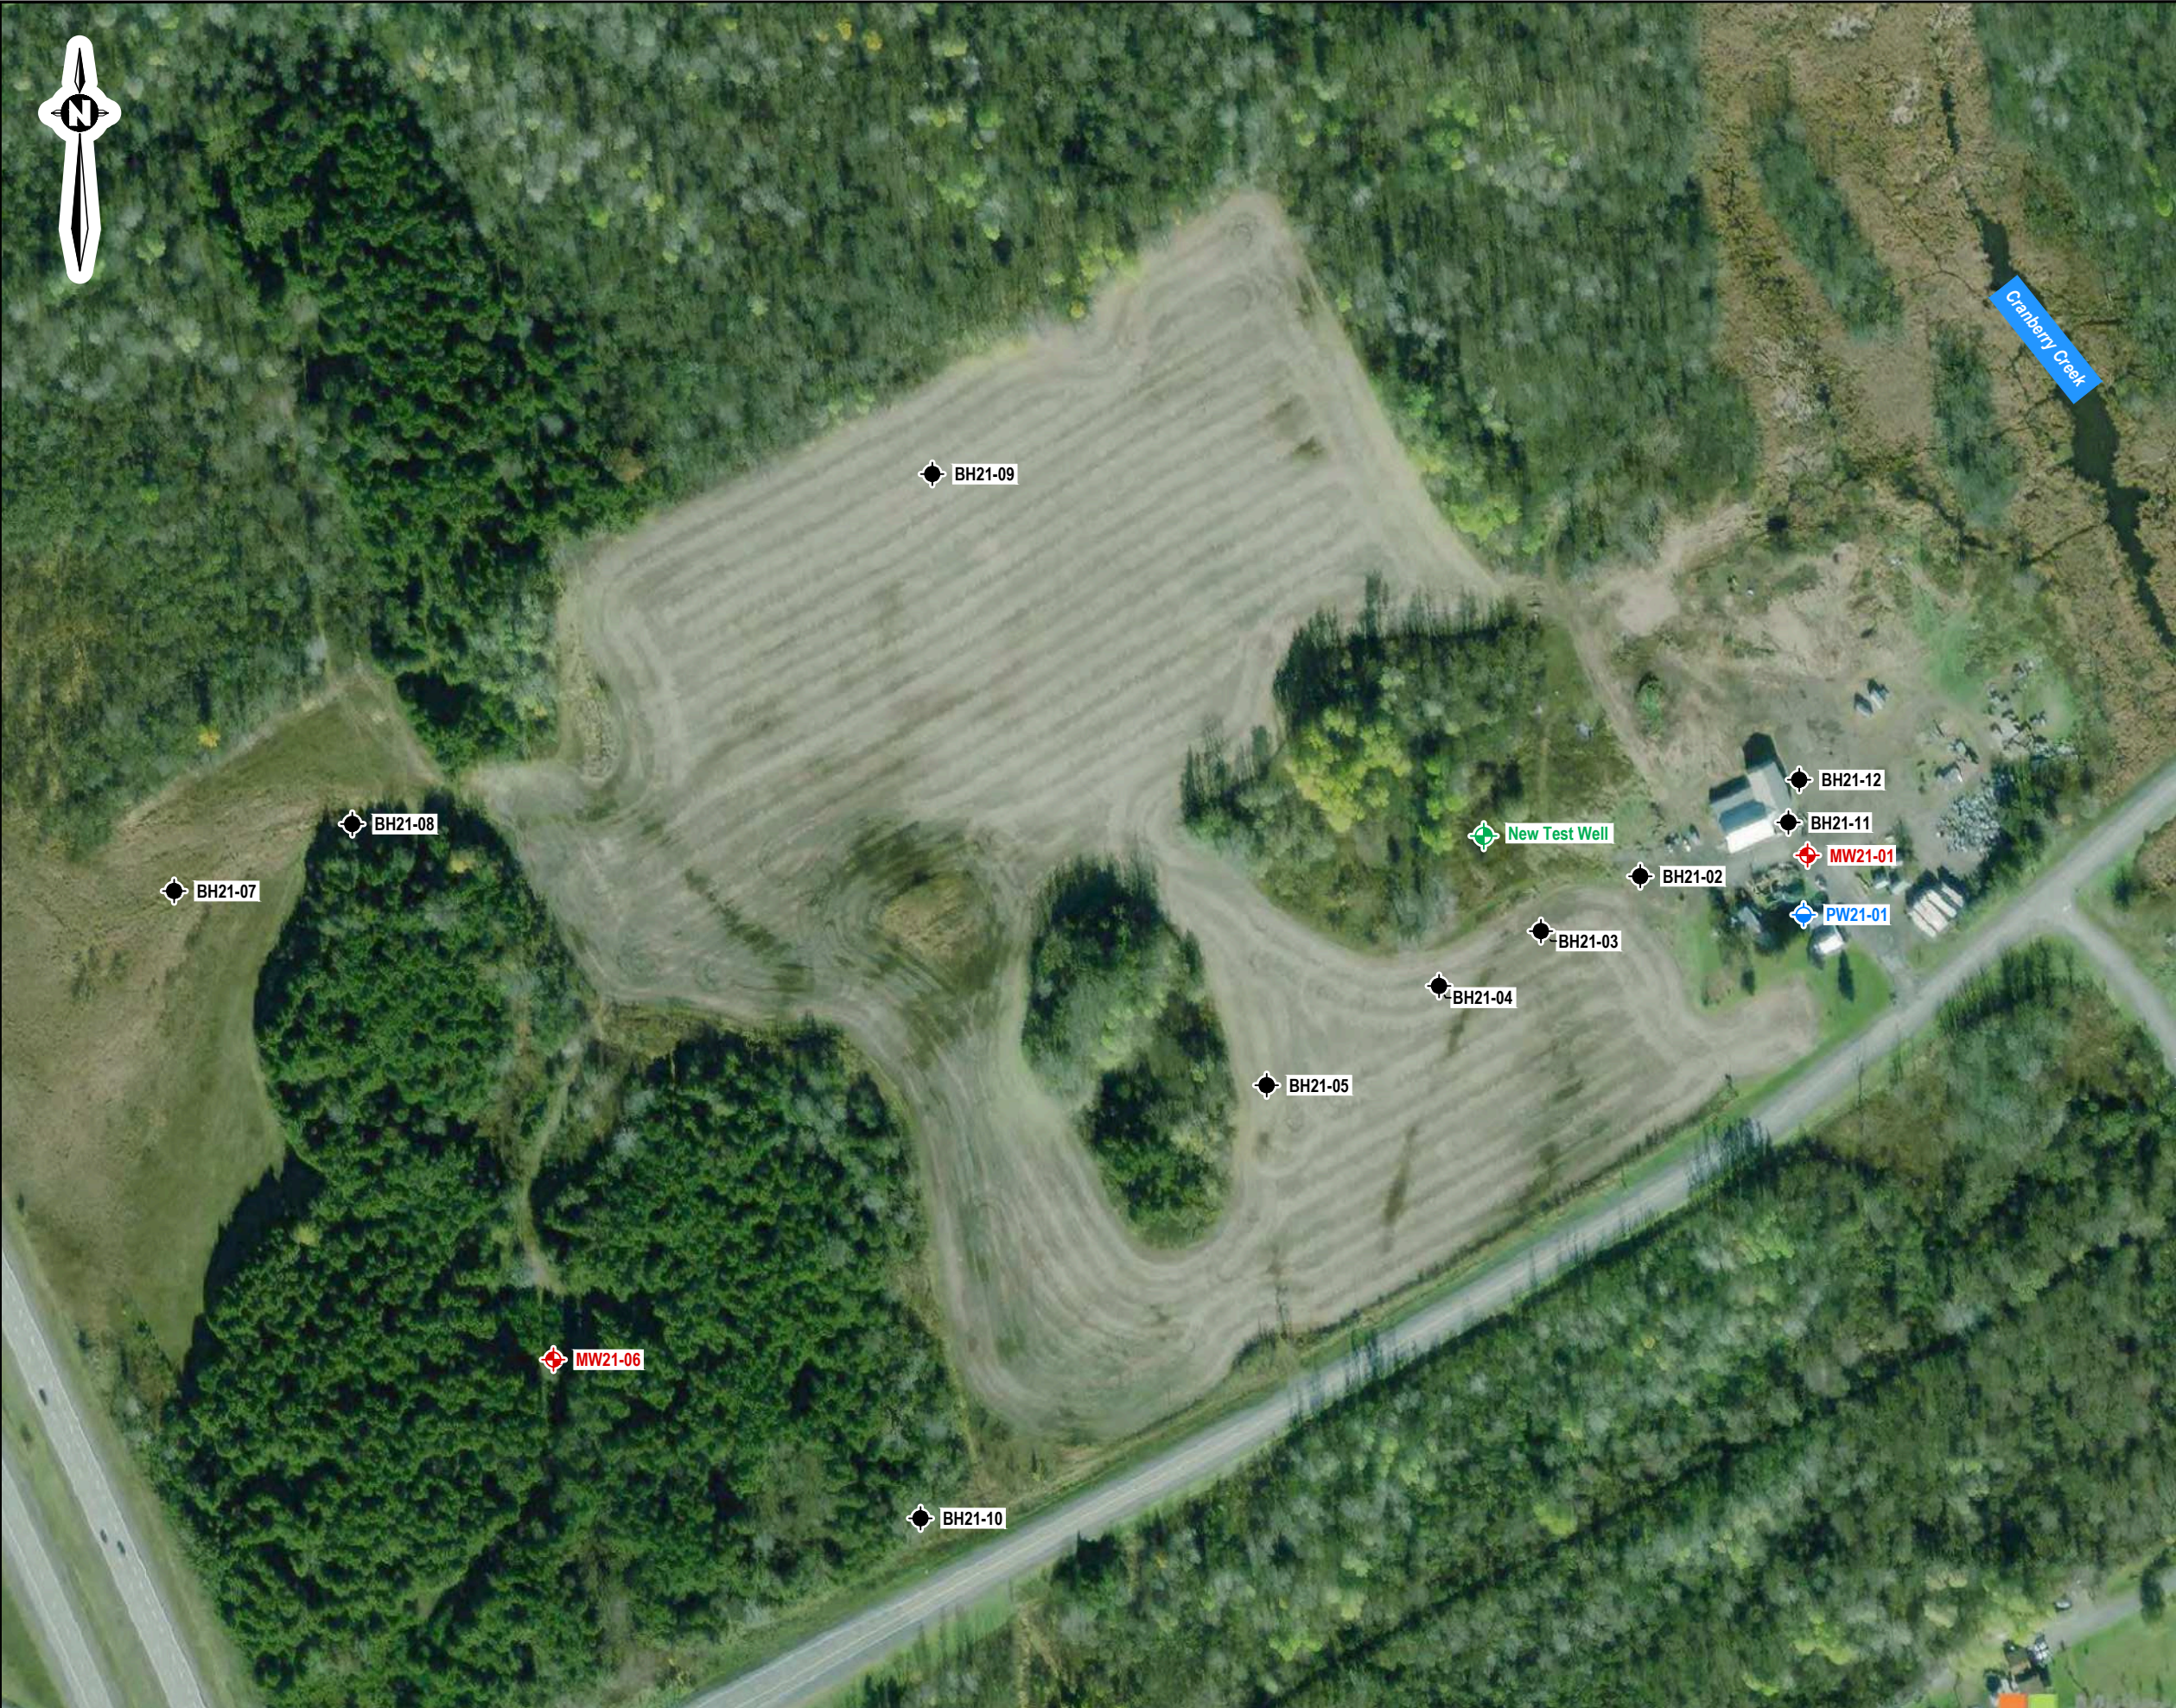
- Legend**
- Approximate location of borehole
  - Approximate location of monitoring well
  - New test well installed in 2024
  - Existing water well
