**PATERSON  
GROUP**

## **Phase II Environmental Site Assessment**

1450, 1454, 1458, 1464 and 1468 Bankfield Road,  
and 5479 and 5485 Elijah Court  
Ottawa, Ontario

Report: PE5397-2R  
November 30, 2022

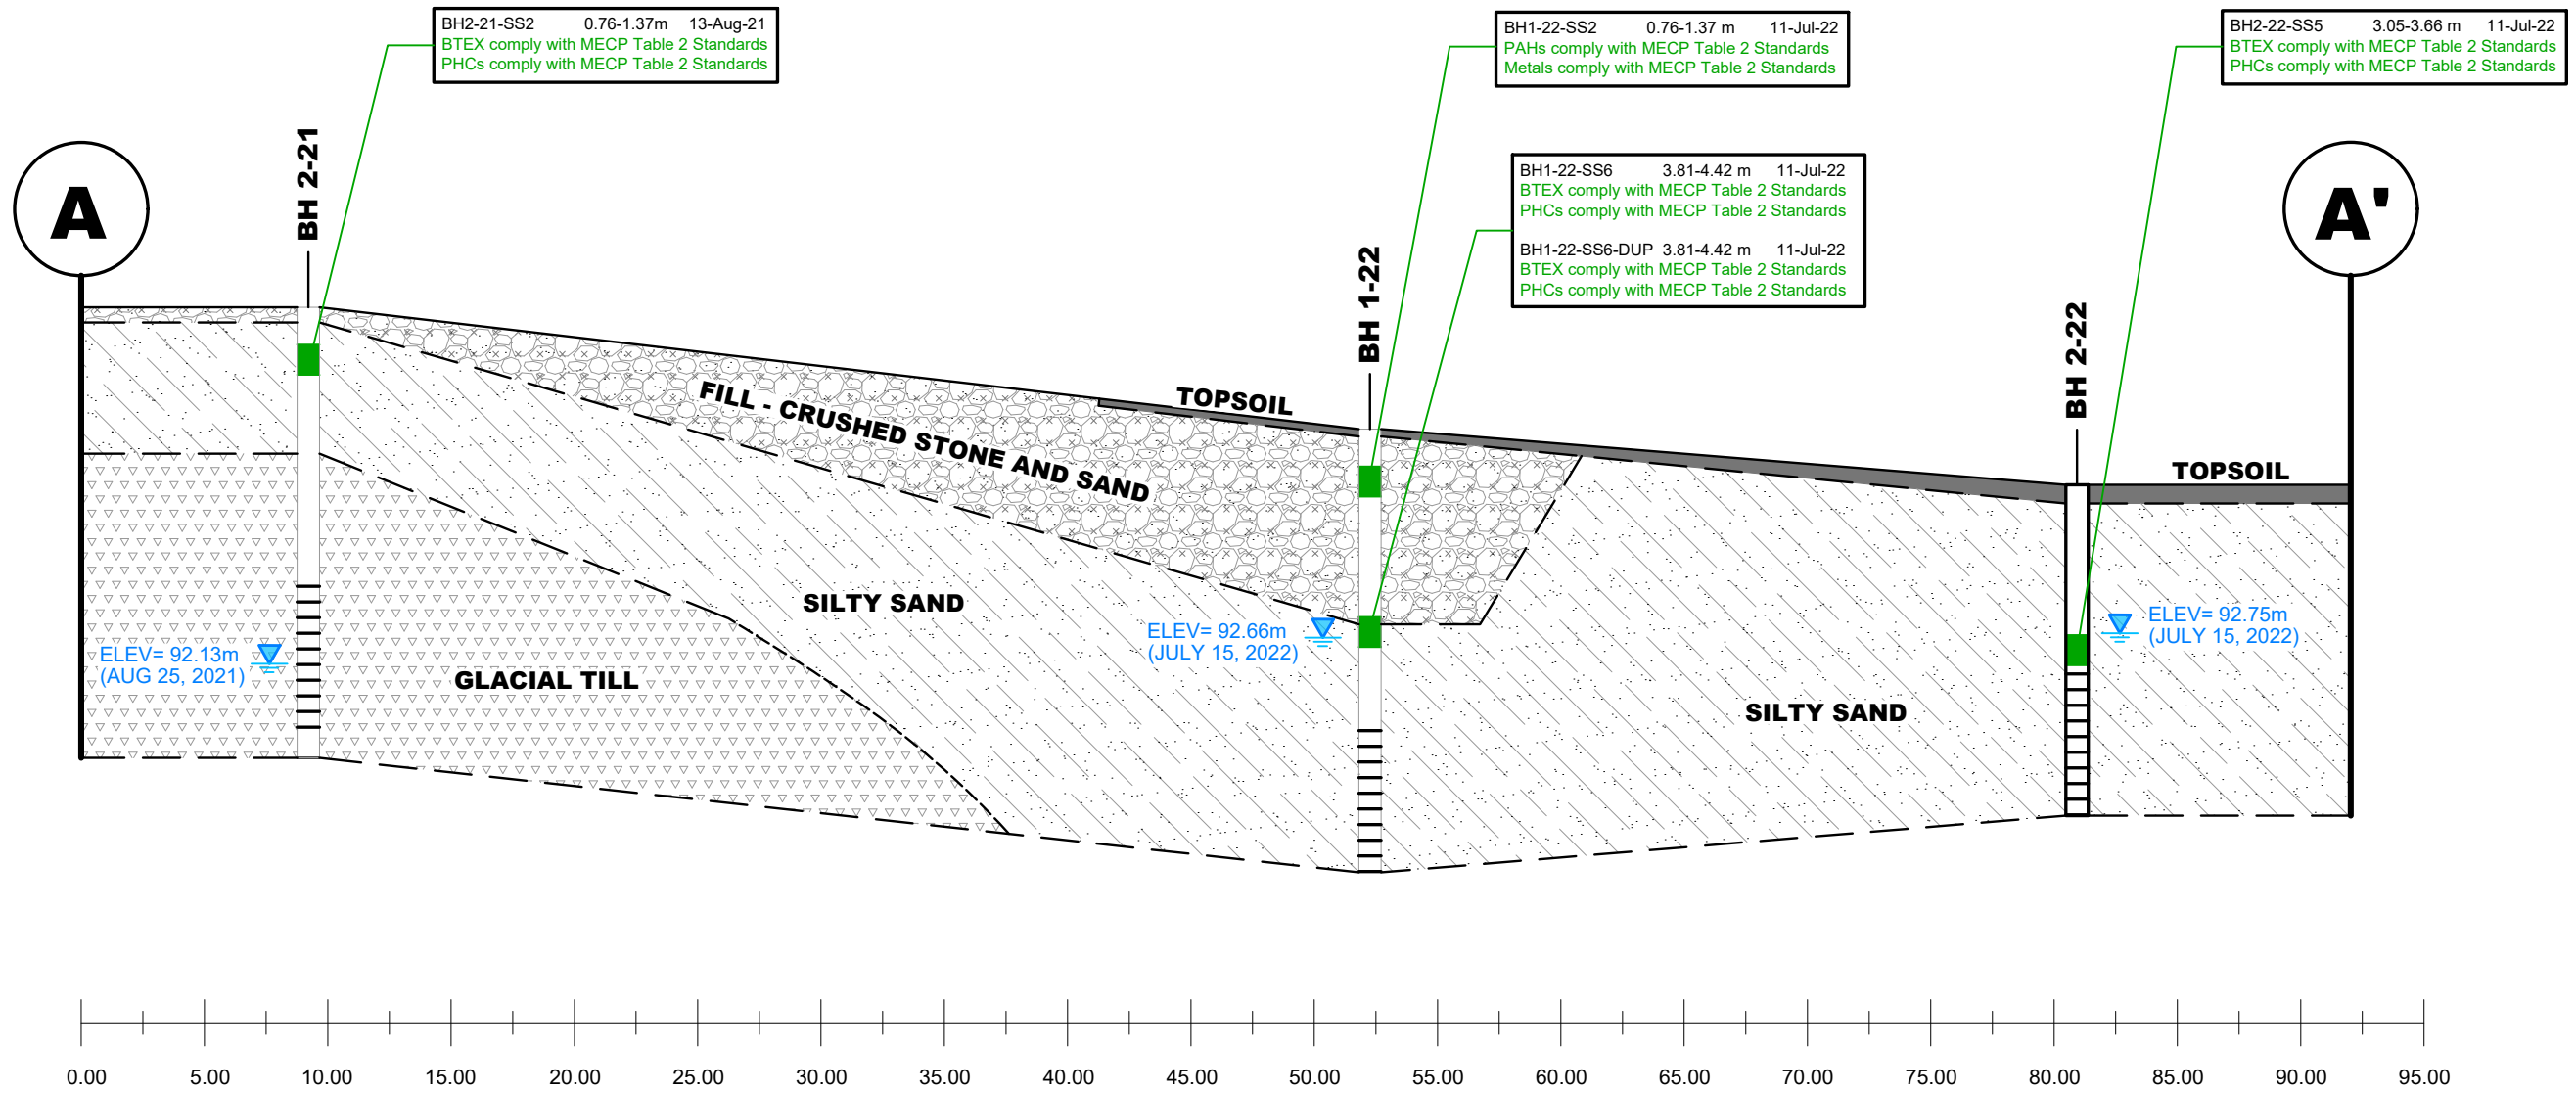
Scale:	1:750	Date:	10/2022
Drawn by:	YA	Report No.:	PE5397-2R
Checked by:	MW	Dwg. No.:	<b>PE5397-4AR</b>
Approved by:	MSD	Revision No.:

**SOIL RESULTS COMPLY WITH THE MECP TABLE 2 STANDARDS**

**MYERS AUTOMOTIVE GROUP**  
**PHASE II - ENVIRONMENTAL SITE ASSESSMENT**  
 1450, 1454, 1458, 1464, 1468 BANKFIELD ROAD & 5479, 5485 ELIJAH COURT  
 OTTAWA, ONTARIO  
**CROSS SECTION A-A' - SOIL**
