**PROPOSED RE-ZONING
FOR A COMMERCIAL ADDITION
TO A RESIDENTIAL DWELLING
LOT 343 R-PLAN 384
67 KEMPSTER AVENUE
CITY OF OTTAWA**

**SERVICING ASSESSMENT REPORT
REPORT No. R-825-93 (REV. #1)
JANUARY 2026**

**T. L. MAK ENGINEERING CONSULTANTS LTD.
NOVEMBER 2025
REF. FILE No. 825-93**

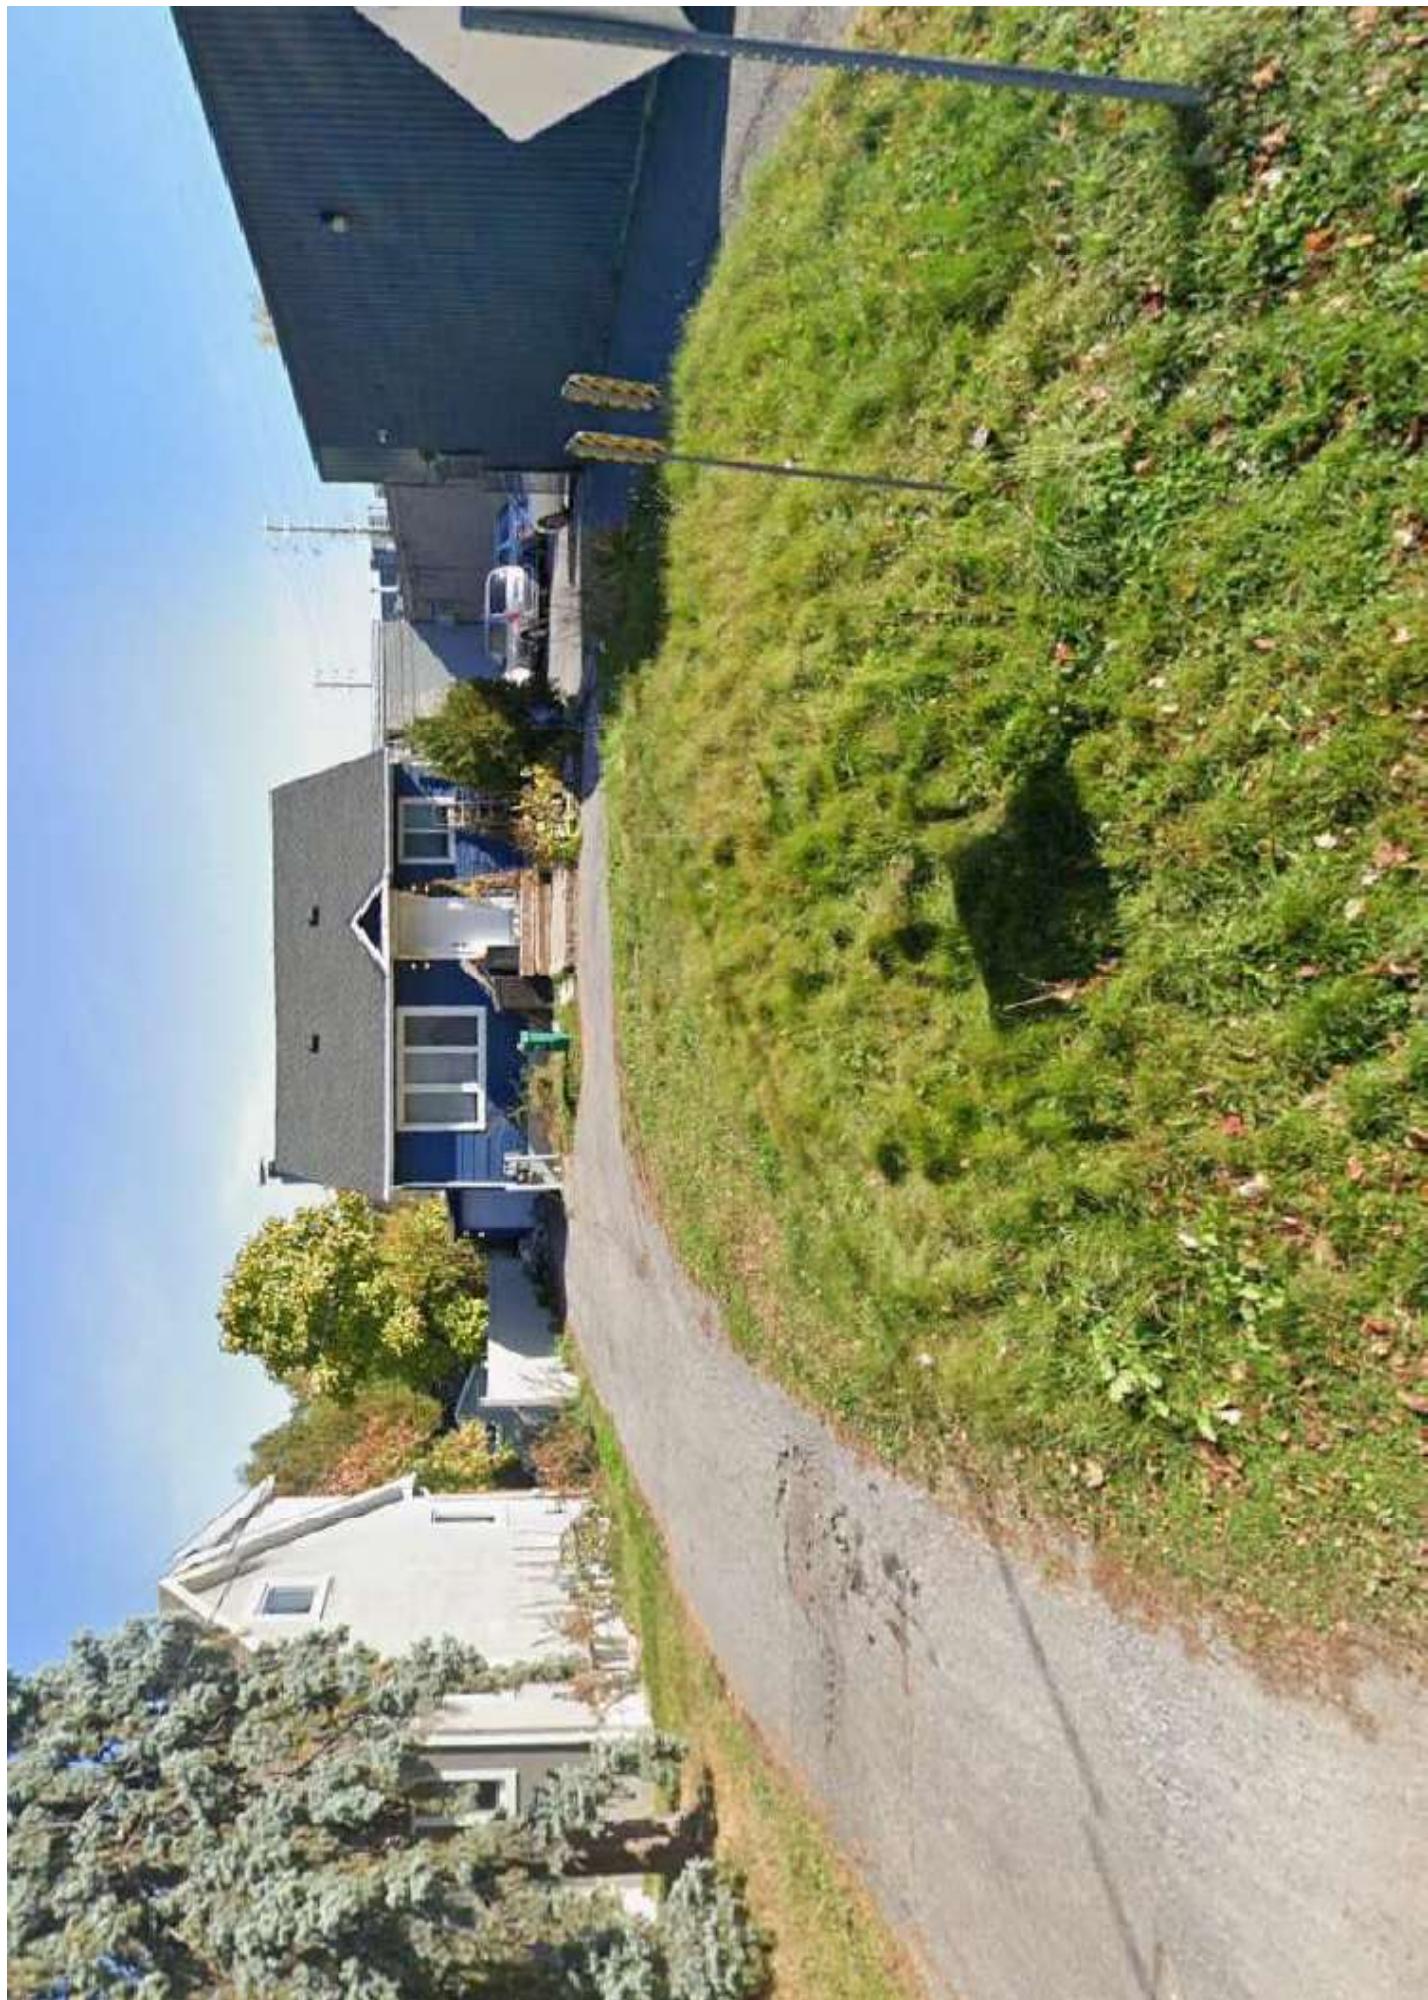
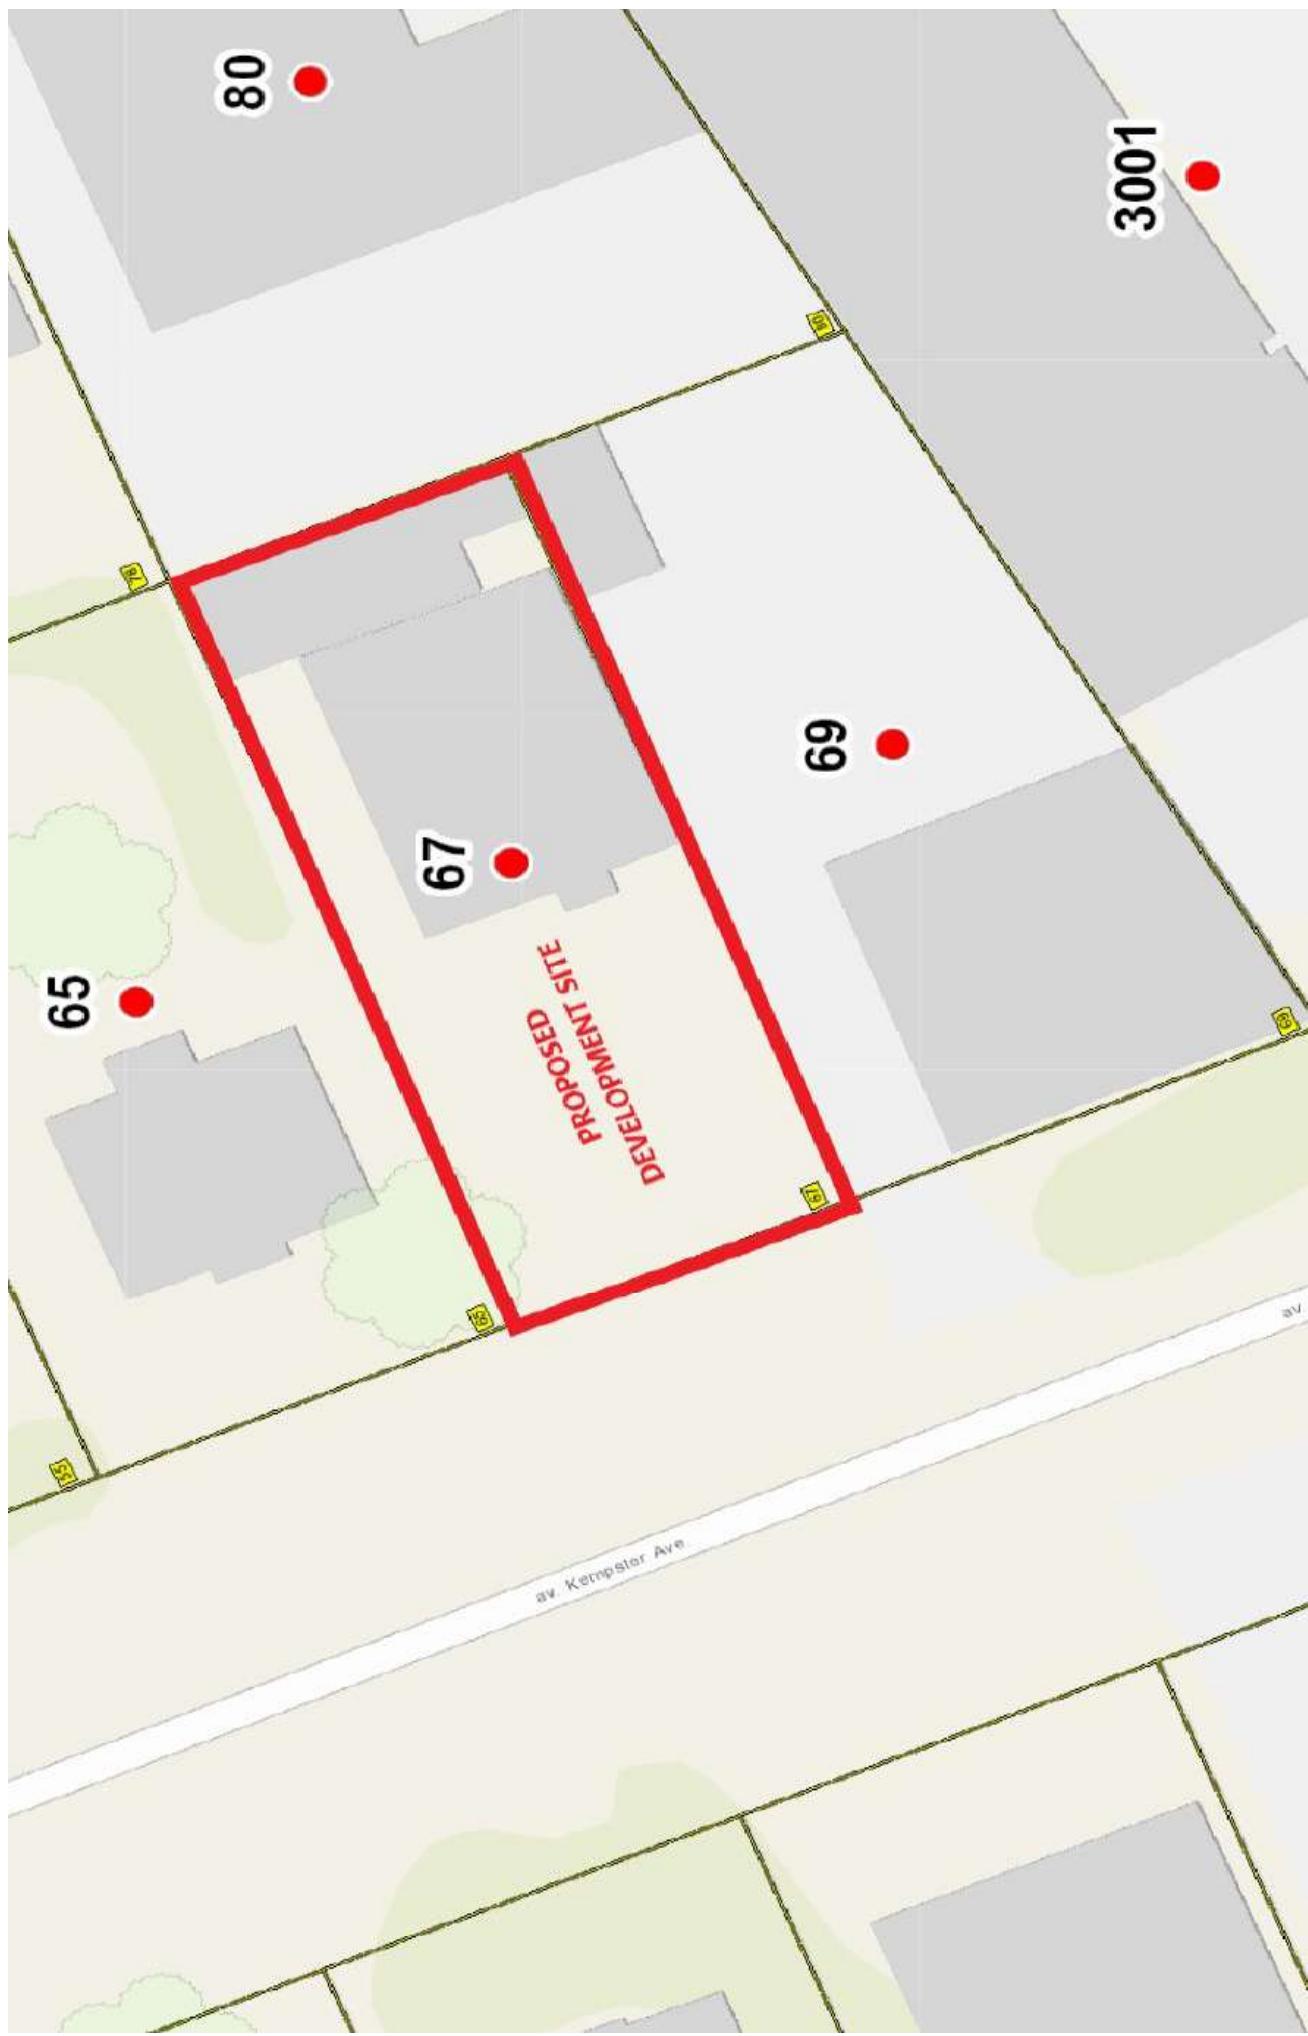
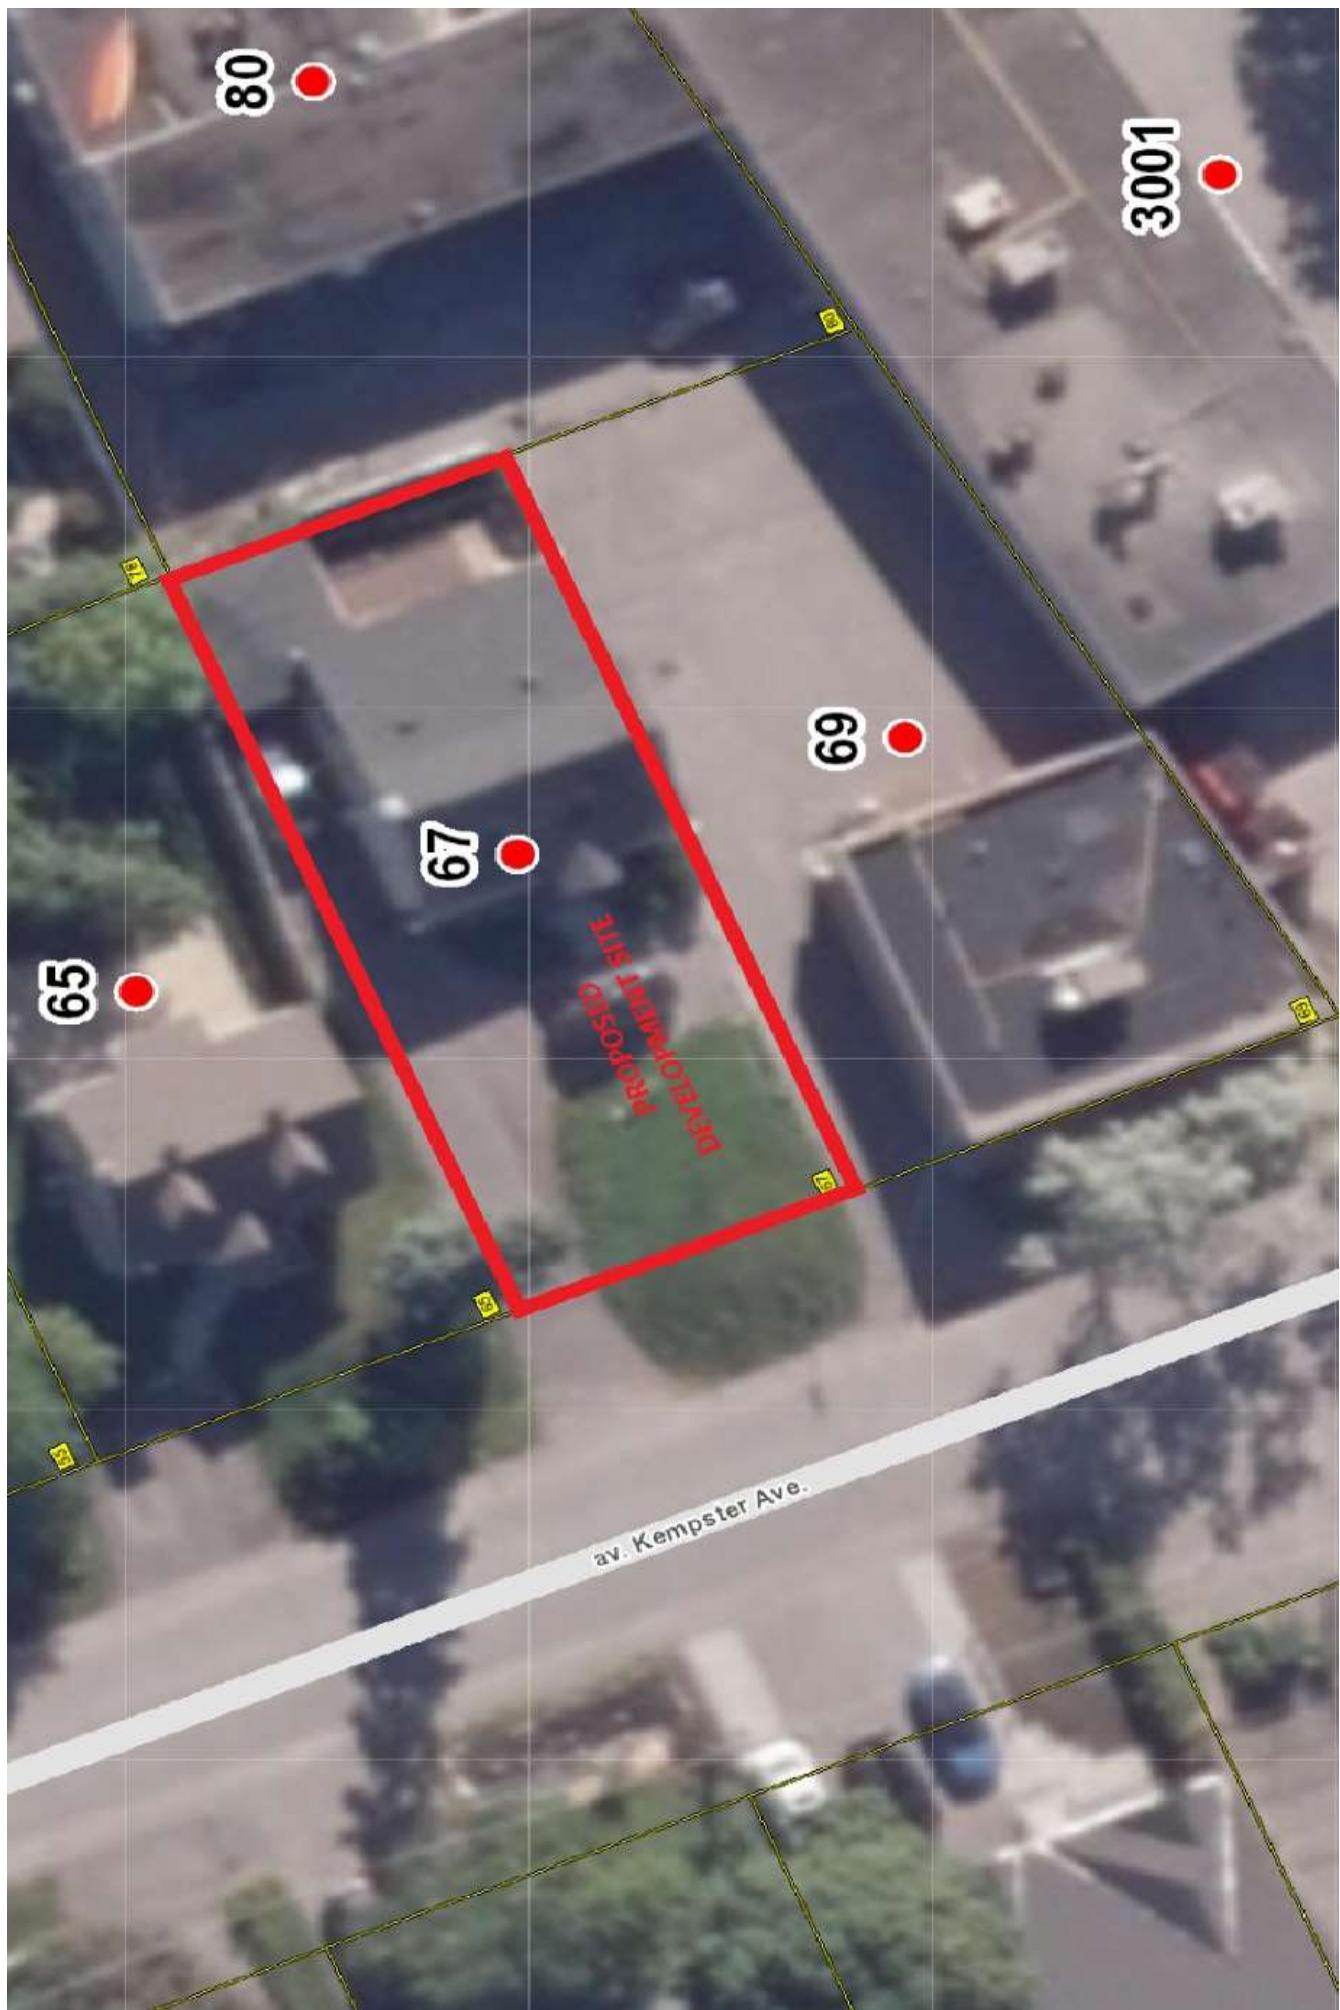
**SITE PRE-DEVELOPMENT CONDITION
GOOGLE IMAGE (2024)
AND
AERIAL PHOTOGRAPHY 2022 (GeoOTTAWA)**

Presently, a $1\frac{1}{2}$ - storey residential building occupies the site. For details of the site's current conditions, refer to the Google image (2024) and aerial photography from (GeoOttawa 2022) found in Appendix B.

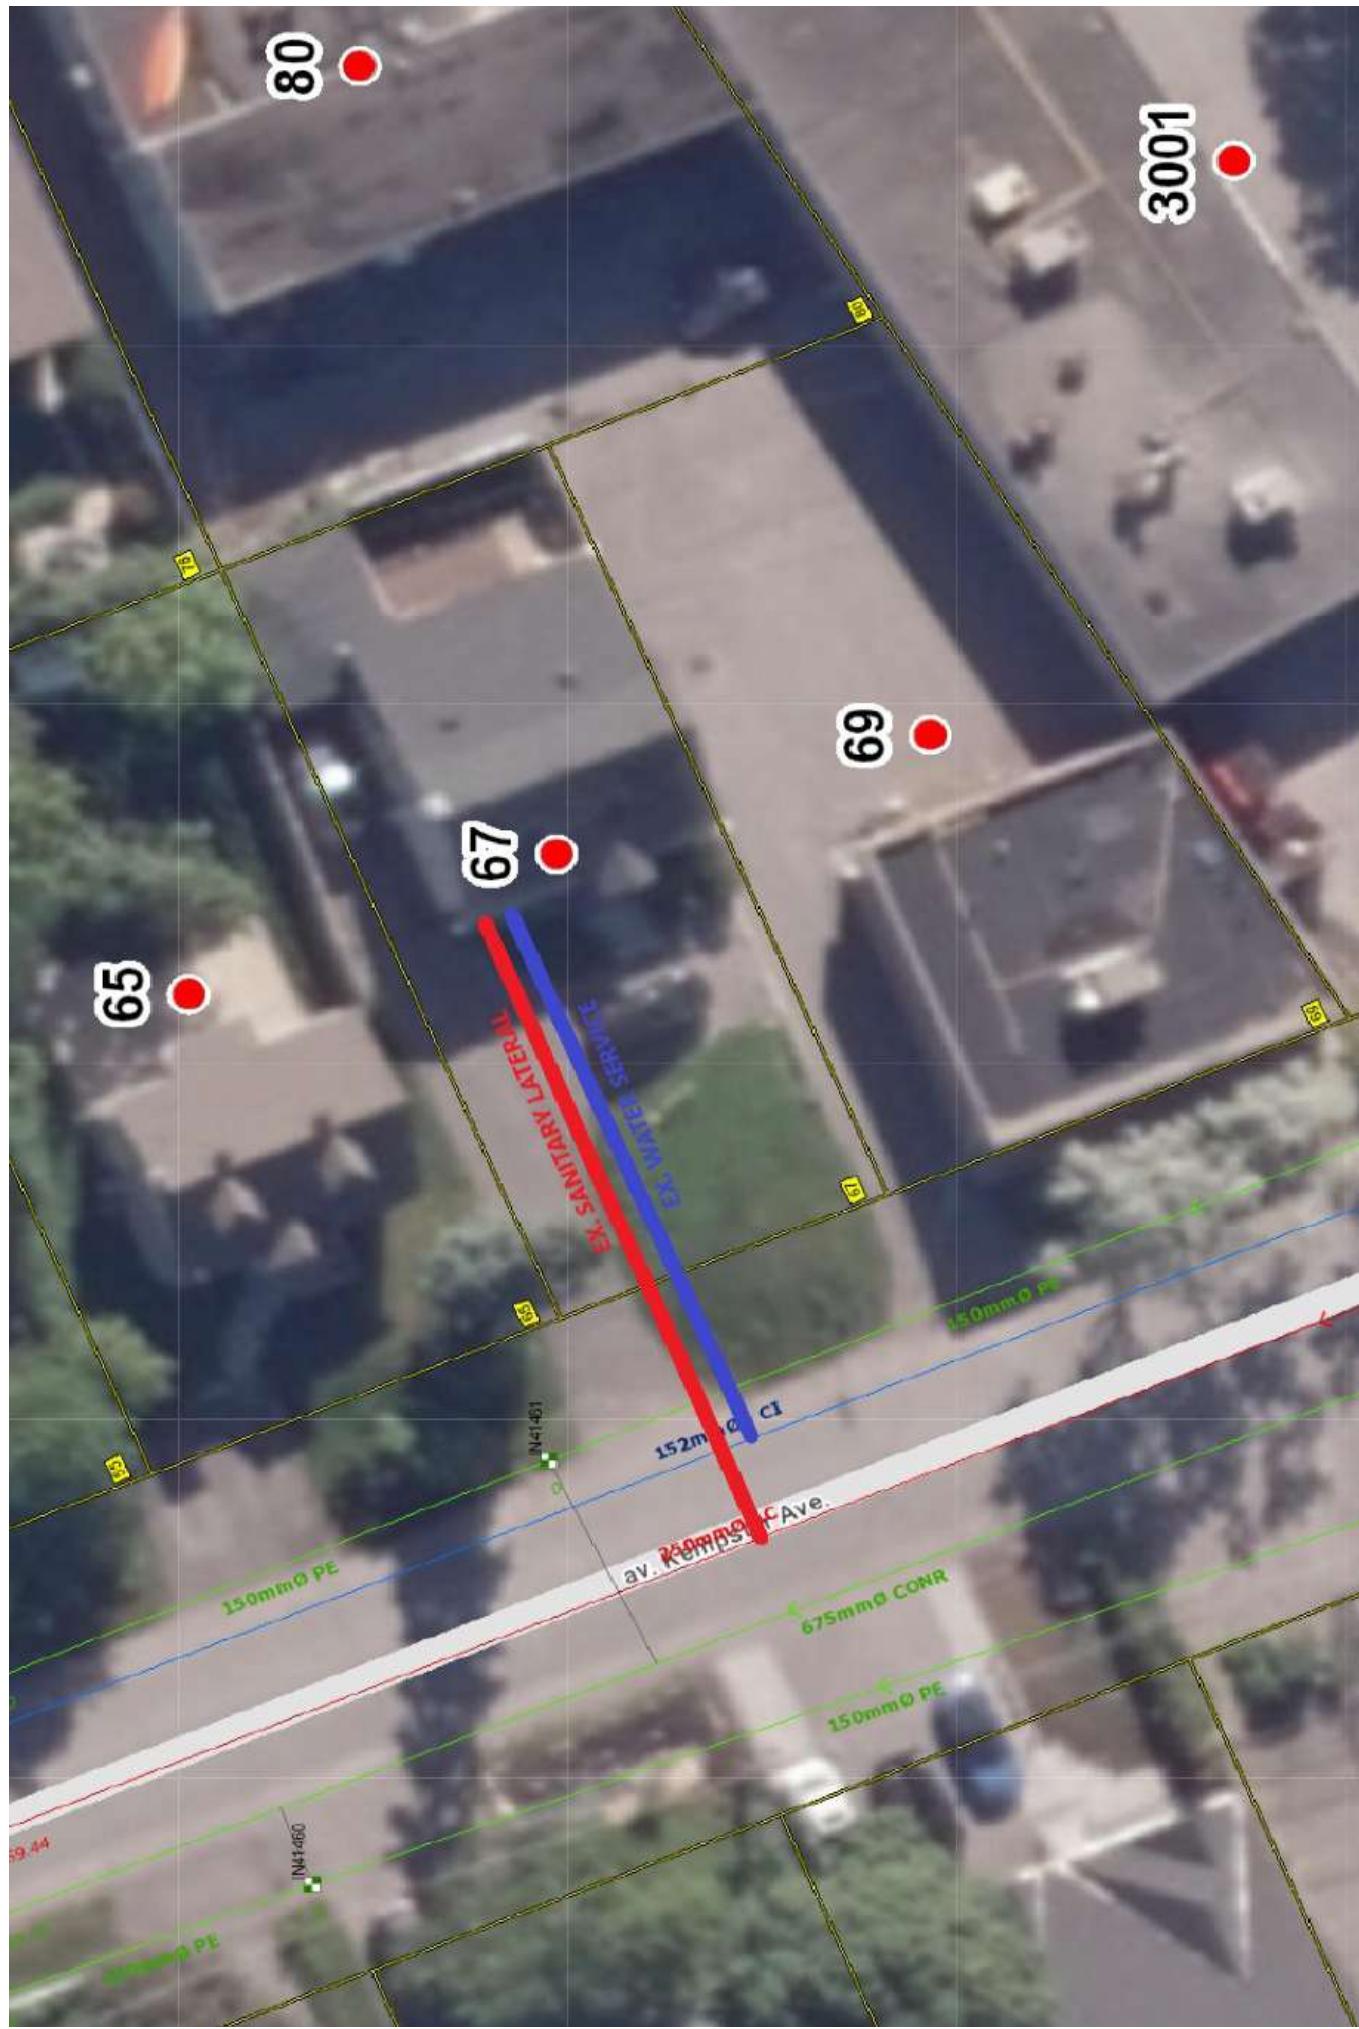
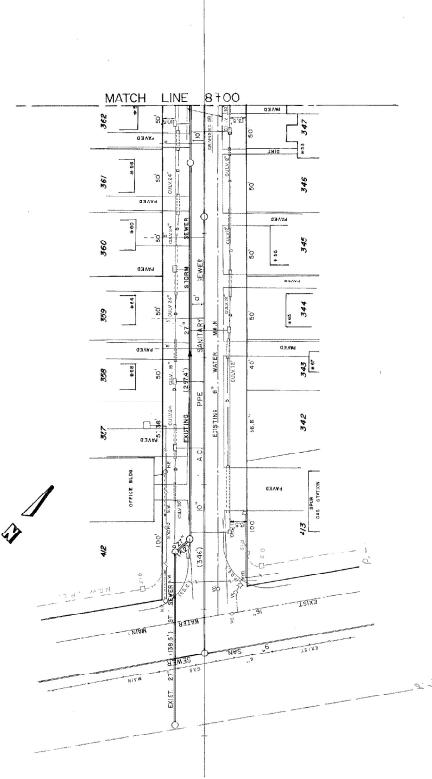
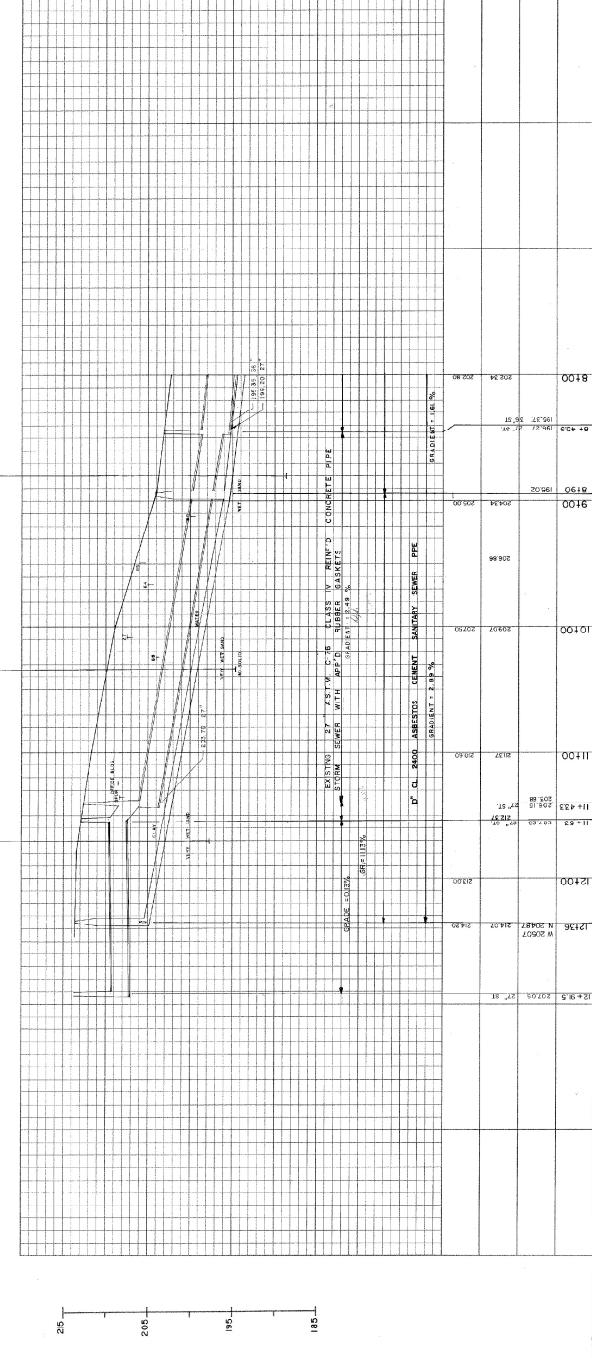
- **EXISTING LATERAL LOCATION**
- **CITY's PLAN AND PROFILE DRAWINGS**
- **TOPOGRAPHICAL SURVEY BY J.D. BARNES LTD.**

Presently, the residential dwelling is serviced by a 19 mm (3/4 inch.) dia. water service pipe which is connected to the existing City watermain system at Kempster Avenue. The building's existing 150 mm dia. concrete sanitary lateral is currently discharging and outletting to the City's 250 mm dia. sanitary sewer. From discussion with the owners of the property, there are no weeping tiles in placed for this building and therefore, storm lateral is not found on this lot. The approximate location of existing water service and sanitary lateral are shown in Appendix C.

Existing grading and drainage of the lot is primarily sloped from a back to front (east to west) direction. See topographical survey field recorded by J.D. Barnes Ltd. attached in Appendix C for details.

Lot drainage on-site is observed to primarily graded to surface drain across the site from east to west or (rear to front) whereupon most of the surface stormwater outlets to the City's road right of way on Kempster Avenue. Refer to J.D. Barnes Ltd. topographical survey found in Appendix C for more details.

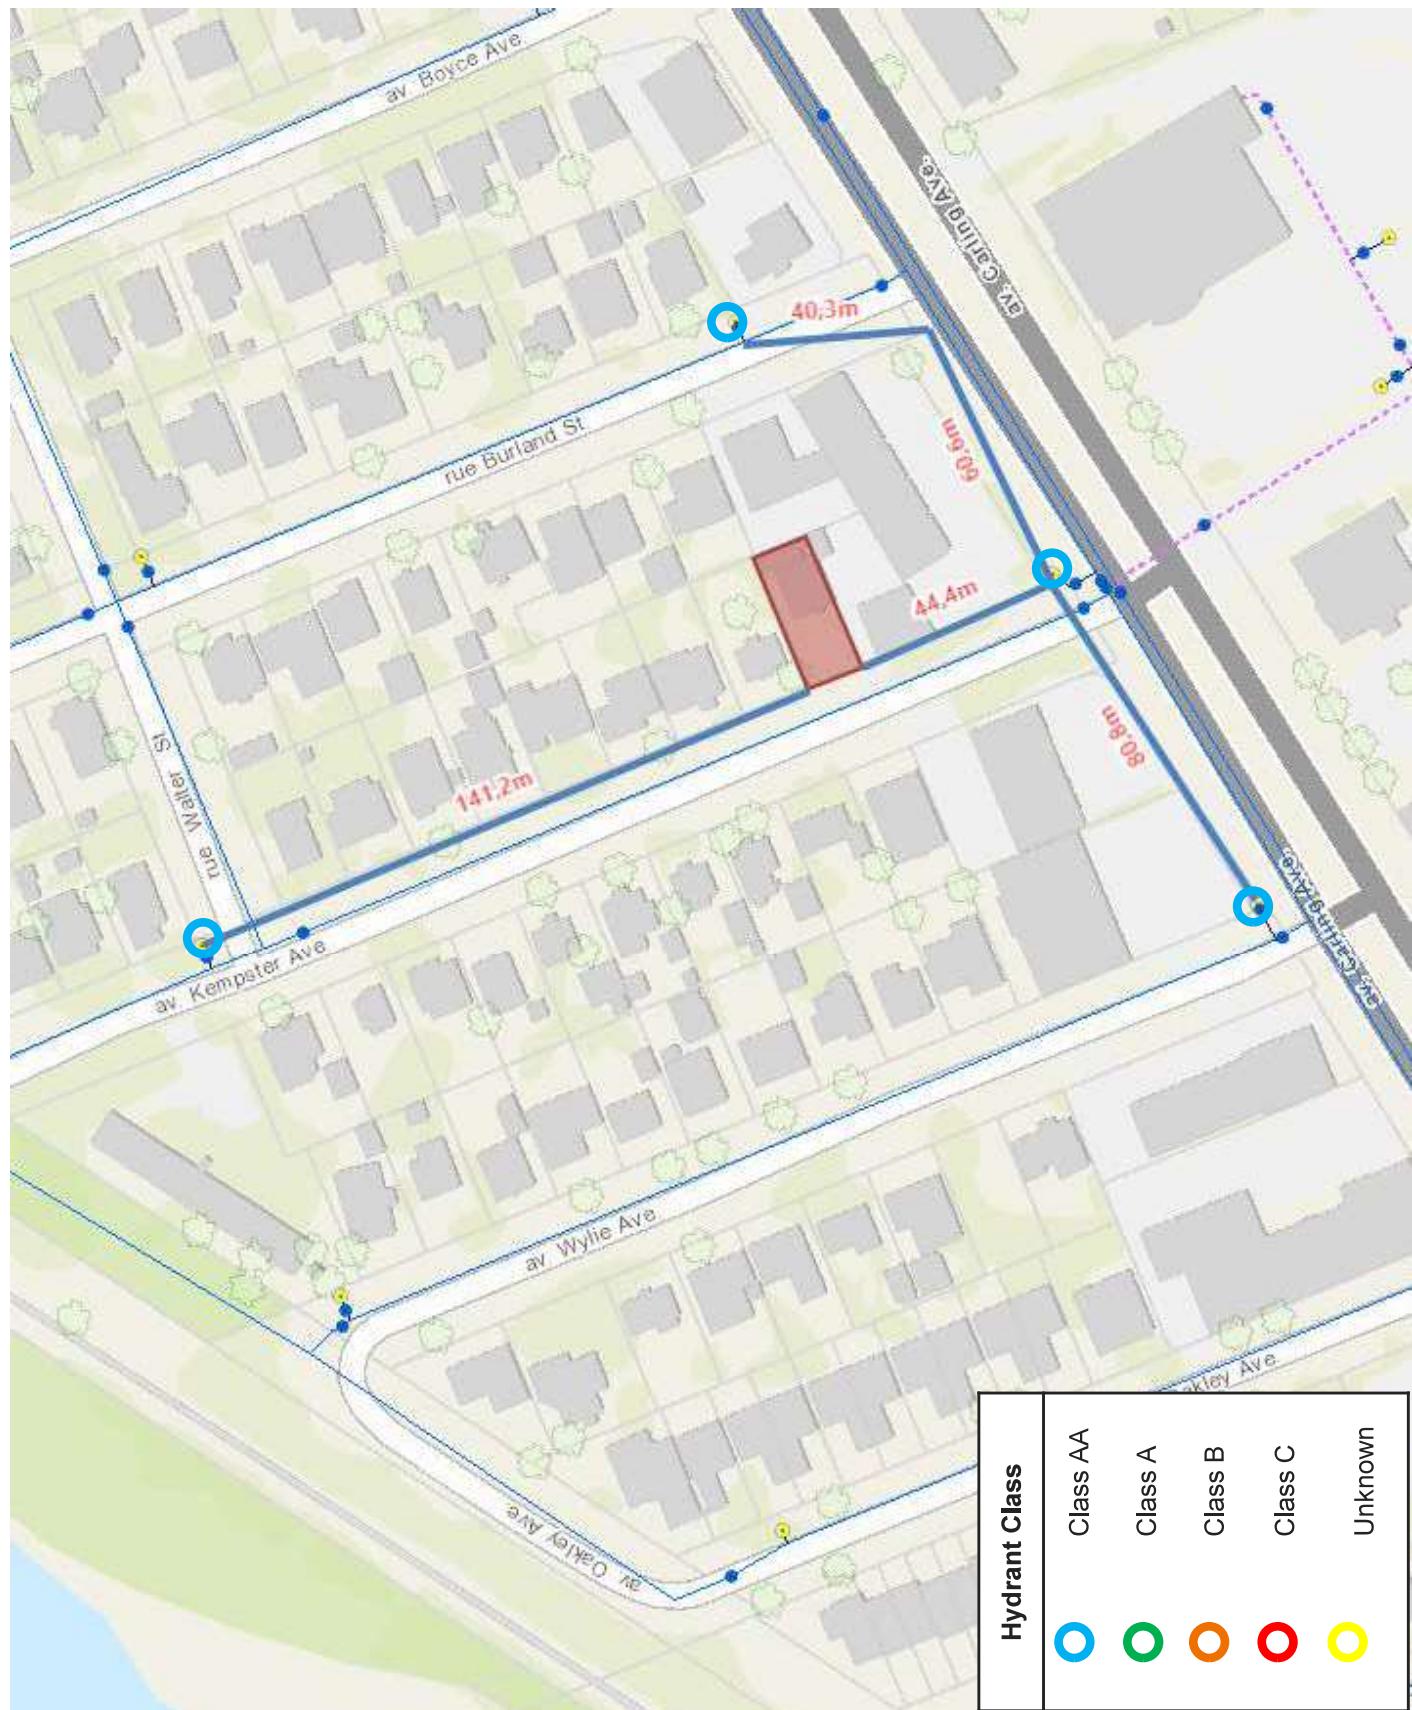
**HYDRANT COVERAGE
FIGURE**

Based on Table 1 of Appendix I of the City of Ottawa Technical Bulletin ISTB-2018-02 and a desktop review (via Google Street View) to confirm hydrant class, four (4) hydrants are located near the building (see attached Hydrant Coverage Figure attached in Appendix E):

- One (1) Class AA hydrant is within 75m, providing a capacity contribution of up to 5,700 L/min.
- Three (3) additional Class AA hydrants are within 150m of the site, each contributing up to 3,800 L/min.

The combined hydrant flow coverage for 67 Kempster Avenue is therefore 17,100 L/min which is considered sufficient based on the expected fire flow requirement for the building (estimated to be less than 9,000 L/min based on building dimensions and usage) using the Ontario Building Code (OBC) Office of the Fire Marshal (OFM) method.

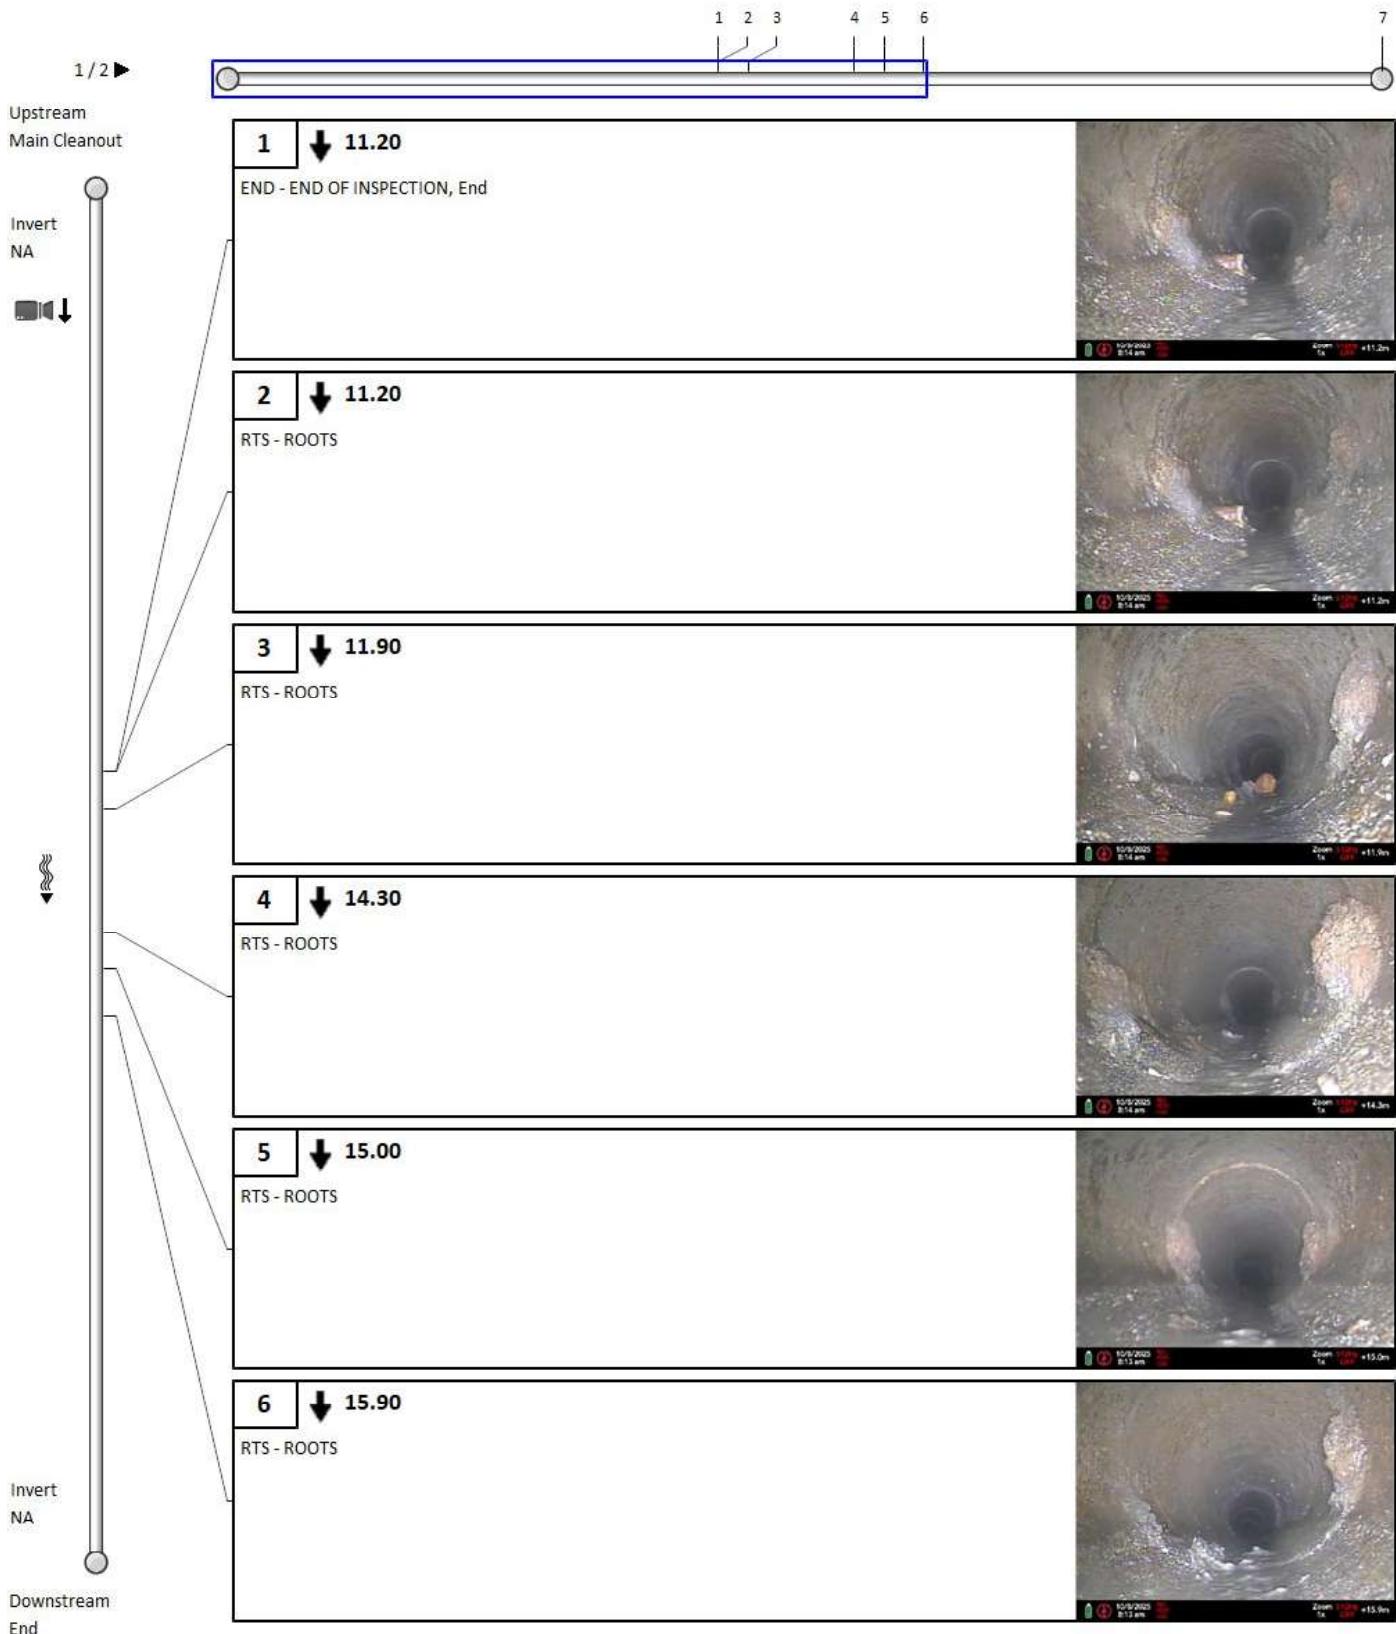
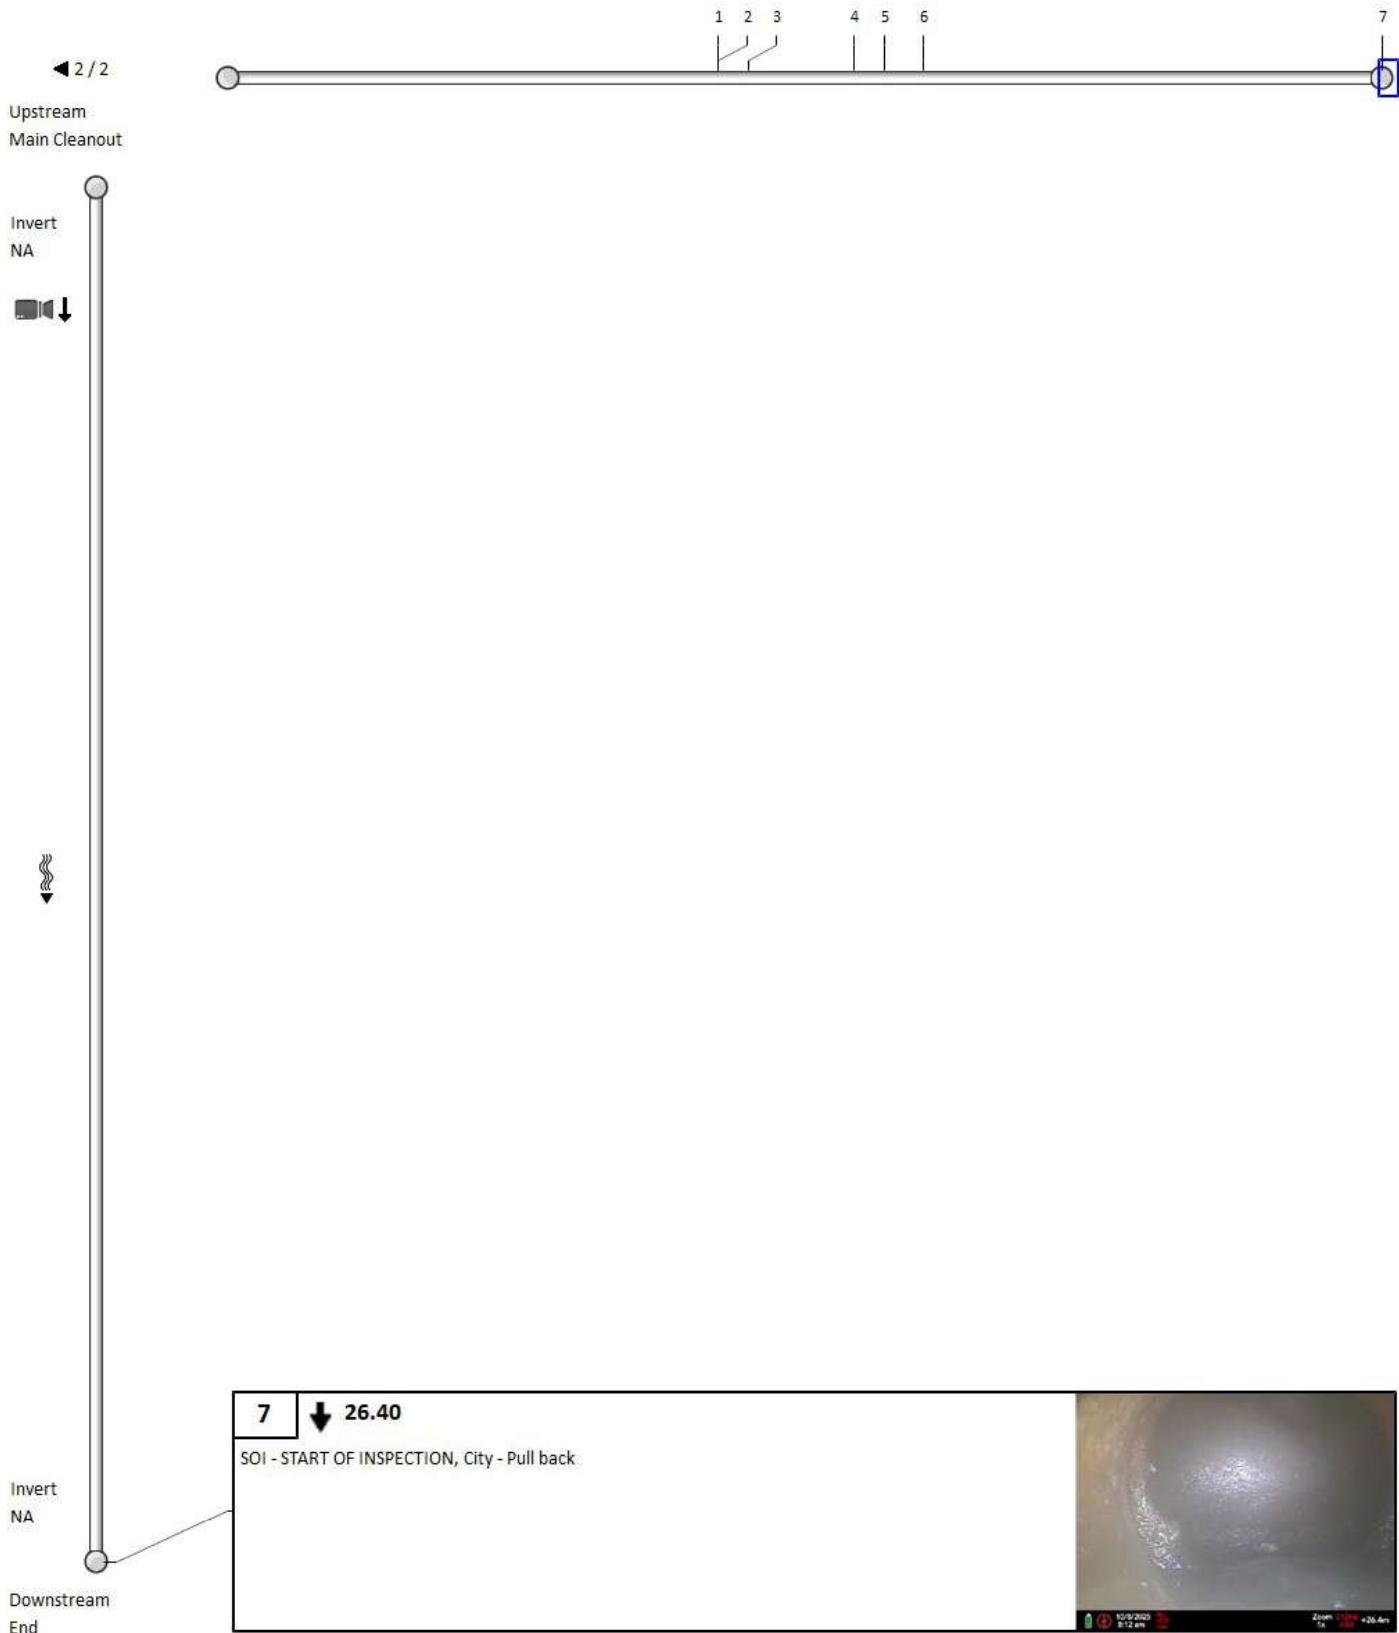
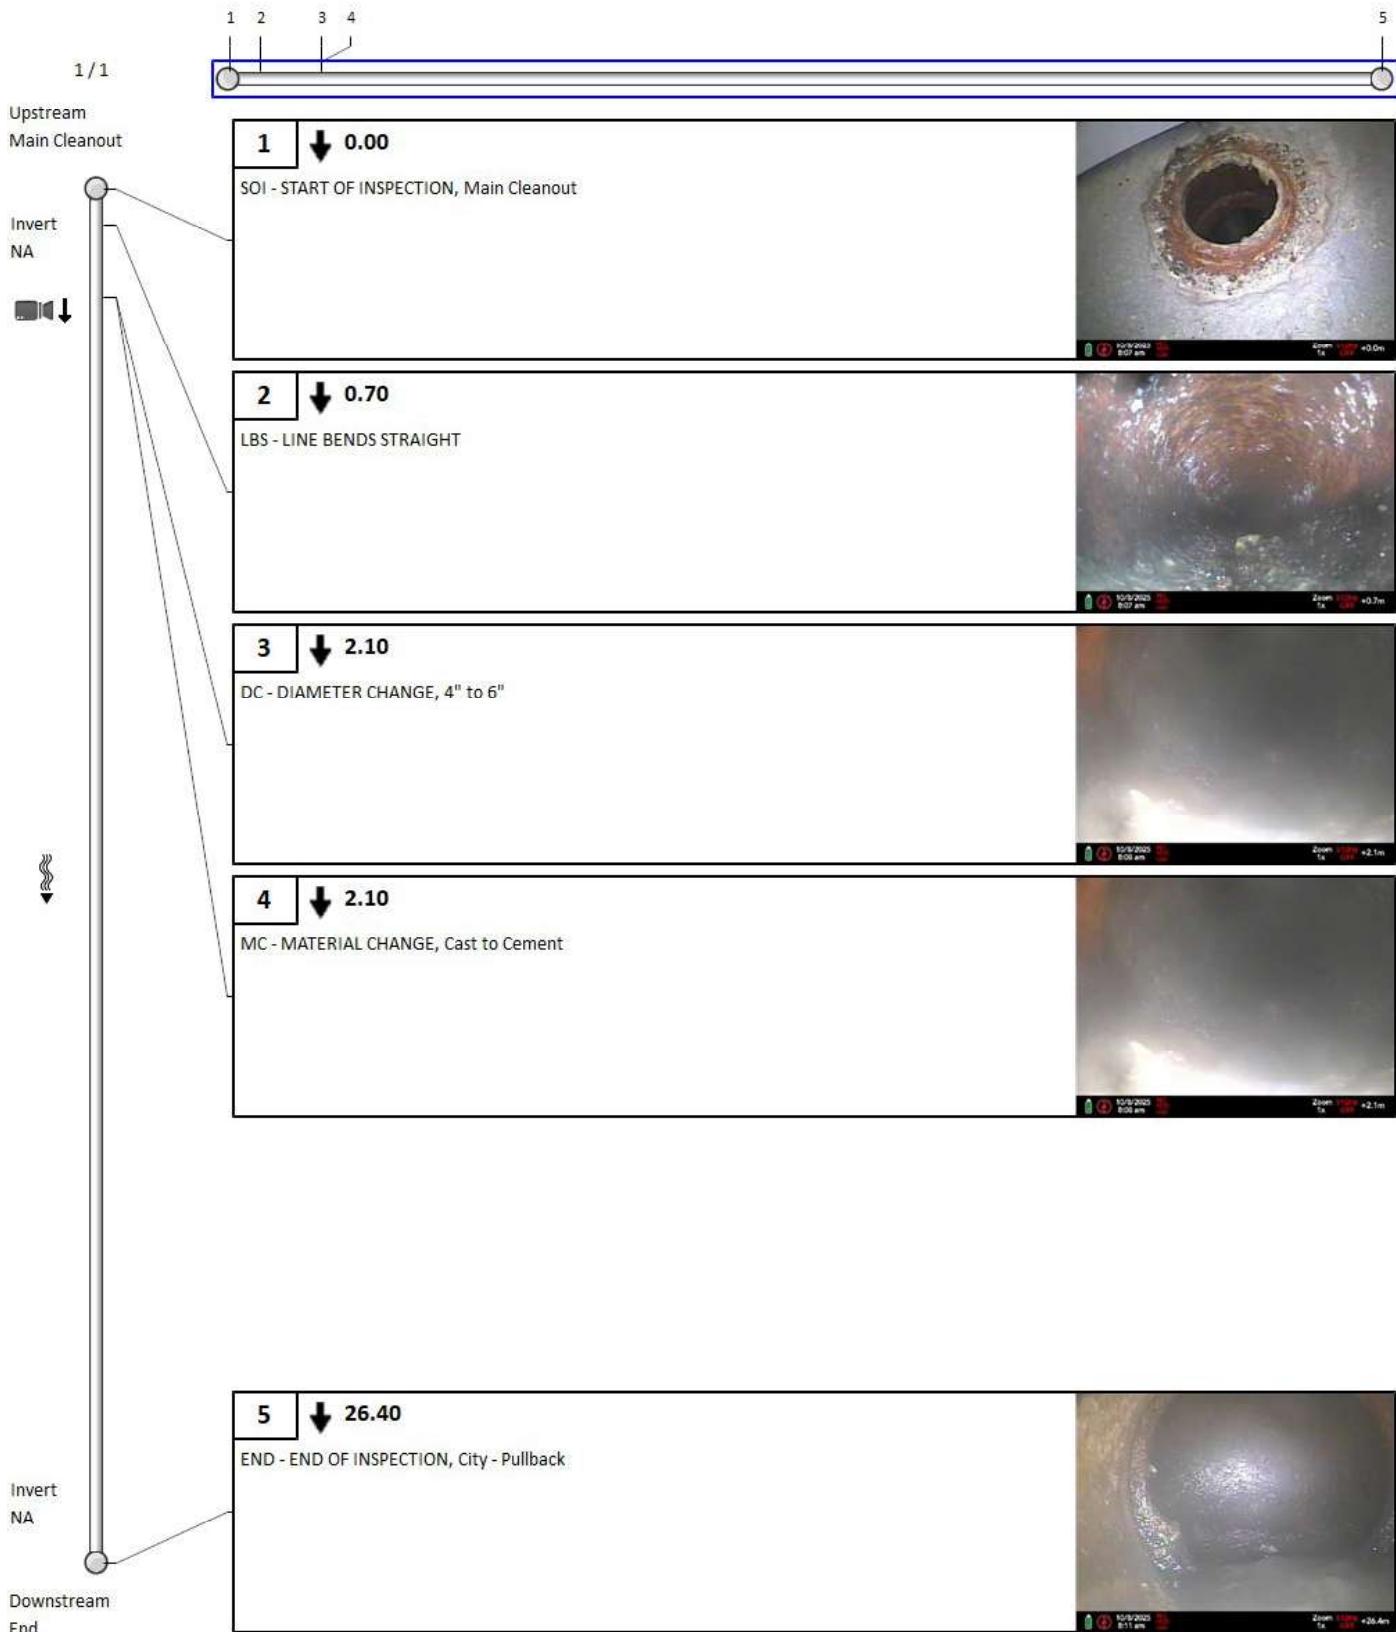
**CLEAN WATER WORKS (CWW)
CCTV REPORT SUMMARY
DATED OCTOBER 8, 2025**

CCTV of the existing 150 mm dia. concrete sanitary service lateral currently servicing the existing house was recently completed and the 150mm dia. PVC sanitary lateral report recently completed at this building were reviewed and appears to be in good condition to convey flows. Some tree roots in the pipe was noted in the CCTV report but it appears that tree roots in the lateral were cut to maintain continued conveyance of sewage flow. Refer to Appendix G for summary of the sanitary lateral CCTV report findings carried out by Clean Water Works Inc. (CWW) dated October 8, 2025. This CCTV report is available in digital format also and can be provided to the City, if required for approval.
