Phase I Environmental Site Assessment

50 Bayswater Avenue and 1088 Somerset Street West
Ottawa, Ontario

Prepared for Manor Park Management

Report: PE5971-1
Date: July 6, 2023

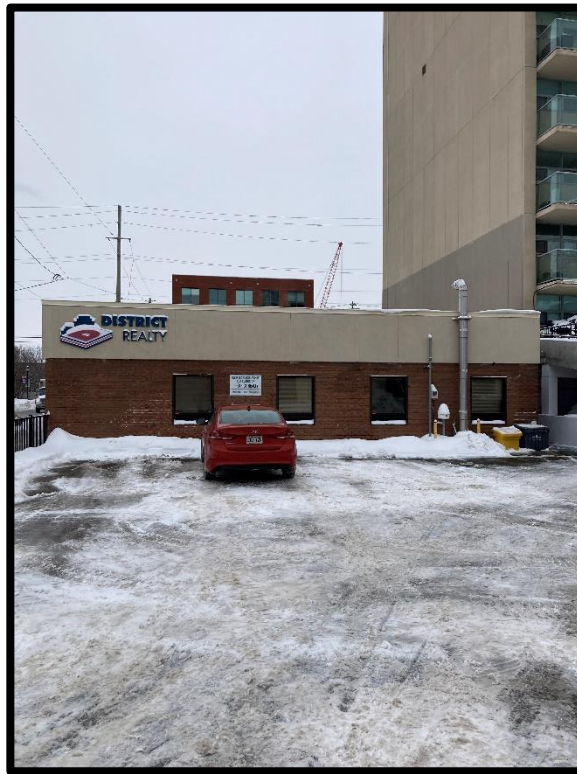
Photograph 2: View of the back of the 50 Bayswater Avenue office building, facing east.

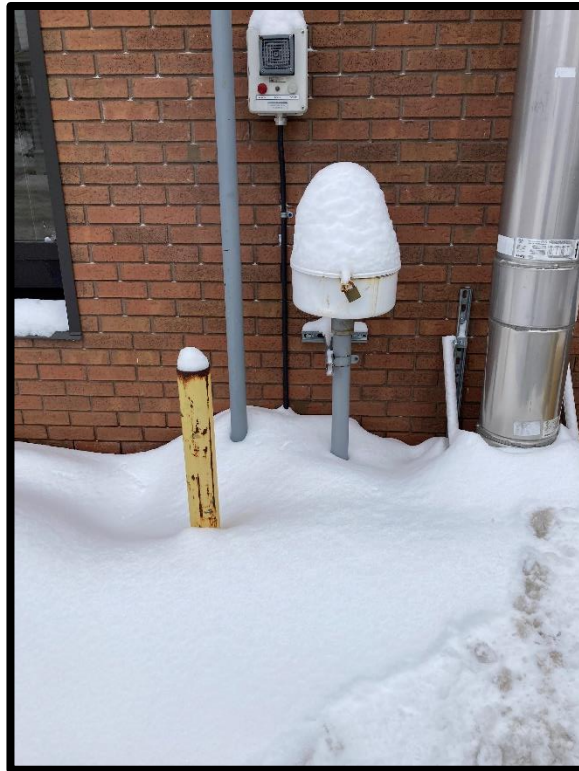
Vent and fill pipes were observed on the exterior of the 50 Bayswater Avenue building (along the west face) at the time of the site visit. The vent and fill pipes and the ground beneath them were noted to be in good condition, with no visual or olfactory signs of contamination noted.

Photograph 3: View of the vent and fill pipes along the back wall of the 50 Bayswater Avenue office building, facing east.

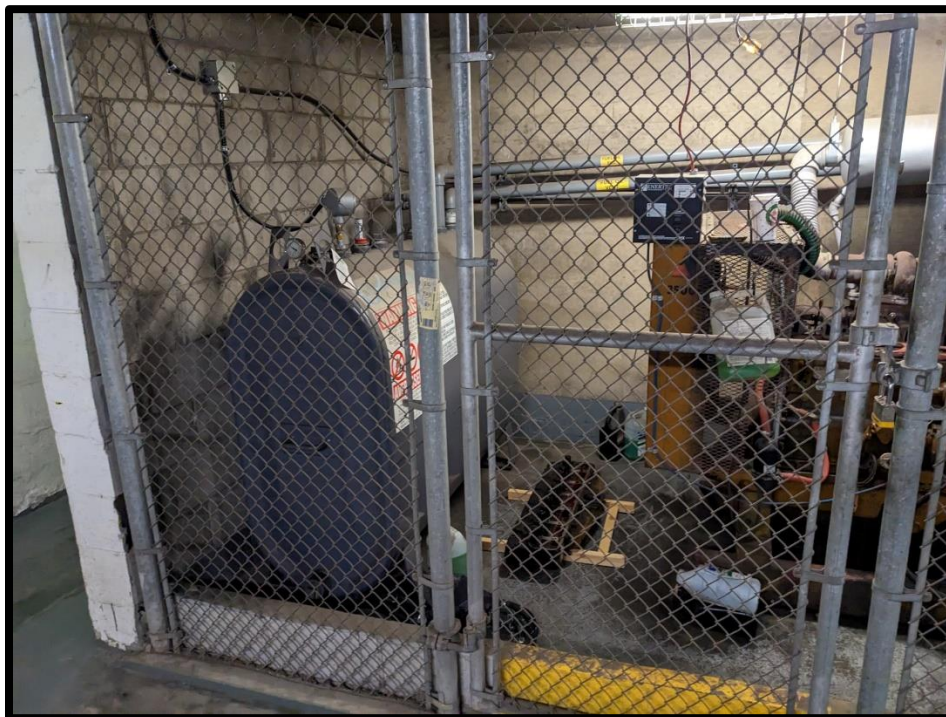
A 935L aboveground storage tank (AST) was identified in the underground parking beneath the 50 Bayswater Avenue property. The storage tank is used to run a generator. The tank and the concrete floor beneath the tank were noted to be in good condition, with no visual or olfactory signs of contamination noted. The presence of this tank is considered to represent an APEC on the Phase I Property.

Photograph 4: View of the front of above ground storage tank in the underground parking structure on the 50 Bayswater Avenue property (February 10, 2023).

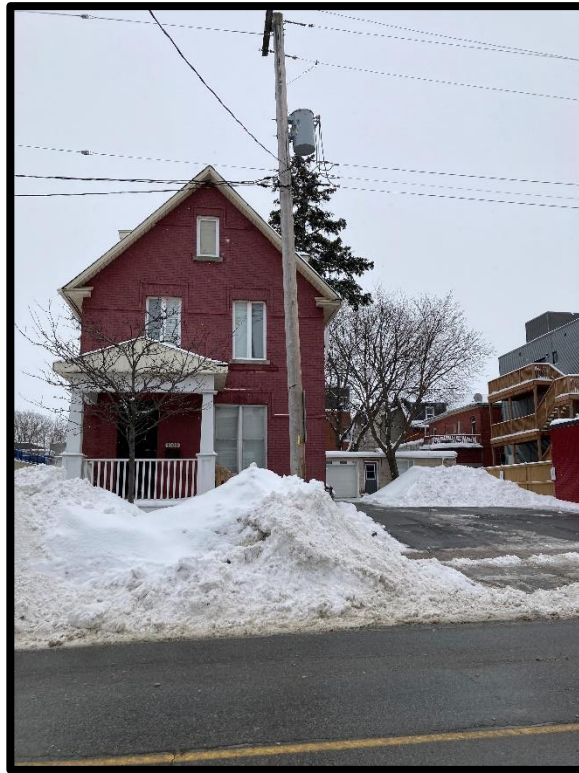
The portion of the Phase I Property addressed 1088 Somerset Street West is currently occupied by a three-storey (with one basement level) mixed used commercial art gallery and residential dwelling. The building is constructed with a stone foundation and is finished on the exterior with brick and vinyl siding in addition to a sloped and shingled roof. The building, constructed sometime prior to 1888, is currently heated via natural gas furnace located in the basement.

Photograph 5: View of the front of 1088 Somerset Street West residential dwelling/commercial building, facing south.

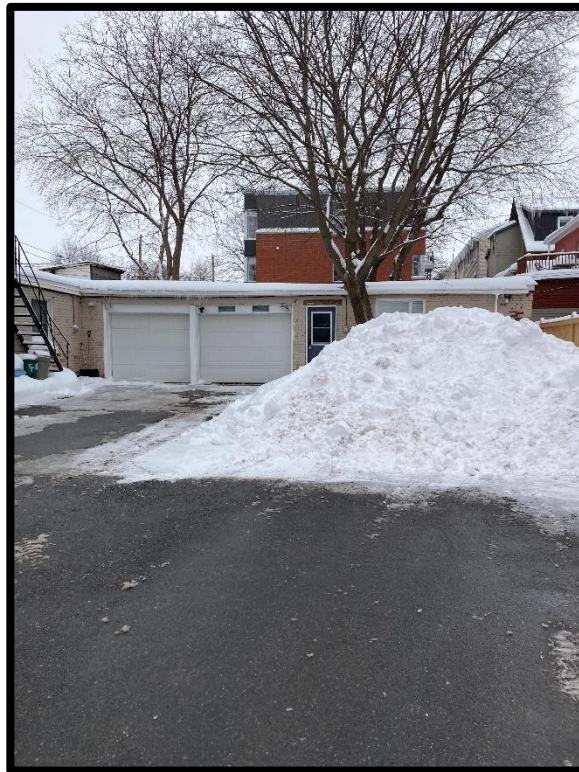
Photograph 6: View of the private garage on the 1088 Somerset Street West property, facing south.
