RE: TREE CONSERVATION REPORT FOR 50 BAYSWATER AVENUE AND 1088 SOMERSET STREET WEST, OTTAWA

This Tree Conservation Report (TCR) was prepared by IFS Associates Inc. (IFS) on behalf of Manor Park Holdings in support of a site plan control application for the construction of two multi-storey commercial/residential buildings at 50 Bayswater Avenue and 1088 Somerset Street in Ottawa. The need for this report is related to trees protected under the City of Ottawa's Tree Protection By-law (By-law No. 2020-340). The By-law reflects Section 4.8.2. of the City of Ottawa's Official Plan which calls for the retention of the City's urban forestry canopy and, in particular, large healthy trees.

DRAWING: Tree Conservation Plan

PROJECT: 50 BAYSWATER AVENUE & 1088 SOMERSET STREET WEST
CITY OF OTTAWA

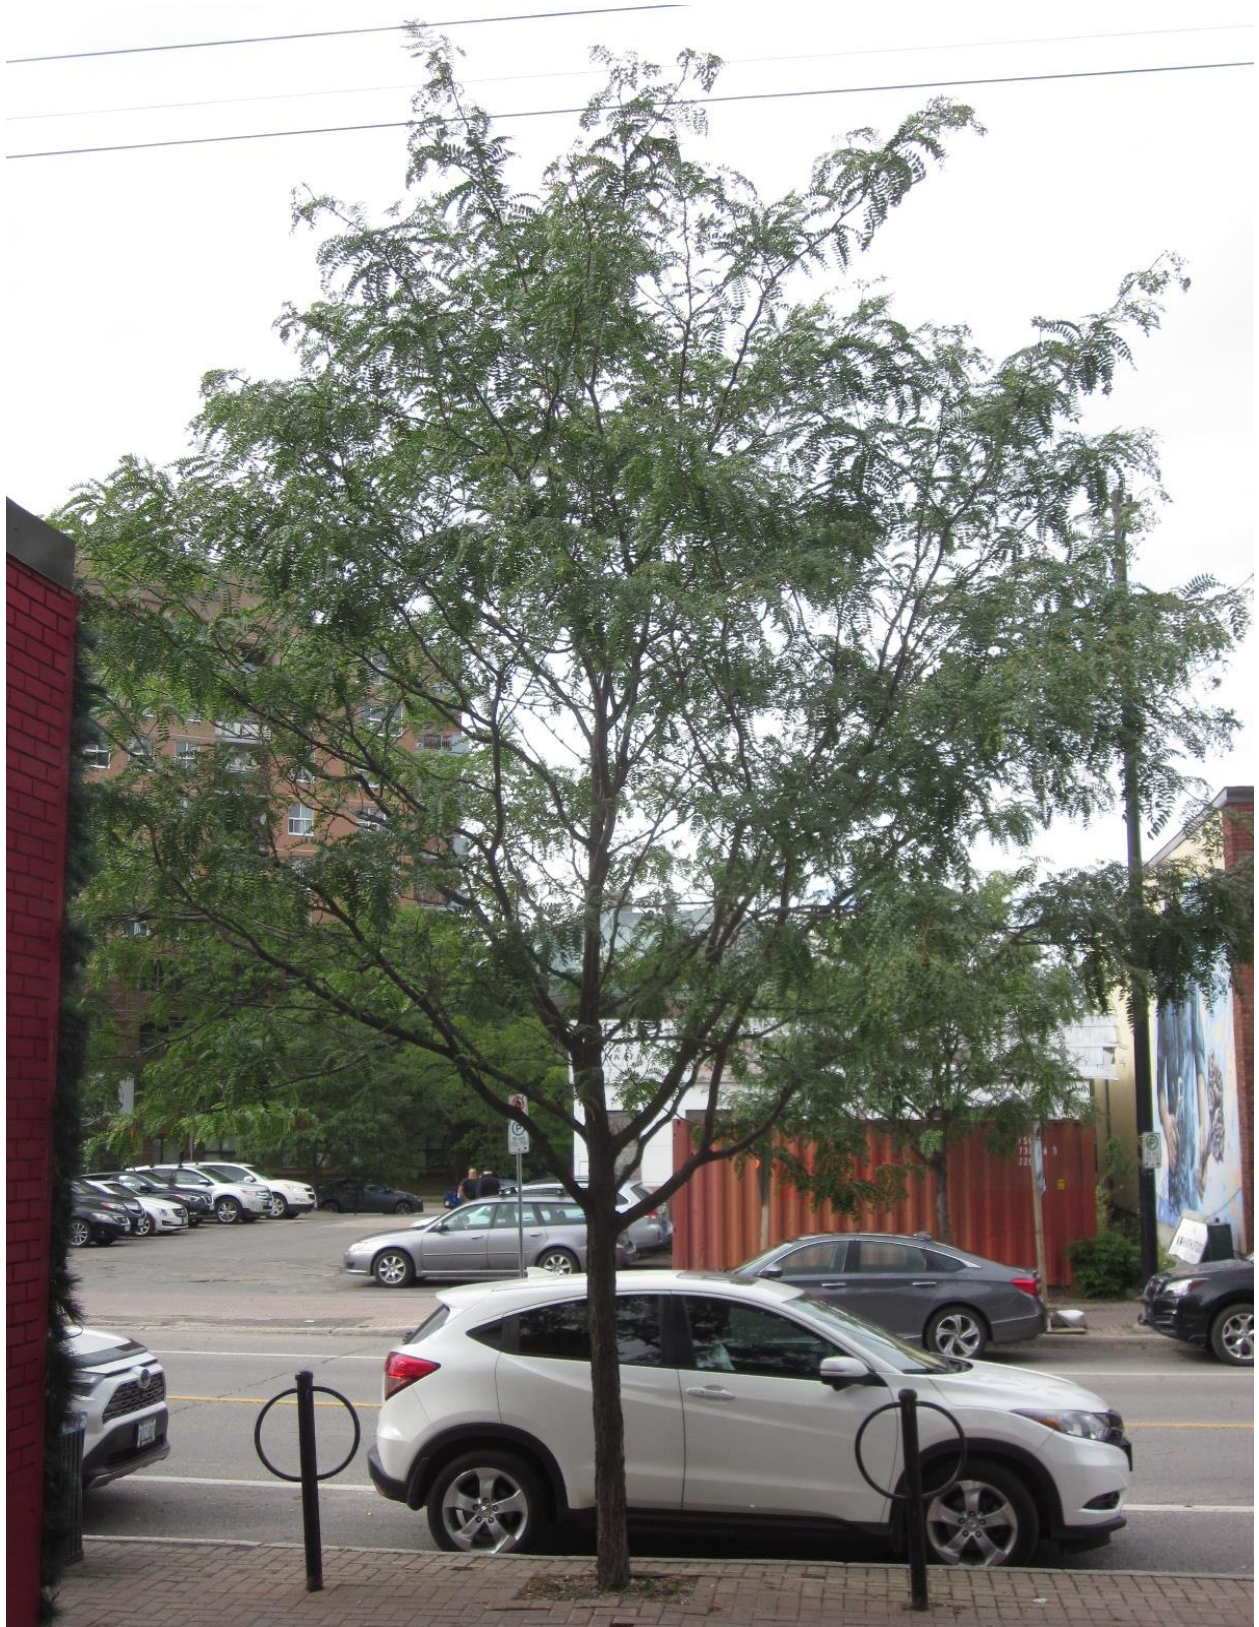
TREE PROTECTION SPECIFICATION

1. PRIOR TO ANY WORK ACTIVITY WITHIN THE CRITICAL ROOT ZONE (CRZ = 10 X DIAMETER) OF A TREE, TREE PROTECTION FENCING MUST BE INSTALLED SURROUNDING THE CRITICAL ROOT ZONE, AND REMAIN IN PLACE UNTIL THE WORK IS COMPLETE.

- DO NOT EXTEND HARD SURFACE OR SIGNIFICANTLY CHANGE LANDSCAPING
3. TREE PROTECTION FENCING MUST BE AT LEAST 1.2M IN HEIGHT, AND CONSTRUCTED OF RIGID OR FRAMED MATERIALS (E.G. MODULOC - STEEL, PLYWOOD HOARDING, OR SNOW FENCE ON A 2"X4" WOOD FRAME) WITH POSTS 2.4M APART, SUCH THAT THE FENCE LOCATION CANNOT BE ALTERED. ALL SUPPORTS AND BRACING MUST BE PLACED OUTSIDE OF THE CRZ, AND INSTALLATION MUST MINIMISE DAMAGE TO EXISTING ROOTS. (SEE DETAIL)

1. As per the City of Ottawa's tree protection barrier specification (included on page 5), erect a fence as close as possible to the CRZ of the tree(s).
2. Do not place any material or equipment within the CRZ of the tree(s).
3. Do not attach any signs, notices or posters to any tree.
4. Do not raise or lower the existing grade within the CRZ without approval.
5. Tunnel or bore instead of trenching within the CRZ of any tree.
6. Do not damage the root system, trunk or branches of any tree.
7. Ensure that exhaust fumes from all equipment are NOT directed towards any tree's canopy.

Picture 1. Tree #1, honey-locust on City property adjacent to 1088 Somerset Street

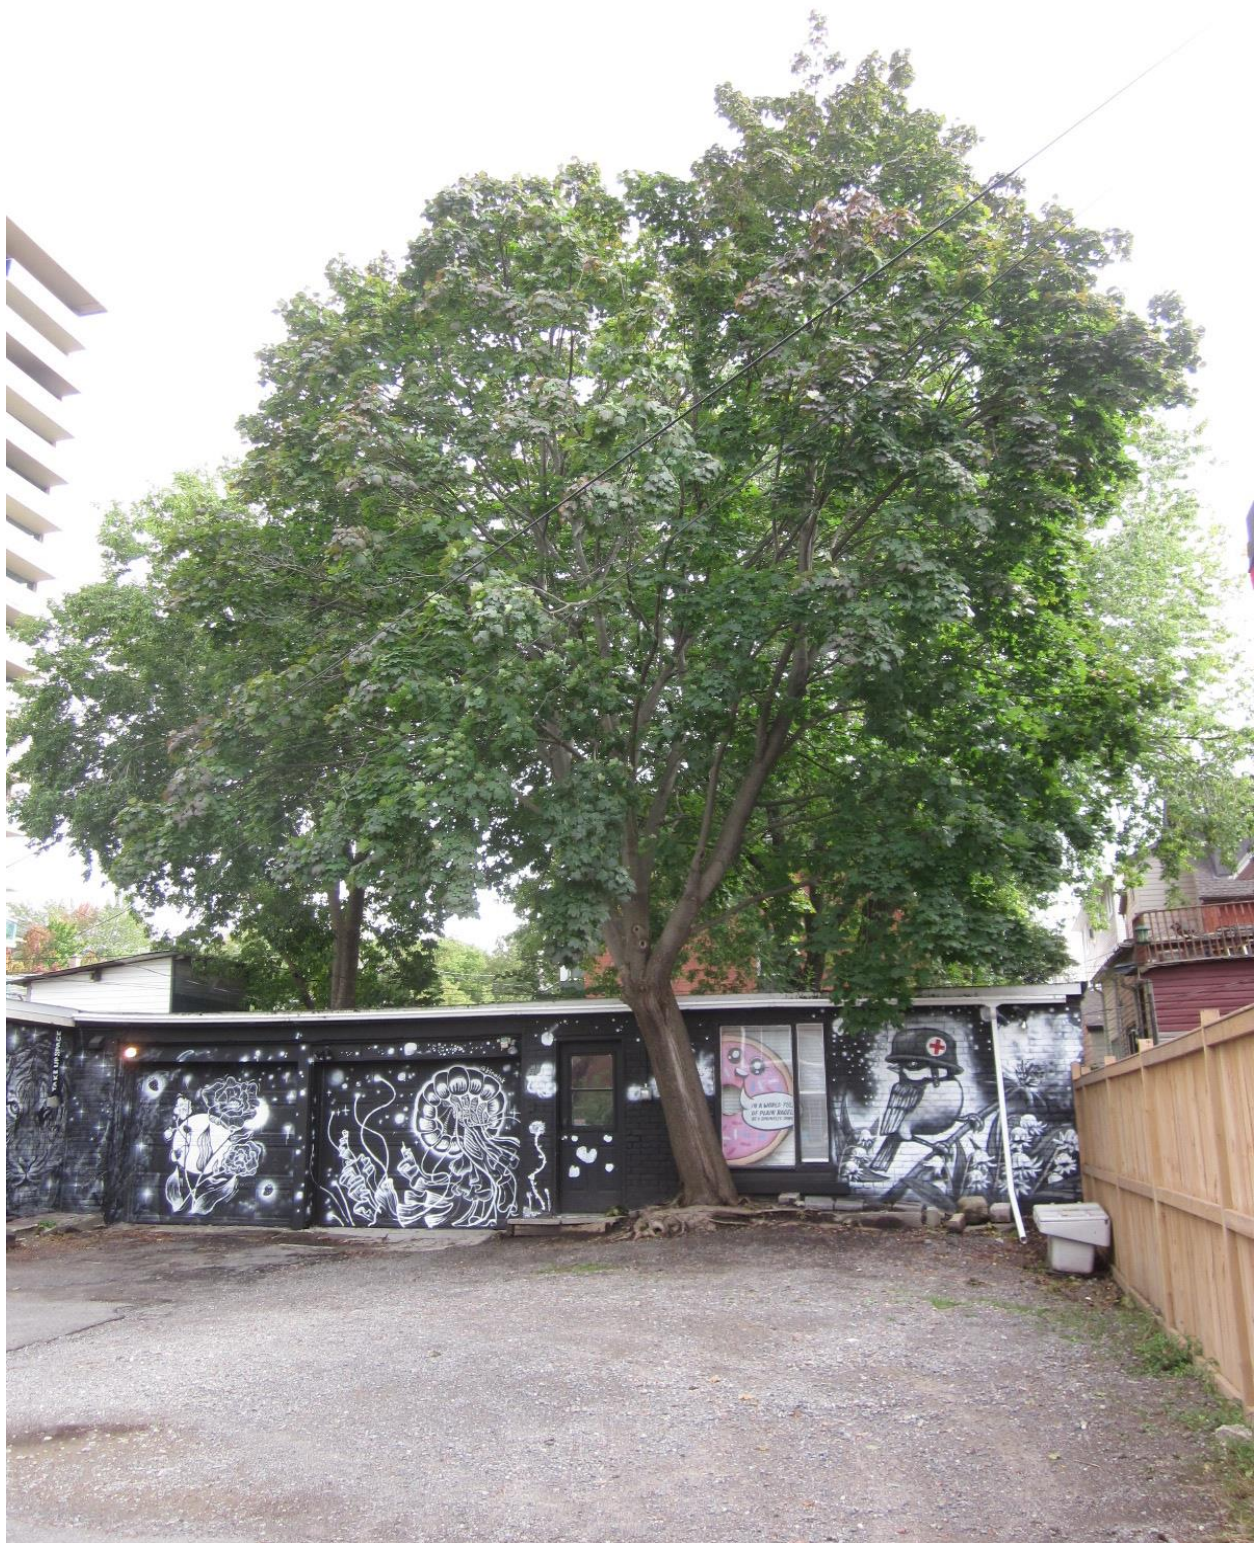
Picture 4. Tree #5, private Norway maple at 1088 Somerset Street

5	Norway maple (<i>Acer platanoides</i>)	Private	49.9	Fair; mature; tri-dominant stems at 3.25m – central with two competing laterals; central stem bisects at 4.5m (with strong union); very weak union between central and northwest lateral; seam on northwest side of lower bole from grade to 2.5m has healed; several exposed, severed roots and multiple girdling roots; introduced invasive species; to be removed (conflicts with construction)
6	Manitoba maple (<i>Acer negundo</i>)	Neighbour	+/-30 & +/- 50	Poor; mature; double-stemmed at grade – dominant stem with competing lateral towards southeast; central stem bisects at 3m; major wounds on both stems at +/- 1.5m; naturalized species; to be preserved and protected
