**REPORT ON**

#### PHASE I ENVIRONMENTAL SITE ASSESSMENT 4401 FALLOWFIELD ROAD CITY OF OTTAWA, ONTARIO

#### 2116885 Ontario Inc. and DCR Phoenix Development Corporation Limited 451 Daly Avenue Ottawa, ON K1N 6H6

DATE: July 31, 2024

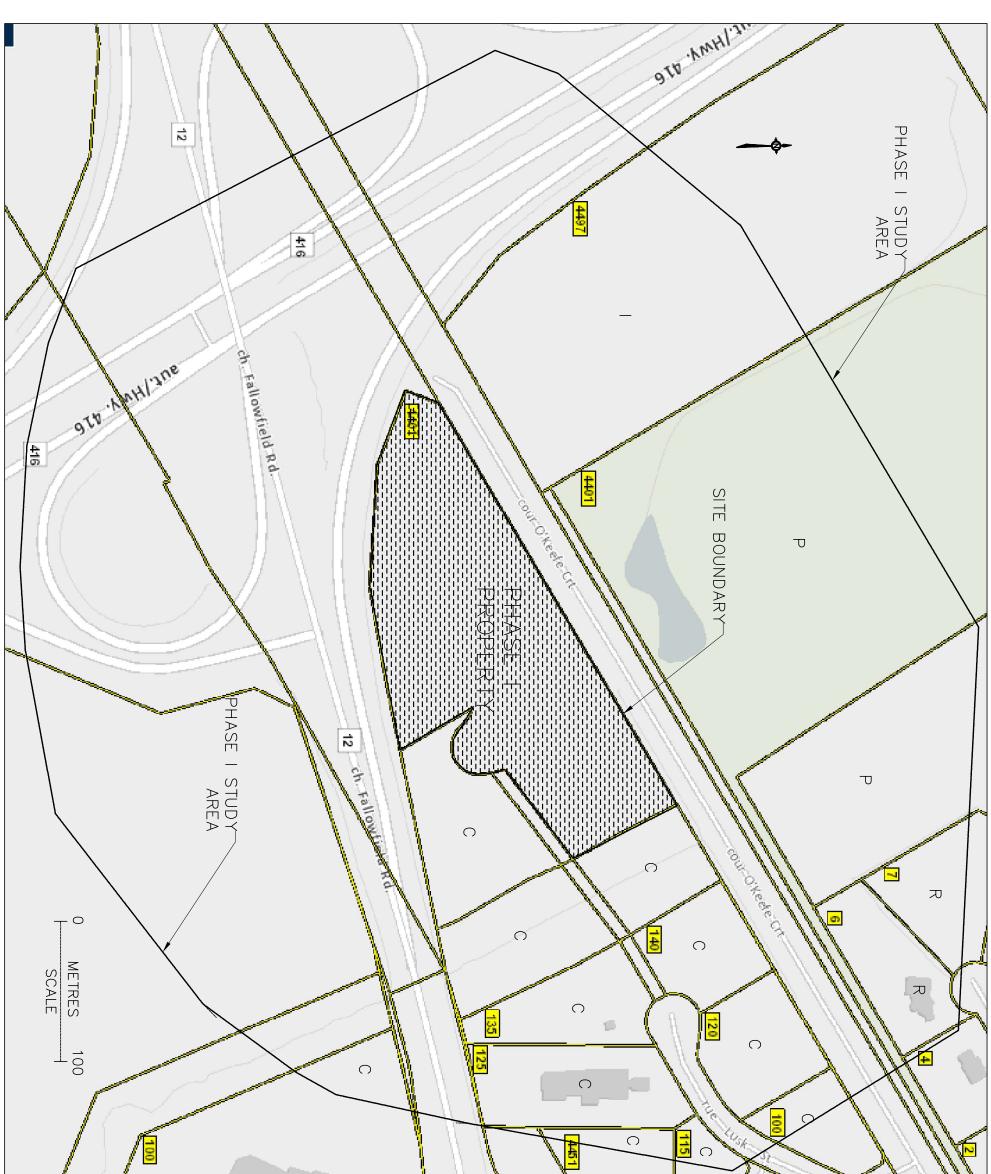
© COPY RIGHT ALONG KOLLAND ASSOCIATES INCORPORATED				Pi	om. CitiG	ate	Dr					12		ch Fallowfield or				77	4	COULO	Nede Cre
240639	DT DT	DESIGNED BY: ——	4401 FALLOWF (O'KEEFE NEPEAN WARD, CITY	LOCATION:	<i>PROJECT:</i> PHASE I ENV SITE ASS CONCEPTUAL	<i>CLIENT:</i> DCR PHOENIX DEVELOPMENT & 2116885 ONTAR	PO, BOX 189, 210 PRESCOTT S KEMPTVILLE ONTARIO KOG 1JUO FAX (613) 258-047 http://www.kollaard.ca	Kollaard Engineers	REV. NAME DATE	REFERENCE: MAPPING OBTAINED FROM OTTAWA GEOMAPS	THERE ARE NO USTS MITHIN PHASE I ESA PROPERTY. NOTE: THIS DRAWNG TO BE CONJUNCTION MITH THE ACC	THERE ARE NO WELLS PROPERTY.	THERE ARE NO ANSI OR BODIES IN THE PHASE I		250 METRES RADIUS	PHASE I SITE	PARK/COM	C COMMERCIAL USE		LEGEND: I INSTITUTIONAL USE	<i>drawing number:</i> FIGURE
39	<i>SCALE:</i> AS SHOWN	<i>DATE:</i> JULY 11, 2024	FALLOWFIELD ROAD D'KEEFE COURT) RD, CITY OF OTTAWA, ON		I ENVIRONMENTAL ASSESSMENT TUAL SITE MODEL	OPMENT CORPORATION LTD.	01T ST (613) 860-0923 -0475 info@kollaard.ca	rd Associates	DESCRIPTION	3 OBTAINED APS	YTY. TO BE READ IN HE ACCOMPANYING REPORT.	S ON THE PHASE I	OR SURFACE WATER E I ESA STUDY AREA.		AREA	BOUNDARY	ň				2

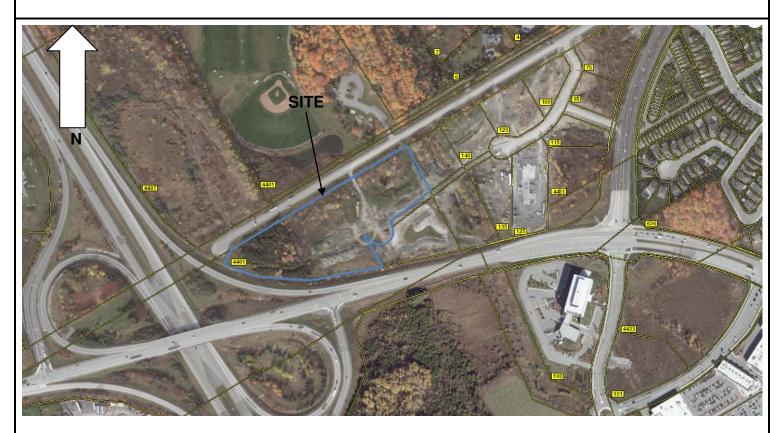
Since 2006, a review of the 2019 air photograph indicates additional fill materials were observed to have been deposited at the site. The 2019 aerial photograph indicates fill was excavated from the adjacent stormwater management pond. Additionally, the current owners of the site indicated the fill materials observed in the air photograph originated from the excavation of the stormwater management pond located near the southeast corner of the site. Confirmation by email was provided by Mr. Craig Cantwell of Arcadis Ottawa that

the pond spoils were the source of the fill materials observed in the air photographs. The fill materials were indicated to consist of native silty clay and glacial till.

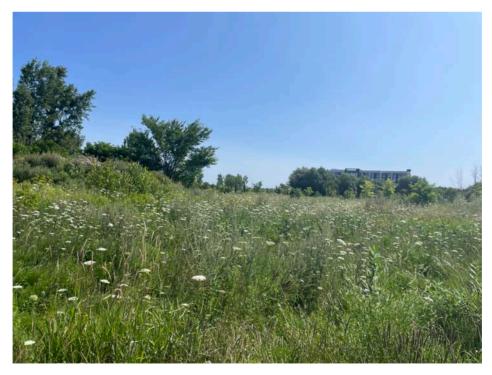
View of some fill pile and hotel facing east
