Phase I Environmental Site Assessment

1291 Summerville Avenue
Ottawa, Ontario

January 14, 2021

Report: PE5083-1

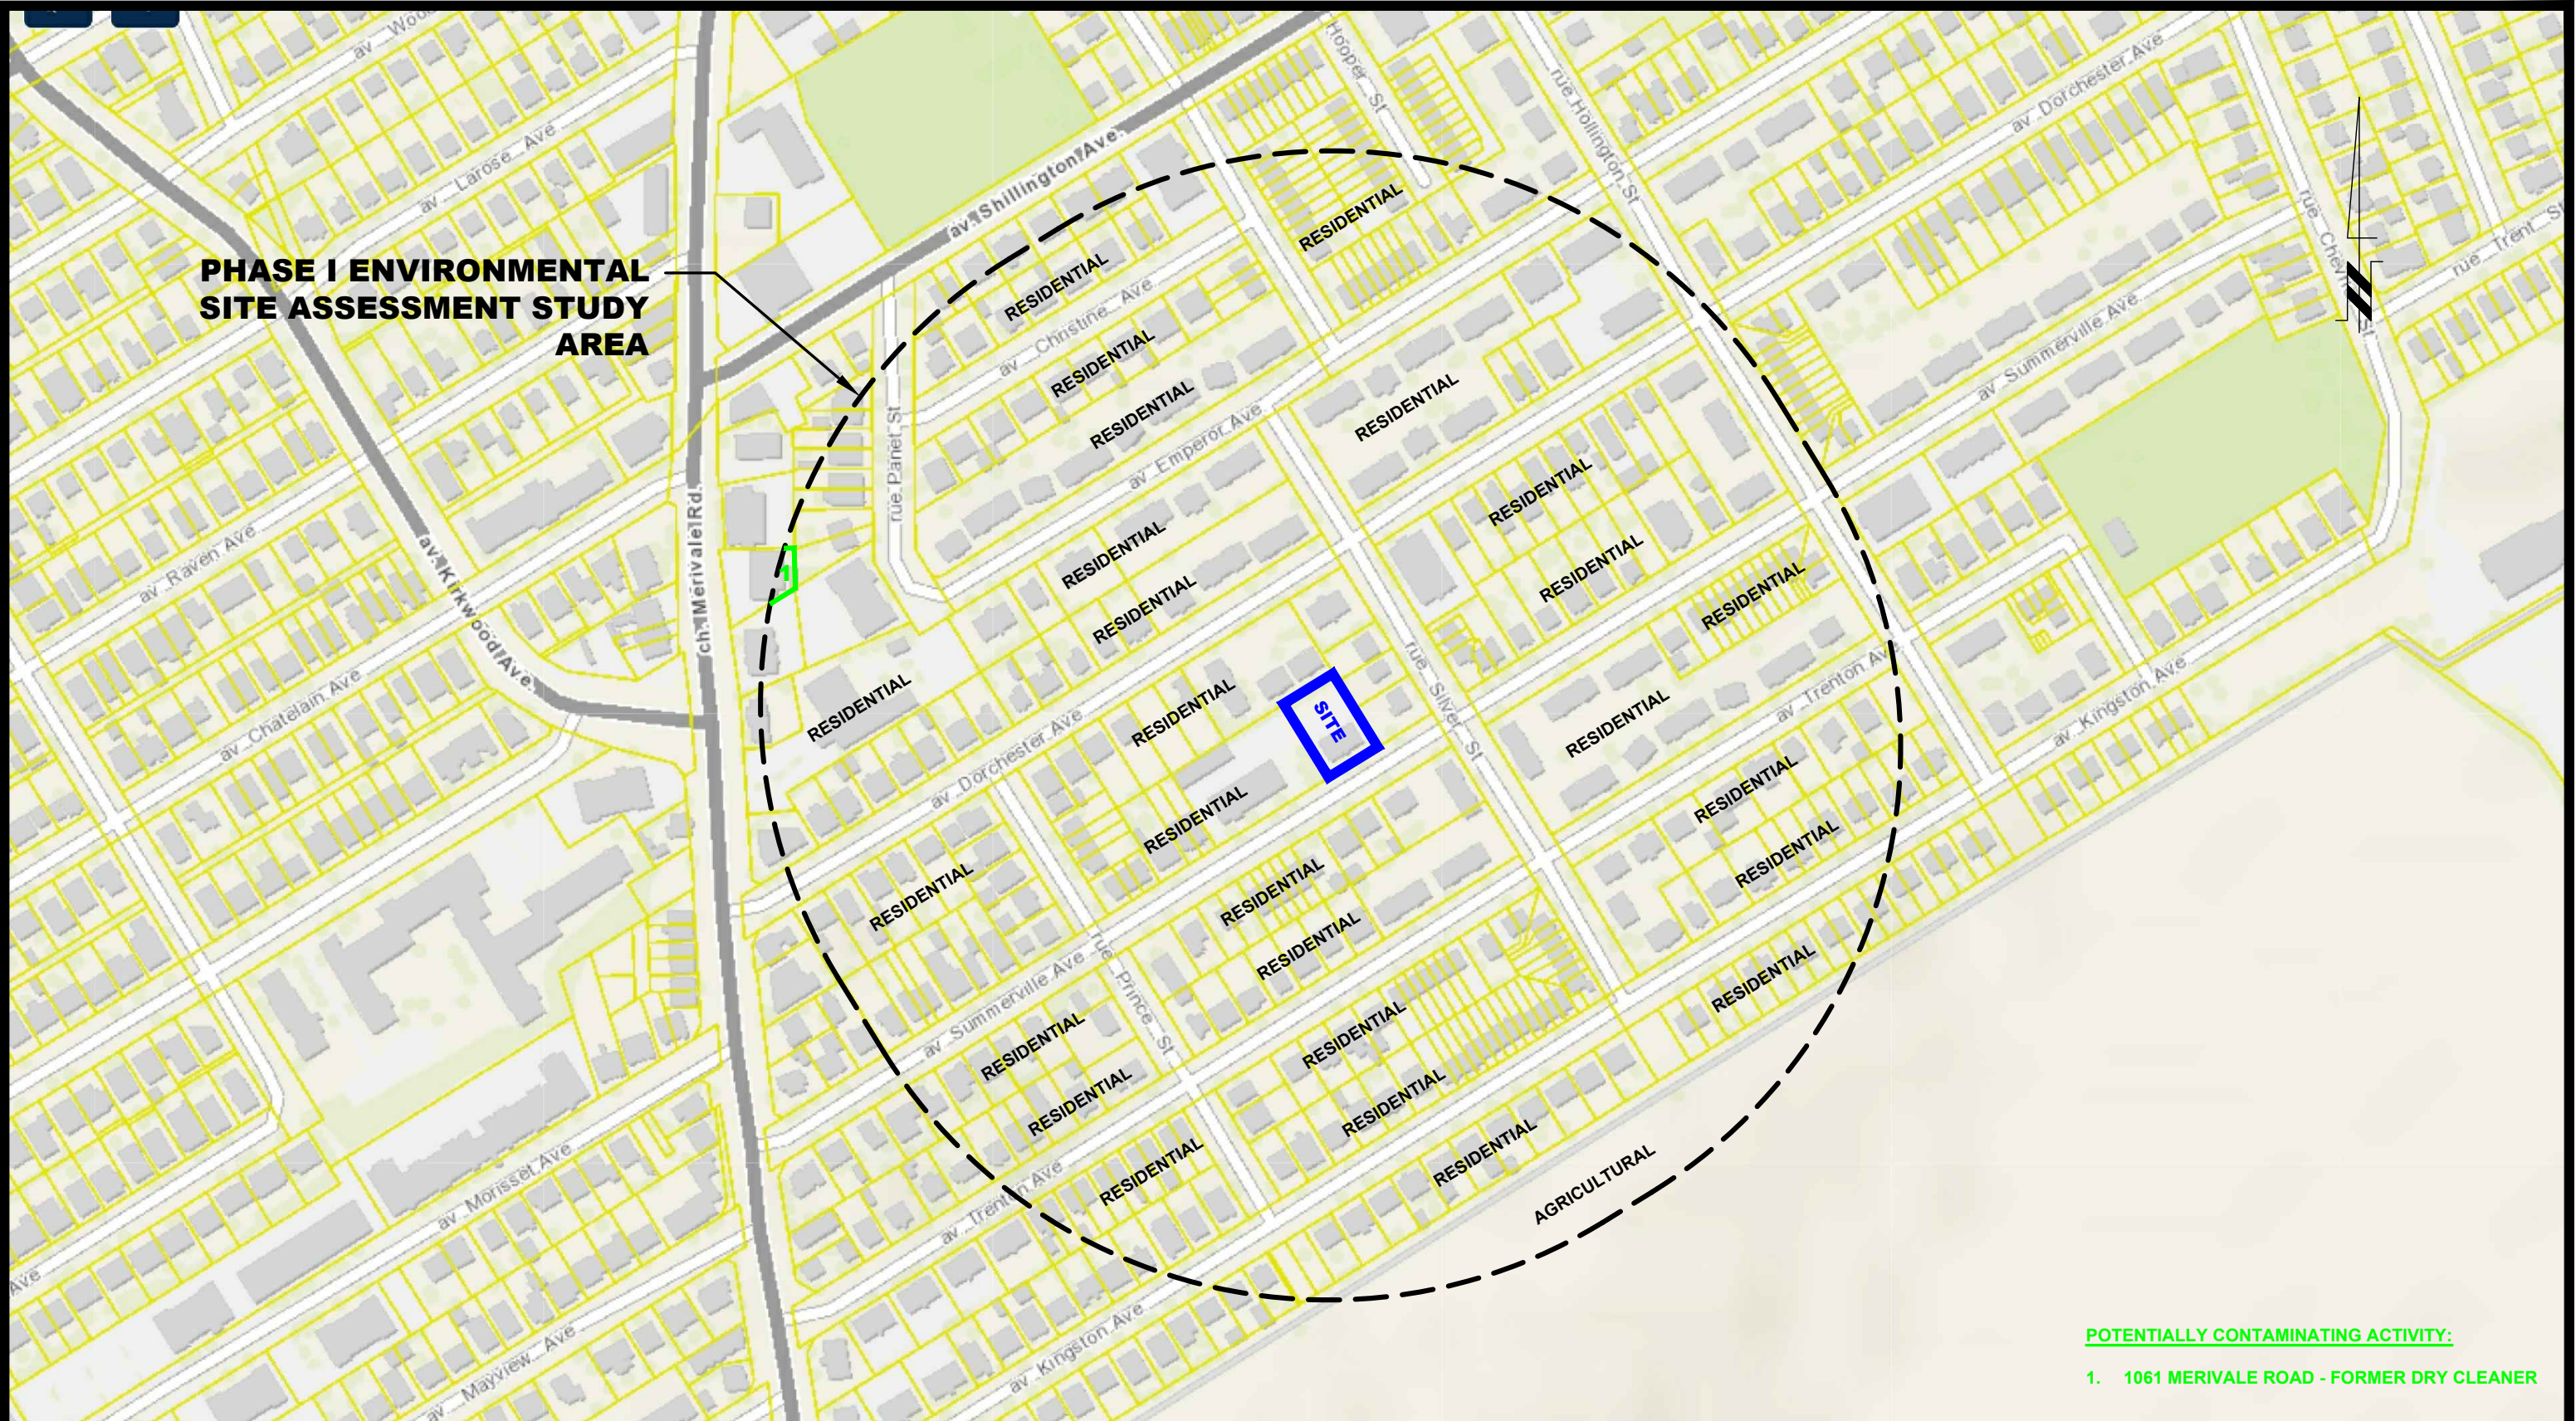
DRAWING PE5083-2 – SURROUNDING LAND USE PLAN

POTENTIALLY CONTAMINATING ACTIVITY:
1. 1061 MERIVALE ROAD - FORMER DRY CLEANER
