Stittsville South W4 Future Neighborhood Area: Environmental Impact Study for the Draft Plan of Subdivision

Final Report

CAIVAN

Project Number: CAIV 1300.4

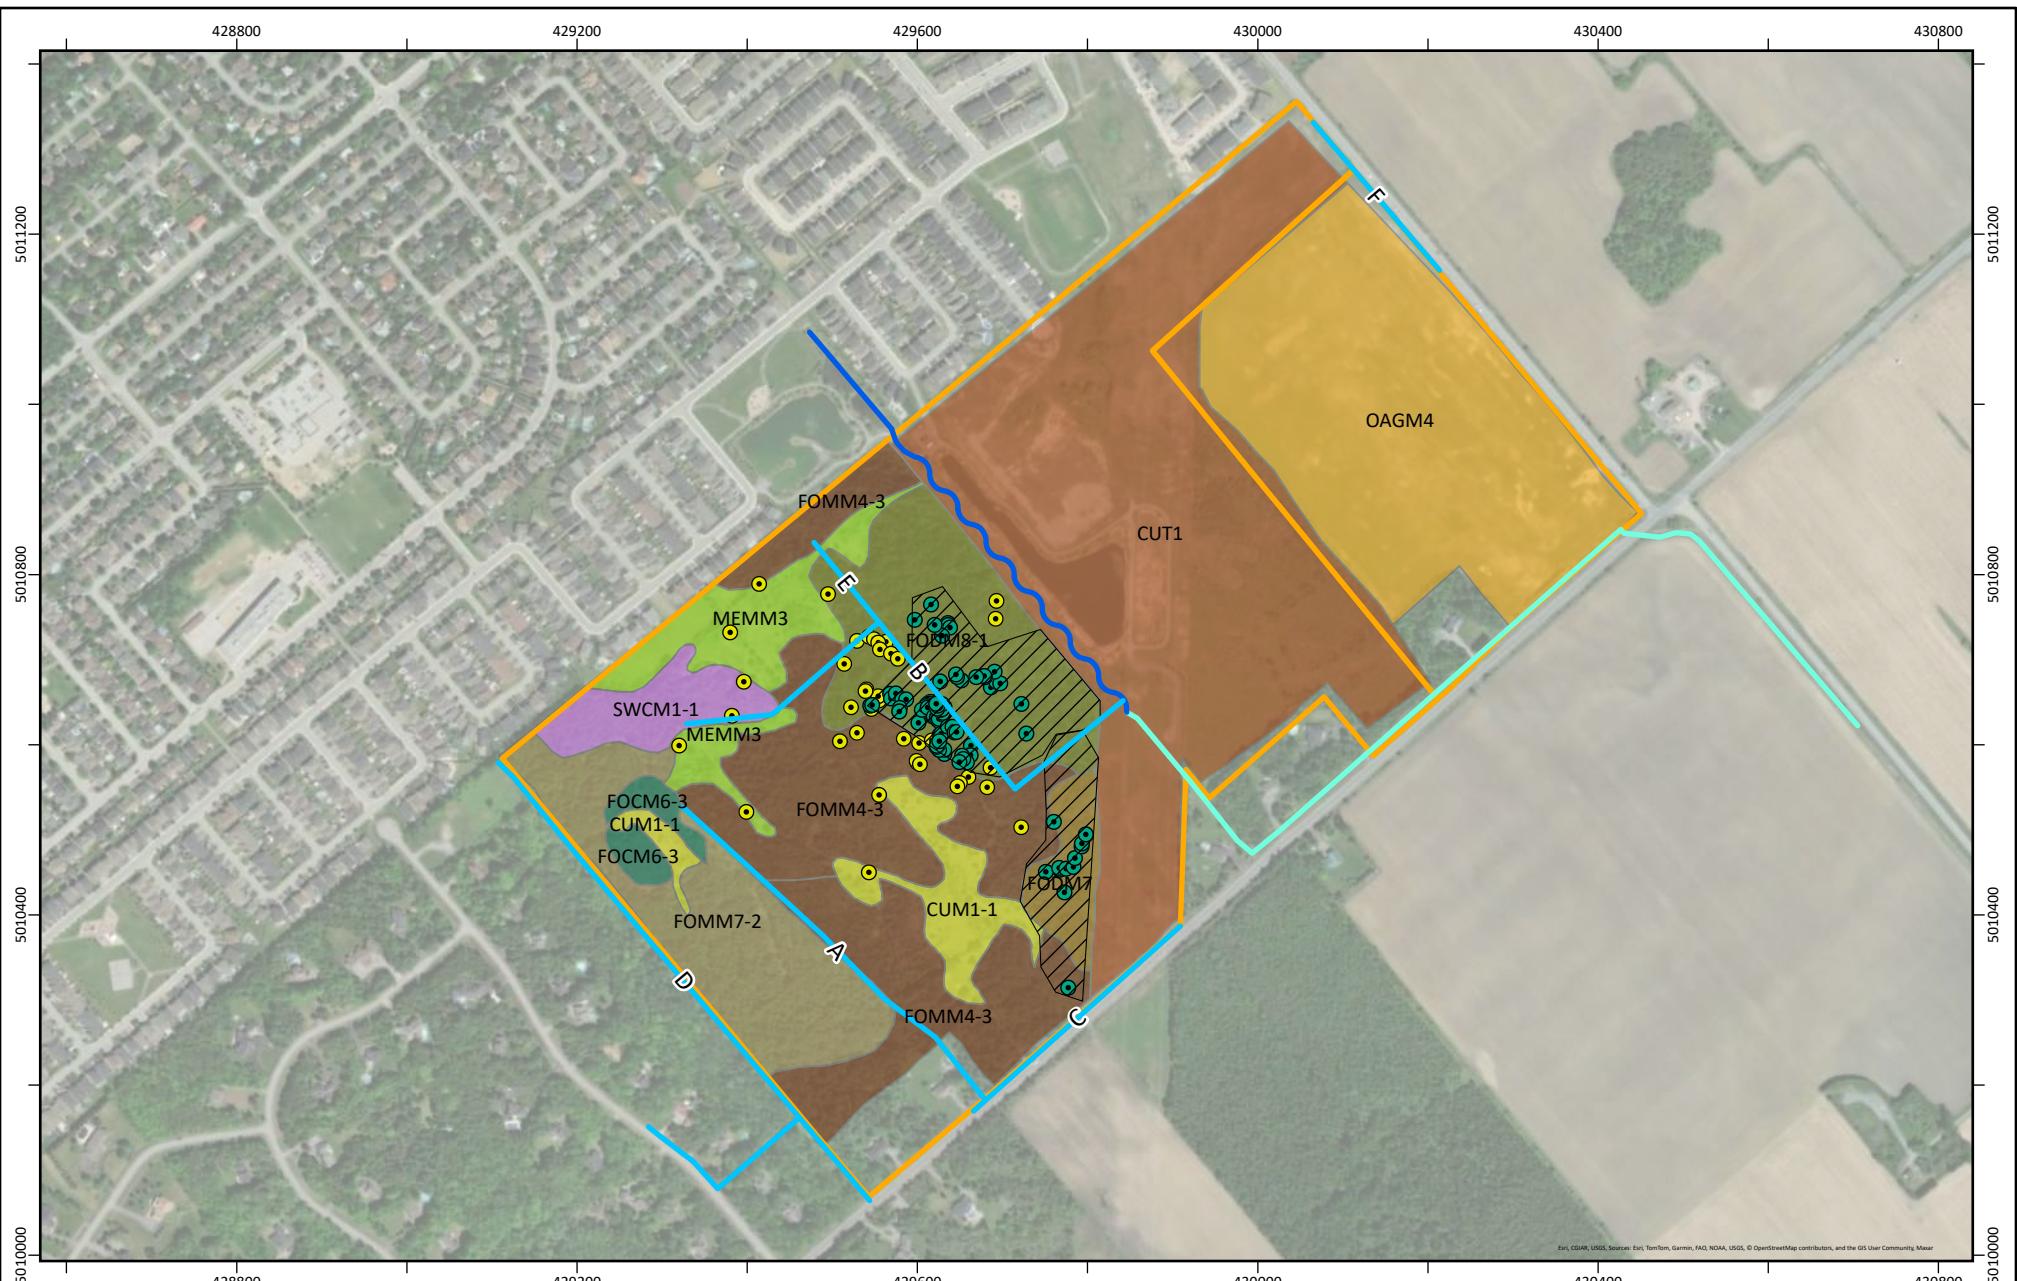
Figure 3. Existing Conditions

A total of ten distinct landcovers or ELC units were delineated on the Site (Figure 3). The majority of the western portion of the Site is a mixed Eastern White Cedar forest, a Poplar dominant deciduous forest, and meadow areas, with smaller areas of Scots Pine plantation and an Eastern White Cedar Swamp. The eastern portion of the Site is dominated by a thicket community and open agricultural lands. KAL Biologists were not permitted direct access to the small, residential parcels along Flewellyn Road as they are privately-owned. Road-side and aerial image reviews, however, indicate land cover on the small parcels (other than of the manicured spaces directly associated with houses and lawns) to correspond with the adjacent landcover of the Site. For each ELC unit identified, the dominant species observed, and any SAR plant species (highlighted in the descriptions below with an asterisk) are discussed in the following sections. An exhaustive list of all plant species observed in each ELC unit as well as tree sizes (DBH), where applicable is included in Appendix E.

Anuran surveys were performed on April 20th, May 23rd, and June 30th, 2023, at eight stations distributed across the Site to capture spatial and habitat variability. A total of five frog species were observed on the Site via evening Frog surveys and incidental observations. A summary of the weather conditions during the anuran survey is provided in Table 6. Frog species and their respective stations and calling codes are summarized in Table 7. Station locations are shown in Figure 3.

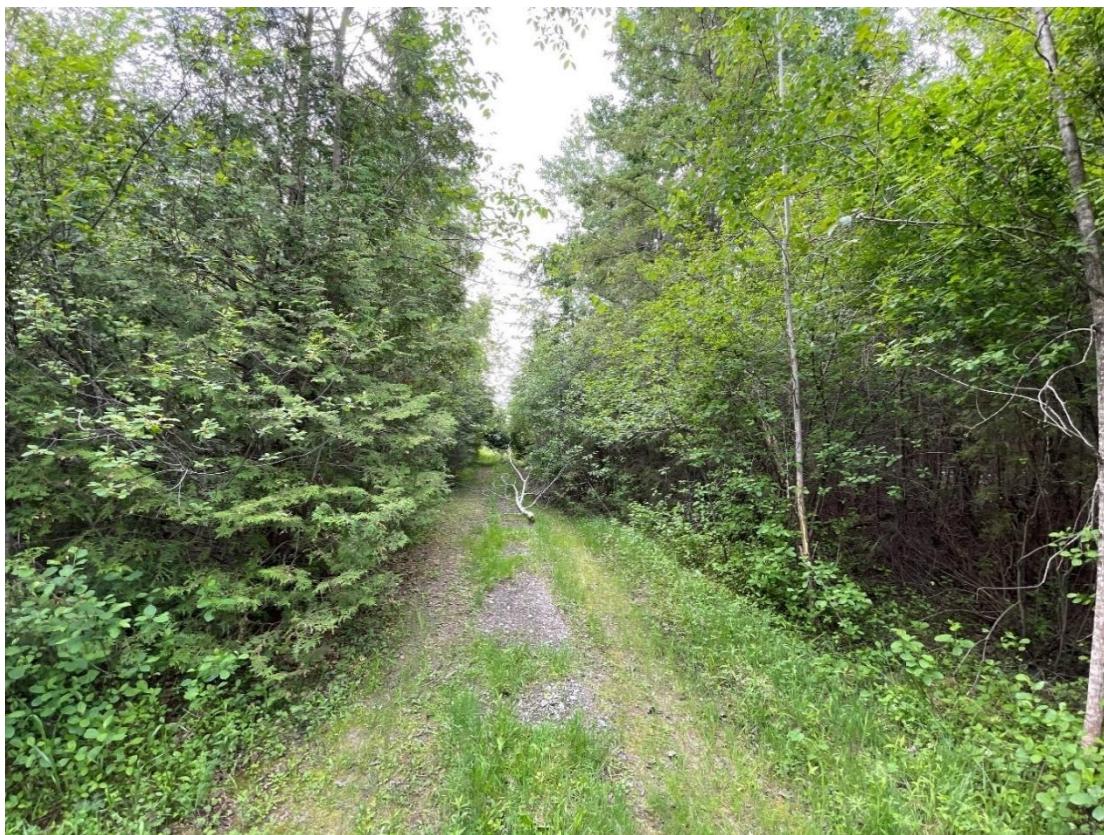
Figure 4. Dry - Fresh White Cedar – Hardwood Mixed Forest Type (FOMM4-3)

A broad swath of the western portion of the Site is characterized as a Dry - Fresh White Cedar – Hardwood Mixed Forest Type (FOMM4-3) community (Figure 4). It is dominated by Eastern White Cedar (*Thuja occidentalis*; 10-20 cm DBH), Trembling Aspen (*Populus tremuloides*; 10-20 cm DBH), Green Ash (*Fraxinus pennsylvanica*; 10-15 cm DBH), Large tooth Aspen (*Populus grandidentata*; ~15 cm DBH), White Spruce (*Picea glauca*; 30 cm DBH), White Pine (*Pinus strobus*; 25 cm DBH), Larch/Tamarack (*Larix laricina*; 15-20 cm DBH), American Beech (*Fagus grandifolia*; 10-15 cm DBH), and American Elm (*Ulmus americana*). Butternut* (*Juglans cinerea*; 20-50 cm DBH) were observed scattered throughout this community.

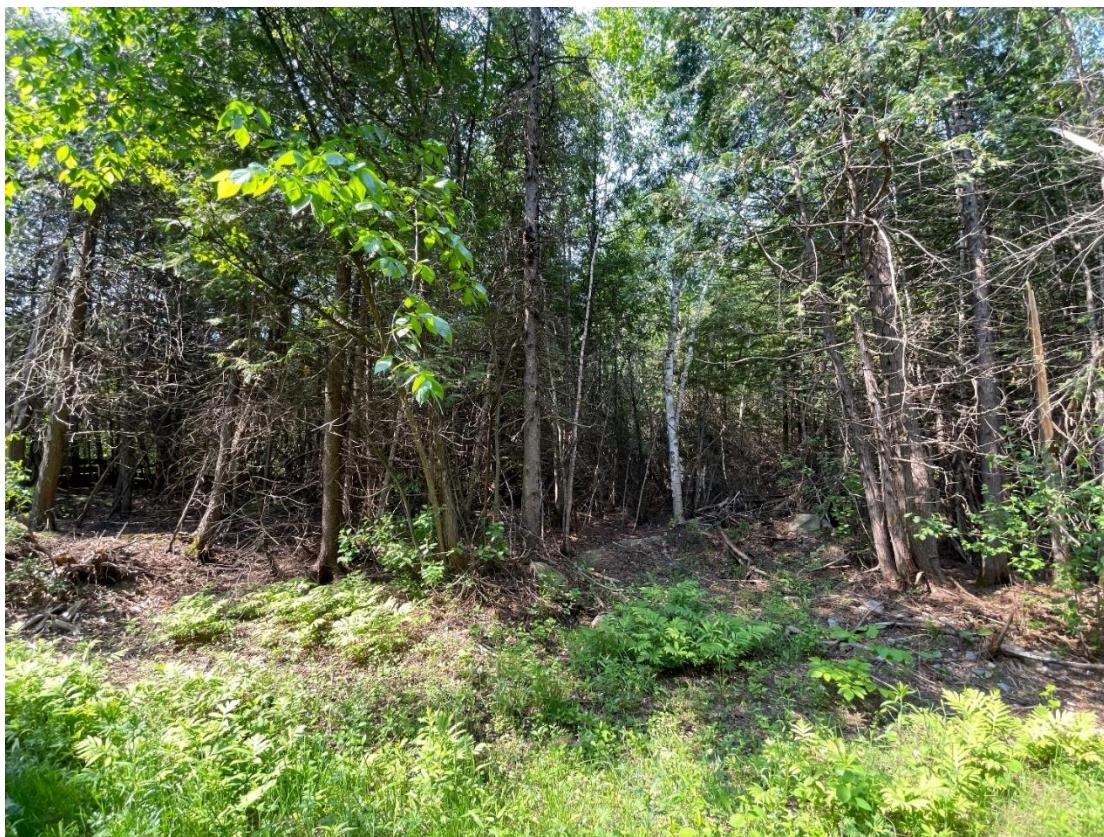
Figure 5. Fresh - Moist White Cedar - Hardwood Mixed Forest Type (FOMM7-2)

The western-most extent of the Site is characterized as a Fresh - Moist White Cedar - Hardwood Mixed Forest Type (FOMM7-2) community (Figure 5). It is dominated by Eastern White Cedar (*Thuja occidentalis*; 5-15 cm DBH), White Birch (*Betula papyrifera*; 10-20 cm DBH), Trembling Aspen (*Populus tremuloides*; 10-35 cm DBH), White Ash (*Fraxinus americana*; 5-8 cm DBH), White Spruce (*Picea glauca*; ~10 cm DBH), and Balsam Fir (*Abies Balsamea*) tree species.

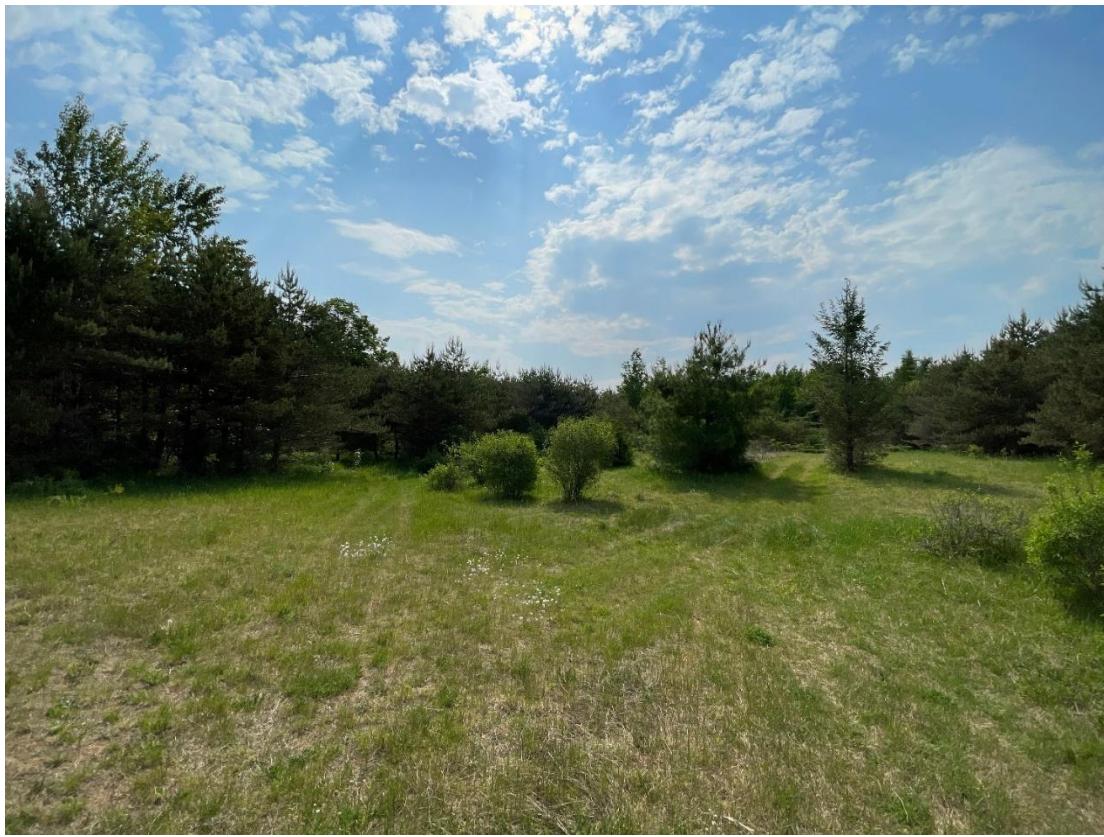
Figure 6. Dry – Moist Old Field Meadow Type (CUM1-1)

A Dry – Moist Old Field Meadow Type (CUM1-1; Figure 6) is located centrally on the Site. This area is characteristic of previous disturbance with scattered tree species including Large tooth Aspen (*Populus grandidentata*; ~5 cm DBH), Trembling Aspen (*Populus tremuloides*; 10-25 cm DBH), Eastern White Cedar (*Thuja occidentalis*; ~10 cm DBH), Scots Pine (*Pinus sylvestris*; 5-10 cm DBH), American Beech (*Fagus grandifolia*; ~10 cm DBH), Apple Spp. (*Malus*; 8-10 cm DBH), White Spruce (*Picea glauca*; 20-25 cm DBH), Larch/Tamarack (*Larix laricina*; ~5-10 cm DBH), Green Ash (*Fraxinus pennsylvanica*; <5 cm DBH). Dominant shrub and groundcover species included Common Juniper (*Juniperus communis*), Trembling Aspen (*Populus tremuloides*) saplings, Orchard Grass (*Dactylis glomerata*), Wild Strawberry (*Fragaria vesca*), Canada Goldenrod (*Solidago canadensis*), Poison Ivy (*Toxicodendron radicans*), Red Raspberry (*Rubus idaeus*), Alder Buckthorn (*Rhamnus frangula*), and Common Blackberry (*Rubus allegheniensis*).

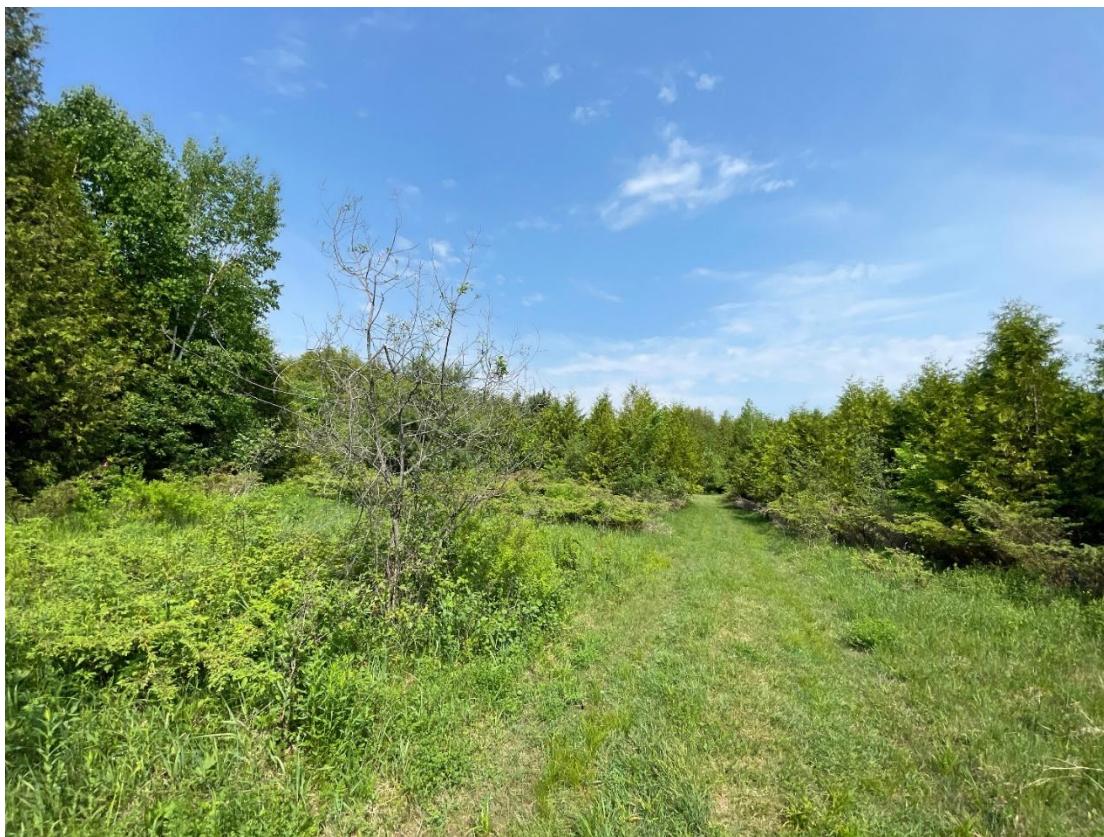
Figure 7. Dry – Fresh Mixed Meadow Ecosite (MEMM3)

A Dry – Fresh Mixed Meadow Ecosite (MEMM3) is located in the northwest corner of the Site (Figure 7). This area is mainly characterized by Eastern White Cedar (*Thuja occidentalis*), Scots Pine (*Pinus sylvestris*; ~10-20 DBH), Larch/Tamarack (*Larix laricina*; ~10 DBH), and scattered Butternut* (*Juglans cinerea*; ~10-20 DBH) trees. Dominant shrub and groundcover species included Common Juniper (*Juniperus communis*), Orchard grass (*Dactylis glomerata*), Wild strawberry (*Fragaria vesca*), Canada Goldenrod (*Solidago canadensis*), Alder Buckthorn (*Rhamnus frangula*), and Common Blackberry (*Rubus allegheniensis*).

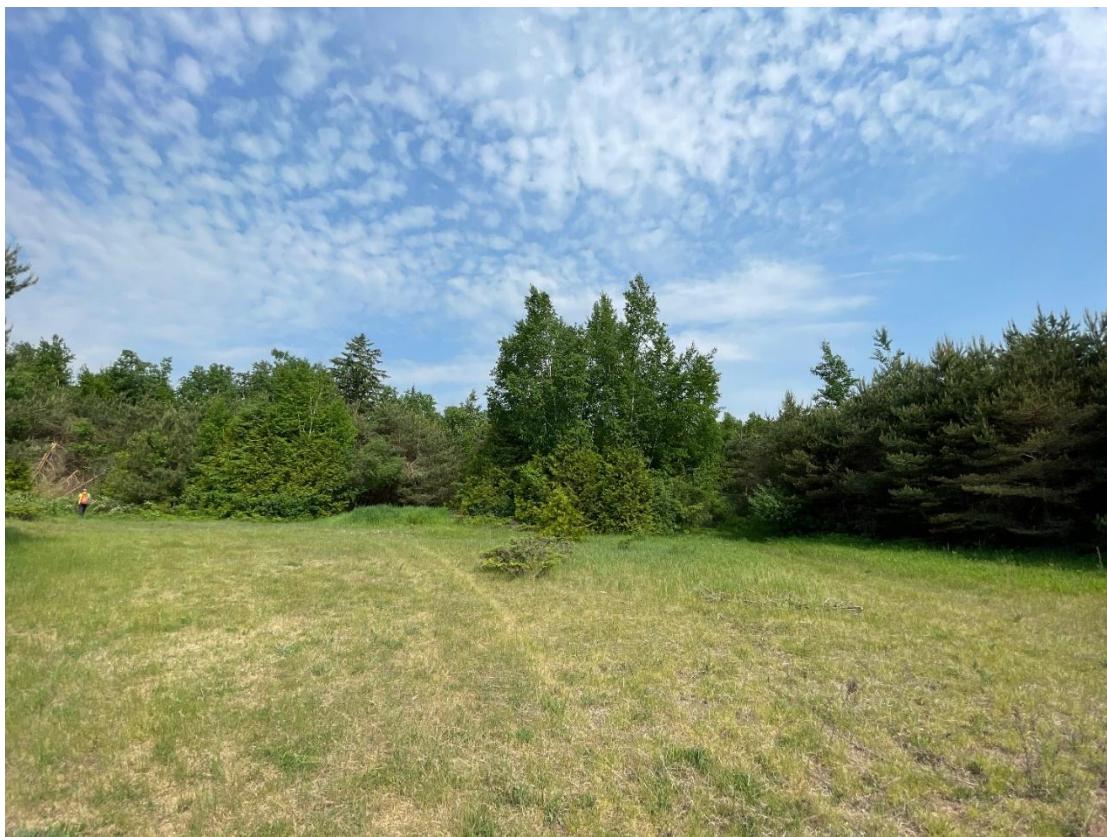
Figure 8. Dry – Fresh Scots Pine Naturalized Coniferous Plantation Type (FOCM6-3)

A Fresh Scots Pine Naturalized Coniferous Plantation Type (FOCM6-3) is located in the northwest corner of the Site (Figure 8). It is mainly dominated by Scots Pine (*Pinus sylvestris*; ~10-20 cm DBH), Jack Pine (*Pinus banksiana*; ~15 cm DBH), Eastern White Cedar (*Thuja occidentalis*), White Pine (*Pinus strobus*; ~20 cm DBH), White Birch (*Betula papyrifera*; 10-20 cm DBH), Butternut* (*Juglans cinerea*), American Beech (*Fagus grandifolia*), and Green Ash (*Fraxinus pennsylvanica*; 10-15 cm DBH).

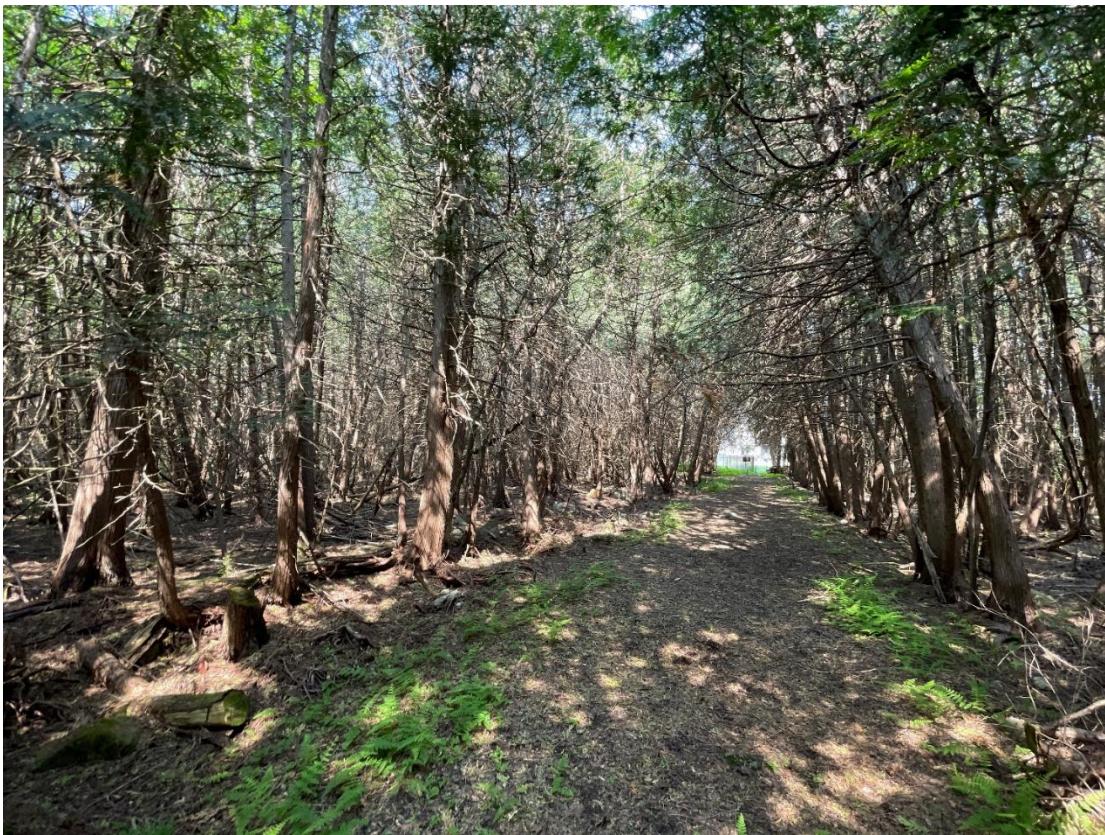
Figure 9. White Cedar Mineral Coniferous Swamp (SWCM1-1)

A White Cedar Mineral Coniferous Swamp (SWCM1-1) is located on Site (Figure 9). It is dominated by Eastern White Cedar (*Thuja occidentalis*) and has ground cover consisting of Bulblet Bladder Fern (*Cystopteris bulbifera*), Alder Buckthorn (*Rhamnus frangula*), Interrupted Fern (*Osmunda claytoniana*), Sensitive Fern (*Onoclea sensibilis*), and Poison Ivy (*Toxicodendron radicans*).

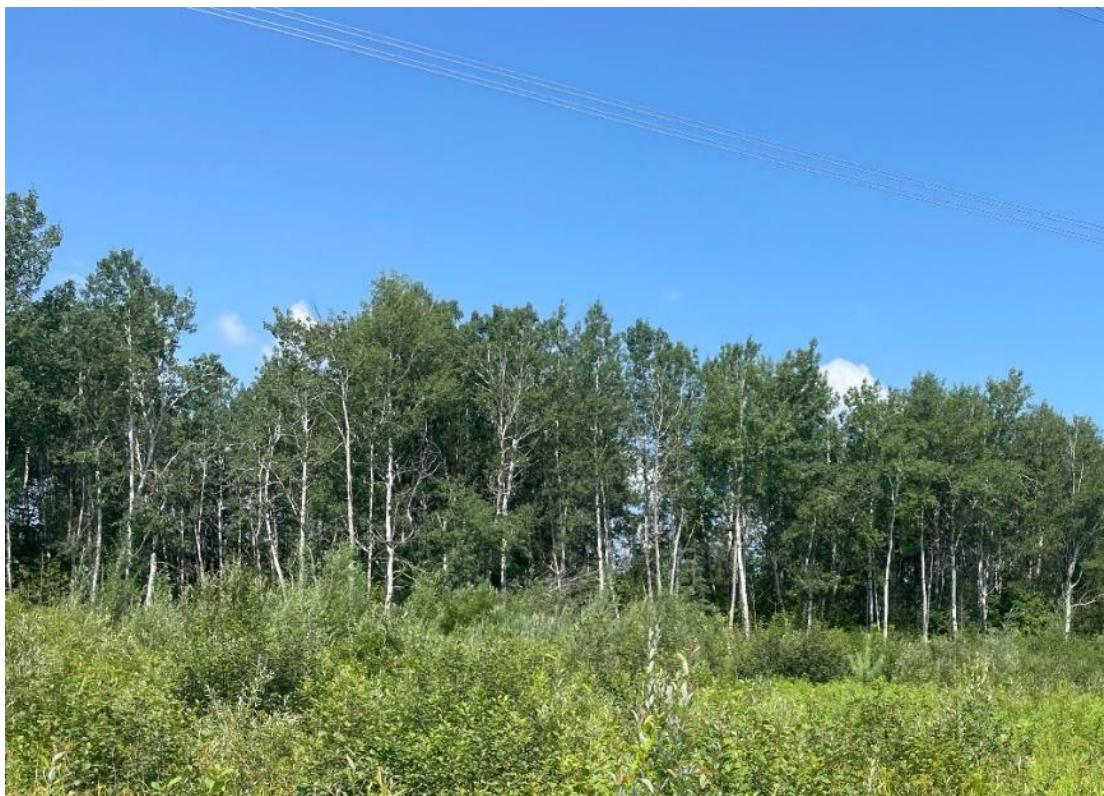
Figure 10. Fresh – Moist Lowland Deciduous Forest Ecosite (FODM7)

A Fresh-Moist Lowland Deciduous Forest Ecosite (FODM7) is located in the center of the Site (Figure 10). It is dominated by Trembling Aspen (*Populus tremuloides*), Eastern White Cedar (*Thuja occidentalis*), Butternut* (*Juglans cinerea*), Black Ash* (*Fraxinus nigra*), and Balsam Poplar (*Populus balsamifera*). Its ground cover consists of Common Buckthorn (*Rhamnus cathartica*), Poison Ivy (*Toxicodendron radicans*), White Panicle Aster (*Sympphyotrichum lanceolatum*), Riverbank Grape (*Vitis riparia*), Common Ragweed (*Ambrosia artemisiifolia*), and Yellow Sweet Clover (*Melilotus officinalis*).

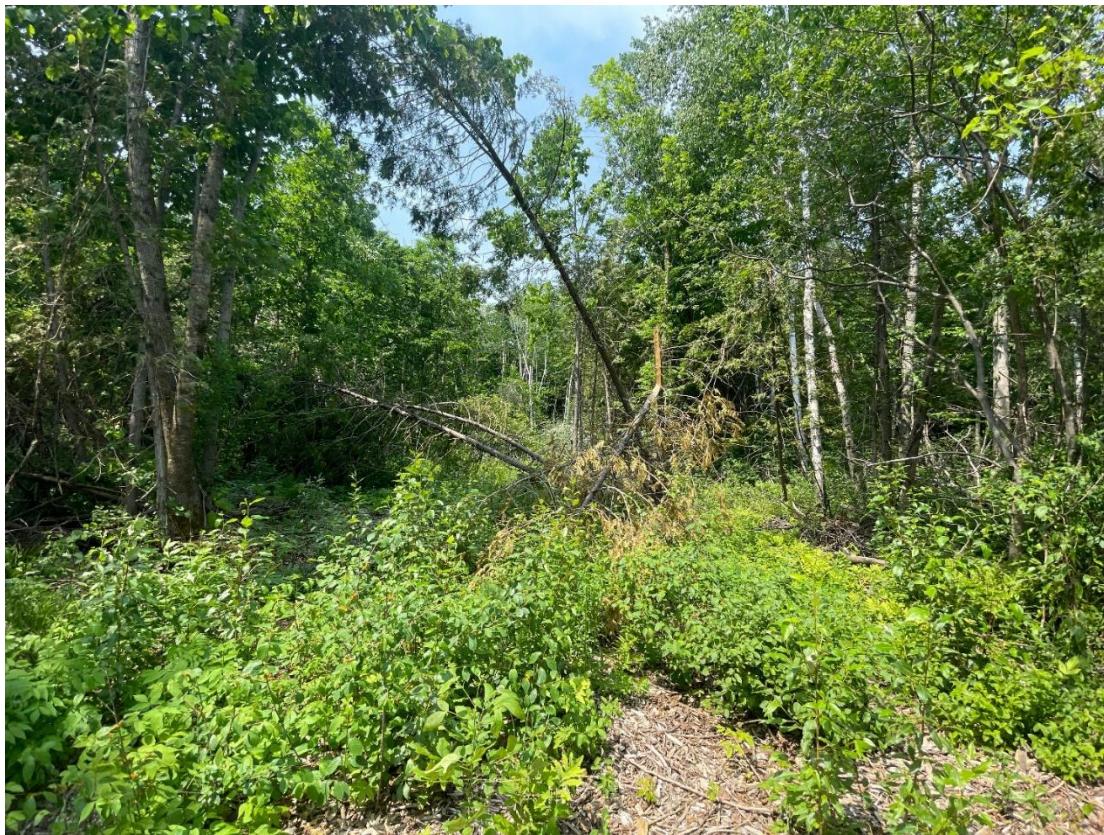
Figure 11. Fresh – Moist Poplar Deciduous Forest Type (FODM8-1)

A Fresh – Moist Poplar Deciduous Forest Type (FODM8-1; Figure 11) is located on Site and is dominated by Trembling Aspen (*Populus tremuloides*; 10-20 cm DBH), White Birch (*Betula papyrifera*; 10-20 cm DBH), Balsam Poplar (*Populus balsamifera*; 10-25 cm DBH), Butternut* (*Juglans cinerea*; 10-20 cm DBH), Eastern White Cedar (*Thuja occidentalis*; 10-20 cm DBH), Basswood (*Tilia americana*; ~30 cm DBH), Red Maple (*Acer rubrum*; ~27 cm DBH), American Elm (*Ulmus americana*; 10-20 cm DBH), and Black Ash* (*Fraxinus nigra*). Its dominant ground cover consists of Common Juniper (*Juniperus communis*), Trembling Aspen saplings (*Populus tremuloides*), Sensitive Fern (*Onoclea sensibilis*), Ostrich Fern (*Matteuccia struthiopteris*), Interrupted Fern (*Osmunda claytoniana*), Canada Goldenrod (*Solidago canadensis*), Poison Ivy (*Toxicodendron radicans*), Alder Buckthorn (*Rhamnus frangula*), Bloodroot (*Sanguinaria*), and Meadow Horsetail (*Equisetum pratense*).

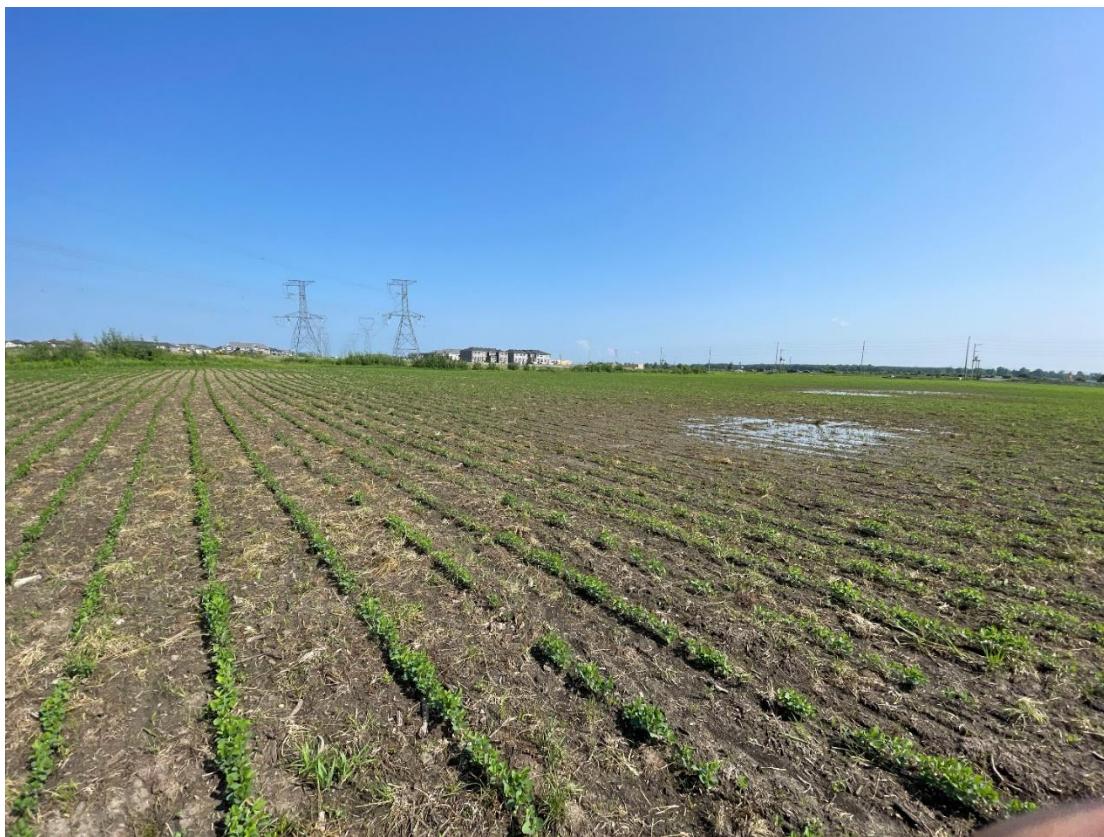
Figure 12. Medium Mineral Open Pasture Type (OAGM4)

A Medium Mineral Open Pasture Type (OAGM4) on Site (Figure 12) is dominated by planted crop cultivar and scattered shrub community species such as Canada Goldenrod (*Solidago canadensis*), Meadow Horsetail (*Equisetum pratense*), Purple Aster (*Sympphyotrichum patens*), Common Mullein (*Verbascum thapsus*), Meadow Buttercup (*Ranunculus acris*), Wild Strawberry (*Fragaria vesca*), and Common Dandelion (*Taraxacum officinale*).

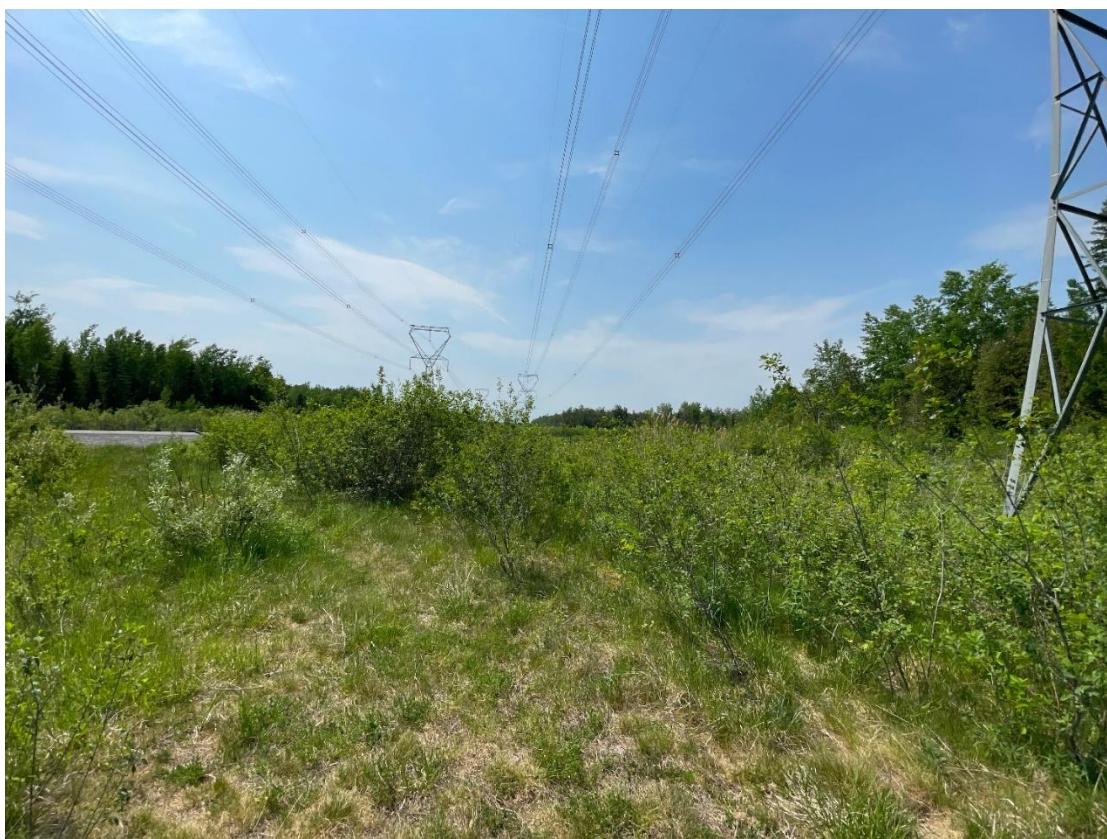
Figure 13. Cultural Thicket Ecosite (CUT1)

A Cultural Thicket Ecosite (CUT1; Figure 13) on Site is dominated by Bebb's Willow (*Salix bebbiana*), Alder Buckthorn (*Rhamnus frangula*), Trembling Aspen Saplings (*Populus tremuloides*), White Willow (*Salix alba*), White Meadowsweet (*Spiraea alba*), and Common Milkweed (*Asclepias syriaca*).
