Phase I – Environmental Site Assessment

304 and 308 Donald Street
Ottawa, Ontario

Prepared for Upscale Homes

Report: PE6501-1R
September 3, 2024

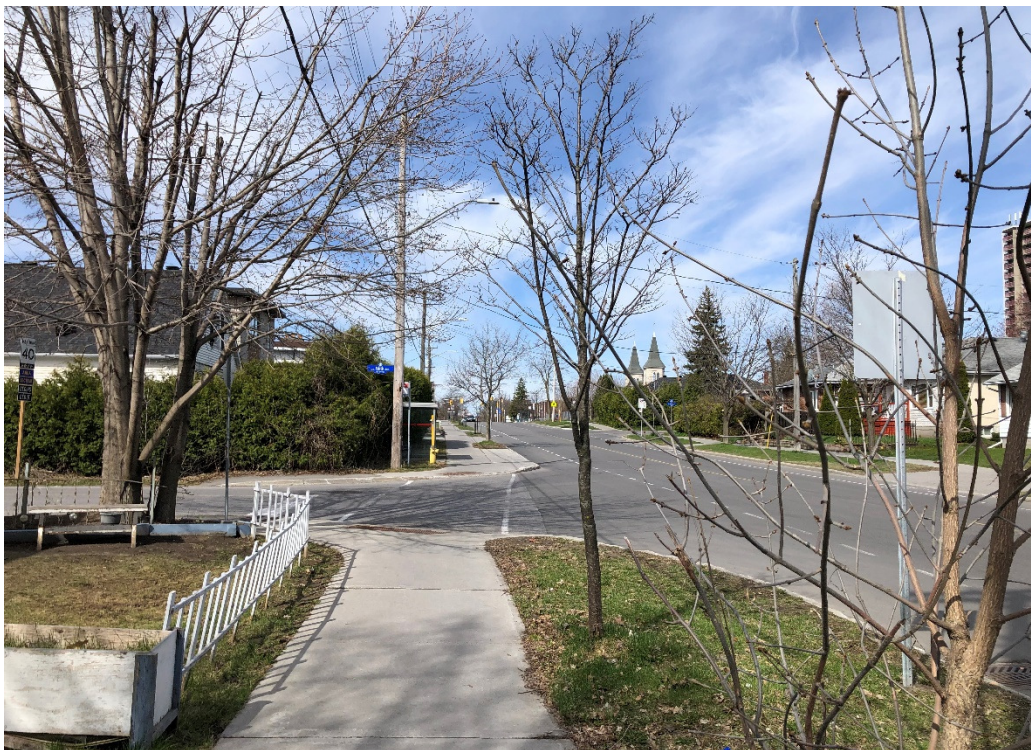
Photograph 4: View looking west, at the intersection of Edith Avenue and Donald Street.

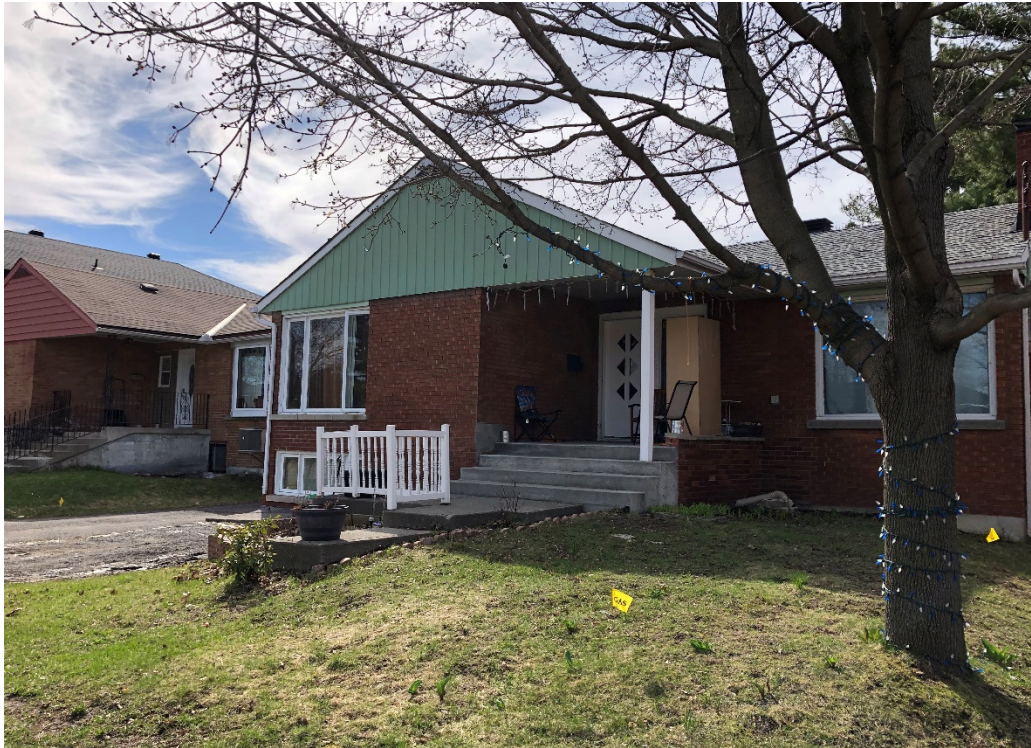
The property addressed 308 Donald Street is occupied by a one-storey residential dwelling, with one full basement level partially submerged. Built sometime in the 1950s, the residence is constructed with a poured concrete foundation and is finished on the exterior with bricks and vinyl siding along the roof. The dwelling has a sloped, shingled roof. The building is currently heated via a natural gas-fired furnace, located in the basement.

Photograph 5: View looking south from Donald Street, towards 308 Donald Street.

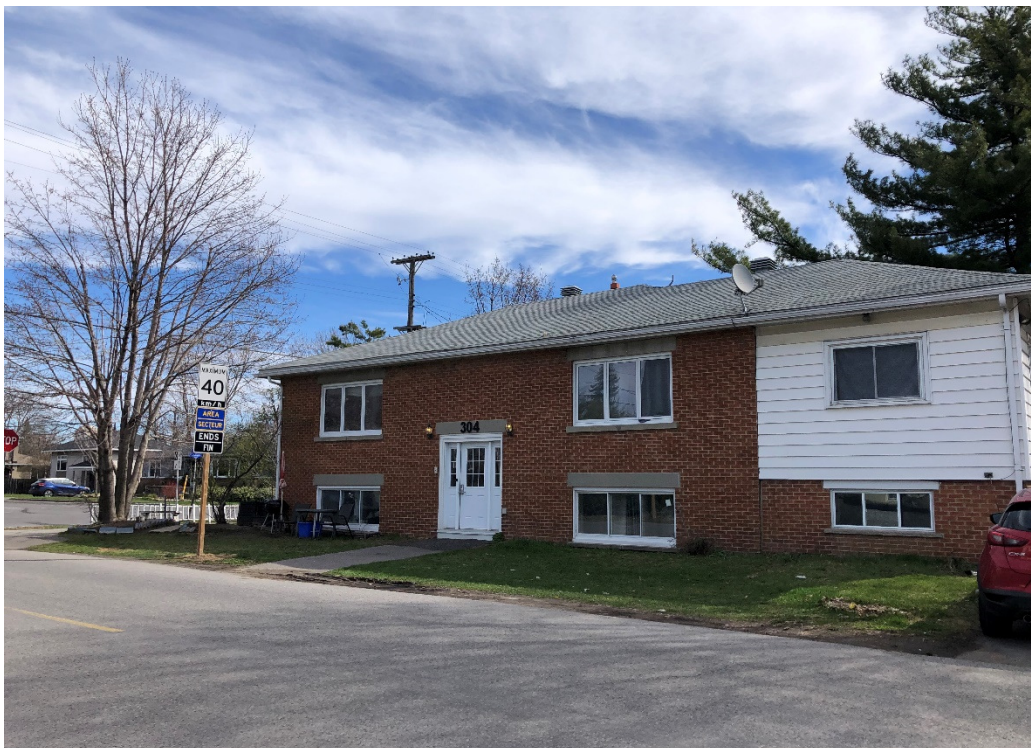
The property addressed 304 Donald Street is occupied a one-storey multi-unit residential building, with one full basement half a level below grade. Built sometime in the 1950s, the residence is constructed with a poured concrete foundation and is finished on the exterior with bricks and vinyl siding at the rear. The building has a sloped, shingled roof. The building is currently heated via a natural gas-fired furnace, located in the basement.

Photograph 6: View looking east from Edith Avenue, towards 304 Donald Street.
