HERITAGE IMPACT ASSESSMENT

254 ARGYLE AVENUE, OTTAWA

Revised August 2024 SUBMISSION

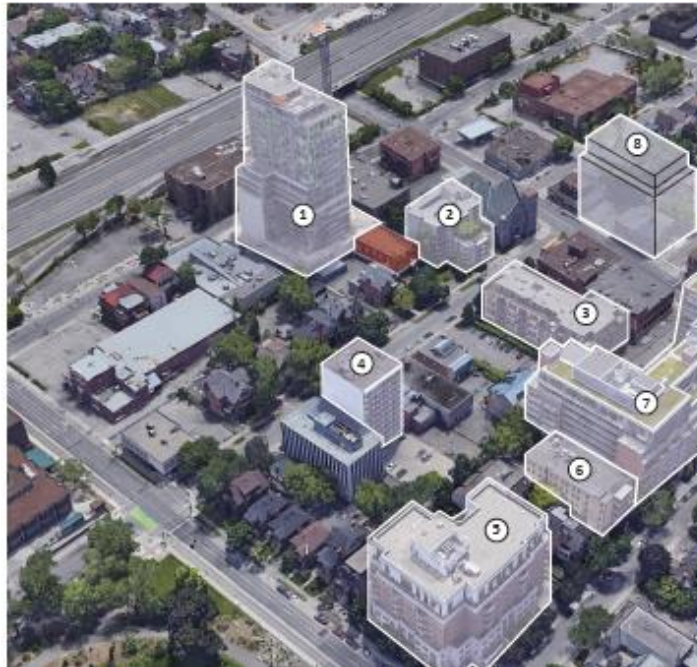
1. 203 Catherine St- SoBa Condominium 209 Units- 21 Floors- 2019
2. 258 Argyle Street- Apartment XX Units- 7 Floors- XXX
3. 255 Argyle Street- Apartment 40 Units- 6 Floors- 1960's
4. 229 Argyle Street- Apartment 79 Units- 12 Floors- 1978
5. 320 McLeod- Opus Condominium 71 Units- 9 Floors- 2007
6. 330 McLeod Street- Apartments ~40 Units- 6 Floors- XXXX
7. 360 McLeod Street- Condominium 164 Units- 9 Floors- 2015
8. 500 Bank street- Apartmenets- 11 Floors- 2022

Figure 4: Aerial view illustrating the built and landscape context within the block bound by Bank, Catherine, O'Connor Streets and Argyle Avenue. The existing development within the site at 254 Argyle is a one-storey Catholic Church constructed circa 1930 (highlighted red). The development integrates the church as a feature of the proposed development. The site is adjacent to 229 Argyle, a 7-storey apartment built pre - 1999. Just south of the site at 203 Catherine is the 21-storey SOBA condominium. Buildings numbered 1-8 identify neighbouring high-rise development. South top of image. Source: Google Earth/Spice.

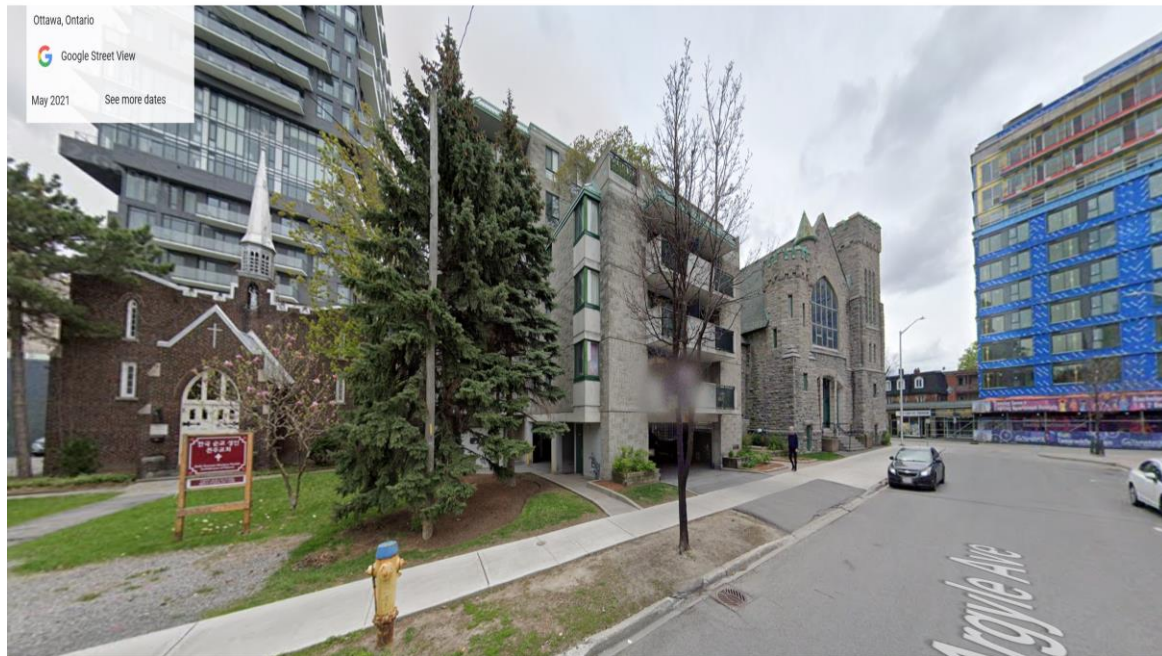
Figure 7: View looking southwest at the corner of Argyle and Bank. Note the position of the former church setback from Argyle. Source: Google Map.

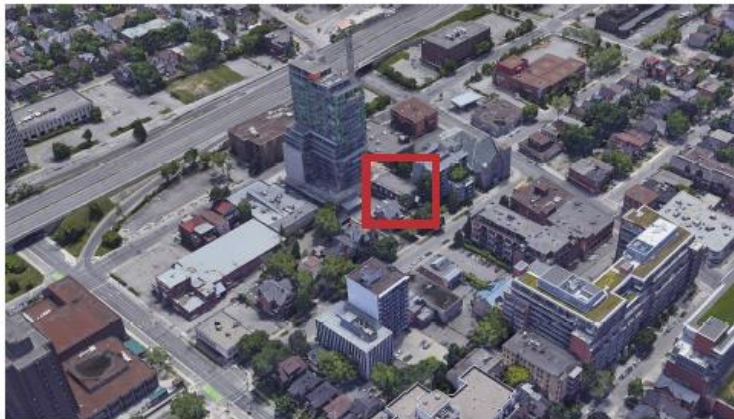
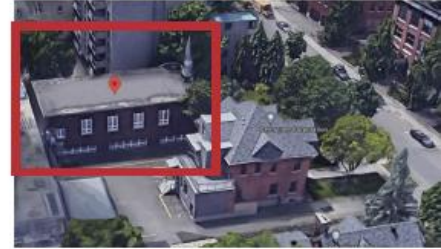
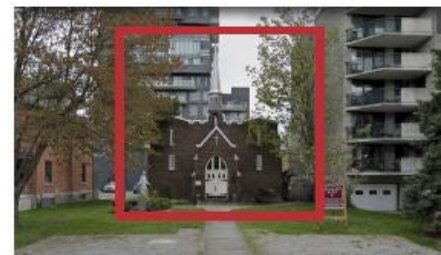
Figure 8: Clockwise Aerial view looking south, a view looking west with the former rectory residential building in the foreground, and a view from Argyle Avenue illustrating the church tucked back between the 12-storey high-rise and the neighbouring red brick residence. Source Spice Design. 2023.

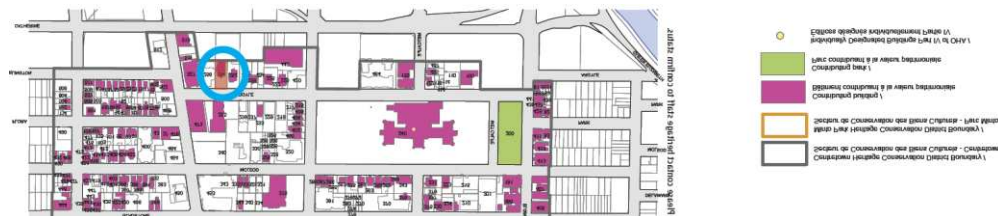
Figure 9: Detail of Map 11, Property Classifications Centretown Heritage Inventory 2020. The plan illustrates the classification of the properties within and adjacent to the development site (254 Argyle Avenue blue bulls' eye) is classified as 'Contributing Building' and 'Character Defining Resource'. Source: Centretown Heritage Inventory, Final Report, May 1, 2020. ERA Architects.

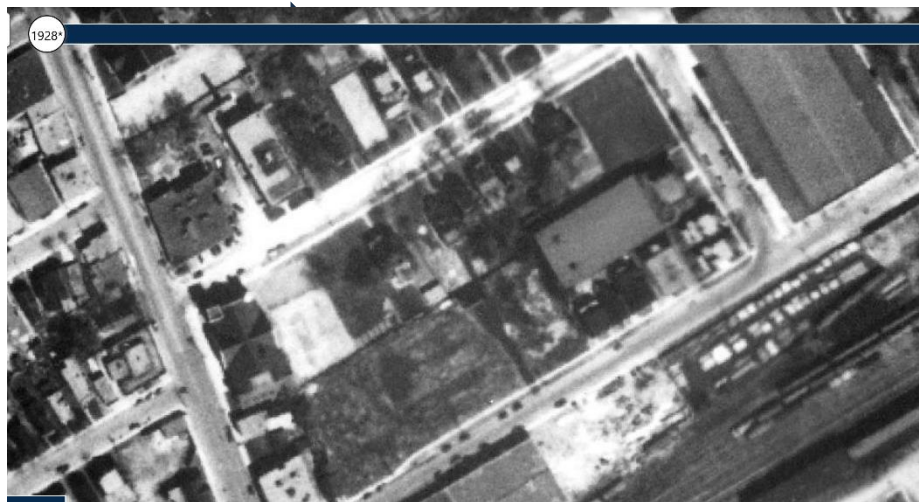
Figure 10: Aerial view 1928 with the church property undeveloped. Lands along Catherine Street appear as vacant plots. Arrowed. Source: Geoottawa

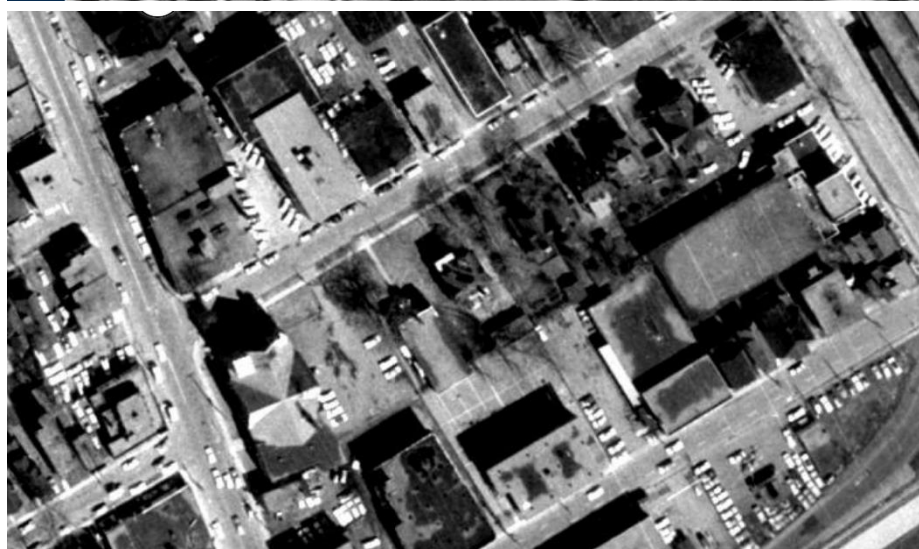
Figure 11: Aerial view 1958 with the shadows highlighting the steeple of the church. (Arrowed.) The property to the west appears to service as a parking lot and remained undeveloped until after 1991. Source: Geoottawa

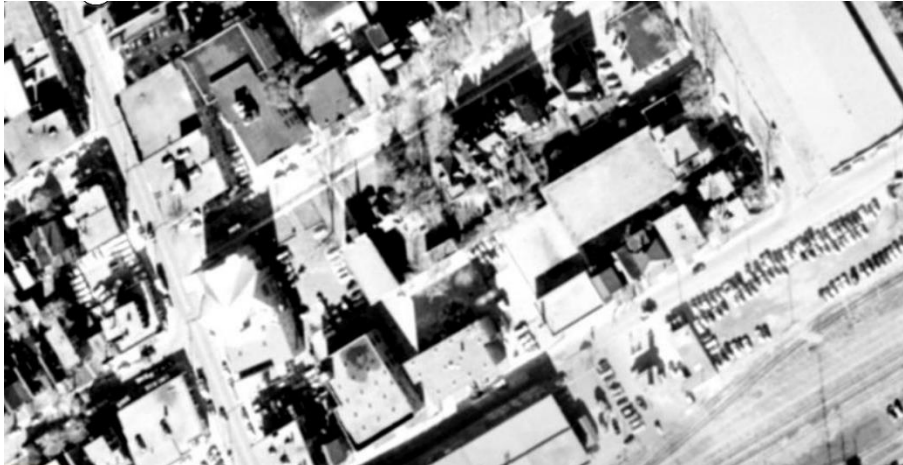
Figure 12: Aerial view 1965 documents the build out along Catherine Avenue with larger flat roofed industrial buildings. Along Argyle, the south side of the street continues to retain its residential character. Source: GeoOttawa

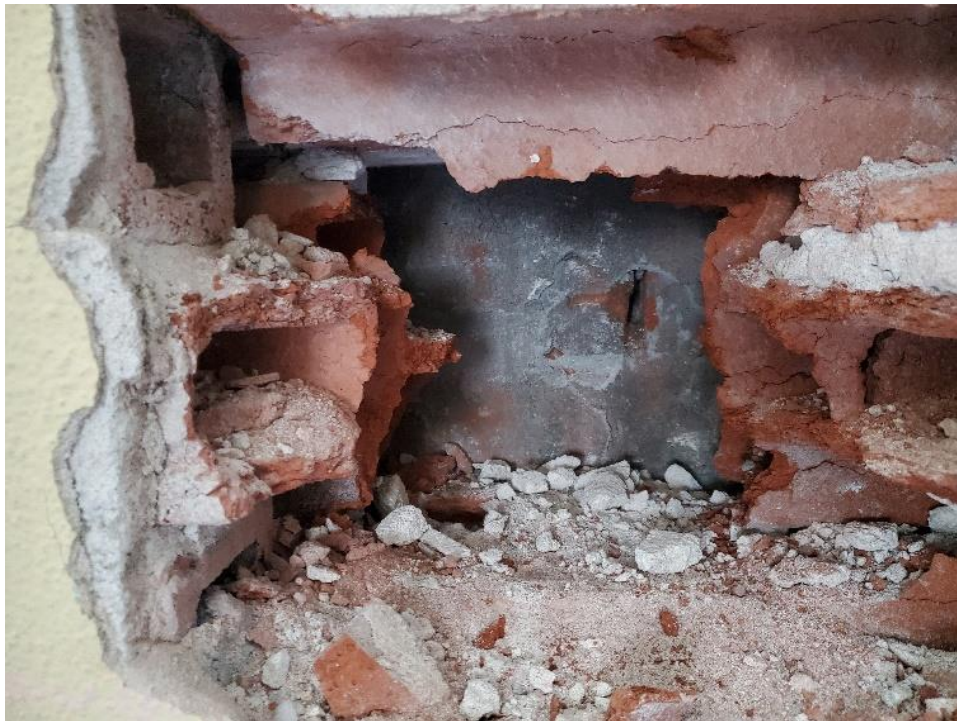
Figure 16: Opening in the Ground Level Wall showing double wythe of hollow terra-cotta with a rough coat and finish coat of plaster on the interior.

Exploratory openings were made on the interior and exterior east side wall (see Figure 14) and the following materials were found:

The clay brick is a rust-brown highly textured brick marketed as tapestry brick.

The brick veneer is a single wythe non-structural, decorative layer applied to the exterior of a building and anchored to the structural terra-cotta wall.

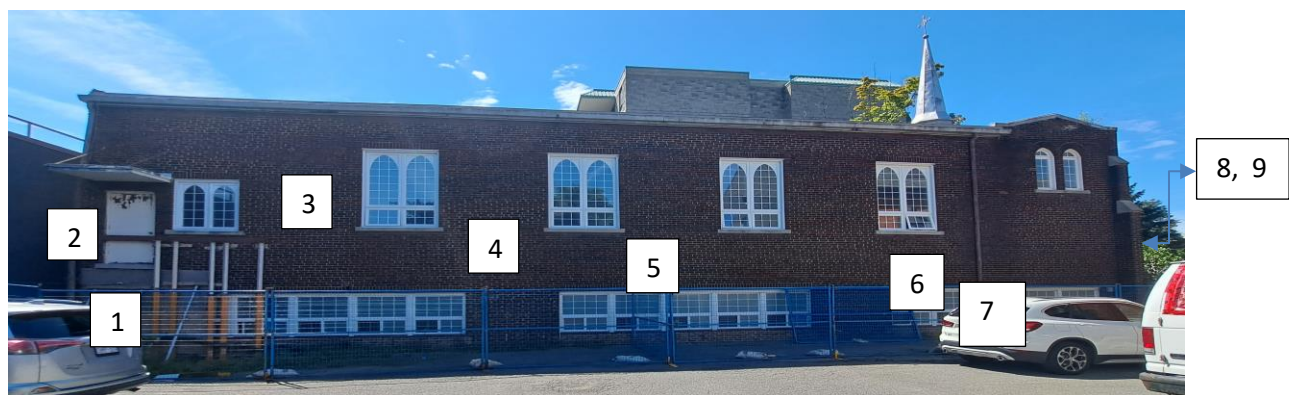
Figure 16: A key view of the east façade provides a reference point for the closeup views of the various issues. The reference numbers refer to the detailed close-up views.

The walls, particularly the east wall, are exhibiting significant deterioration and loss of bonding between the brick veneer and the terra-cotta structural backup. The following list taken from the Remisz report outlines deficiencies:

- The wall leans outwardly by 1cm for every meter.
- Downspouts are undersized with water running down the face and emptying too close to the building, concentrating water against the foundation.

- Dark staining of brick around downspouts and below windowsills and loss of mortar indicates water entry.
- Step cracks ranging from 3mm to 5mm, especially around the windows and at the southeast corner. The cracks indicate settlement of the building and separation of bond.

- The entire upper 2' of the east façade at the roofline has been repointed. Along the base under the bank of windows, the brick has been replaced, documenting a history of water infiltration and damage. The replacement brick does not match the original tapestry brick (see figure 16-7)

- Step cracks in the brick cladding extend from second floor windows and at the top corners of the two large basement windows. The Windowsills are cracked with several wide cracks at the southeast corner, documenting subsidence or movement to the wall.

- There is substantial settlement in the southeast corner, which is the closest area to the excavation works performed at 203 Catherine Street back in 2015. The total movement at the southeast corner was 72mm when observed by Keller Engineering on February 24, 2017.

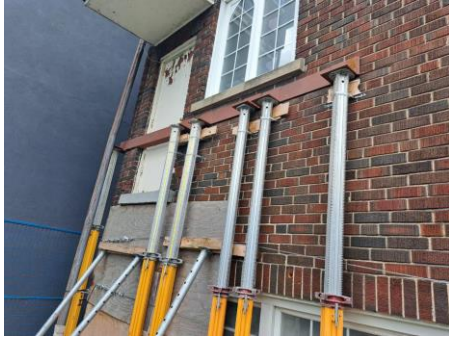
1. Substantial settlement at the corner requiring temporary bracing to prevent collapse of back wall and portion of the east façade.

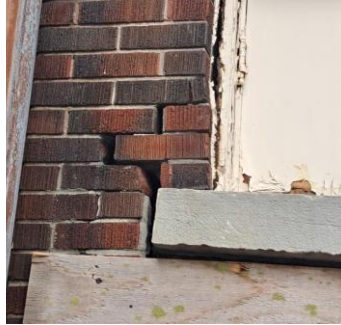
2. Back corner the wall has kicked out and separated requiring extensive temporary bracing.

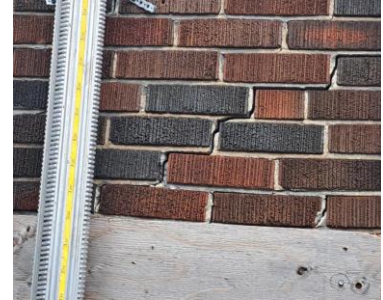
3. Stepped crack south end of east façade with vertical support lag bolted thro the wall.

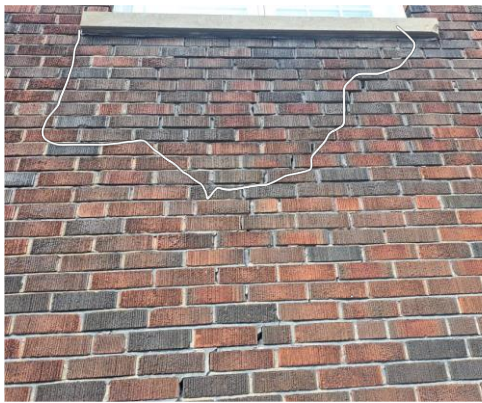
4. Staining of the brick under windows indicates long term water running down the face with cracking from the upper to the lower window.

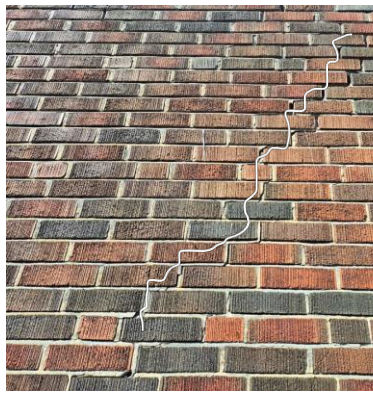
5. Stepped cracks and lost mortar along east façade.

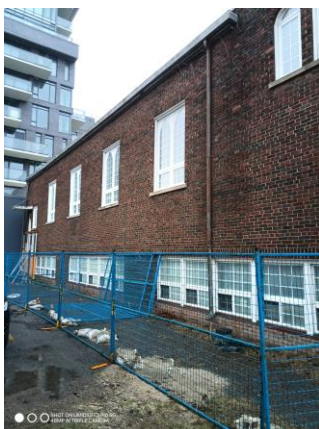
7. The brick along the base of the church has been replaced using a different brick.

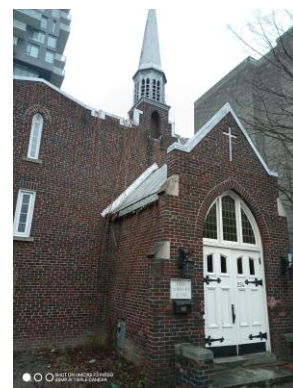
9. Front façade with staining along the base and in the corner.

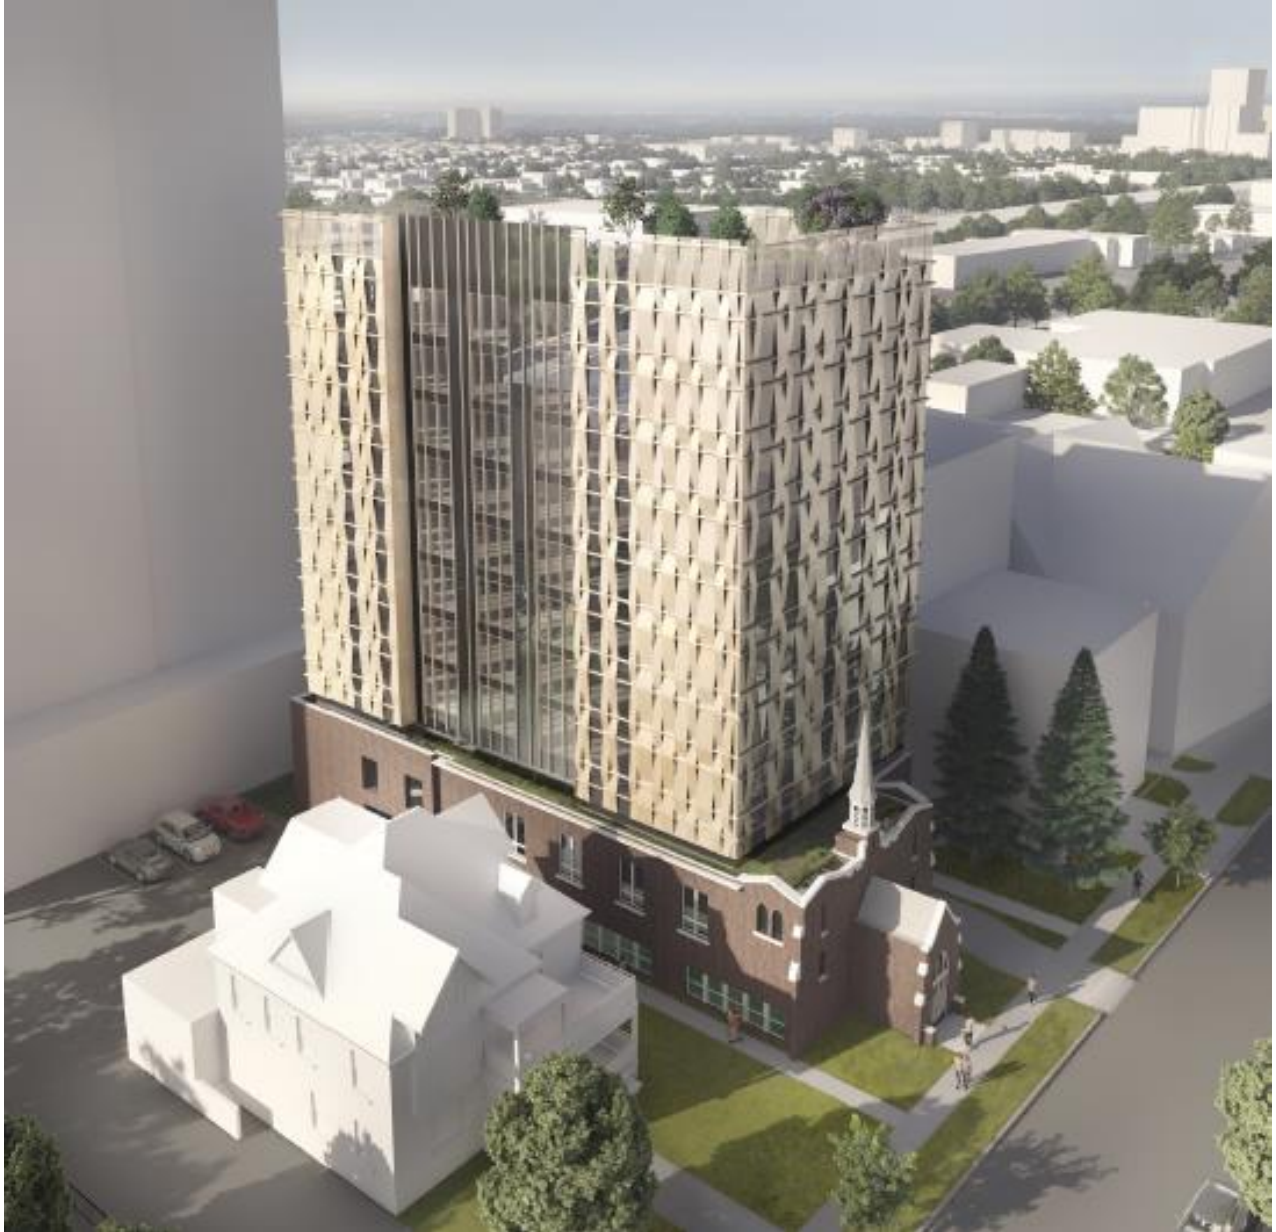
Figure 18: Bird's eye looking southwest, showing the scale and relationship of the proposed development. Source CSV Architects /Spice Design 2024.

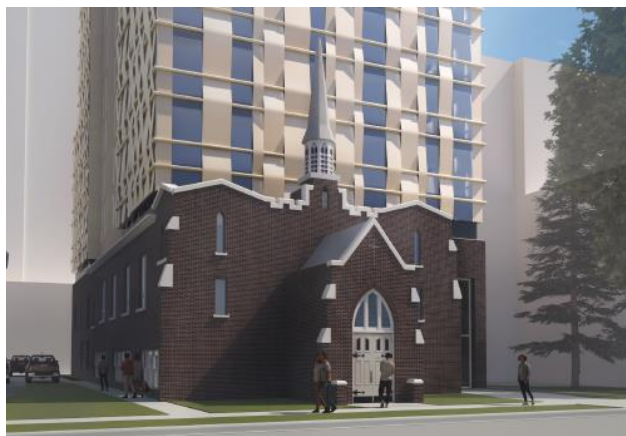
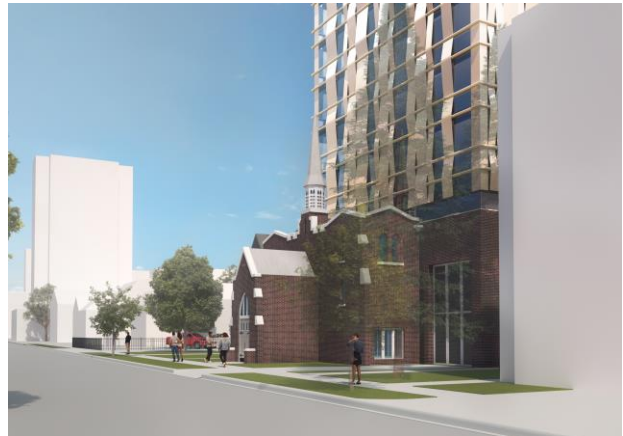
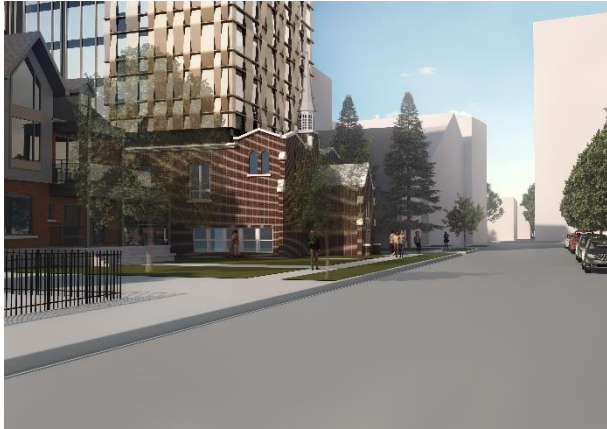
Figures 19, 20 & 21: Three views from Argyle Avenue looking west and east allow the church to stand proud with positioning similar to the United Church on the corner. This repositioning has given the church a far more defining role on the street. Source: Spice Design 2024.

Access to basement parking is via a driveway into an enclosed ramp descending along the west side of the Church, thus the full eastern side of the rebuilt Church wall will be visible.

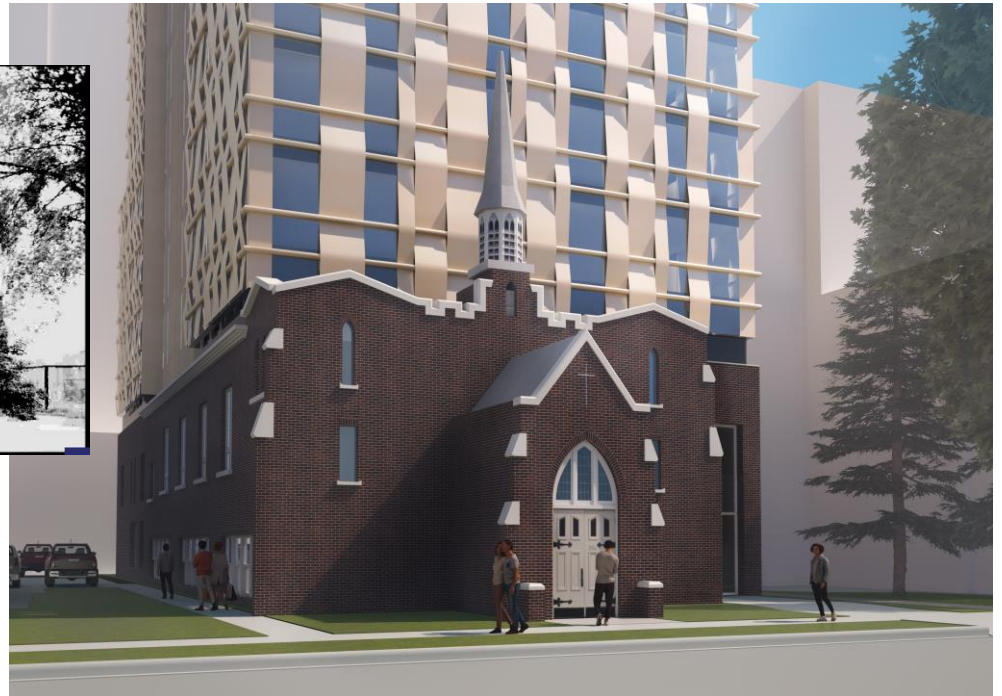
Figure 23: Proposed plan for the ground floor illustrated the reuse of the front of the church as a café/bar, ground floor amenity area, vertical circulation, and ground floor units along the south. The new podium/base (shown in red) reinstates the original material and height of the church is re-clad in salvaged with the salvaged red brick acknowledging the original treatment of the church. Source: Spice Studio/ CSV Architects Design Brief, August 2024.

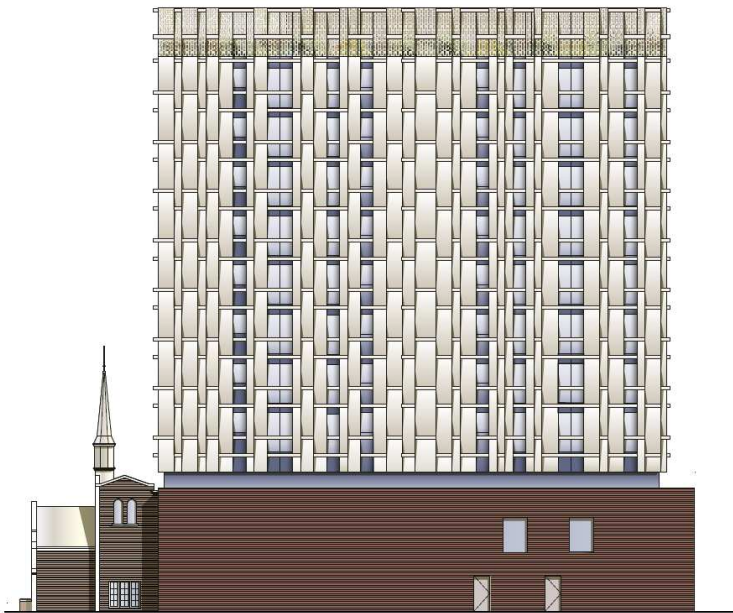
WEST ELEVATION

*Figures 25, 26, 27 and 28: **East, South, East, and North elevations** The Former Church serves as a podium that sits proud of the new development setback behind the steeple. The 9 -storey tower setback from the street is positioned to allow the reconstructed church façade to be interpreted on the front and east elevations stand proud. Source: Spice Design 2024.*

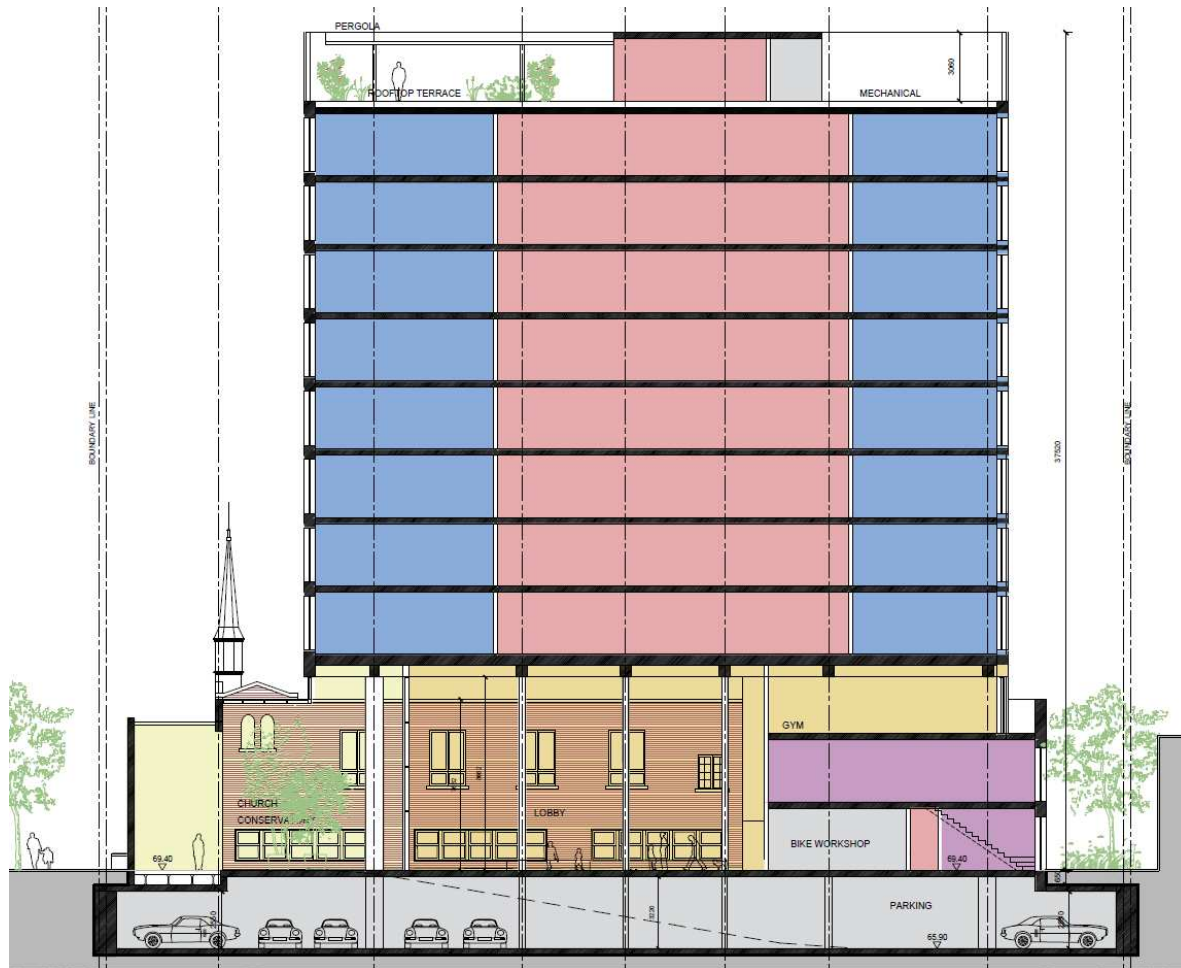
Figure 29: Longitudinal Section with Argyle Avenue to the north. Source: CSV Architecture/ Spice Design 2024.

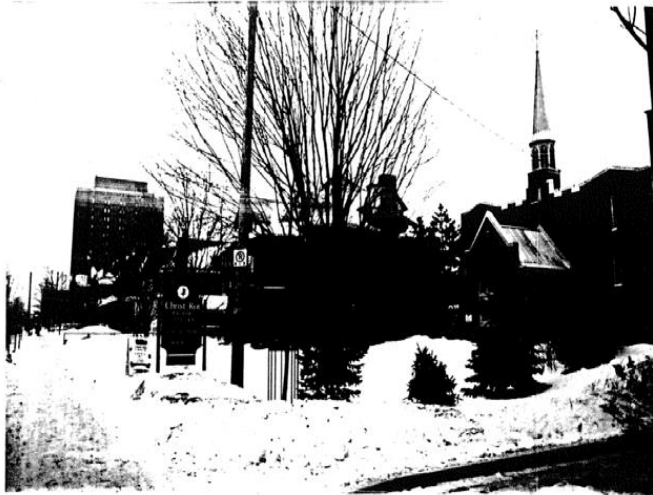
PHOTO DATE: Winter 1996
 VIEW: SE
 SOURCE: AY.
 NEGATIVE NUMBER: A-25

Compatibility With Heritage Environs: very compatible with heritage mixed use environment
