# Phase II Environmental Site Assessment

535 Legget Drive Ottawa, Ontario

Prepared for KRP Properties Inc.

**Report: PE6661-2 October 2, 2024**

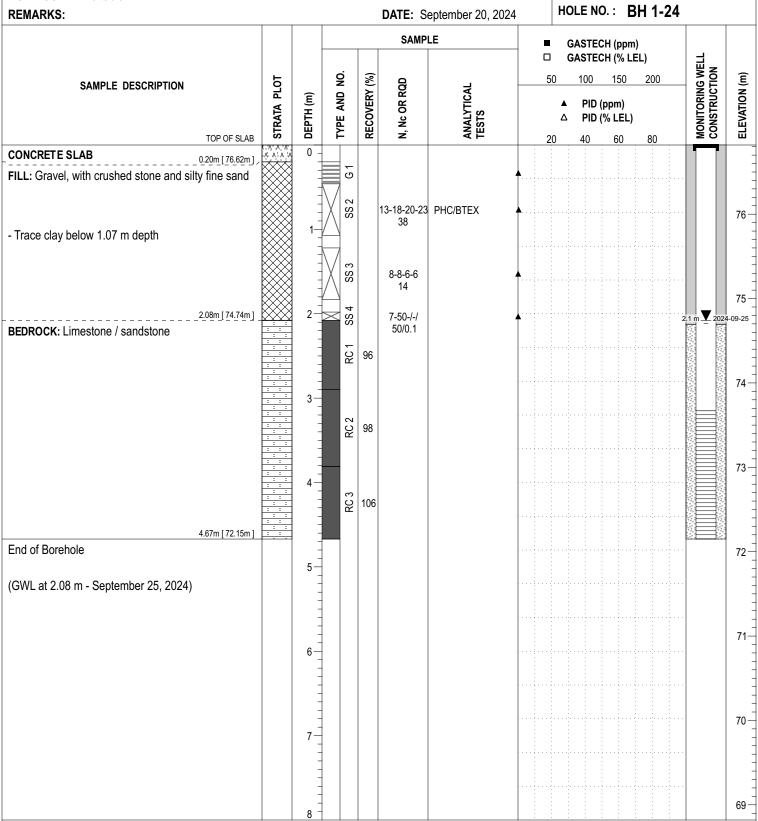
PROJECT: Phase II Environmental Site Assessment FILE NO.: PE6661

**BORINGS BY: Portable Drill**
