BGO Bank & Walkley
Ottawa, ON

Title
TREE CONSERVATION REPORT

TCR 01

TCR 02

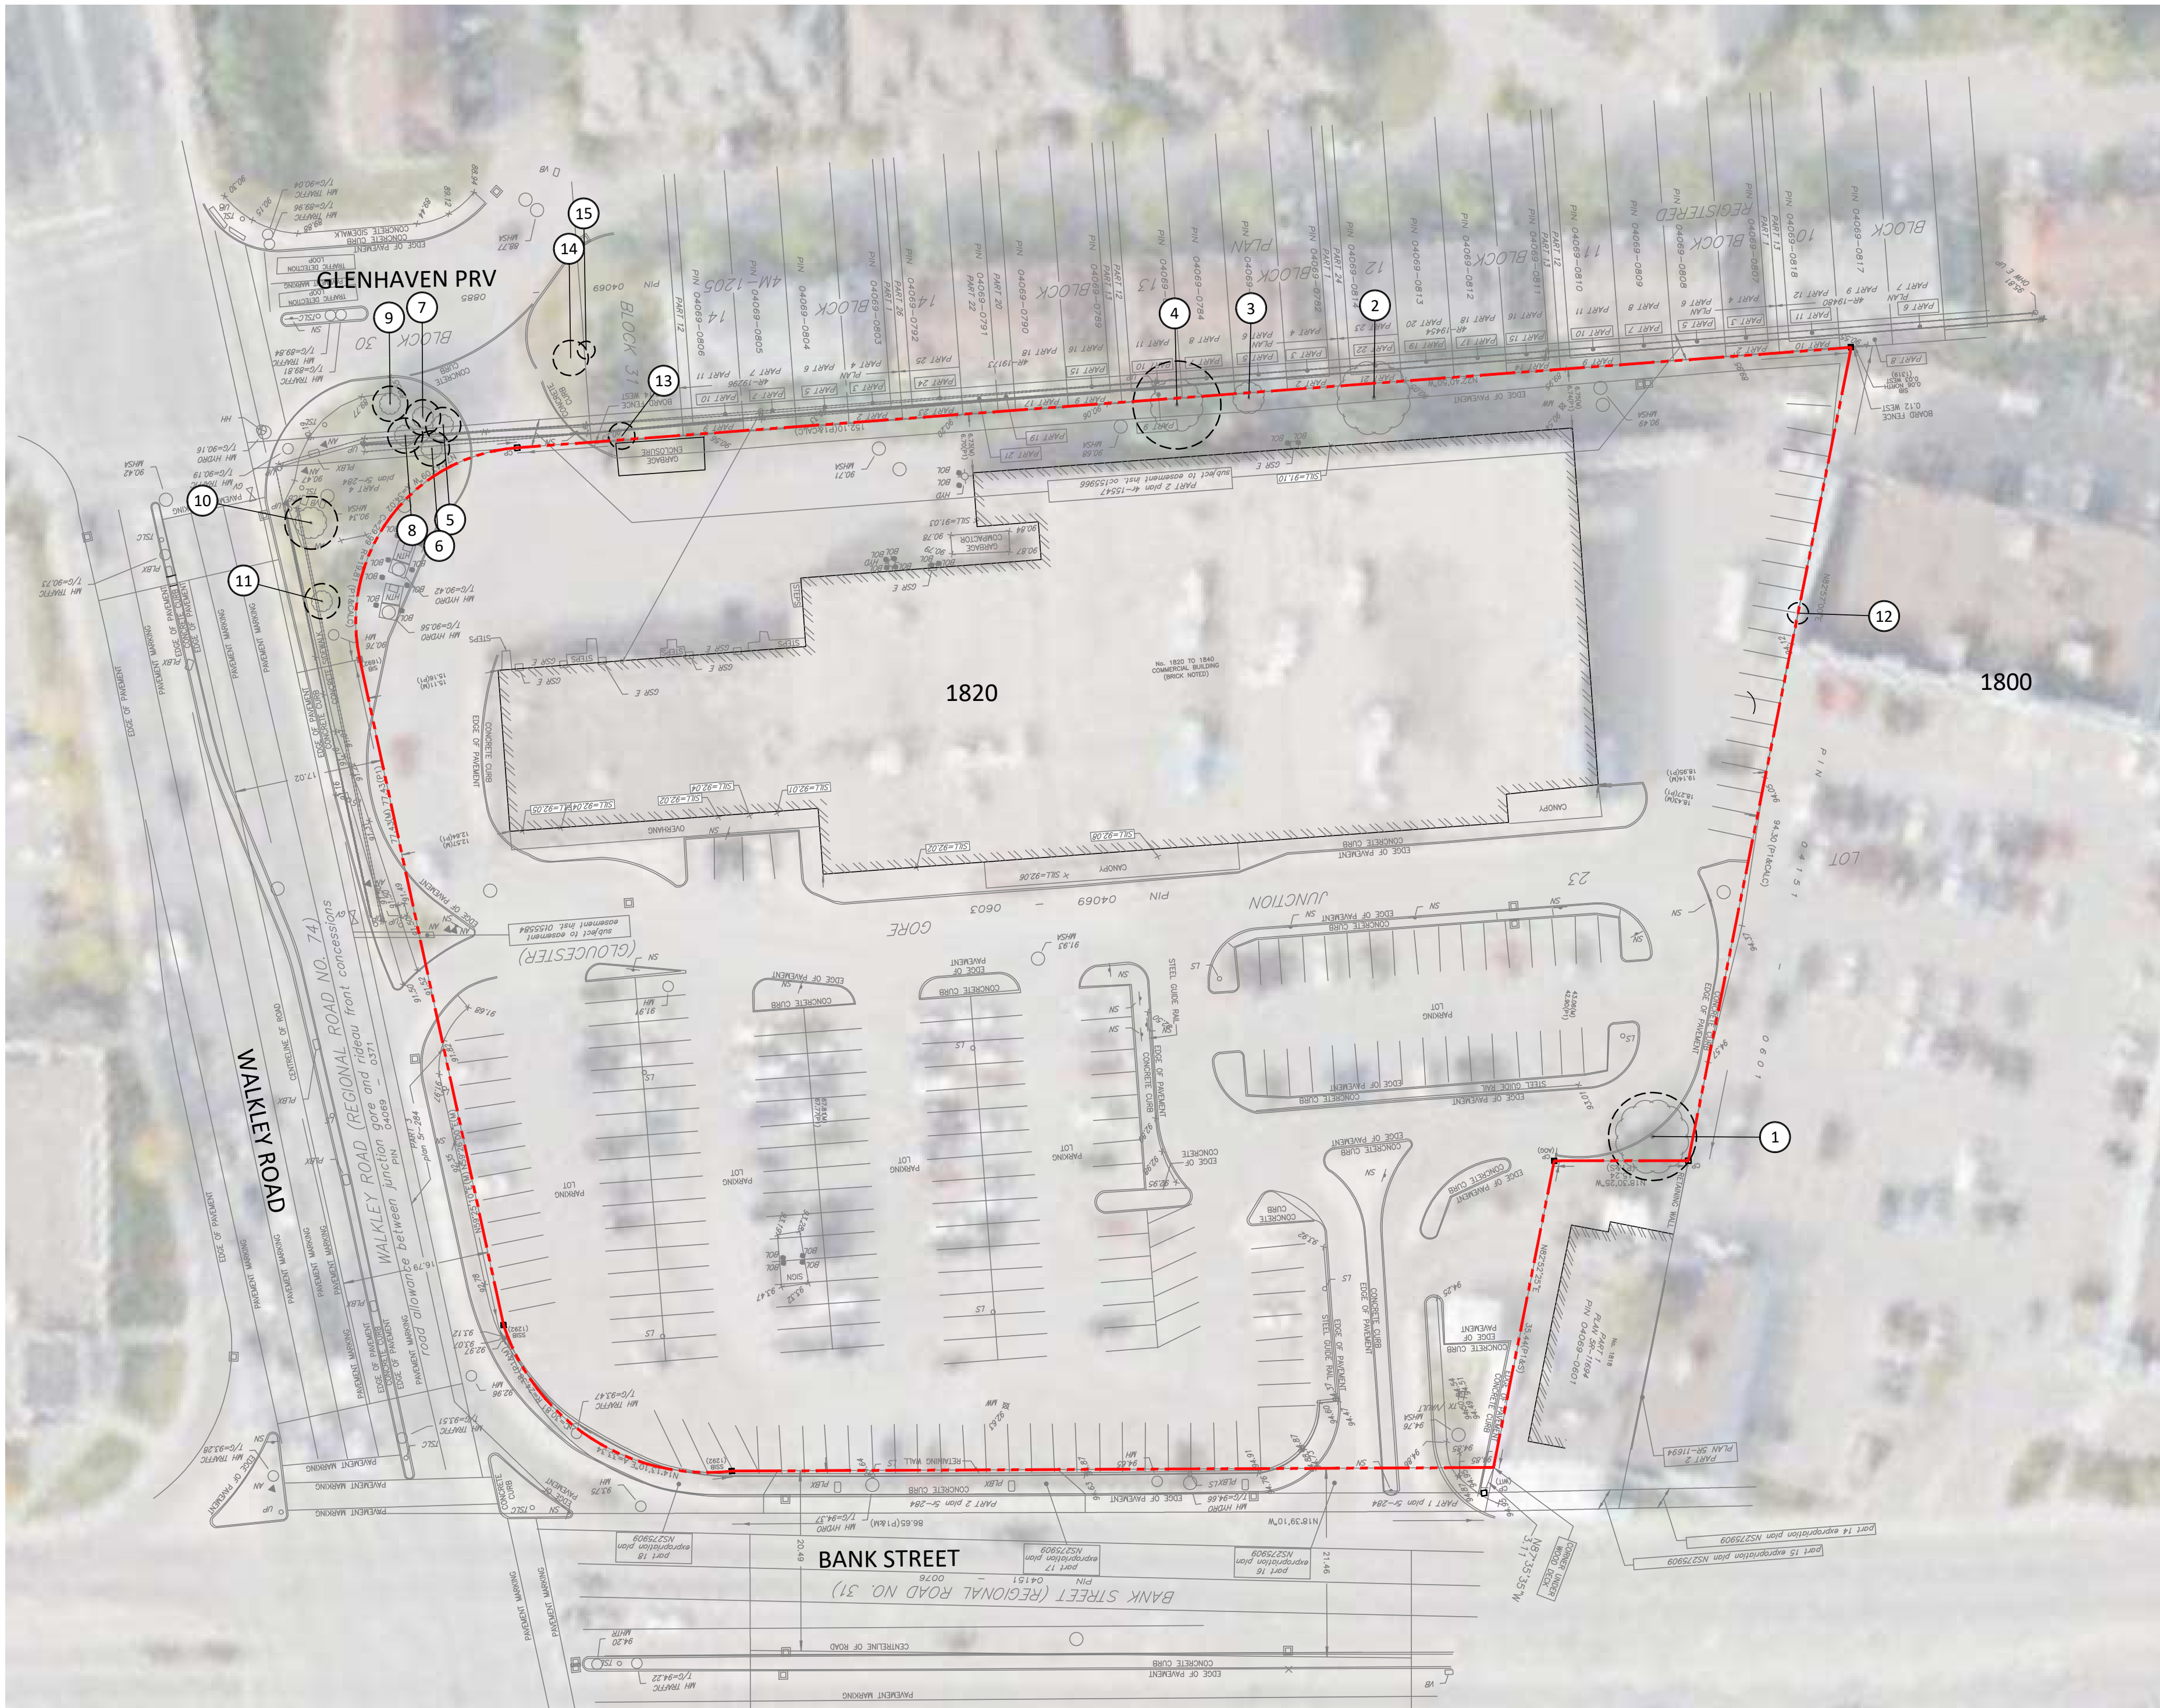
1 EXISTING CONDITIONS

Tree #	Botanical Name	Common Name	DBH (cm)	Ownership		Condition	NOTES	To Be Preserved	Reason for Removal
1	Acer platanoides	Norway Maple	50	Private	1822 Bank St	Moderate	Asymmetrical canopy, Dieback ~15% @ canopy, Broken limbs, Single stem, Bark rot @ limbs, Girdled roots	NO	Tree location in conflict with proposed site construction
2						Missing	Tree Removed	N/A	
3						Missing	Tree Removed	N/A	
4	Ulmus spp.	Elm	50	Private	1822 Bank St	Moderate	Asymmetrical canopy, Dieback ~10% @ limbs, Pruned @ O.H., Poor branch union, Multi-stem w/ 3	NO	Heavily pruned tree and conflict with site construction activities
5	Acer platanoides	Norway Maple	20	Private	ROW Glenhaven Prv	Moderate	Asymmetrical canopy, Dieback ~30% @ Canopy, Pruned limbs, Single stem, Bark rot @ cavities	YES	
6	Acer platanoides	Norway Maple	20	Private	ROW Glenhaven Prv	Moderate	Asymmetrical canopy, Broken limbs, Single stem, Pruned branches, Heart rot @ limbs, Girdled trunk from staking	YES

7	Acer platanoides	Norway Maple	20	Private	ROW Glenhaven Prv	Moderate	Asymmetrical canopy, Dieback ~10% @ canopy, Single stem, Included bark, Girdled roots	YES	
8	Acer platanoides	Norway Maple	20	Private	ROW Glenhaven Prv	Good	Asymmetrical canopy, Pruned branches @ O.H., Single stem	YES	
9	Acer platanoides	Norway Maple	20	Private	ROW Glenhaven Prv	Good	Asymmetrical canopy, Dieback ~10% @ canopy, Single stem, Girdled roots	YES	
10	Acer platanoides	Norway Maple	30	City		Moderate	Symmetrical canopy, Dieback ~15% @ canopy, Single stem, Girdled roots	NO	Tree location in conflict with proposed ROW construction
11	Acer platanoides	Norway Maple	20	City		Good	Symmetrical canopy, Single stem	NO	Tree location in conflict with proposed ROW construction
12	Ulmus spp.	Elm	12	Boundary	1822 Bank St/1800 Bank St	Moderate	Asymmetrical canopy, Broken limbs, Single stem, (2) Leaders @ 2m above grade, Included bark, Grown into C.L. fence	NO	Tree location in conflict with proposed site construction

13	Celtis occidentalis	Hackberry	15	Private	ROW Glenhaven Prv	Moderate	Symmetrical canopy, Single stem, Grown btwn 2 privacy fences	NO	Tree location in conflict with proposed site construction
14	Acer platanoides 'Crimson King'	Norway Maple	20	Private	ROW Glenhaven Prv	Moderate	Symmetrical canopy, Single stem, (3) Leaders @ 2m above grade, Large crack on trunk	NO	Tree location in conflict with proposed site construction
15	Picea pungens var. 'Glauca'	Colorado Blue Spruce	10	Private	ROW Glenhaven Prv	Poor	Asymmetrical canopy, Dieback ~80% @ canopy, Single stem	NO	Tree location in conflict with proposed site construction

- NOTES:
- THE EXISTING SITE CONSISTS OF SINGLE STOREY BRICK COMMERCIAL BUILDING WITH AN ASPHALT PARKING LOT.
 - THERE ARE A TOTAL OF FIFTEEN TREES INCLUDED IN THE TREE CONSERVATION REPORT, IN VARYING CONDITIONS.
 - THE DEVELOPMENT SITE IS NOT CONSIDERED OF PRIMARY, SUPPORTING OR CONTRIBUTING SIGNIFICANCE AS NATURAL LANDS IN THE GREENSPACE MASTER PLAN
 - THERE ARE NO OTHER APPLICATIONS AFFECTING THE LAND UPON WHICH TREES ARE TO BE PROTECTED, INJURED OR DESTROYED.

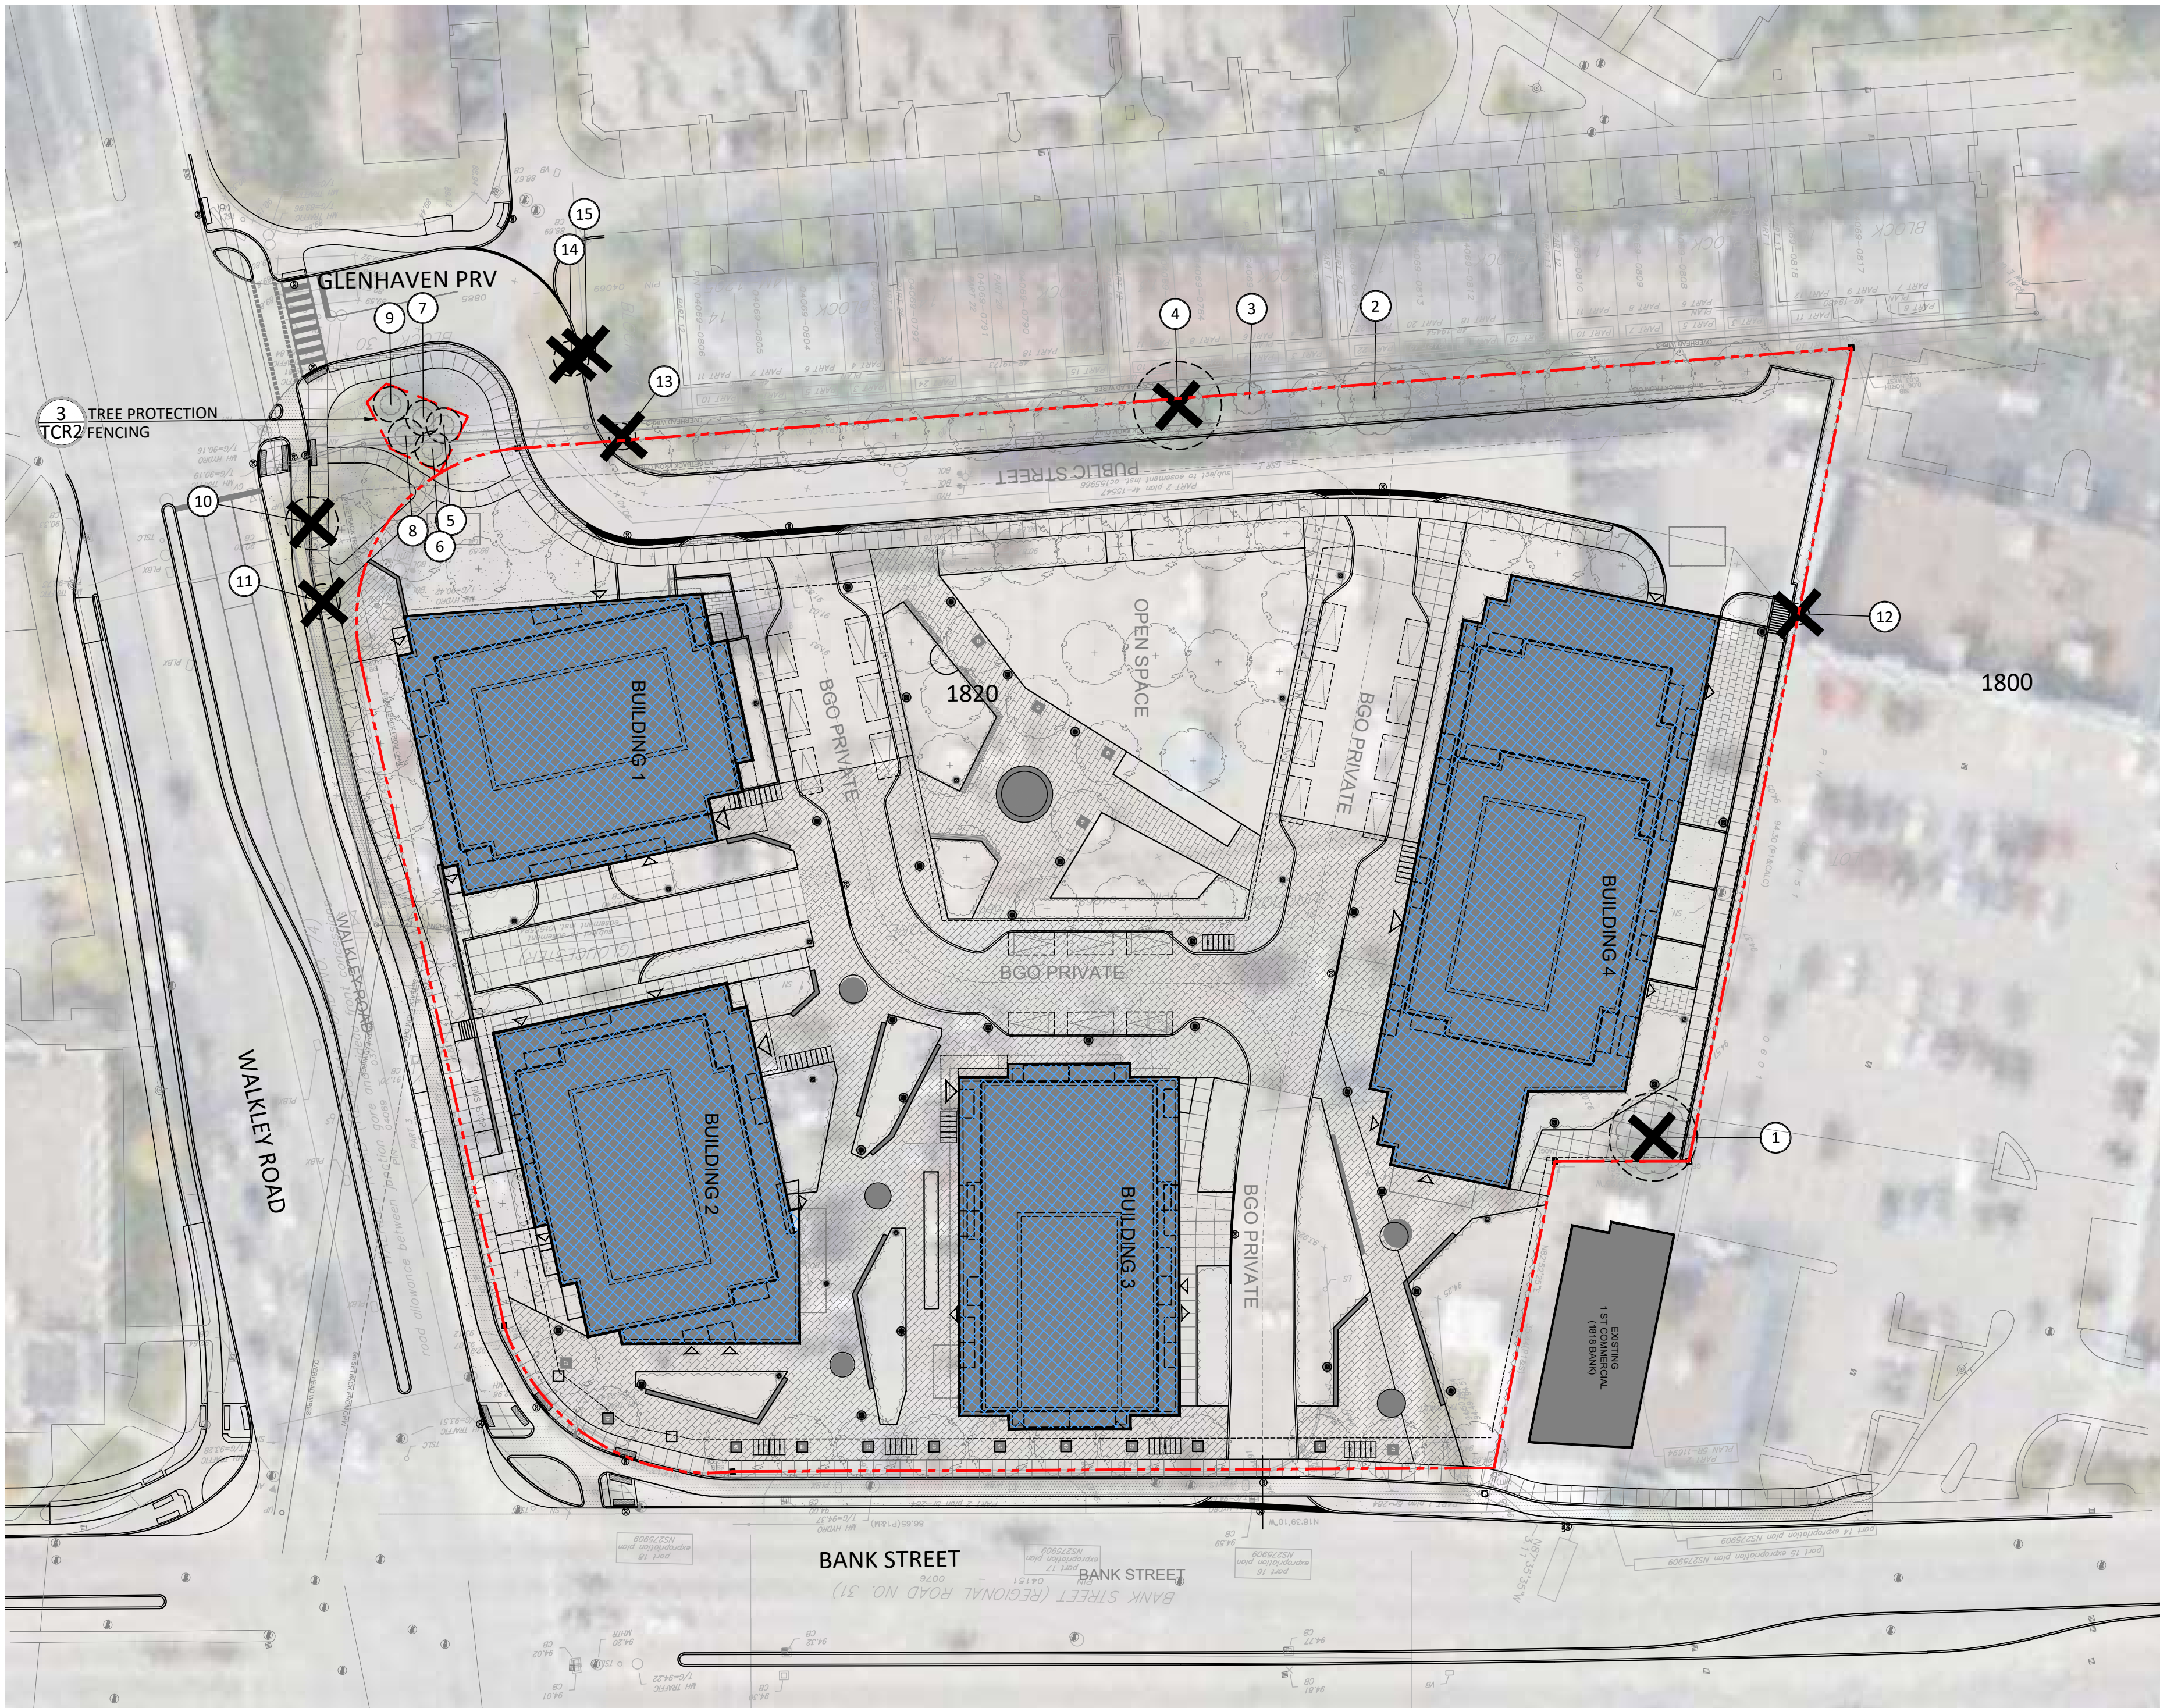
2 PROPOSED DEVELOPMENT

Tree #	Botanical Name	Common Name	DBH (cm)	Ownership		Condition	NOTES	To Be Preserved	Reason for Removal
1	Acer platanoides	Norway Maple	50	Private	1822 Bank St	Moderate	Asymmetrical canopy, Dieback ~15% @ canopy, Broken limbs, Single stem, Bark rot @ limbs, Girdled roots	NO	Tree location in conflict with proposed site construction
2						Missing	Tree Removed	N/A	
3						Missing	Tree Removed	N/A	
4	Ulmus spp.	Elm	50	Private	1822 Bank St	Moderate	Asymmetrical canopy, Dieback ~10% @ limbs, Pruned @ O.H., Poor branch union, Multi-stem w/ 3	NO	Heavily pruned tree and conflict with site construction activities
5	Acer platanoides	Norway Maple	20	Private	ROW Glenhaven Prv	Moderate	Asymmetrical canopy, Dieback ~30% @ Canopy, Pruned limbs, Single stem, Bark rot @ cavities	YES	
6	Acer platanoides	Norway Maple	20	Private	ROW Glenhaven Prv	Moderate	Asymmetrical canopy, Broken limbs, Single stem, Pruned branches, Heart rot @ limbs, Girdled trunk from staking	YES

7	Acer platanoides	Norway Maple	20	Private	ROW Glenhaven Prv	Moderate	Asymmetrical canopy, Dieback ~10% @ canopy, Single stem, Included bark, Girdled roots	YES	
8	Acer platanoides	Norway Maple	20	Private	ROW Glenhaven Prv	Good	Asymmetrical canopy, Pruned branches @ O.H., Single stem	YES	
9	Acer platanoides	Norway Maple	20	Private	ROW Glenhaven Prv	Good	Asymmetrical canopy, Dieback ~10% @ canopy, Single stem, Girdled roots	YES	
10	Acer platanoides	Norway Maple	30	City		Moderate	Symmetrical canopy, Dieback ~15% @ canopy, Single stem, Girdled roots	NO	Tree location in conflict with proposed ROW construction
11	Acer platanoides	Norway Maple	20	City		Good	Symmetrical canopy, Single stem	NO	Tree location in conflict with proposed ROW construction
12	Ulmus spp.	Elm	12	Boundary	1822 Bank St/1800 Bank St	Moderate	Asymmetrical canopy, Broken limbs, Single stem, (2) Leaders @ 2m above grade, Included bark, Grown into C.L. fence	NO	Tree location in conflict with proposed site construction

13	Celtis occidentalis	Hackberry	15	Private	ROW Glenhaven Prv	Moderate	Symmetrical canopy, Single stem, Grown btwn 2 privacy fences	NO	Tree location in conflict with proposed site construction
14	Acer platanoides 'Crimson King'	Norway Maple	20	Private	ROW Glenhaven Prv	Moderate	Symmetrical canopy, Single stem, (3) Leaders @ 2m above grade, Large crack on trunk	NO	Tree location in conflict with proposed site construction
15	Picea pungens var. 'Glauca'	Colorado Blue Spruce	10	Private	ROW Glenhaven Prv	Poor	Asymmetrical canopy, Dieback ~80% @ canopy, Single stem	NO	Tree location in conflict with proposed site construction

- TREES IDENTIFIED FOR RETENTION ARE IN MODERATE TO GOOD CONDITION AND CAN BE REASONABLY PROTECTED FROM CONSTRUCTION ACTIVITIES, GIVEN ADEQUATE TREE PROTECTION MEASURES AS DESCRIBED ARE TAKEN.

- THE AREAS WITHIN THE TREE PROTECTION ZONE MUST REMAIN UNDISTURBED AT ALL TIMES. NO WORK OR MATERIAL STORAGE IS PERMITTED WITHIN THE TREE PROTECTION ZONE.

- INSTALLATION OF TREE PROTECTION FENCE SHALL BE LOCATED AT THE CRITICAL ROOT ZONE.
CRITICAL ROOT ZONE : 10cm x DIAMETER AT BREAST HEIGHT (DBH)
EXAMPLE: DBH = 30cm; CRZ = 300cm / 3.0m
