**PATERSON  
GROUP**

May 27, 2024

File: PE5584-LET.04

Subject: **Phase I - Environmental Site Assessment Update  
Part of 3285 and 3305 Borrisokane Drive  
Ottawa, Ontario**

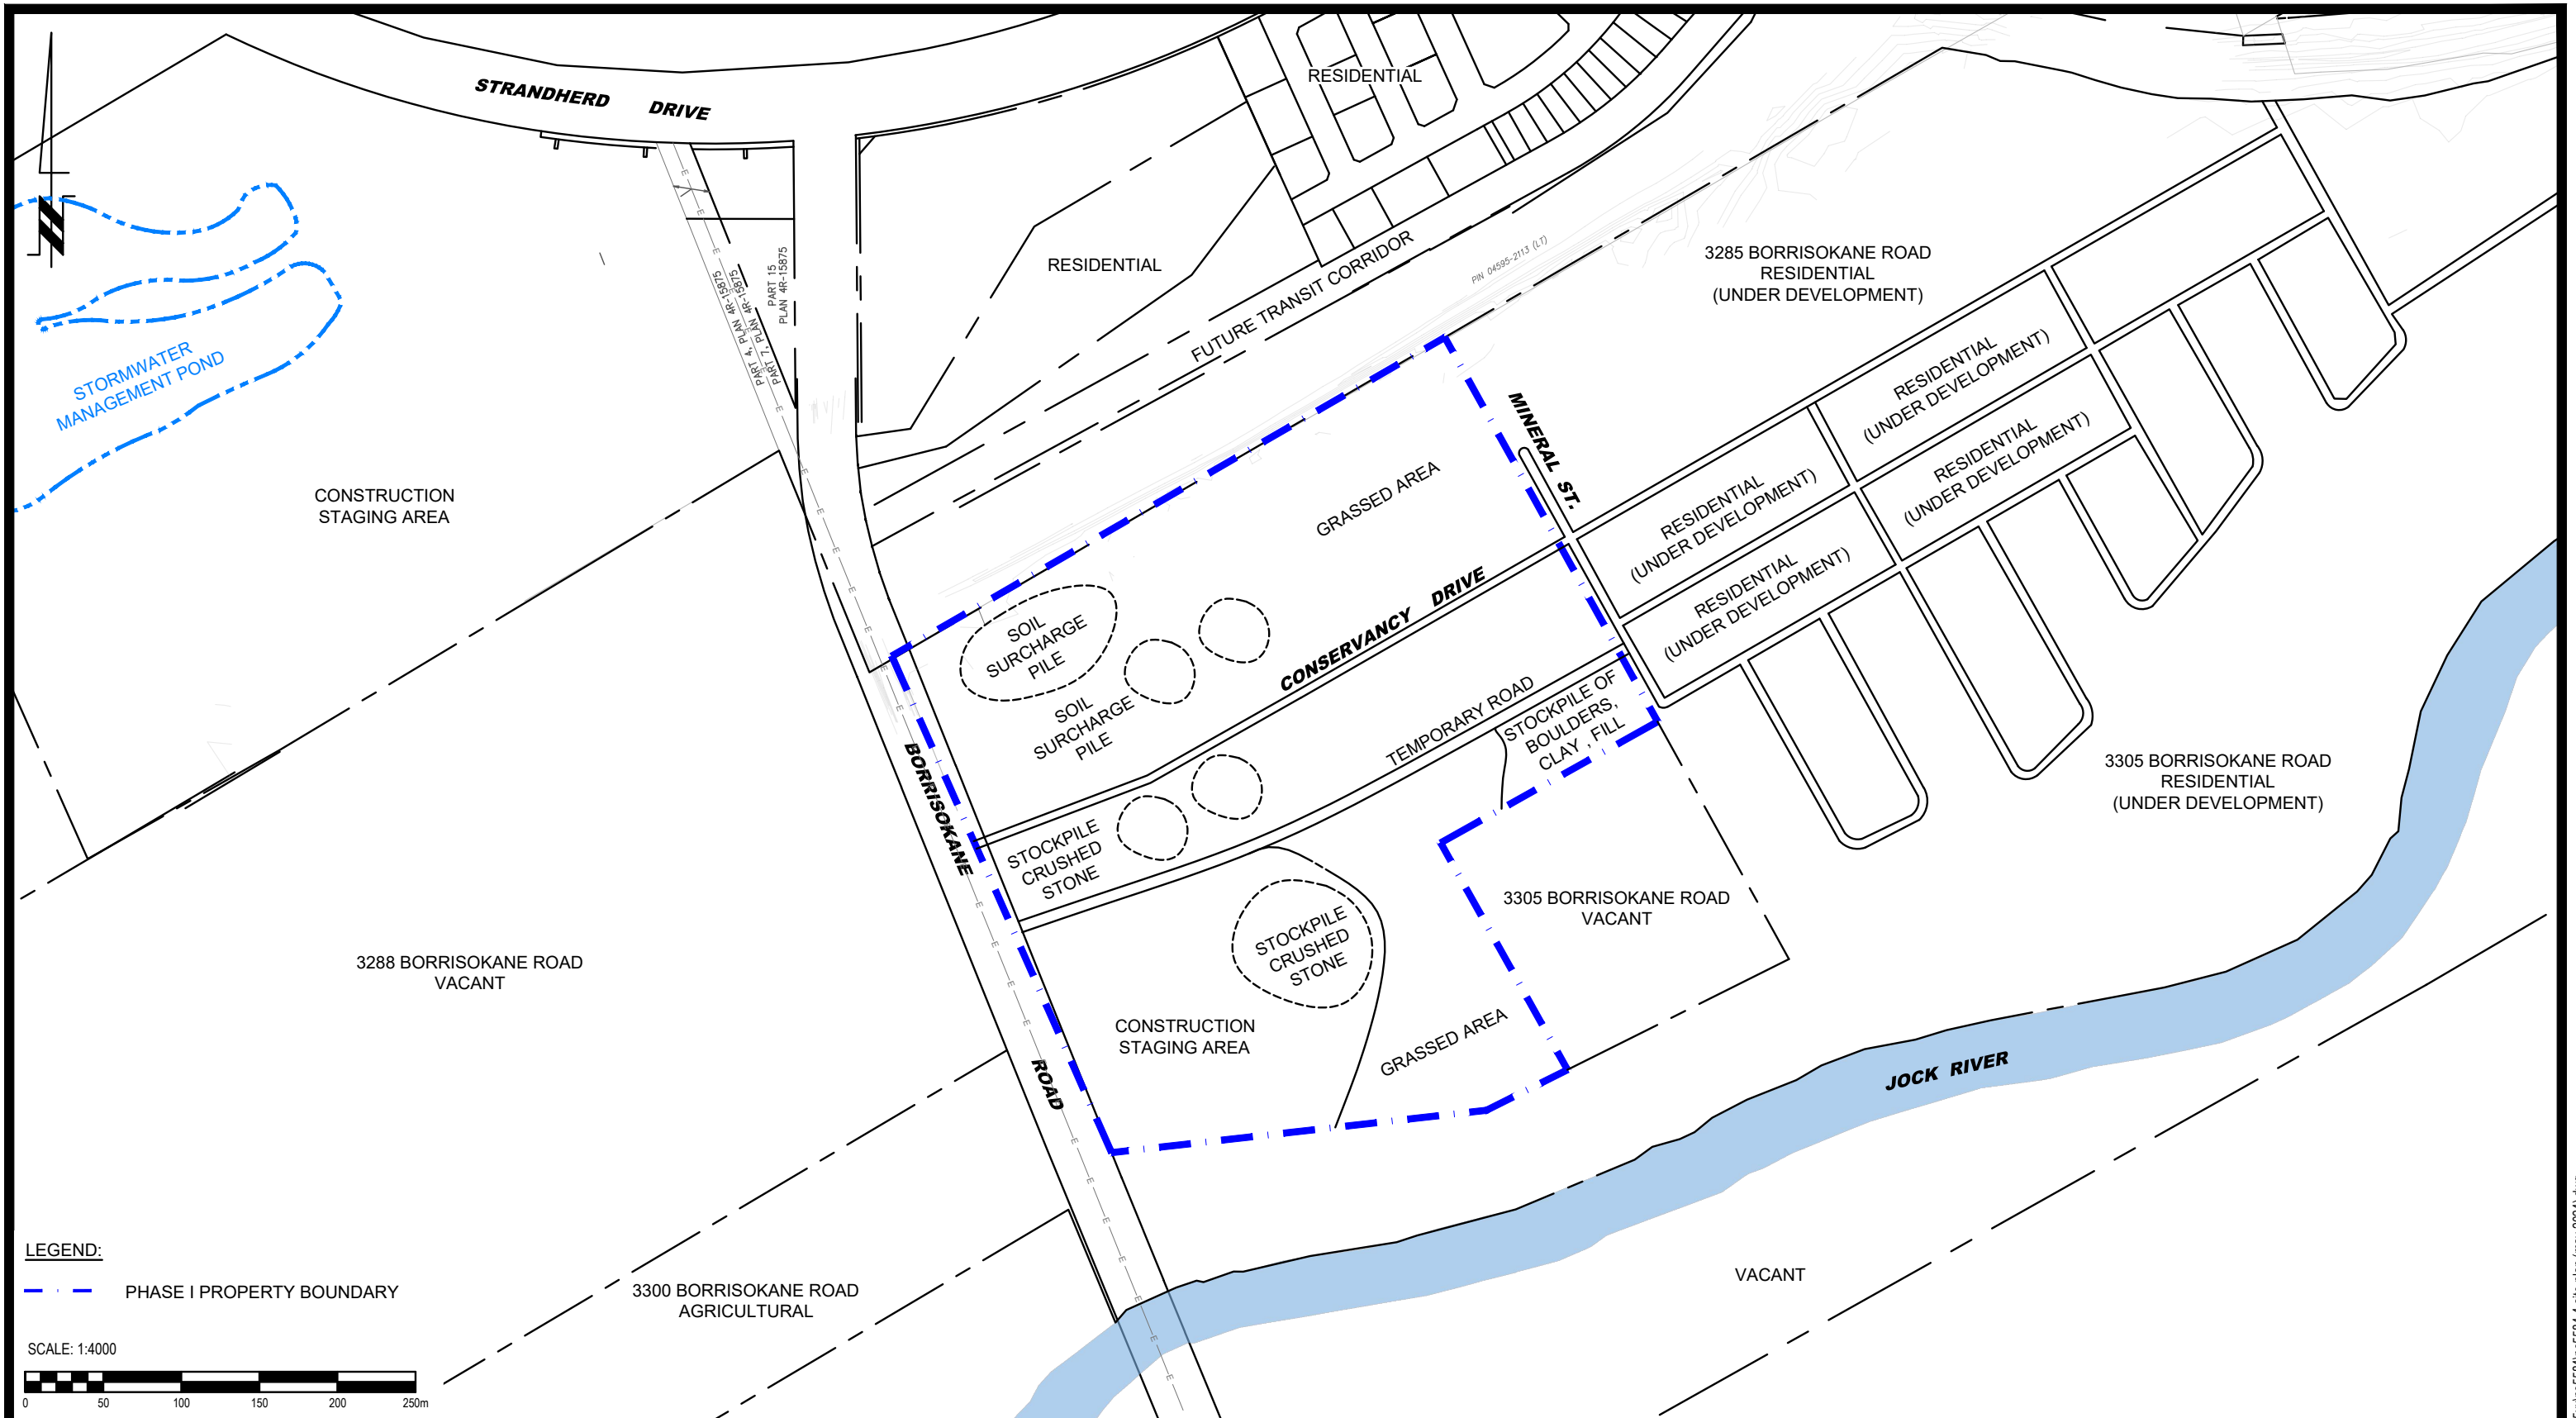
**SITE PLAN**

The Phase I Property is shown on Drawing PE5584-4 – Site Plan.

The Phase I Property is primarily occupied by vacant lightly vegetated land with gravel service roads that run east-west across the central portion and along north and south edge of the property. Three surcharge stockpiles were observed on the northern portion of the Phase I Property. These piles consist of engineered fill and/or reworked native material and are used to assess the loading capabilities of the native soils prior to development.

Two small stockpiles of concrete and asphalt were observed near southeast corner of the Phase I Property. Additionally, several small stockpiles of boulders and clay fill were observed on the eastern portion of the Phase I Property. Small amounts of rebar were observed in the concrete within the stockpiles. Although the stockpiled rebar, concrete and asphalt are not considered to have the potential to impact the Phase I Property, it is recommended they are removed and properly disposed of prior to development.

The southwestern portion of the Phase I Property is currently being used as construction staging area for residential development taking place on the adjacent lands to the east of the Phase I Property. Two shipping containers and two site trailers were observed along with stored construction material such as concrete pipes, watermain pipes, manholes, etc.
