## **Phase Two Environmental Site Assessment**

593, 601 & 603 Laurier Ave W  
Ottawa, Ontario

LRL File No.: 240447

October 18, 2024

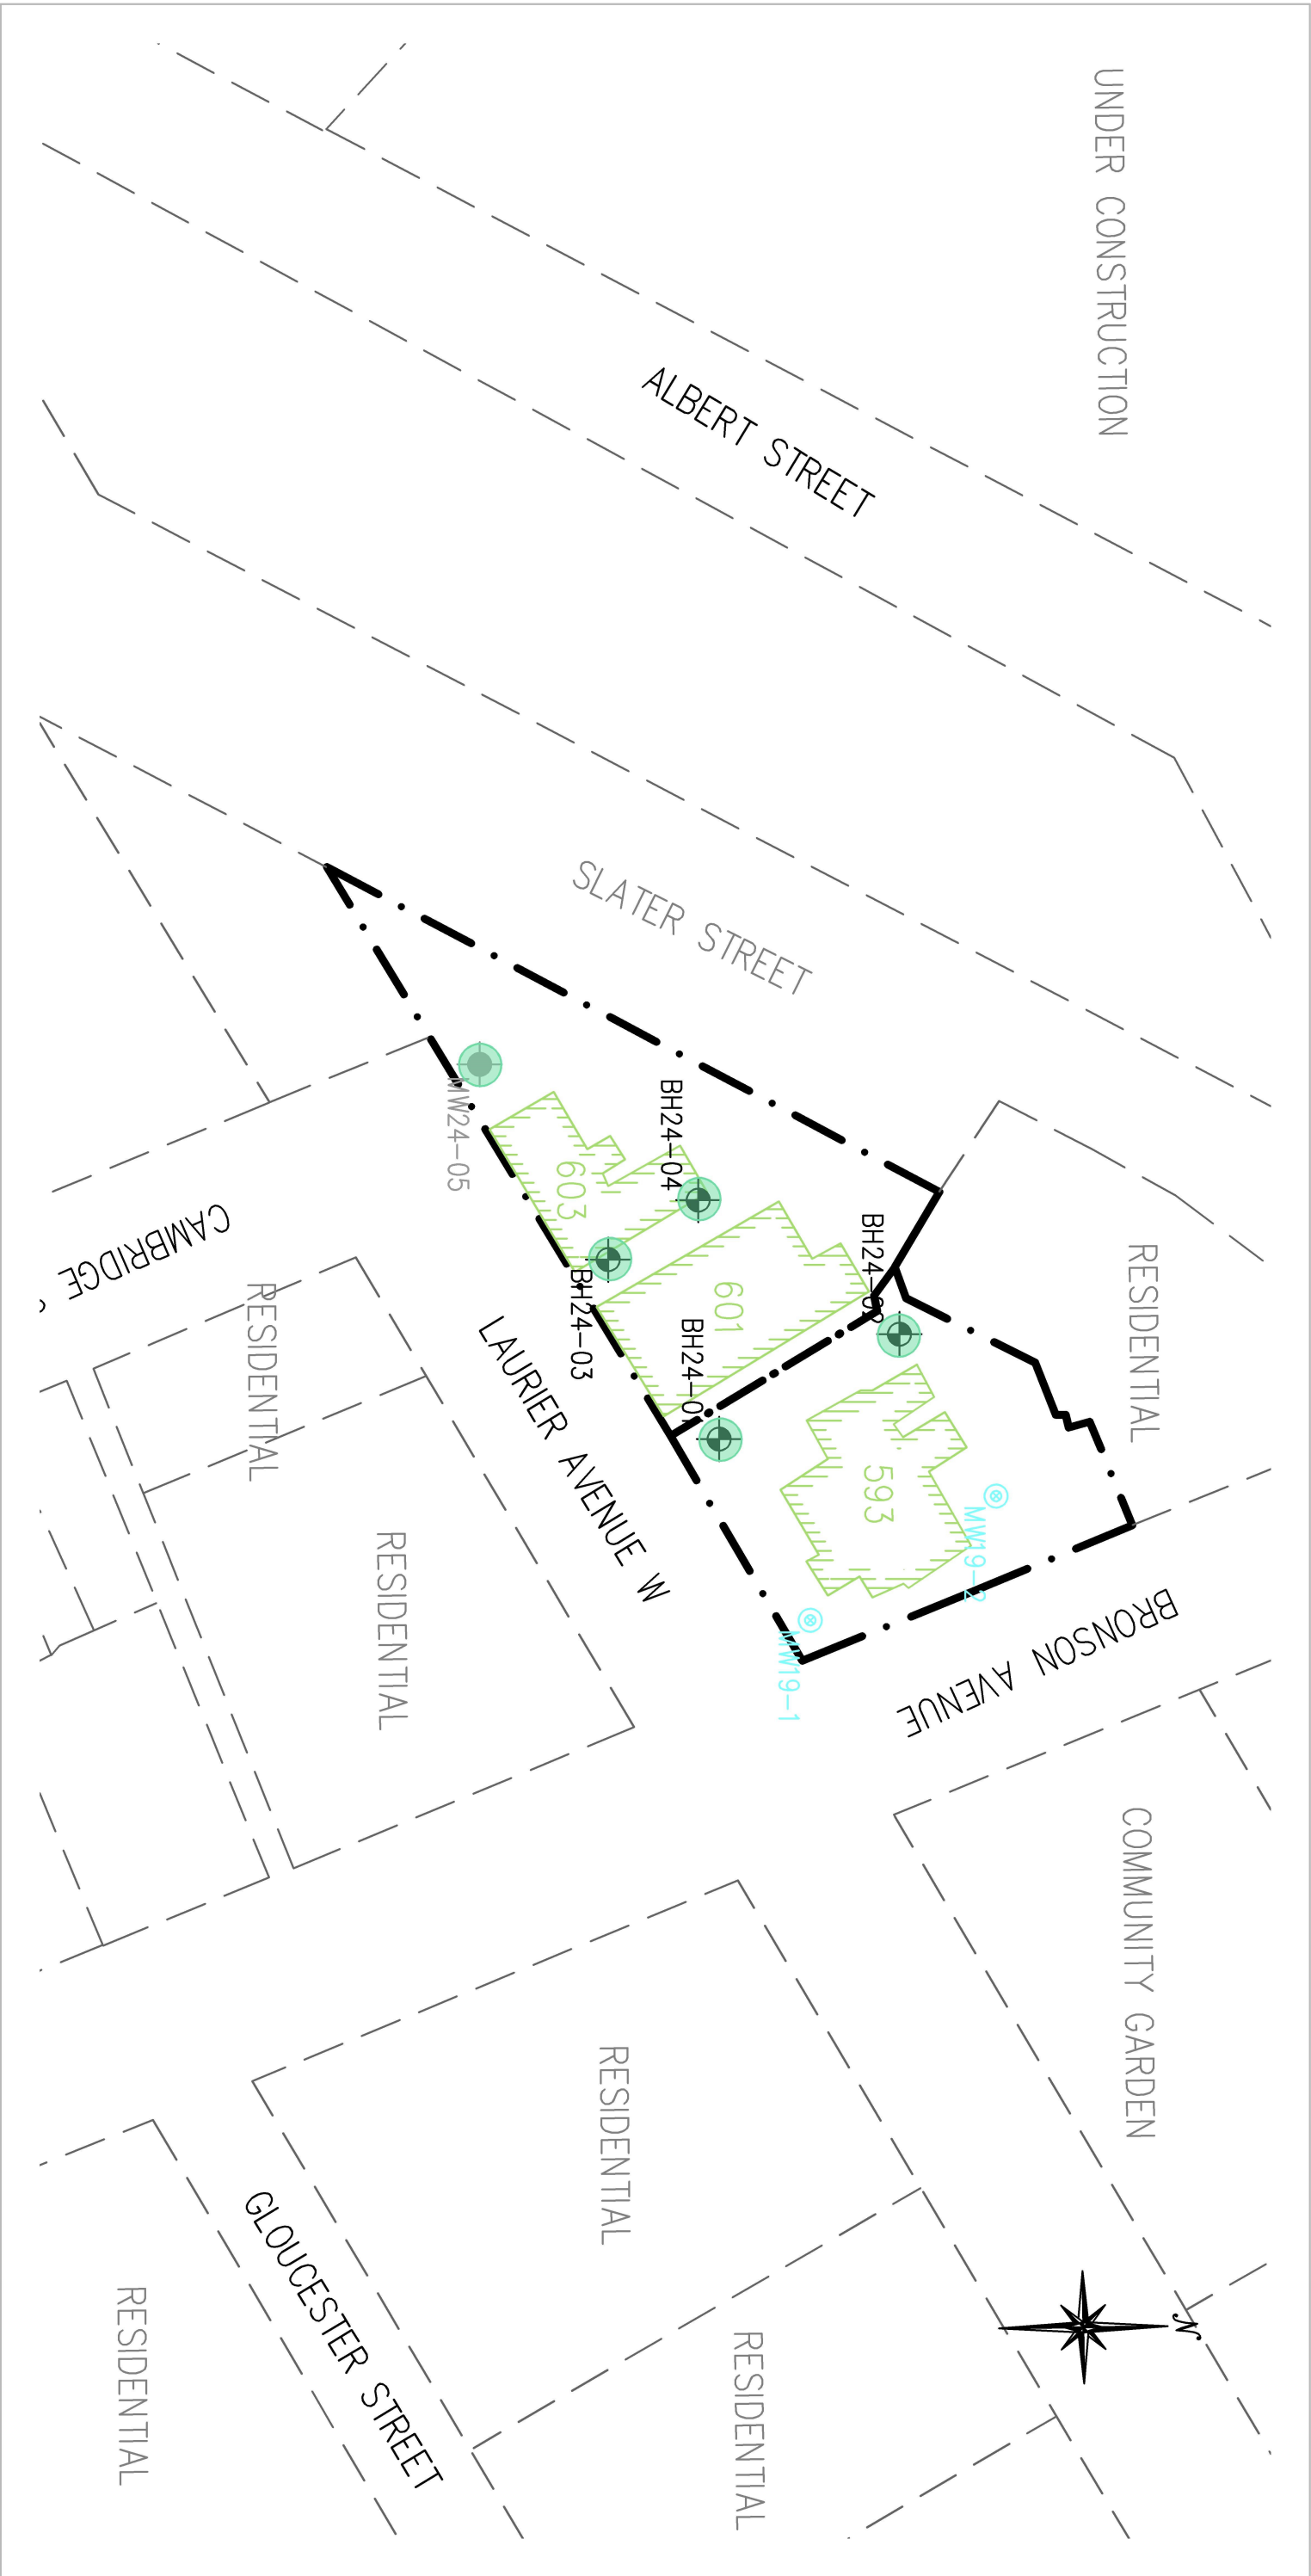
**FIGURE8A**

- Subject Sites
- Neighbouring Property Extents
- Existing Buildings
- Borehole / Monitoring Well - Meets Table 7 SCS
- Borehole / Monitoring Well - Exceeds Table 7 SCS
- Concentration Exceeding Table 7 SCS
- Existing Monitoring Well (2019)
- Newly Advanced Borehole (2024)
- Newly Installed Monitoring Well (2024)
- Approximate Contamination Plume
- Extents of Contamination Plume Not Fully Defined

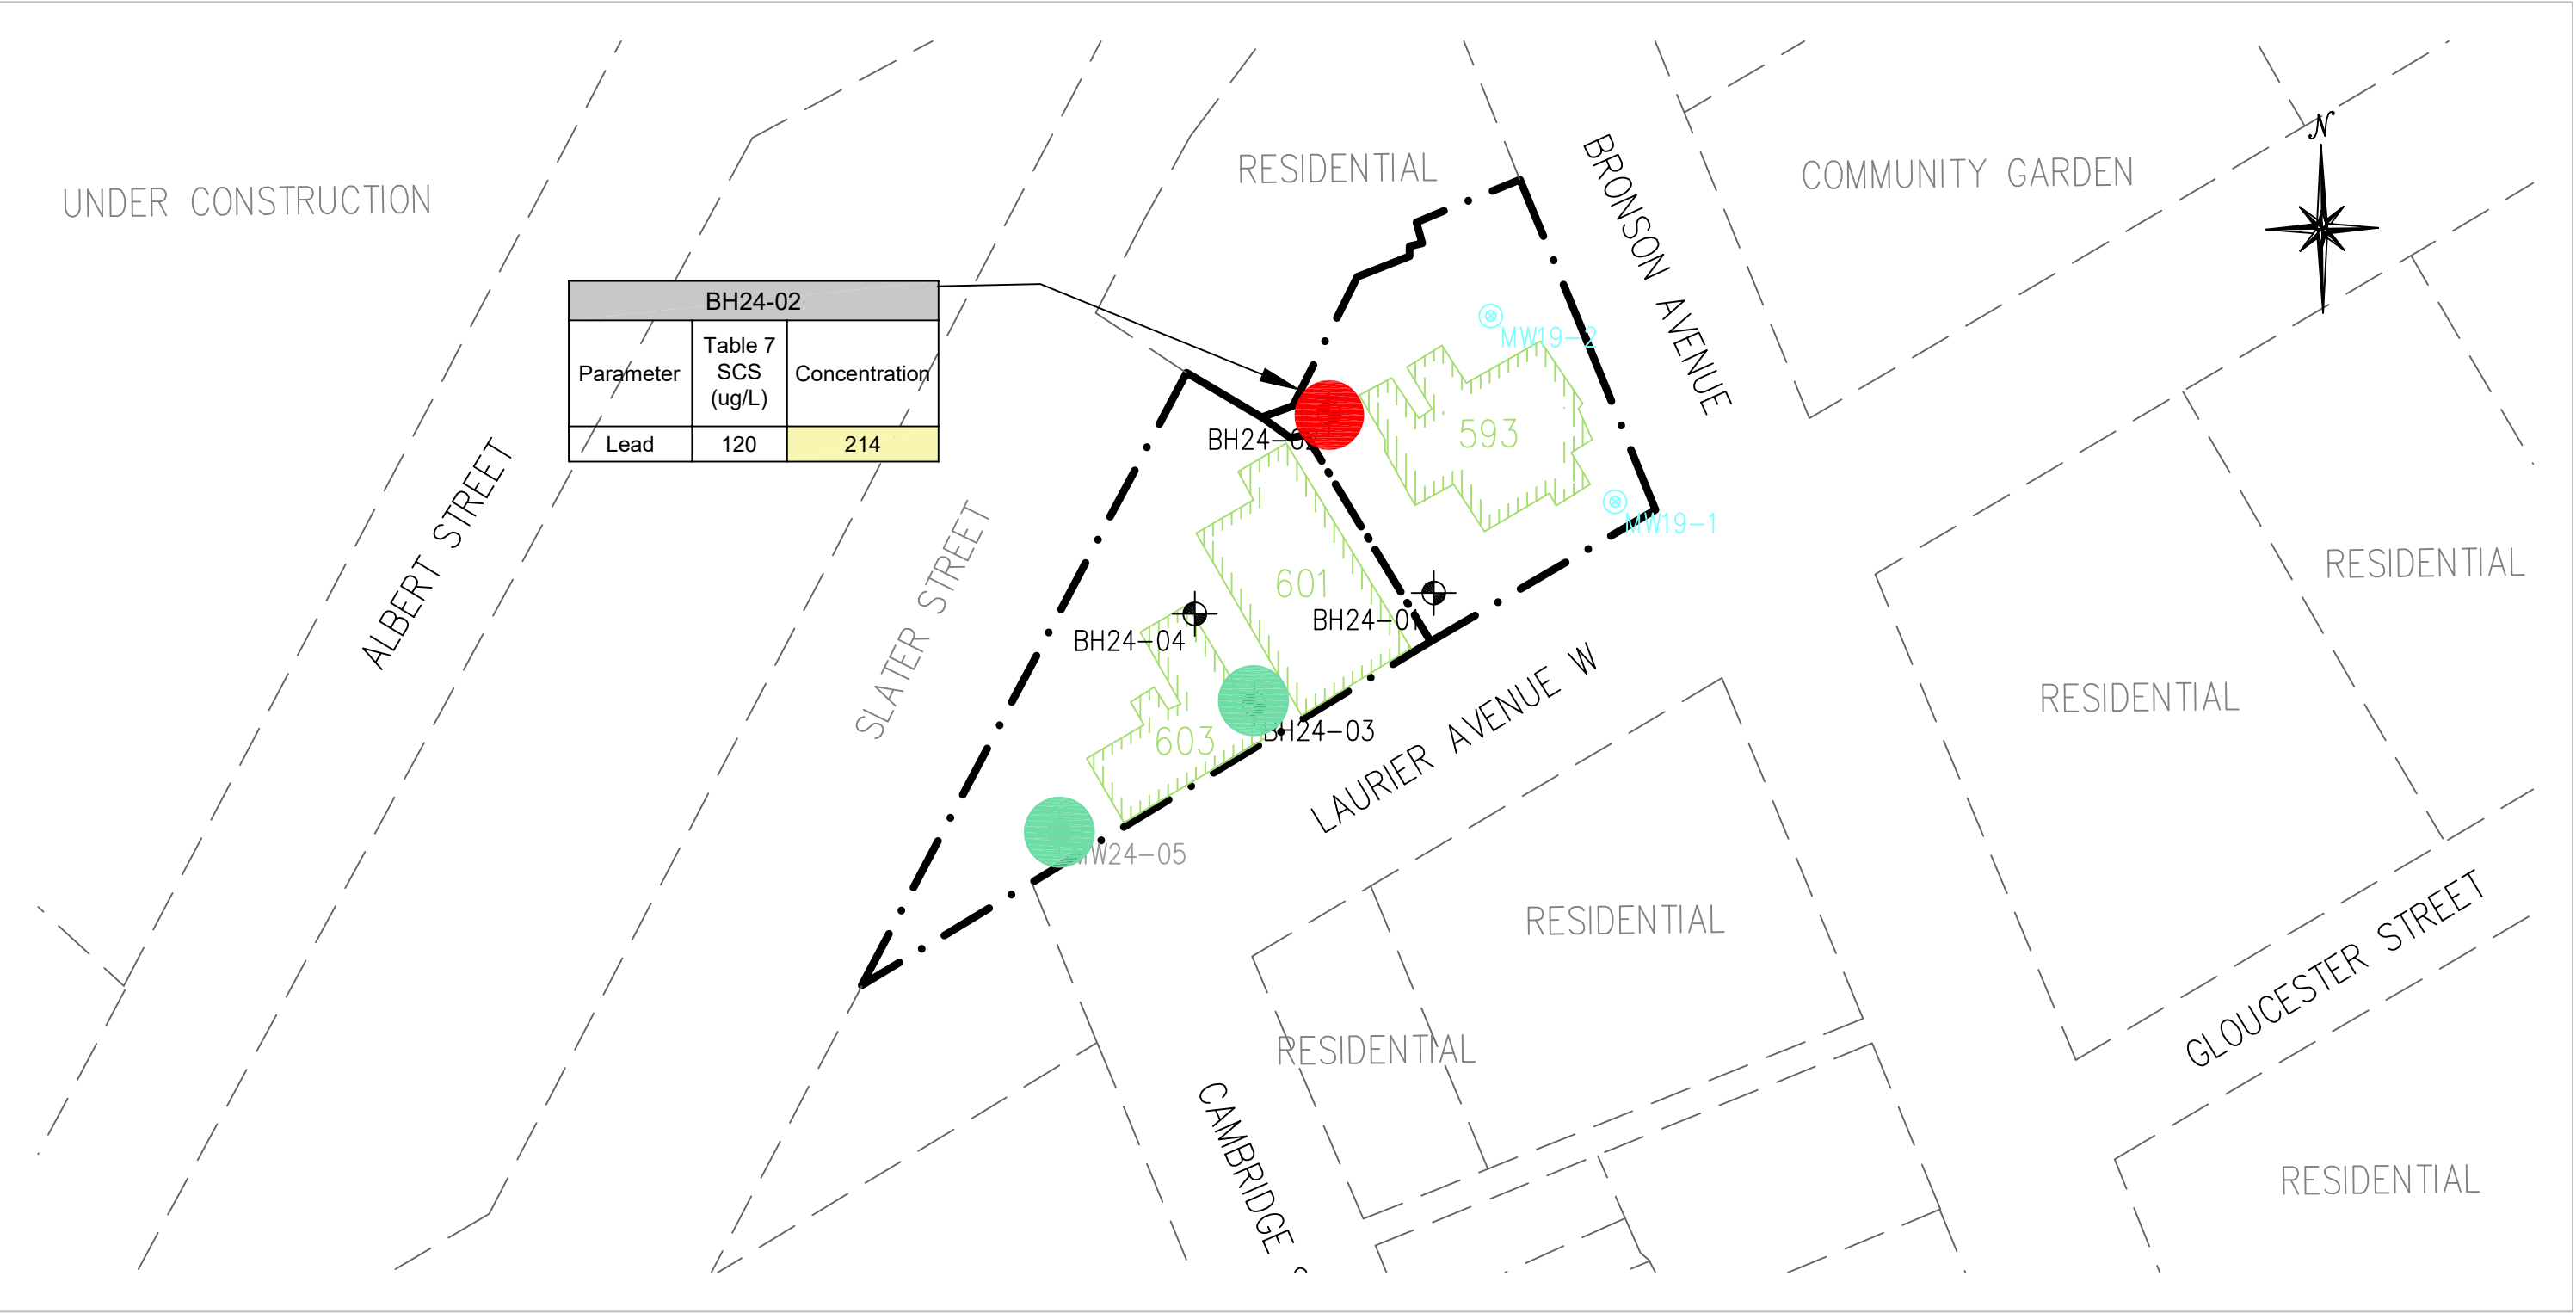
FIGURE8D

| BH24-02 | | |
| Parameter | Table 7 SCS (ug/L) | Concentration |
