Phase II – Environmental Site Assessment

7628 Flewellyn Road
Ottawa, Ontario

Report: PE5254-2

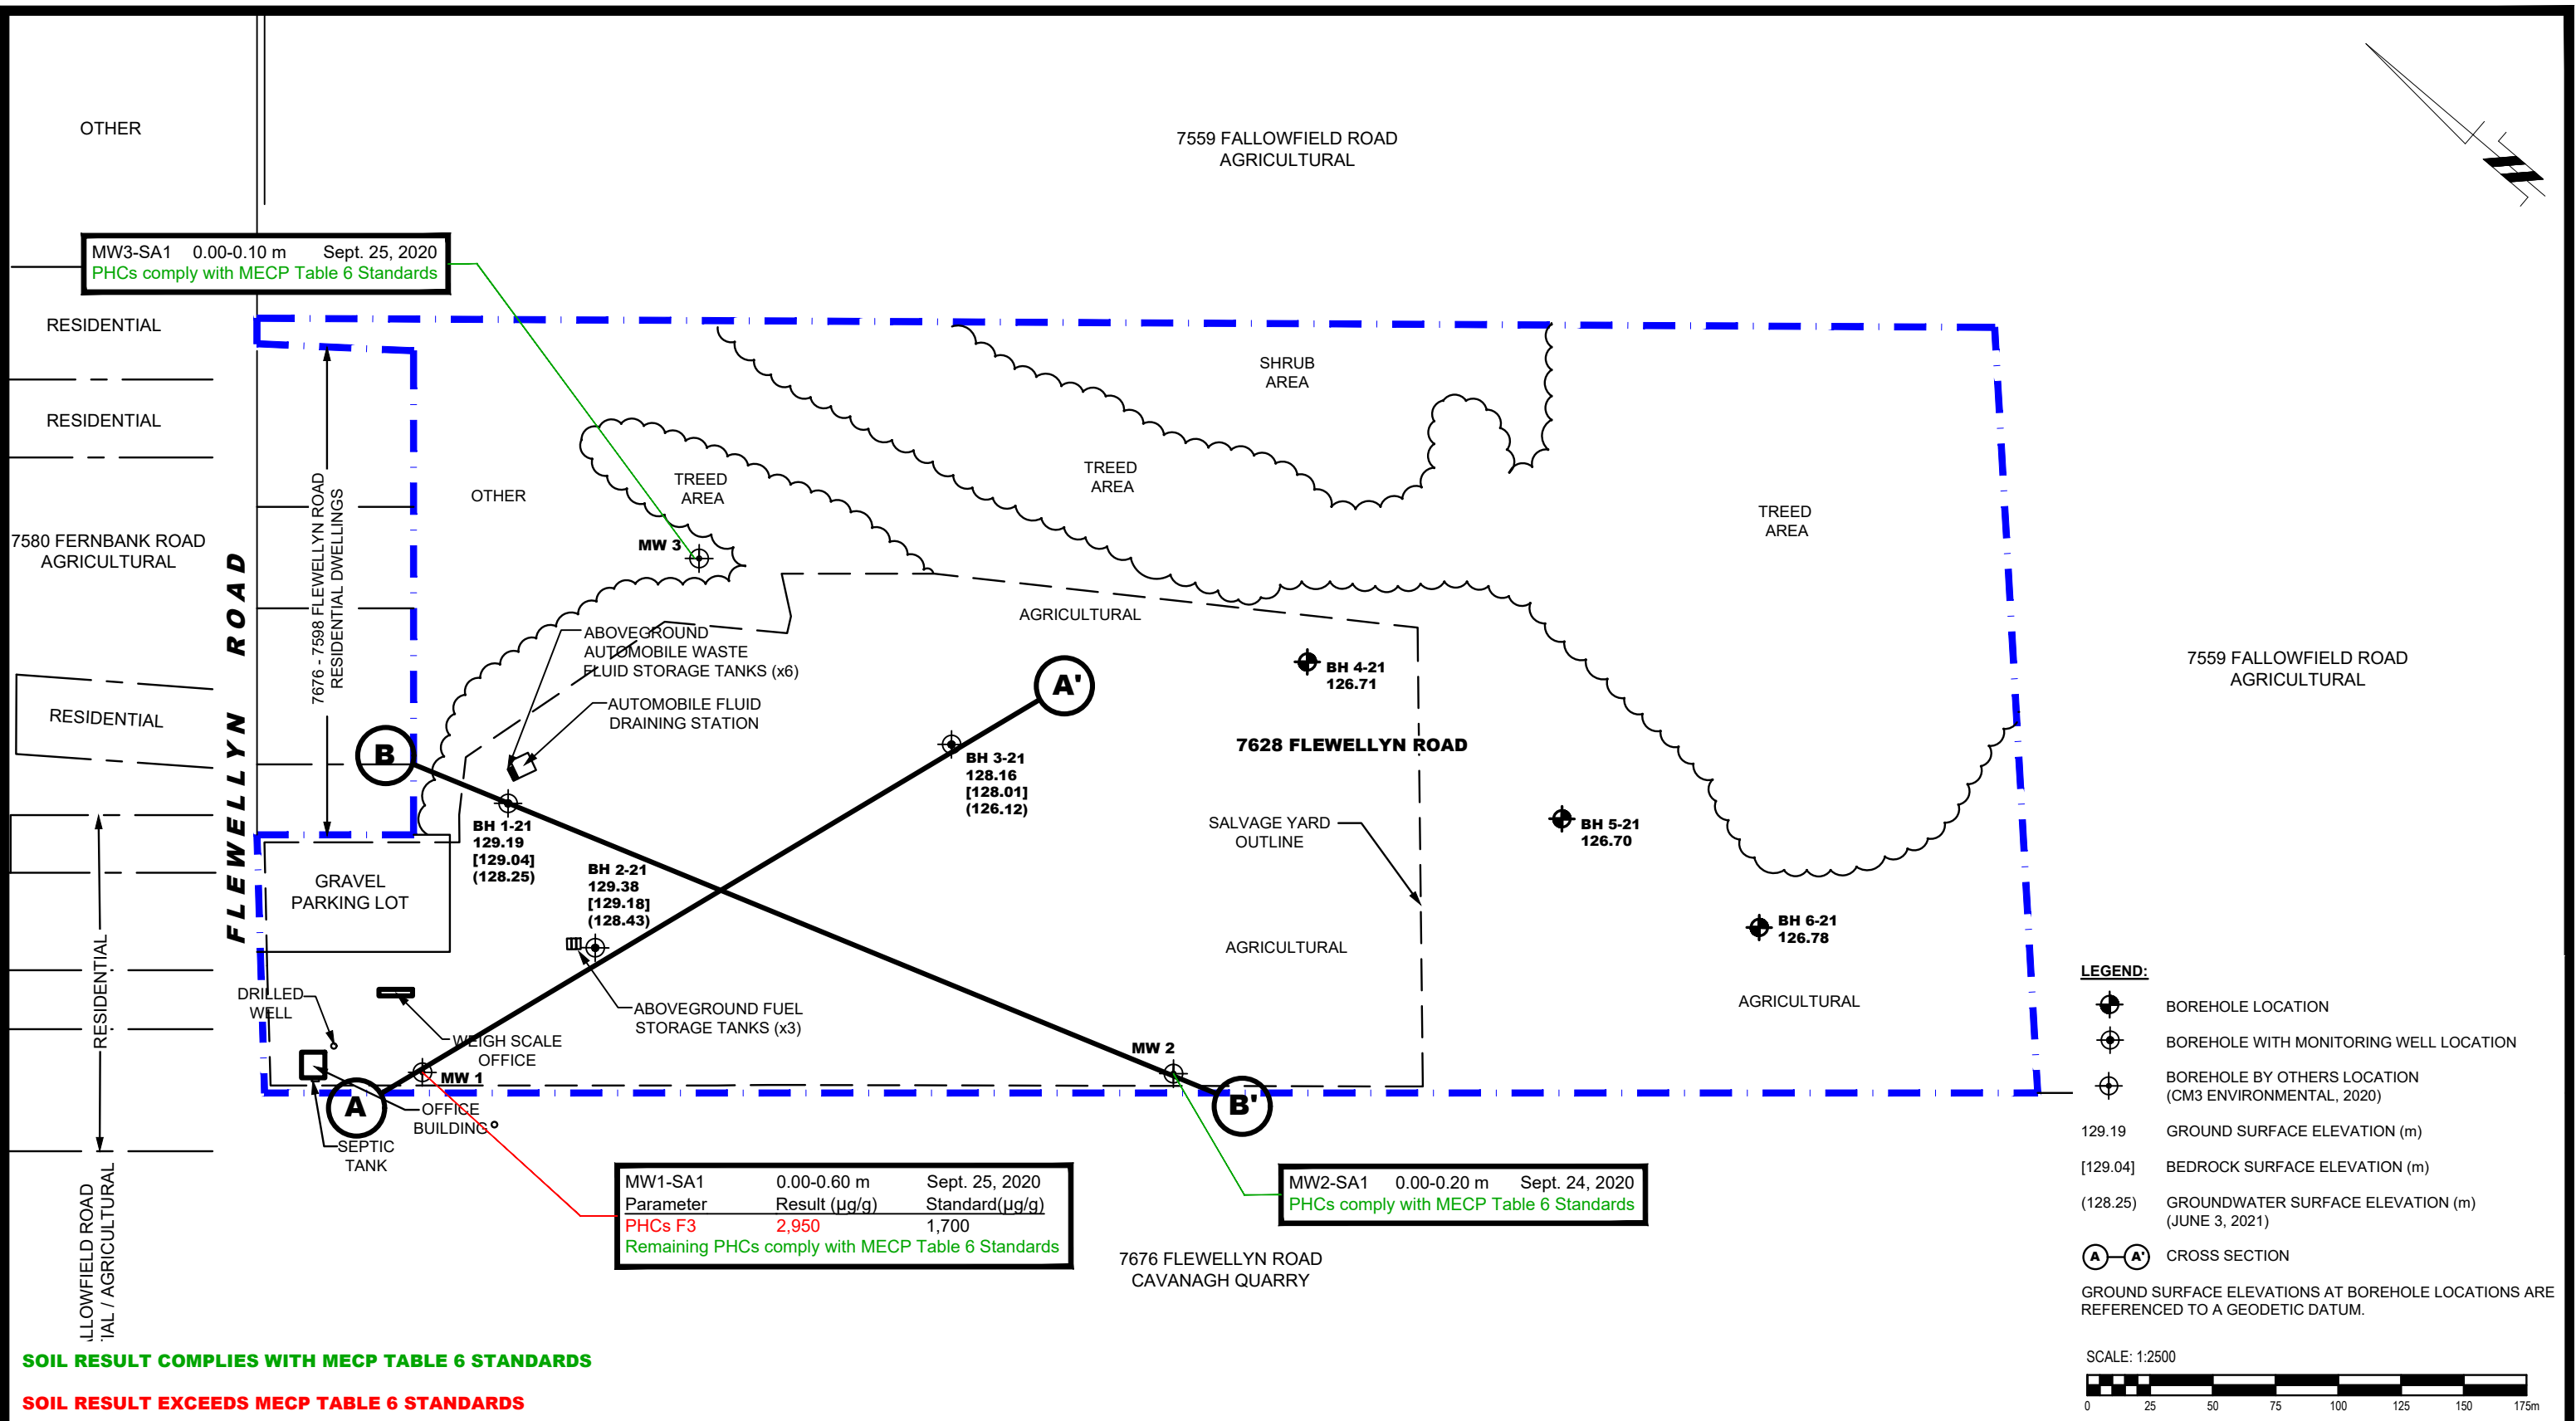
Drawing PE5254-4 – Analytical Testing Plan – Soil (PHCs)

MW3-SA1 0.00-0.10 m Sept. 25, 2020
 PHCs comply with MECP Table 6 Standards

MW1-SA1 0.00-0.60 m Sept. 25, 2020
 Parameter Result (µg/g) Standard(µg/g)
 PHCs F3 2,950 1,700
 Remaining PHCs comply with MECP Table 6 Standards

Based on the findings of this assessment, as well as the previous subsurface investigation completed by CM3 Environmental Inc. in September 2020, PHC contaminated soil was identified in the vicinity of MW1. While this soil possesses no risk to the use of the subject site, considerations should be given to remediating this soil at the time of future site redevelopment. This will require the segregation of clean soil from impacted soils, the latter of which will require disposal at an approved waste disposal facility.

Prior to off-site disposal at a licensed landfill, a leachate analysis of a representative sample of contaminated soil must be conducted in accordance with Ontario Regulation 347/558.

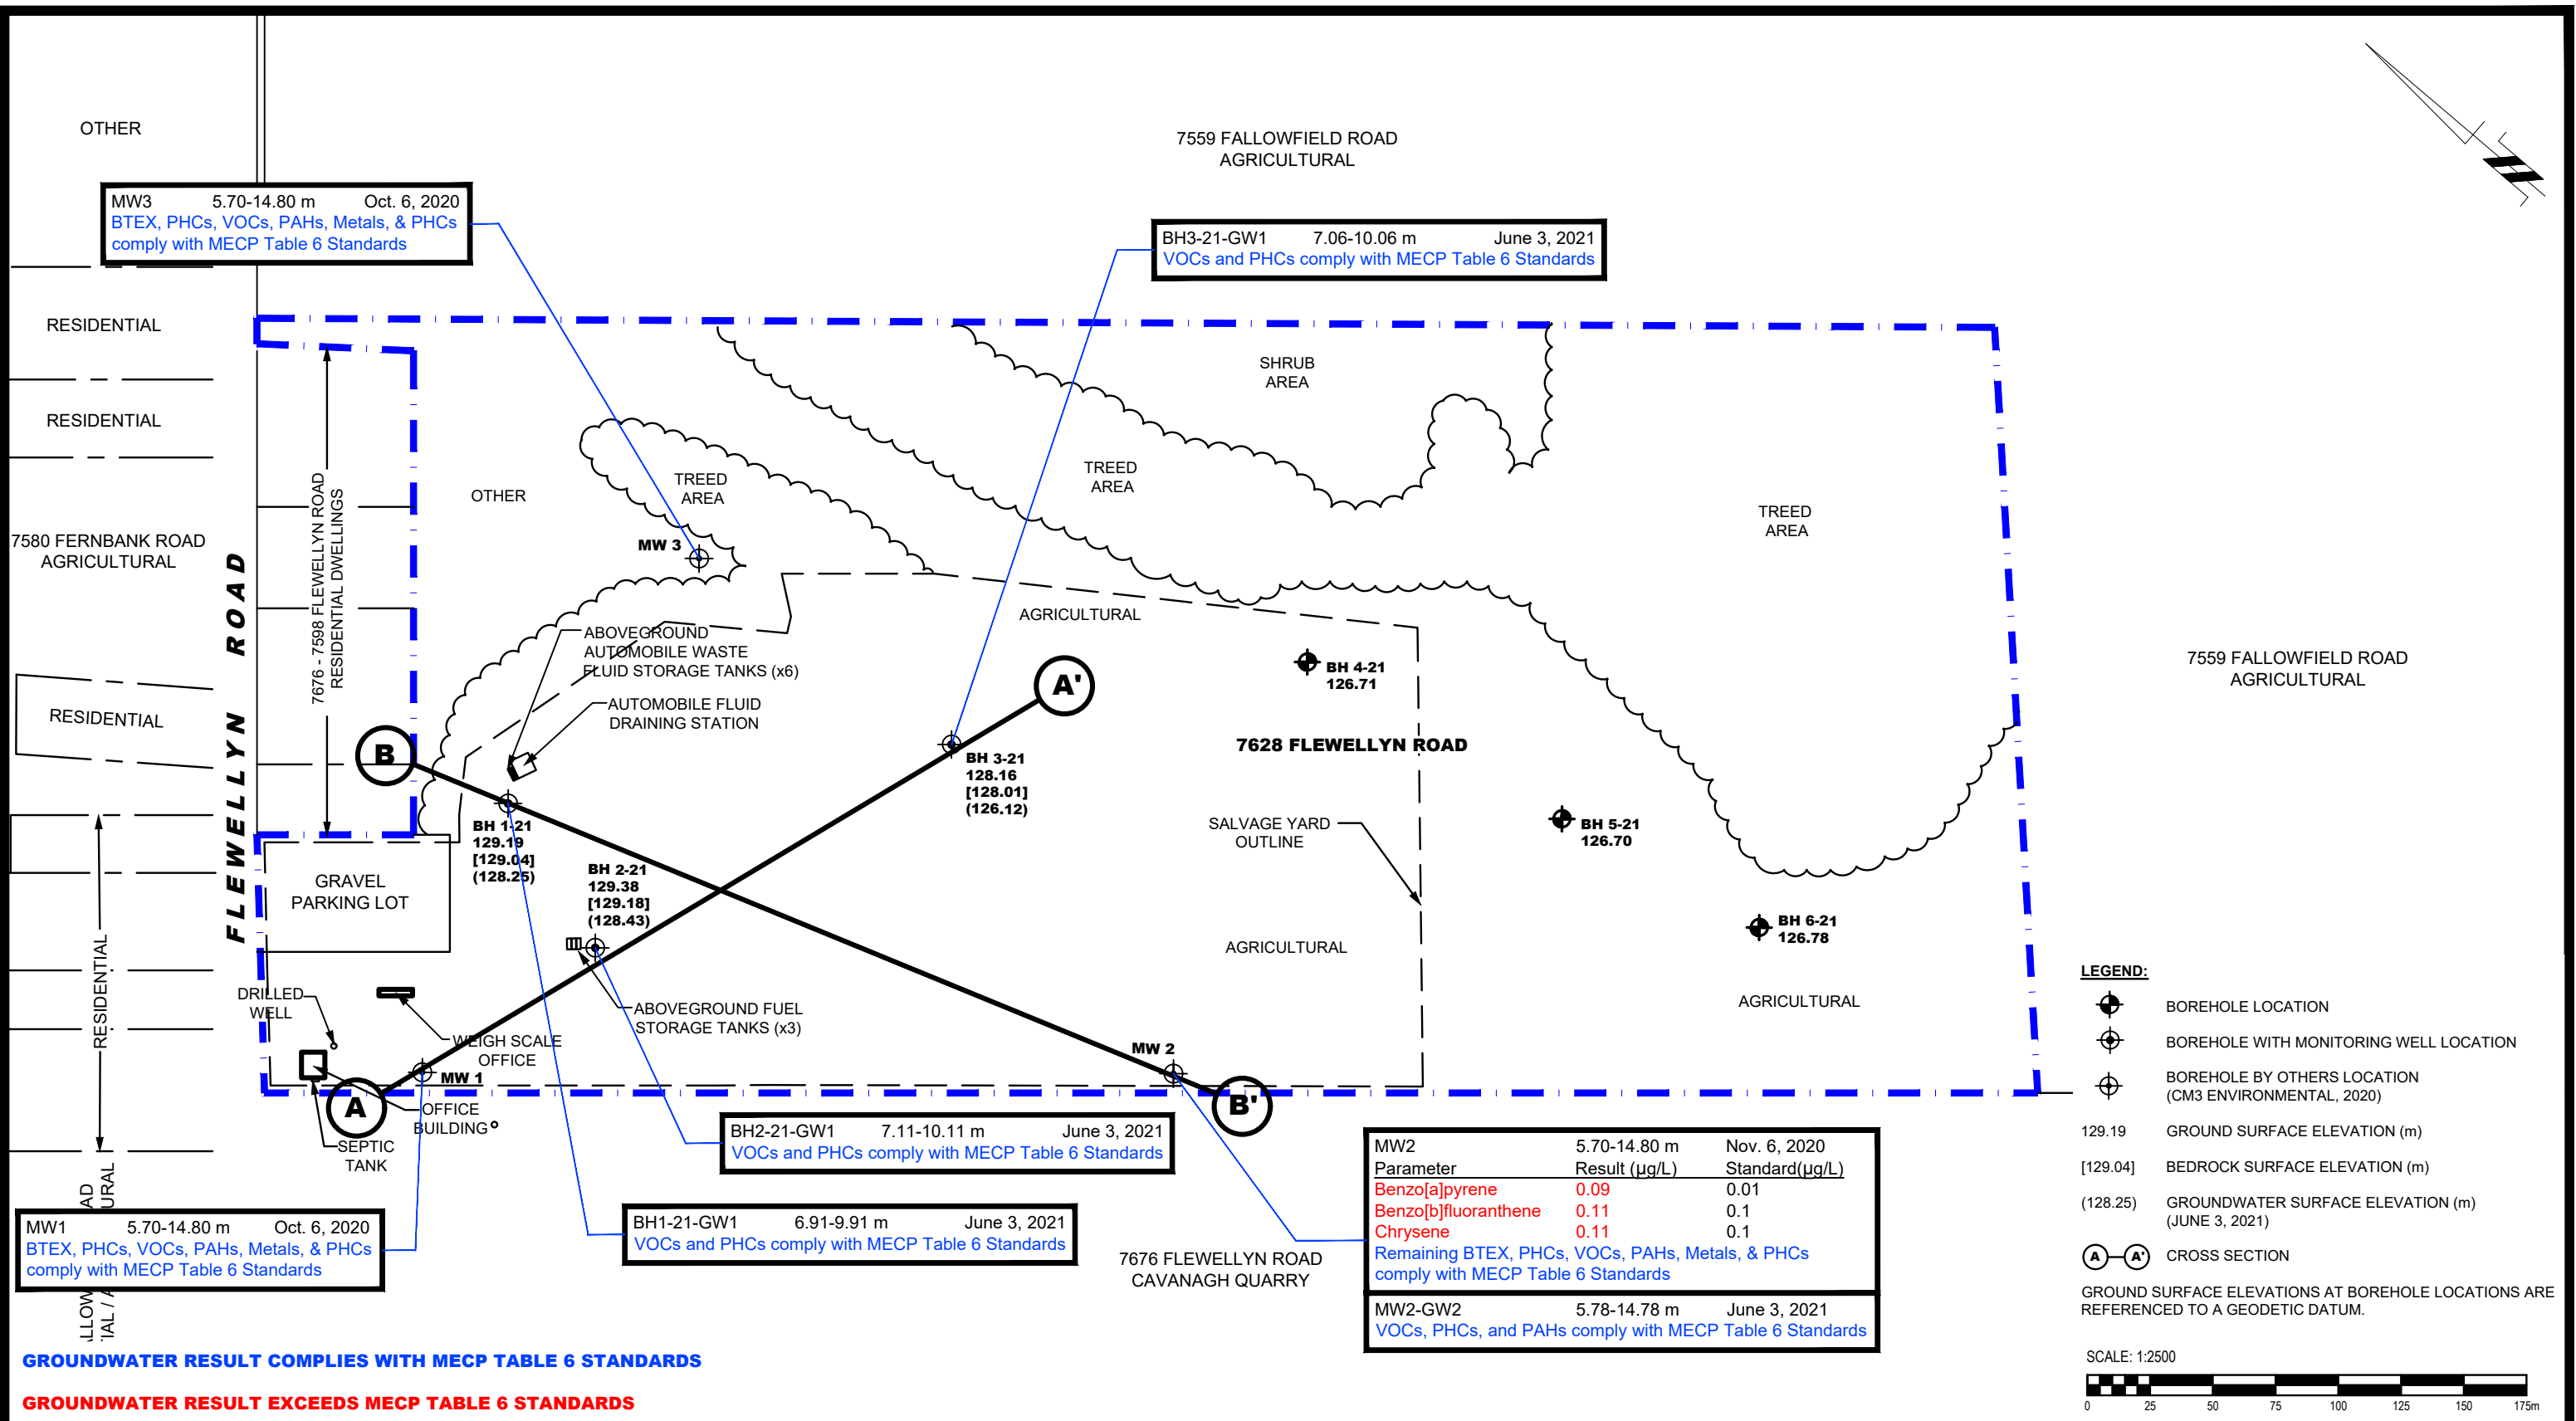
Drawing PE5254-6 – Analytical Testing Plan – Groundwater

MW3 5.70-14.80 m Oct. 6, 2020
 BTEX, PHCs, VOCs, PAHs, Metals, & PHCs
 comply with MECP Table 6 Standards

BH3-21-GW1 7.06-10.06 m June 3, 2021
 VOCs and PHCs comply with MECP Table 6 Standards

BH2-21-GW1 7.11-10.11 m June 3, 2021
 VOCs and PHCs comply with MECP Table 6 Standards

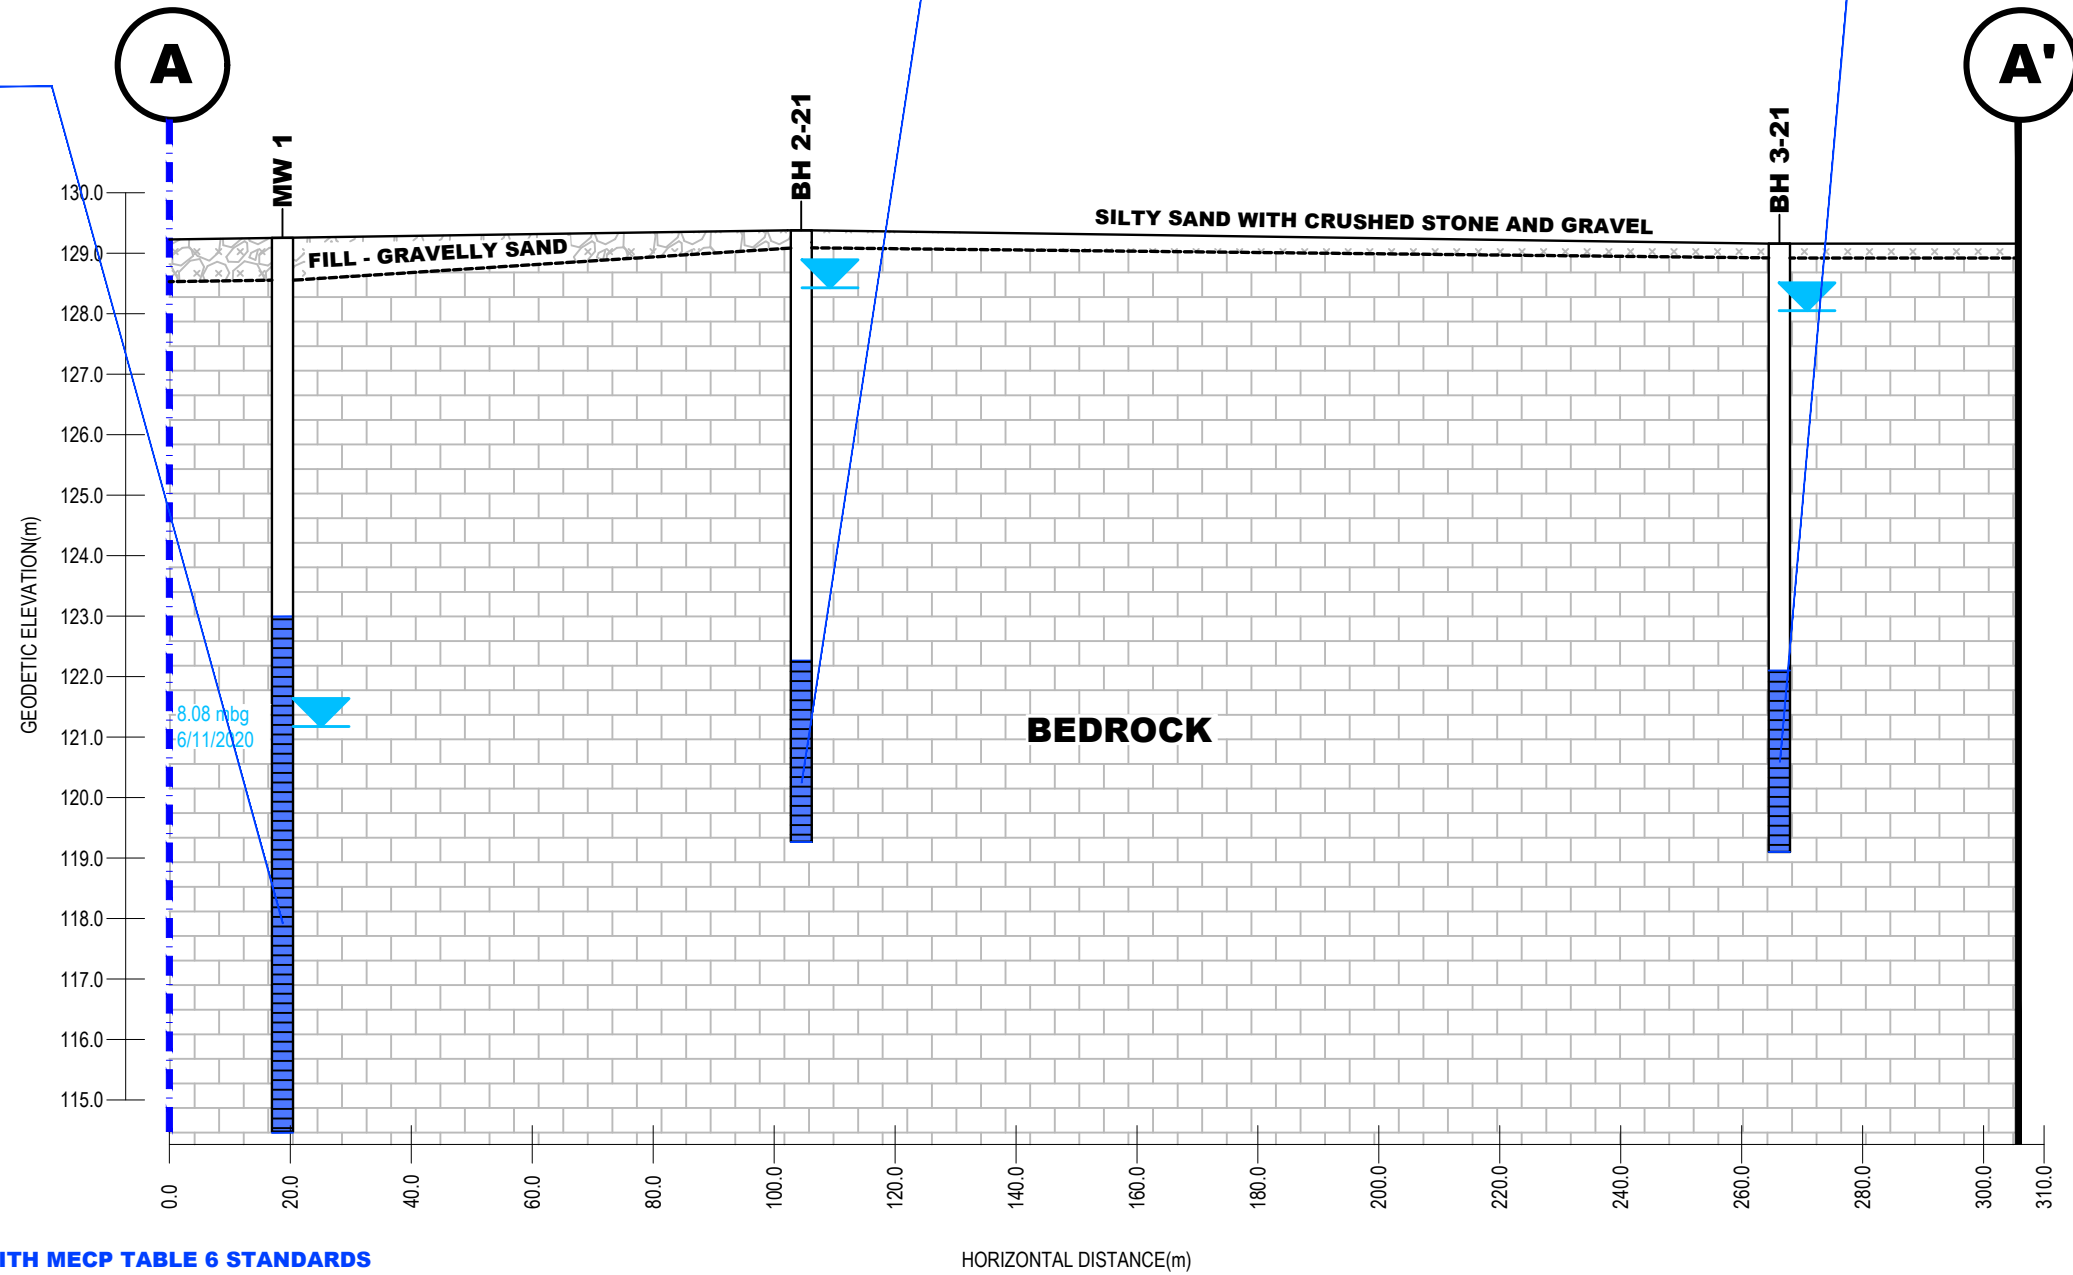
DRAWING PE5254-6A – CROSS SECTION A-A' – GROUNDWATER

BH1-21-GW1 6.91-9.91 m June 3, 2021
 VOCs and PHCs comply with MECP Table 6 Standards

MW2	5.70-14.80 m	Nov. 6, 2020
Parameter	Result (µg/L)	Standard(µg/L)
Benzo[a]pyrene	0.09	0.01
Benzo[b]fluoranthene	0.11	0.1
Chrysene	0.11	0.1
Remaining BTEX, PHCs, VOCs, PAHs, Metals, & PHCs comply with MECP Table 6 Standards		
MW2-GW2	5.78-14.78 m	June 3, 2021
VOCs, PHCs, and PAHs comply with MECP Table 6 Standards

It should be noted that, while the previous investigation by CM3 did identify some minor PAH contamination in the recovered groundwater sample from MW2, a resampling of this well, carried out as part of this current investigation, did not identify any PAH contaminants at concentrations exceeding the selected MECP Table 6 potable groundwater standards. As a result, the groundwater at this location is not considered to be contaminated. No other contaminant concentrations exceeding the selected MECP Table 6 potable groundwater standards were identified in any of the other groundwater samples recovered from the monitoring wells installed on the subject site.

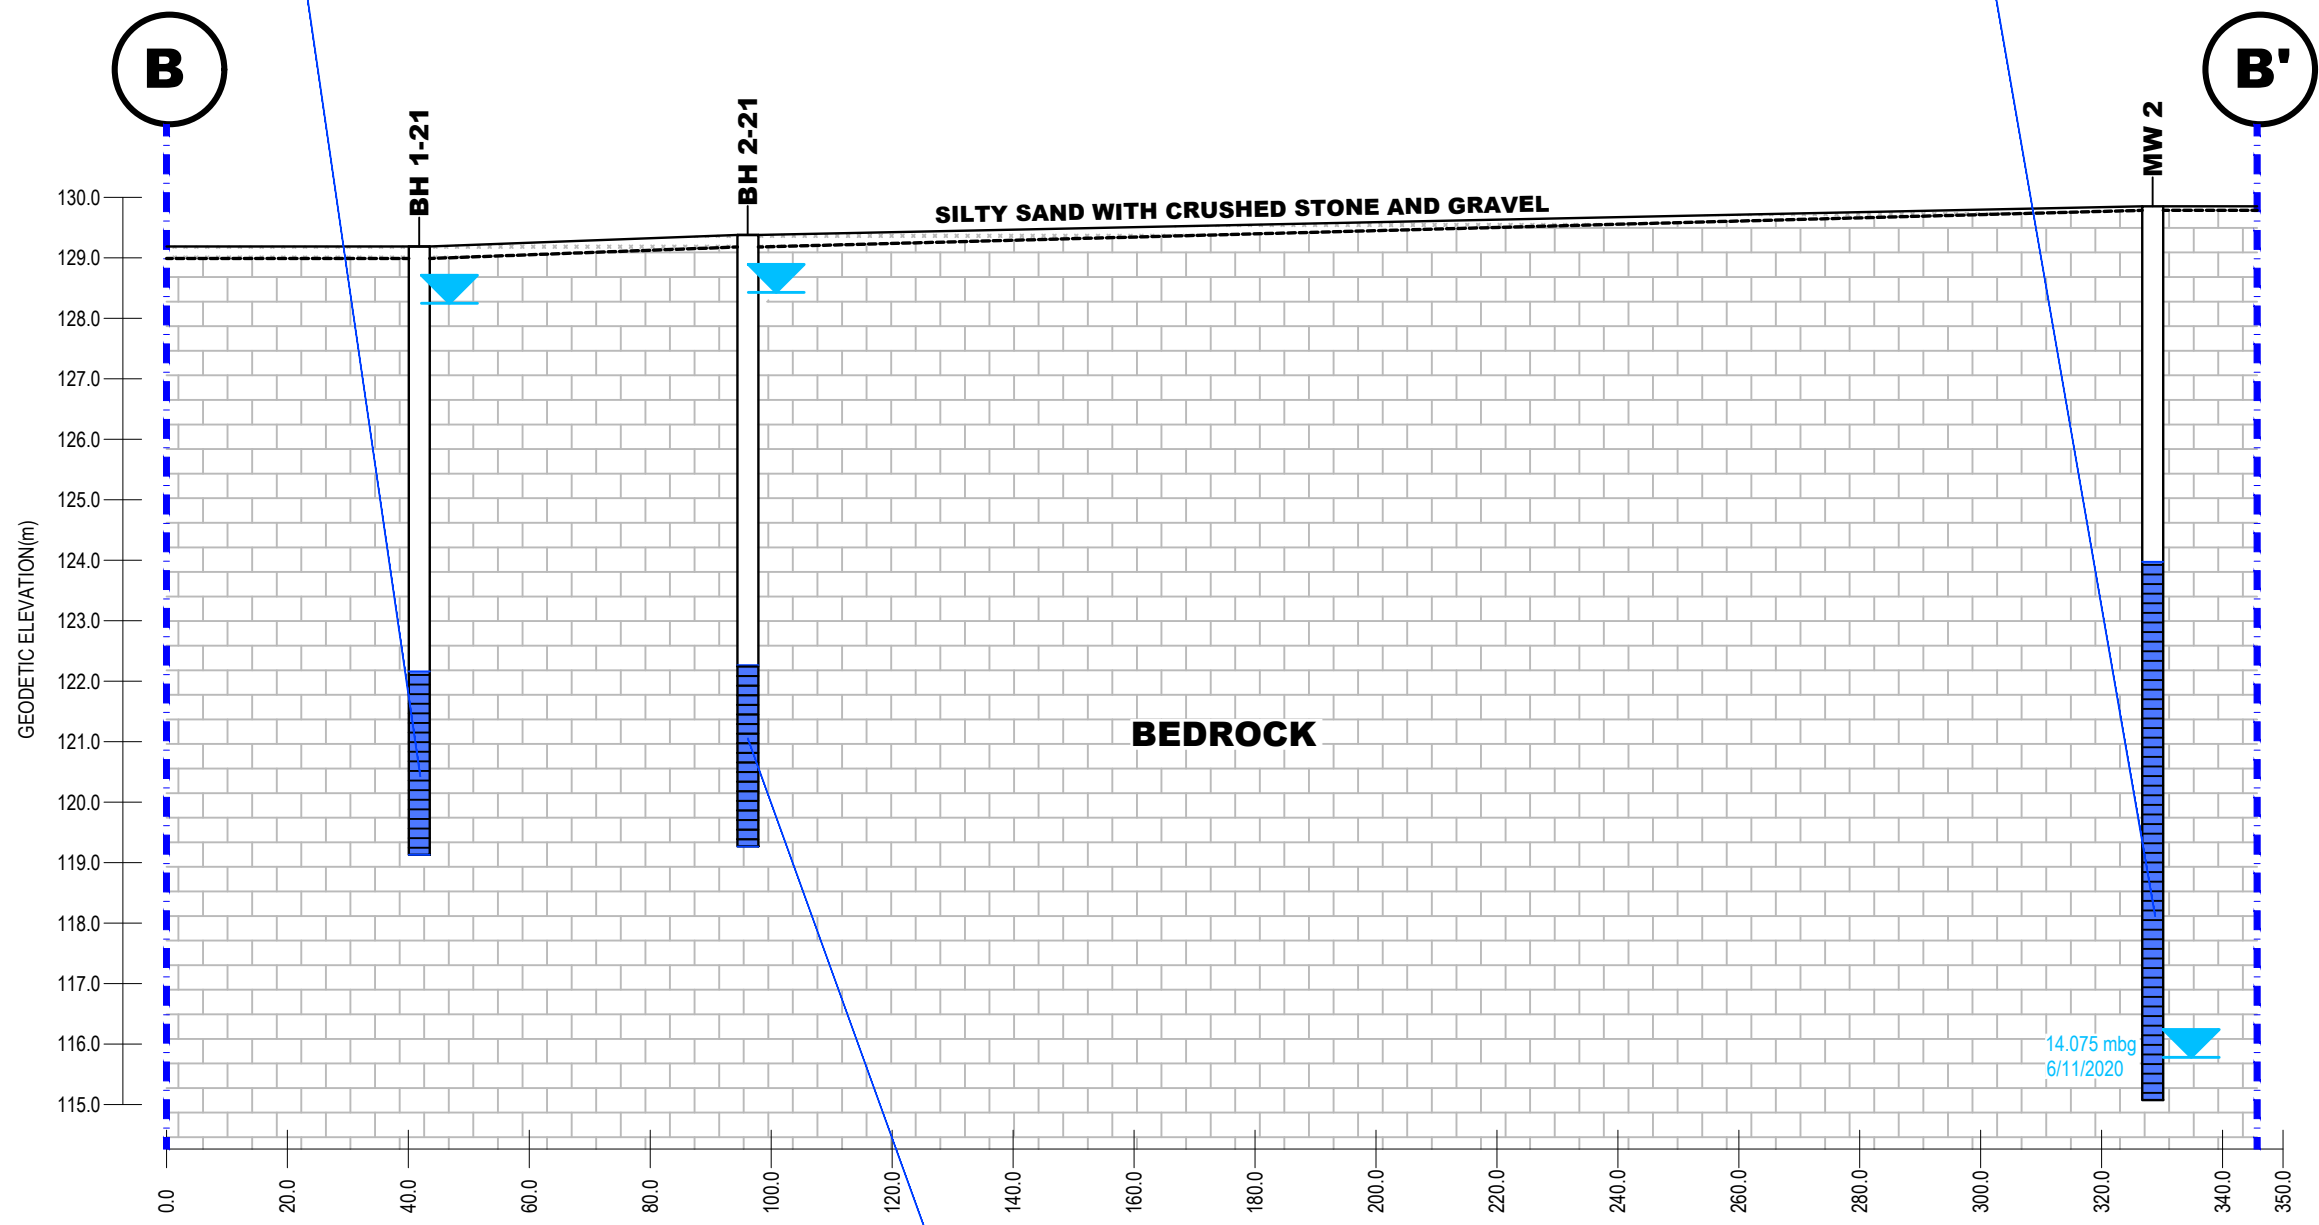
DRAWING PE5254-6B – CROSS SECTION B-B' – GROUNDWATER

BH2-21-GW1 7.11-10.11 m June 3, 2021
 VOCs and PHCs comply with MECP Table 6 Standards
