**HENRY INVESTMENTS  
14072375 Canada Inc.**

**Phase I Environmental Site Assessment  
73-79, 83 Ste-Cecile Street,  
Ottawa, Ontario**

**CM3 Project SDC1009**

**December 16, 2022**

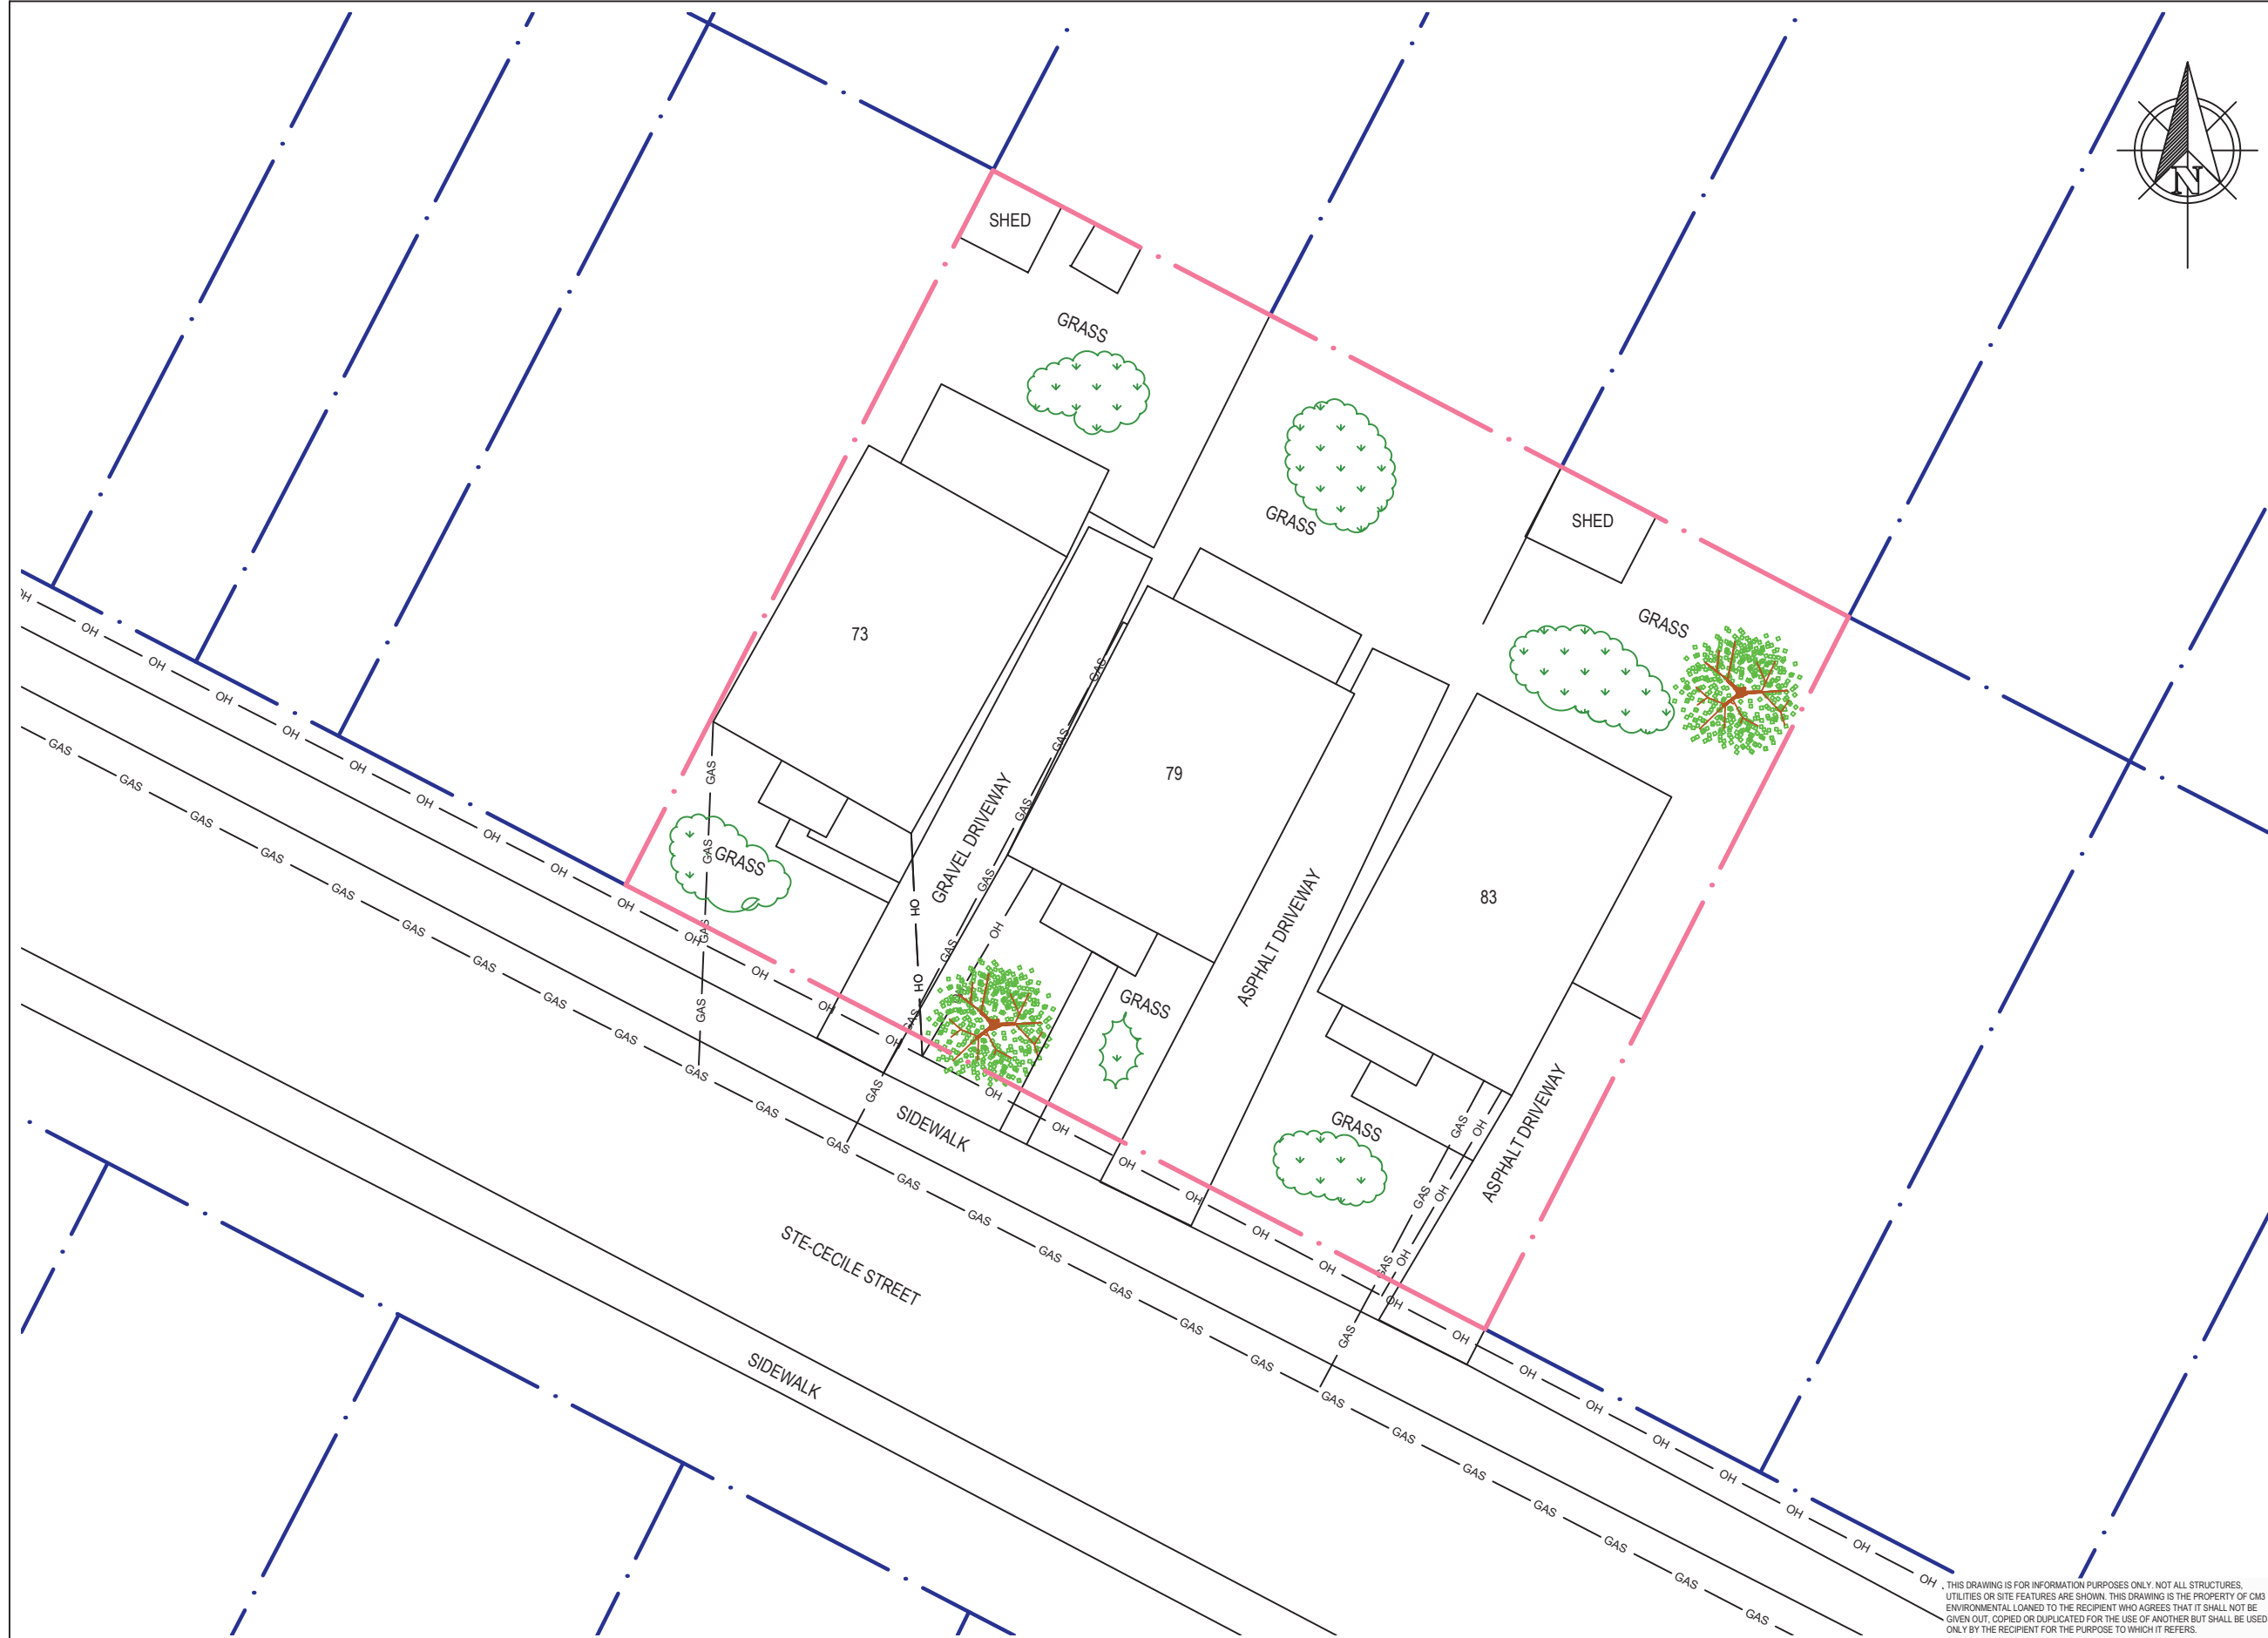
Project:	SDC1009	Drawn By:	SDC
Date:	DEC 2022	Reviewed By:	BDC
Scale:	1:3000	Figure:	2

The Phase I Study Area included the subject property at 73-79, 83, Ste-Cecile Street, Ottawa, Ontario, and all lands within a 300 m radius of the property boundary. The Phase I study area is provided on **Figure 2**.

Photographs of the adjacent properties are provided in **Appendix A**. The adjacent and surrounding properties in the Phase I study area are included on **Figure 2**.

The subject properties were operational as residential properties with single tenant or multitenant buildings on-site. The properties were primarily grass covered with asphalt driveways. Drainage from the subject sites is south onto Ste-Cecile Street and was controlled by storm sewers underneath the street. No water bodies were identified within the Phase I study area. The Phase I study area is provided on **Figure 2**.

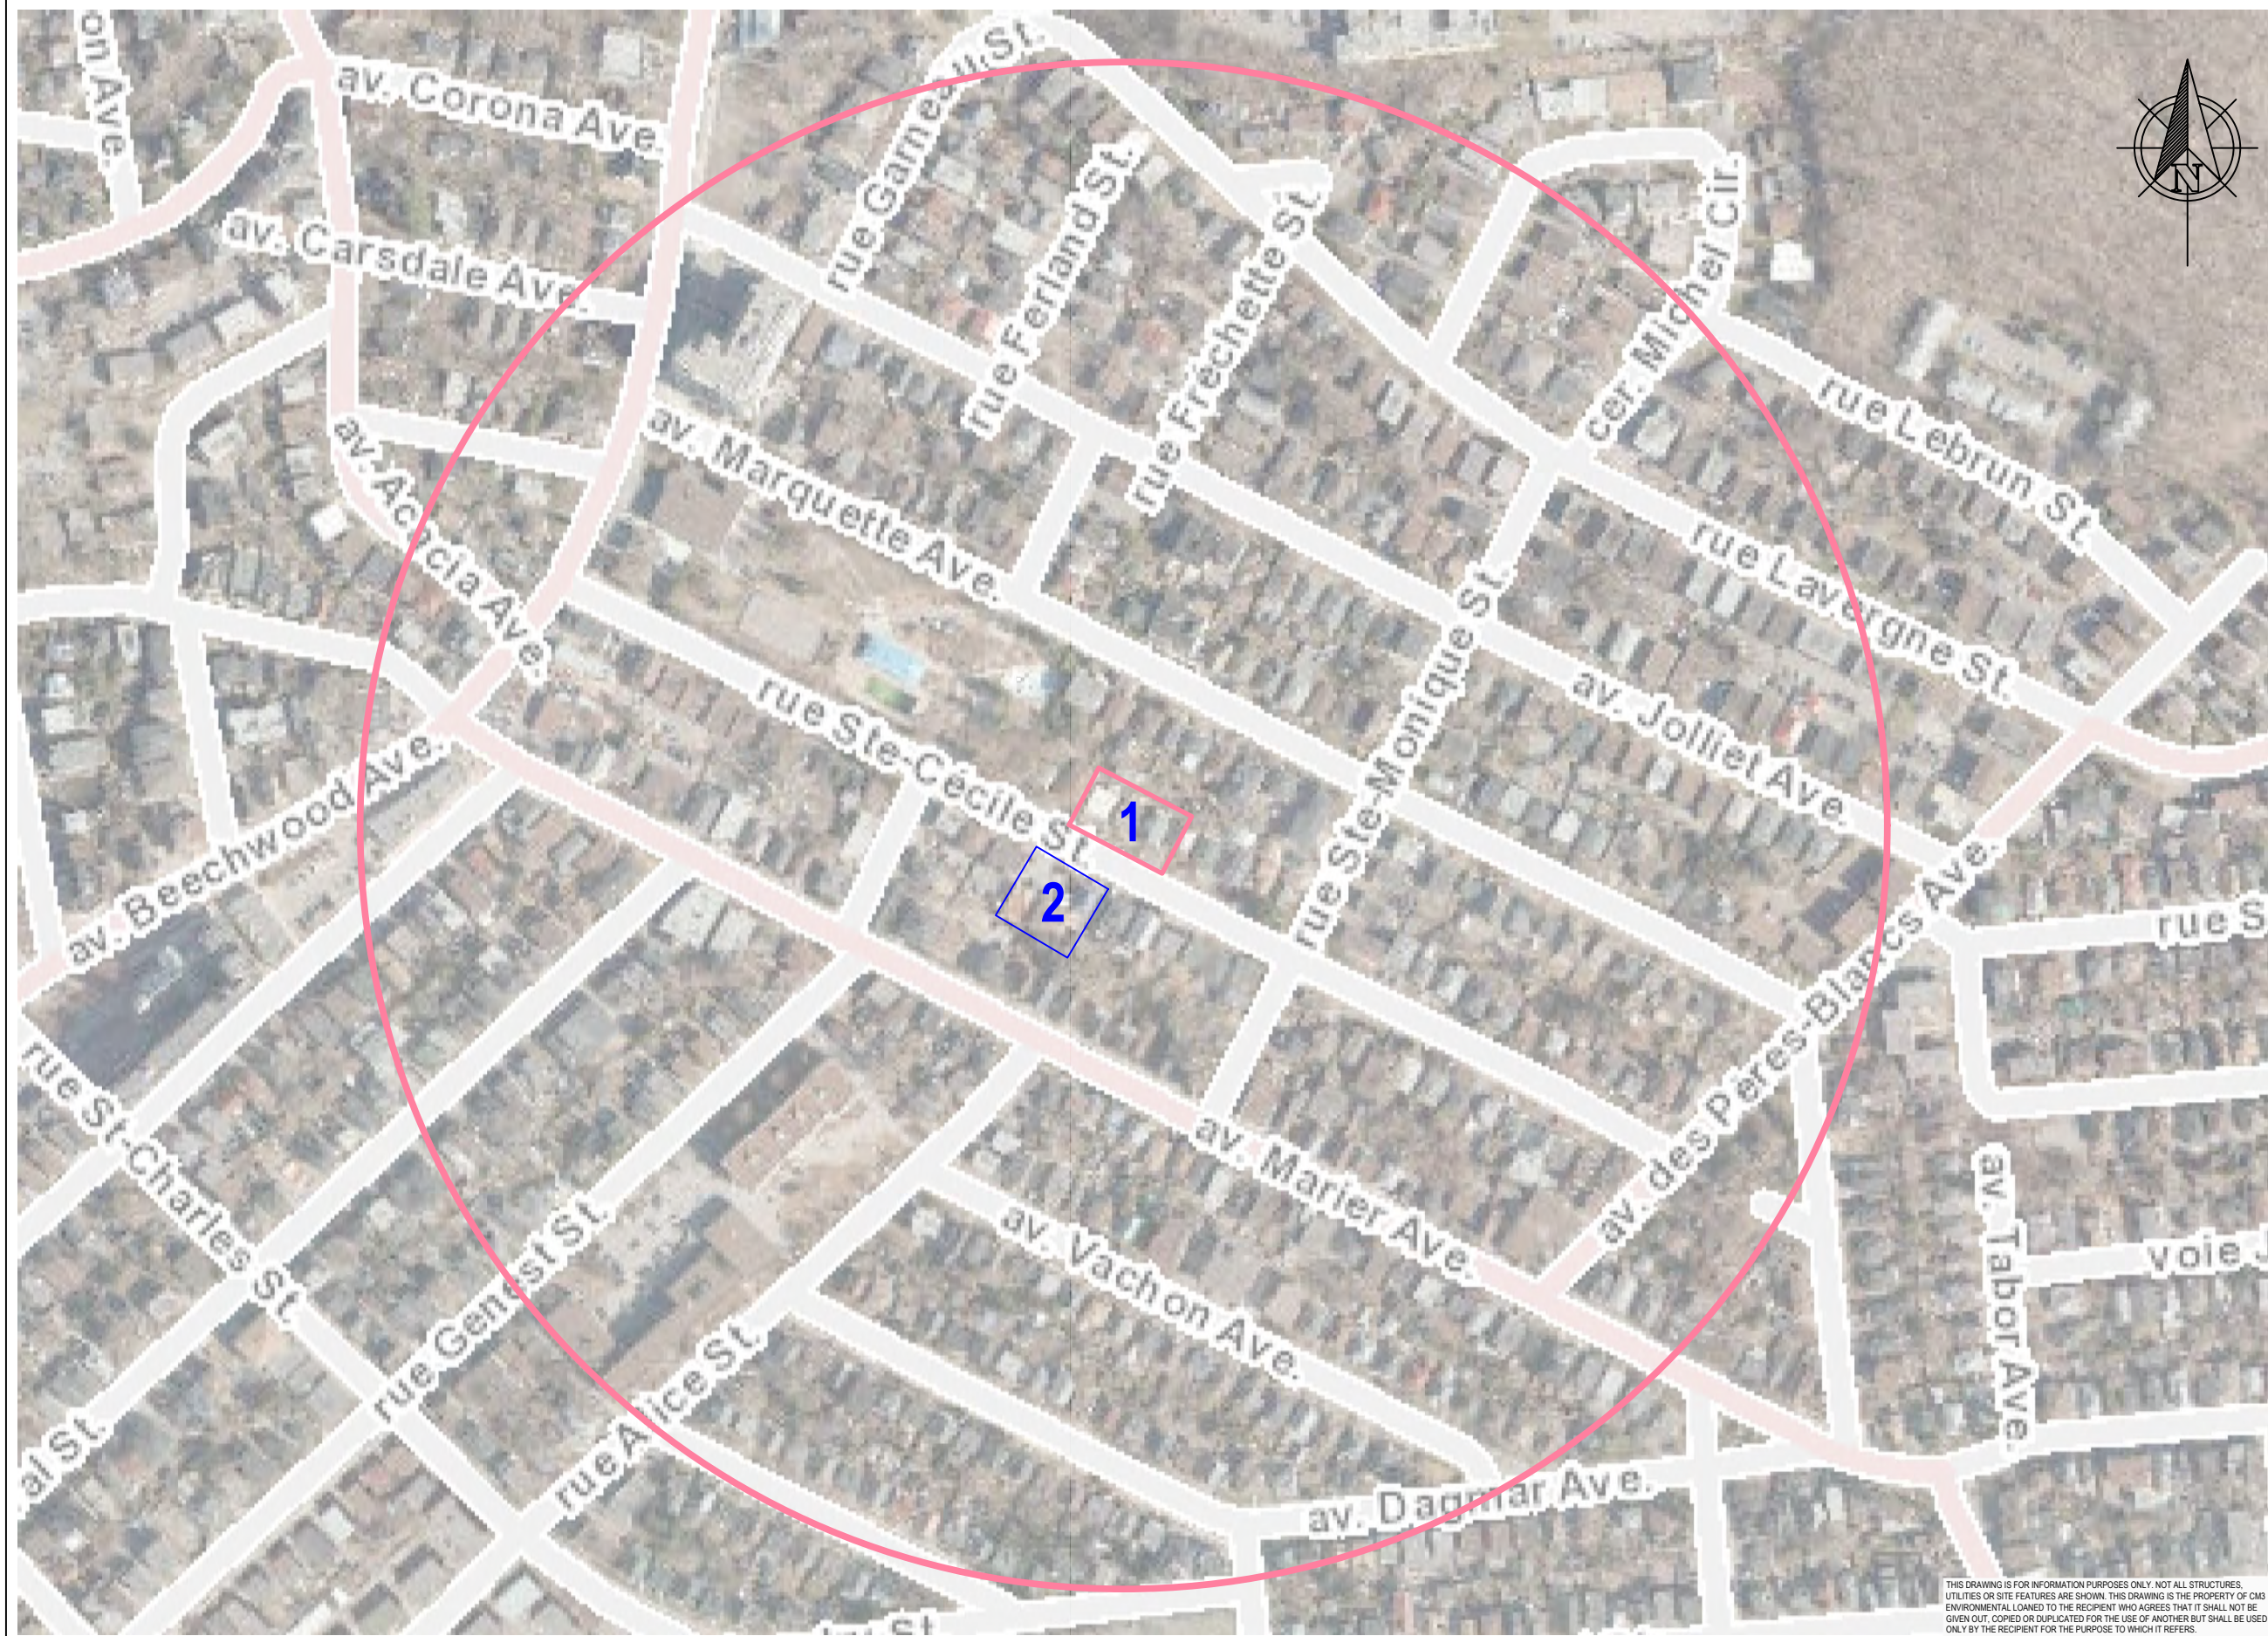
SITE PLAN

A site plan is provided as **Figure 3**. Photographs of the subject property are provided in **Appendix A**.

The cover consisted of mainly grass with asphalt driveways and minor landscaping. The general groundcover is indicated on **Figure 3**.

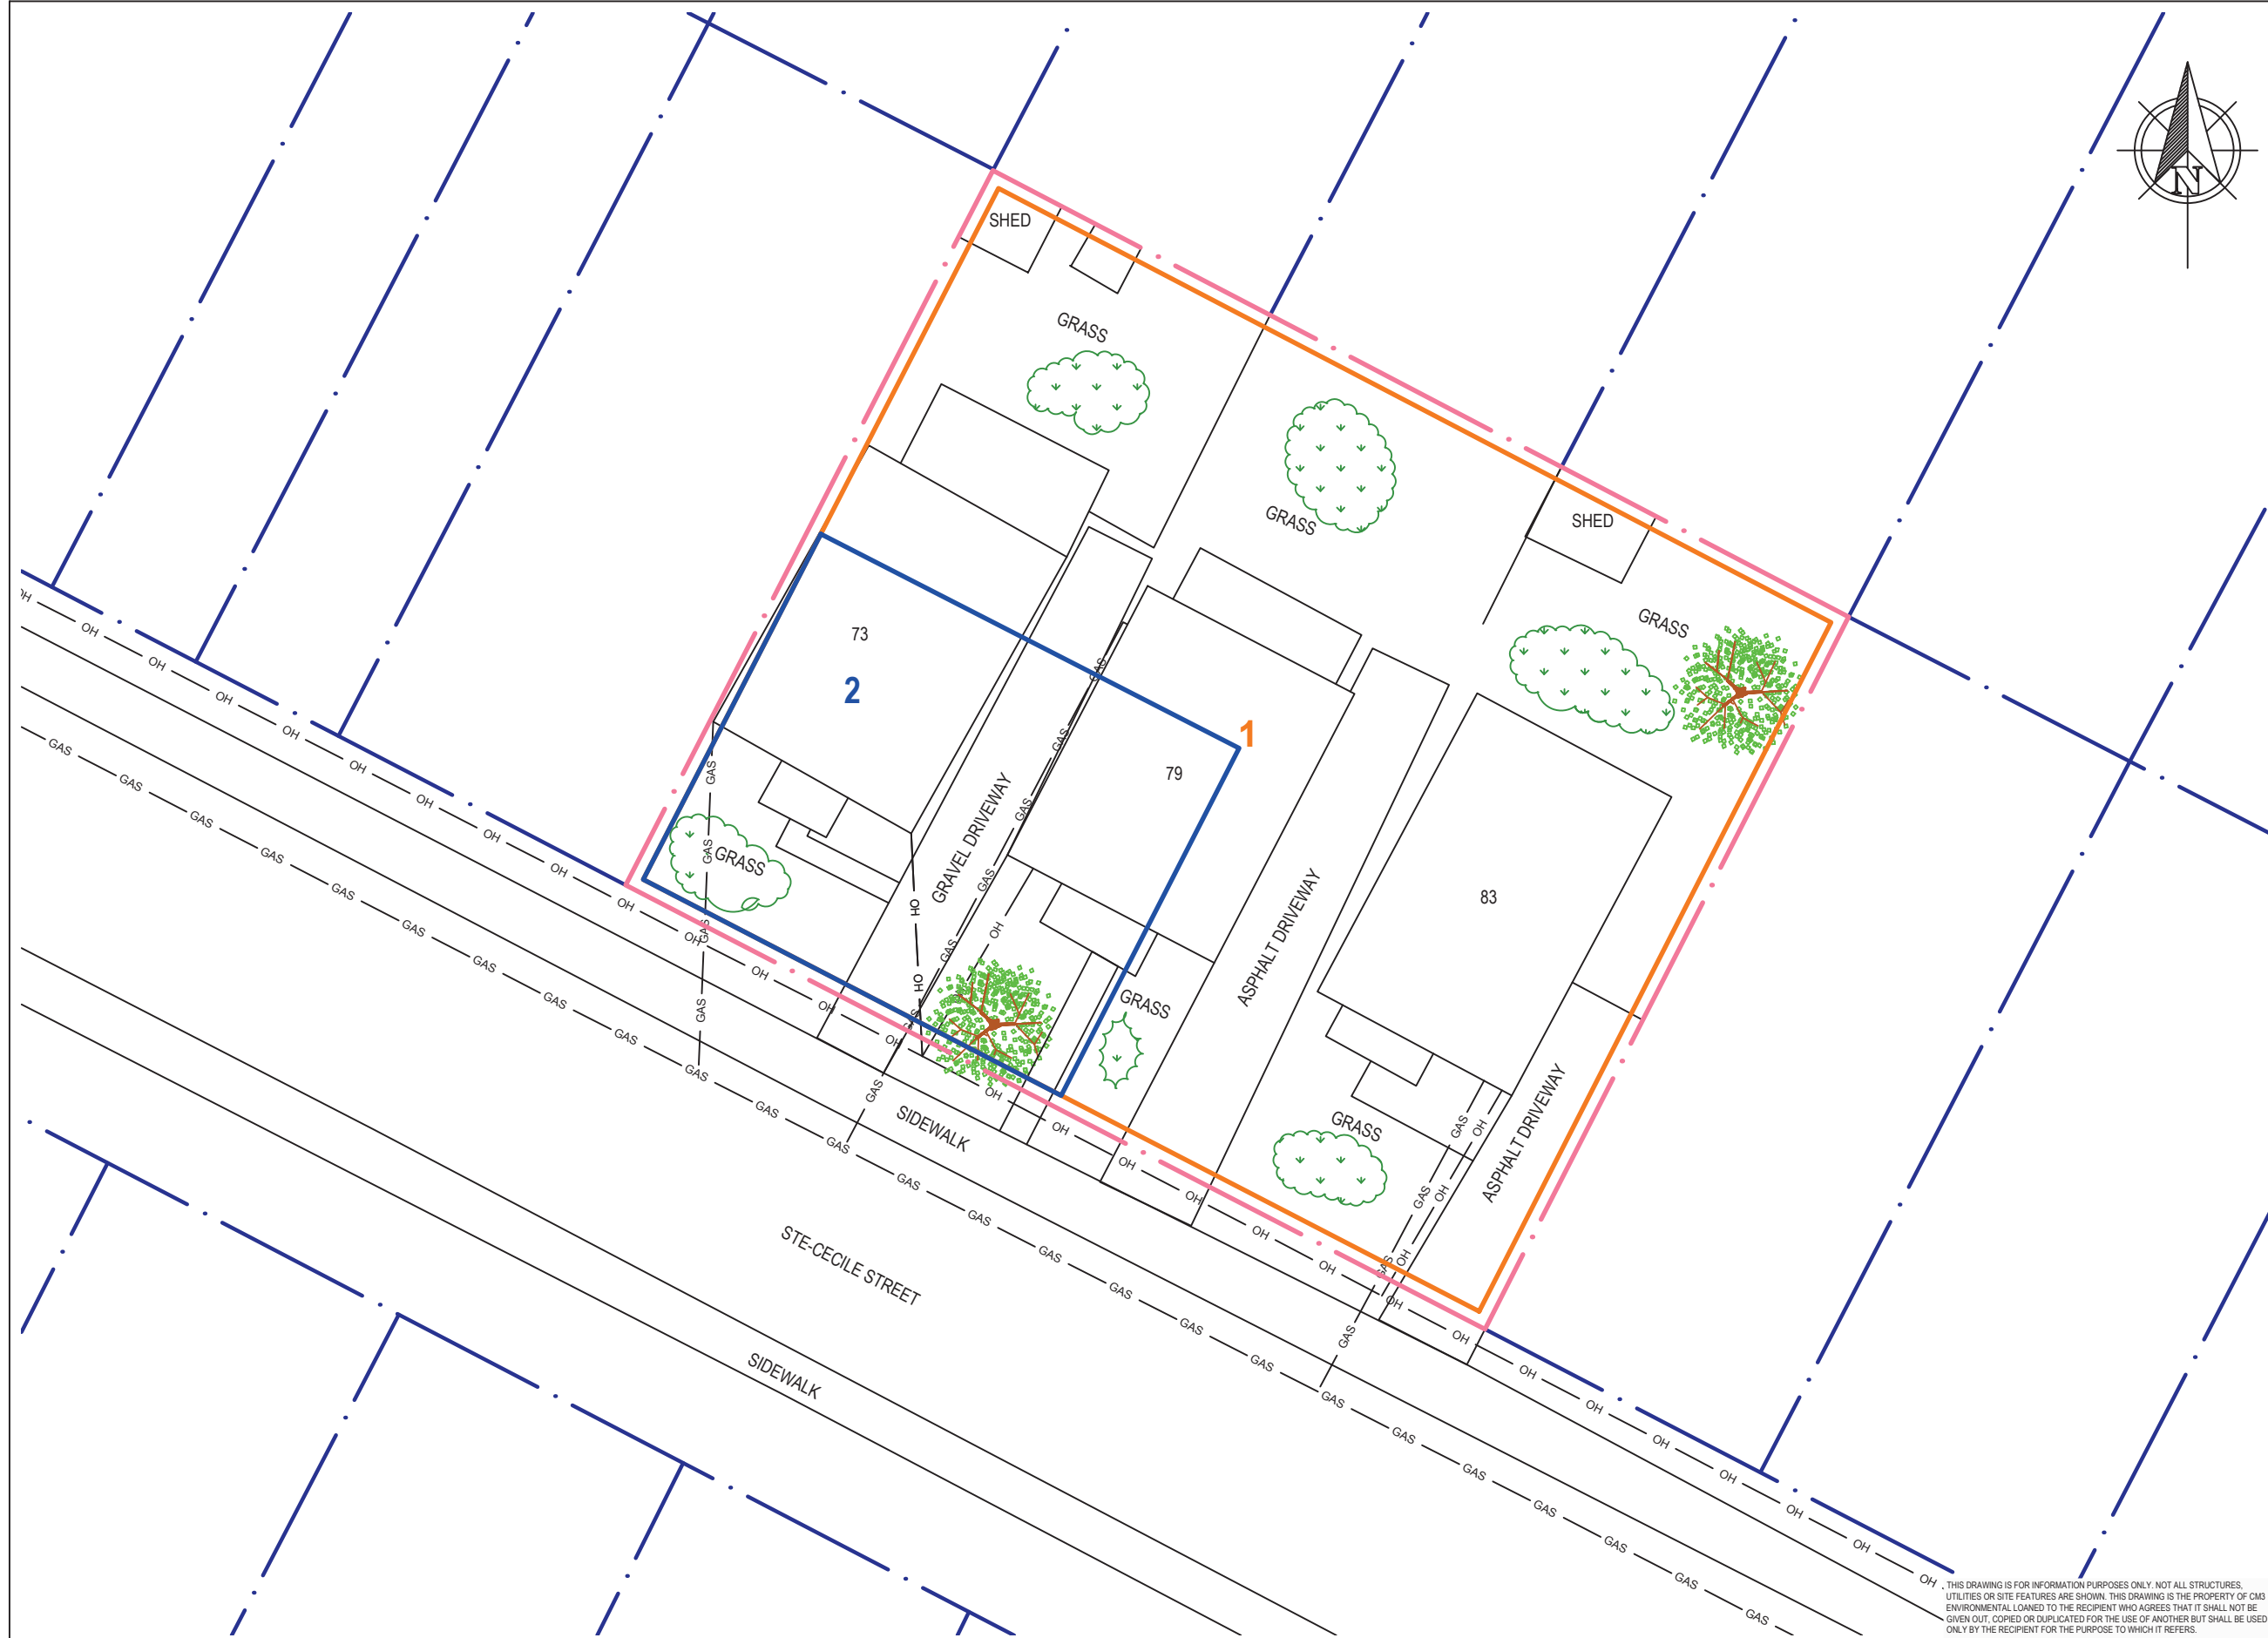
- PROPERTY BOUNDARY
- SITE
- BUILDING
- NATURAL GAS
- OVERHEAD ELECTRICAL
- MONITORING WELL
- 1 APEC 1 - UNKNOWN QUALITY OF IMPORTED FILL  
73, 79 AND 83 STE. CECILE ST.  
(PCA 1)
- APEC 2 - METAL FABRICATION OFF-SITE (PCA 2)

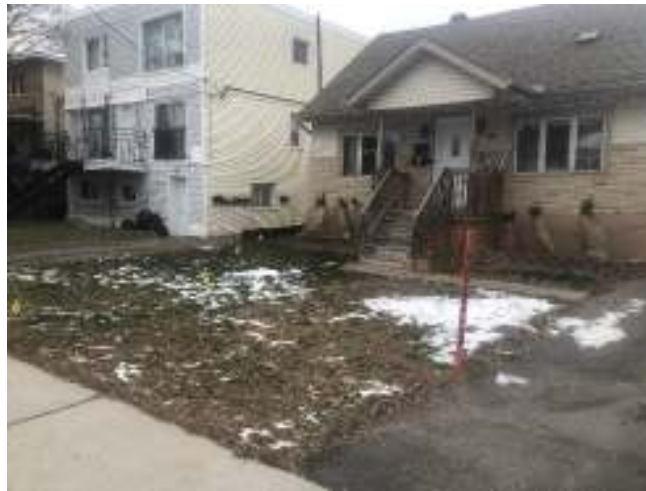
**Photograph 1:** Looking north at south end (front) of 73 Ste-Cecile Street. Neighboring property 71 Ste-Cecile to the left.

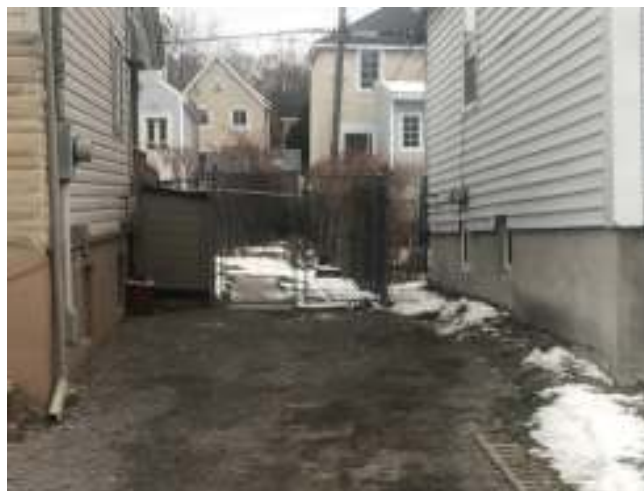
**Photograph 2:** Looking north down the gravel laneway between 73 and 79 Ste-Cecile. Note the natural gas meter located at the north west corner of 79 Ste-Cecile.

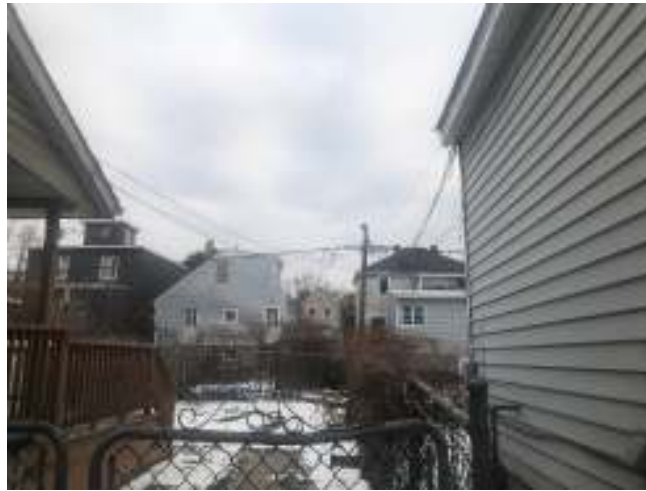
**Photograph 3:** Looking north into the backyard of 73 Ste-Cecile. Note the overhead communications wires running to both 73 and 79 Ste-Cecile as well as the wire mains traveling west and east along the north end of the property.

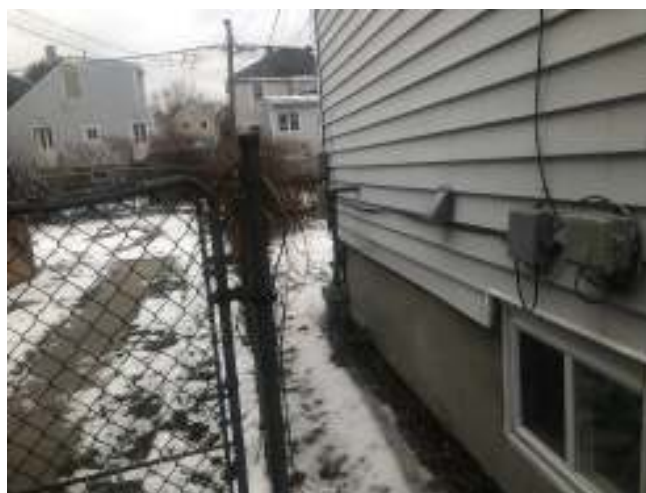
**Photograph 4:** Gas meter located at the north-west corner of 79 Ste-Cecile.

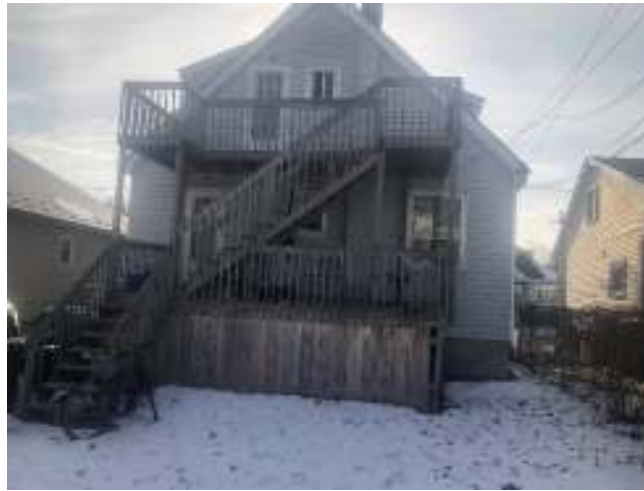
**Photograph 5:** Looking south at south rear wall of 79 Ste-Cecile.

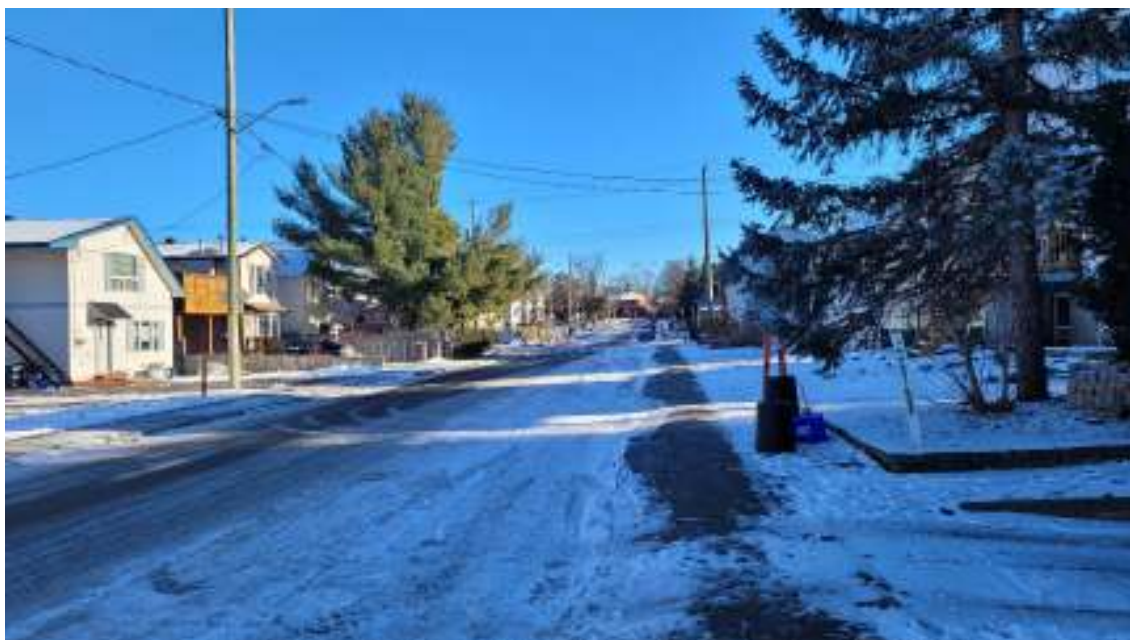
**Photograph 6:** Photograph looking south-east on south side of Ste-Cecile Street across from subject properties.

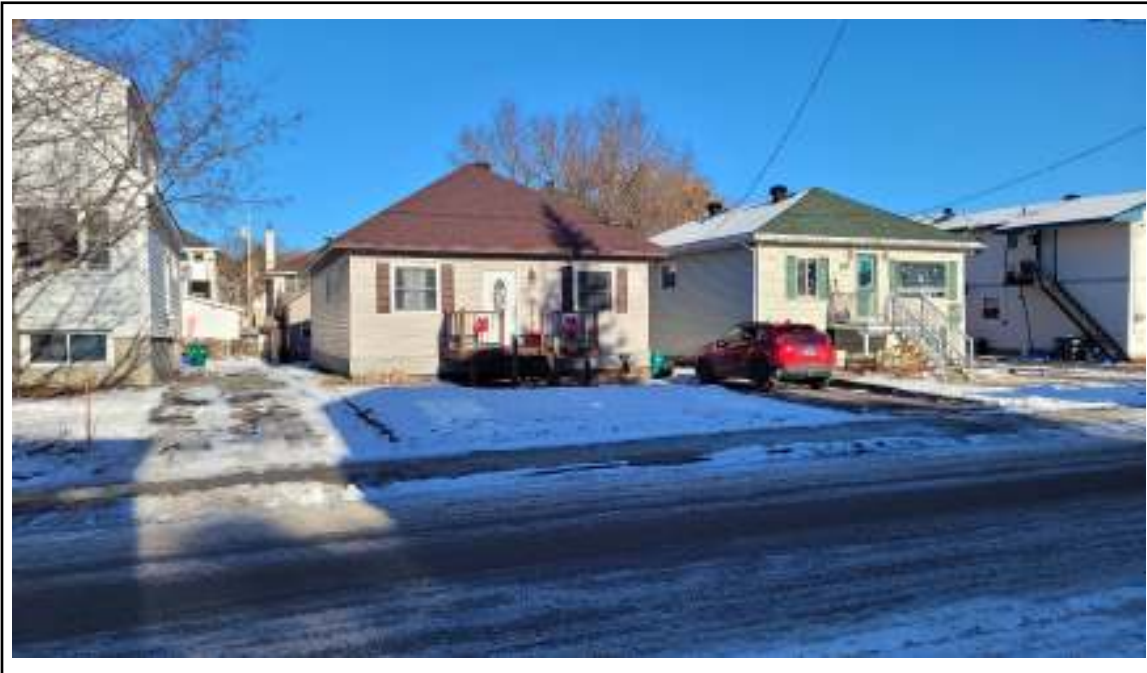
**Photograph 7:** Looking north-east from south side of Ste-Cecile Street with front (south) side of 83 Ste-Cecile Street in photo center, partial 79 Ste-Cecile on left.

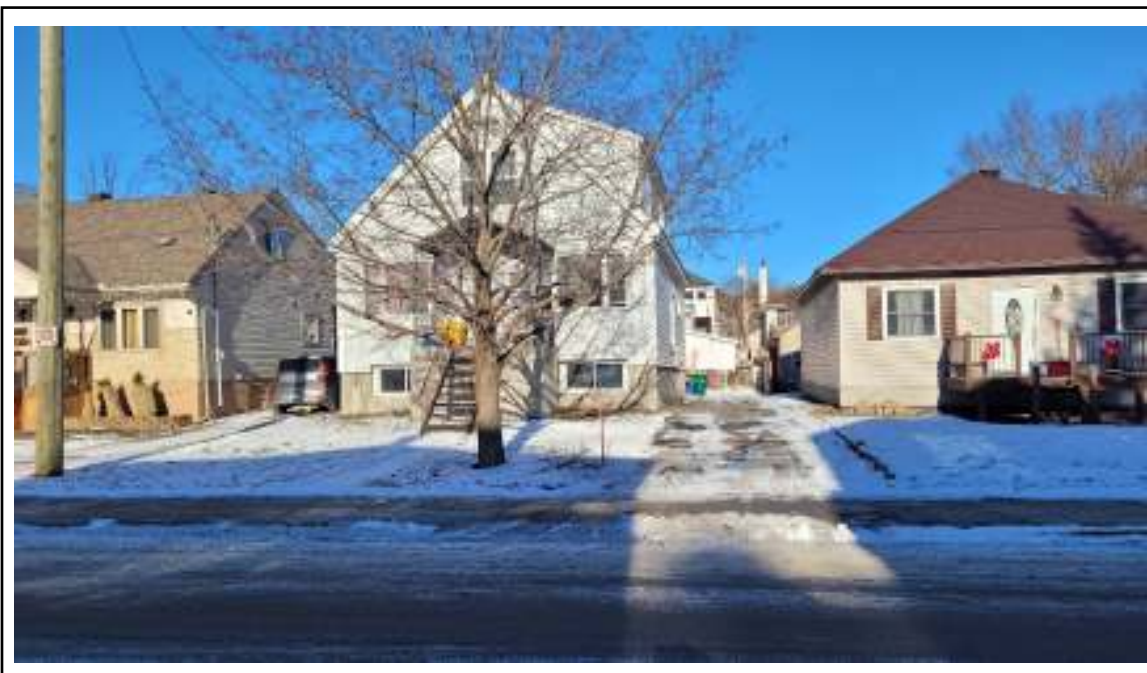
**Photograph 8:** Looking north-east from south side of Ste-Cecile Street with front (south) side of 79 Ste-Cecile in photo center, partial 73 Ste-Cecile on left and partial 83 Ste-Cecile on right.

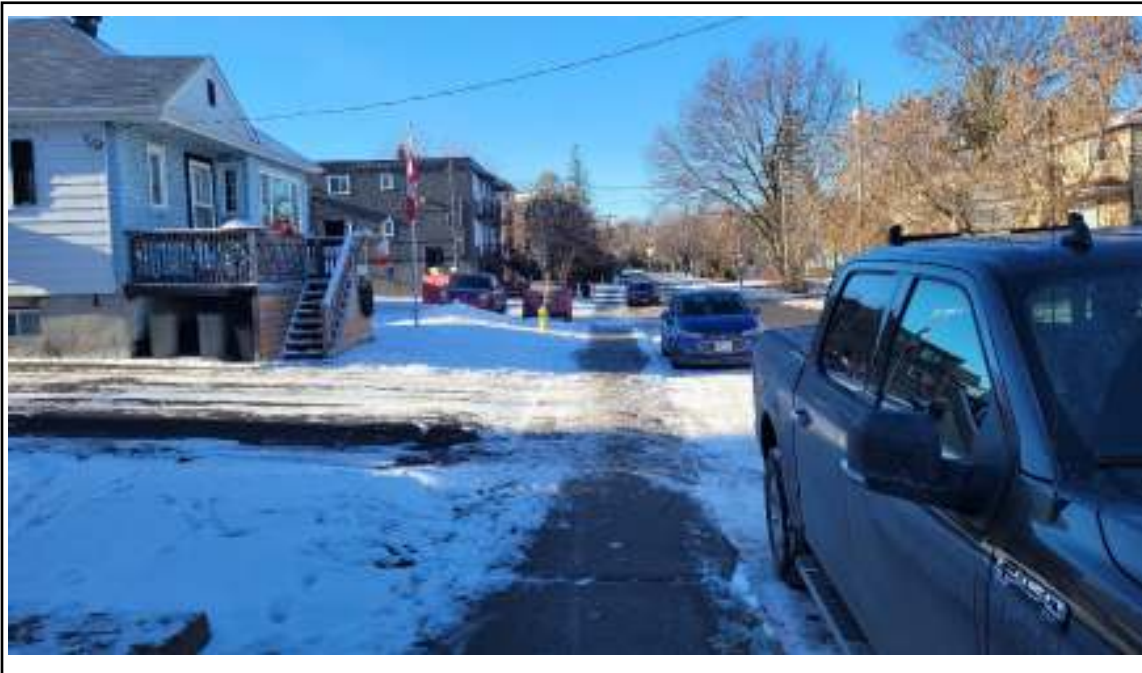
**Photograph 9:** Looking north-west along north side of Ste-Cecile Street.

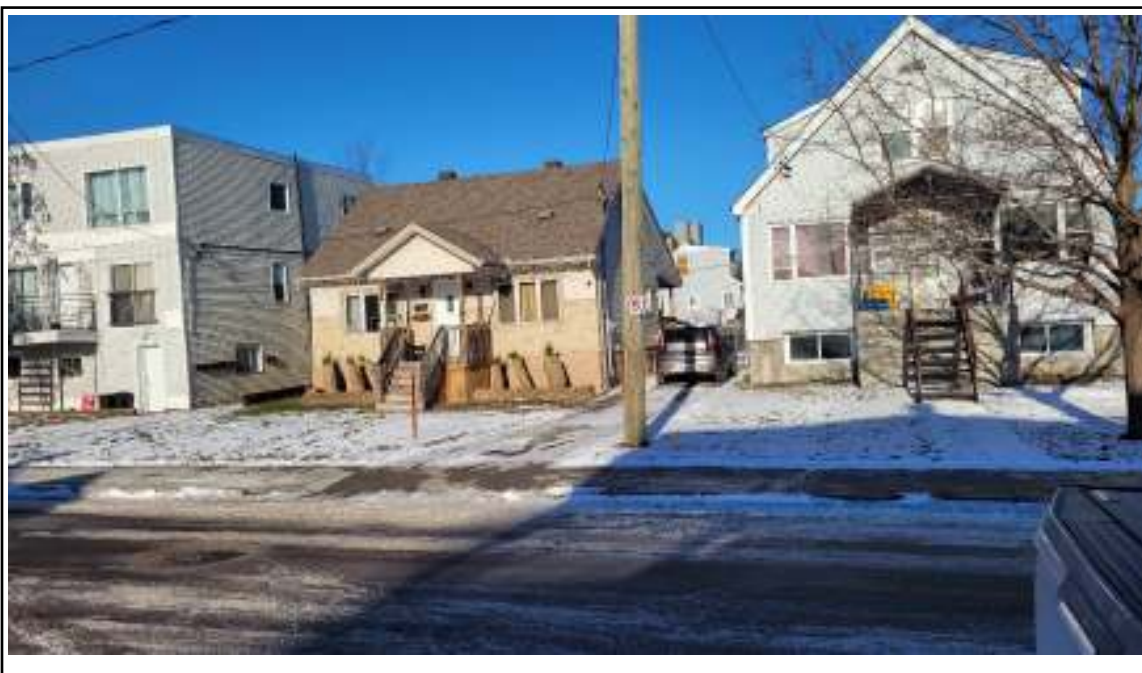
**Photograph 10:** View north-east from south side of Ste-Cecile Street with front (south) side of 73 Ste-Cecile in photo center and 79 Ste-Cecile on left. Sanitary sewer manhole in center of Ste-Cecile Street in front of 73 Ste-Cecile.

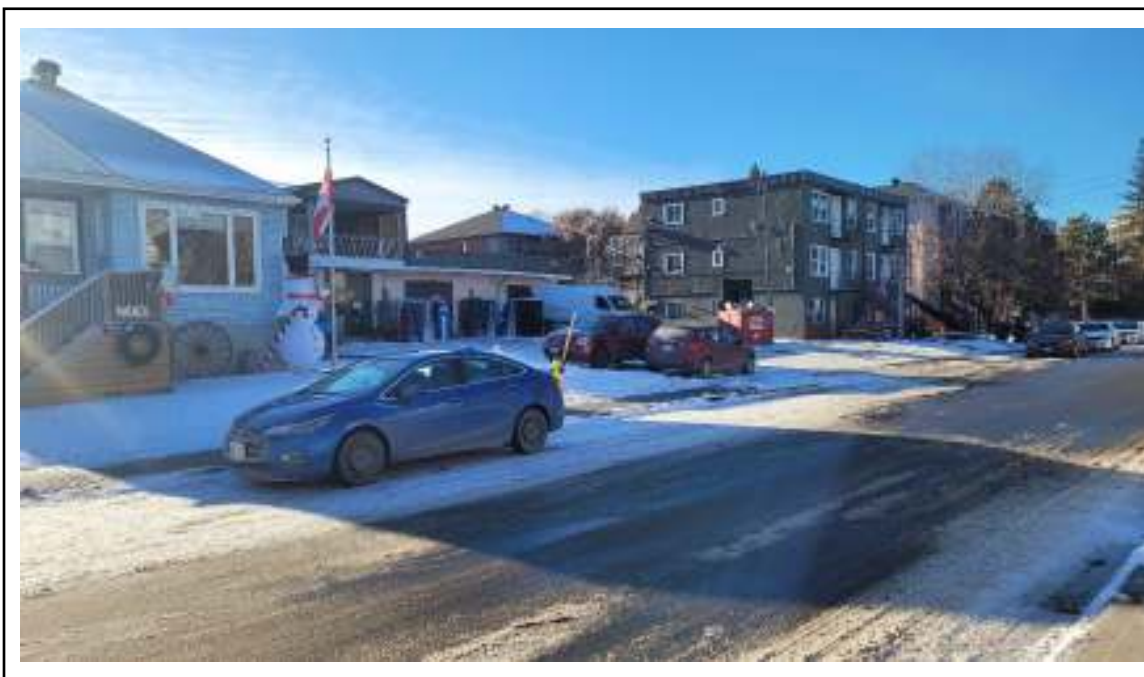
**Photograph 11:** View south-west from north side of Ste-Cecile Street in front of 73 Ste-Cecile. Storm drain catch basin is on lower right and 82 Ste-Cecile is in center, (former metal fabrication, current vending machine repair).

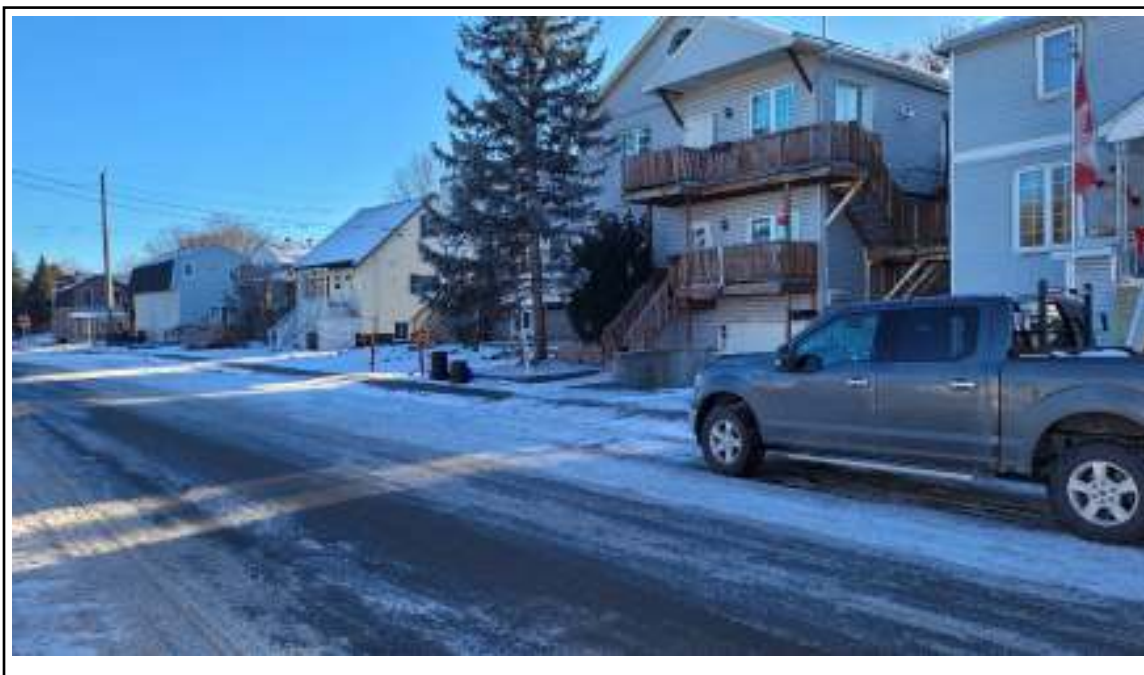
**Photograph 12:** View south-east from north side of Ste-Cecile Street in front of 73 Ste-Cecile. Residential properties on south side of street.

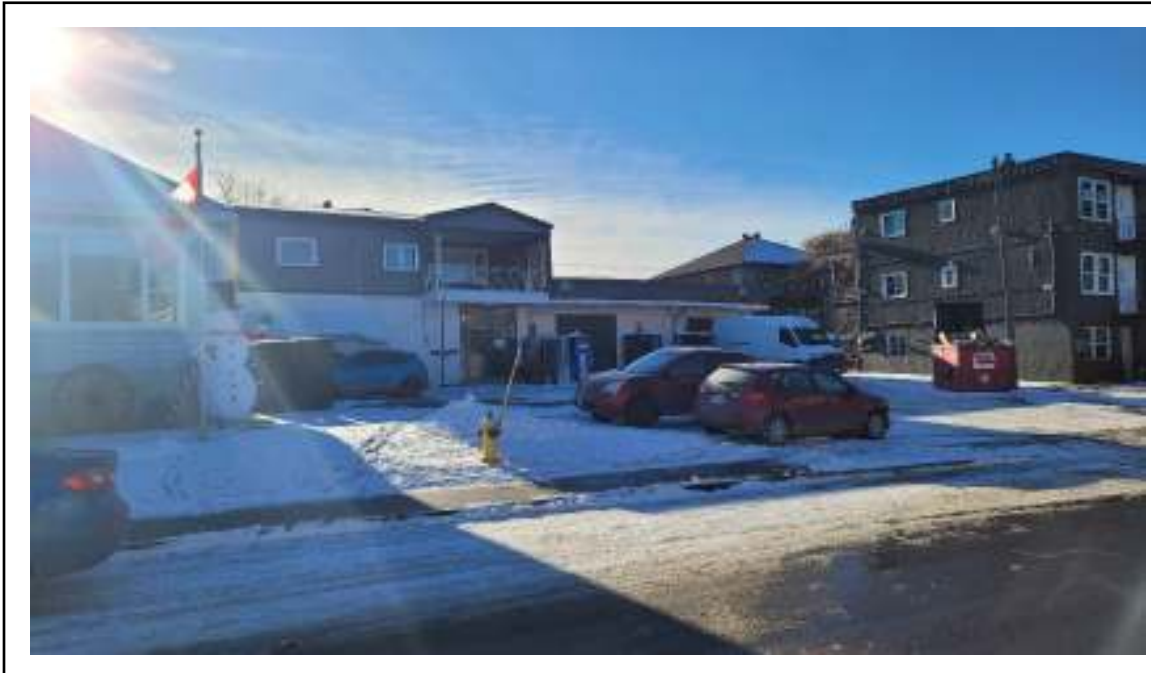
**Photograph 13:** View south-west from north side of Ste-Cecile Street at 82 Ste-Cecile, (former metal fabrication, current vending machine repair).

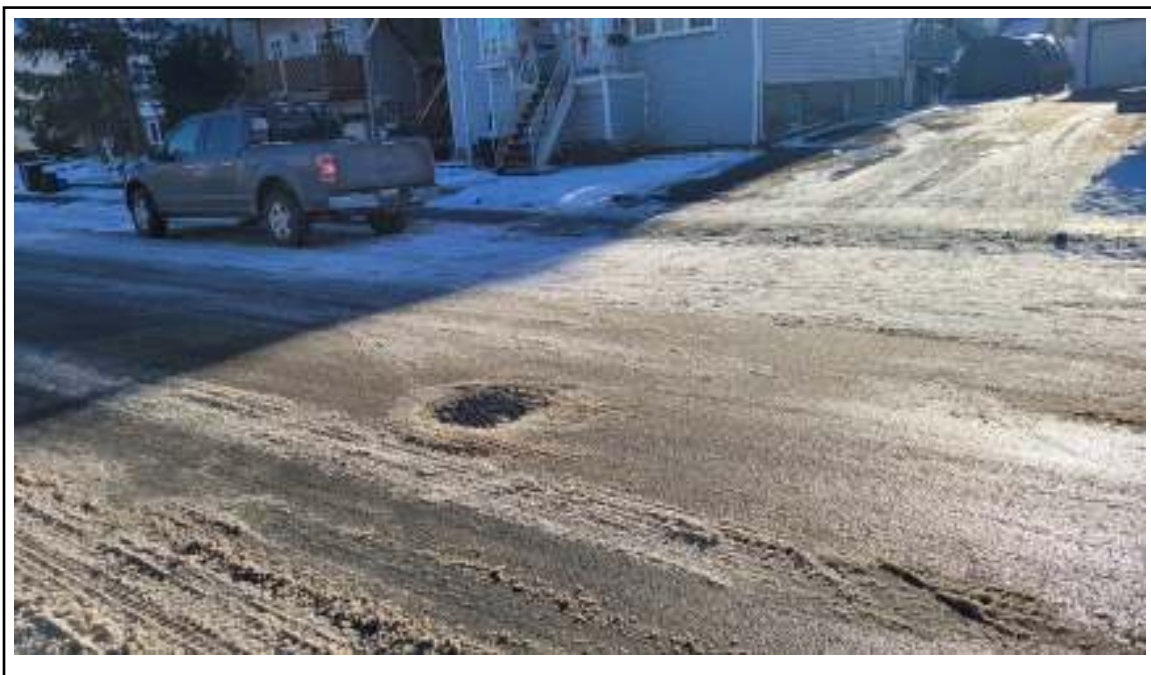
**Photograph 14:** View south-east of sanitary manhole in center of Ste-Cecile located in front of 73 Ste-Cecile.
