**Phase One Environmental Site Assessment  
Proposed Residential Development  
1174 Carp Road  
Ottawa, Ontario**

GEMTEC Project: 101785.004

November 21, 2024  
GEMTEC Project: 101785.004

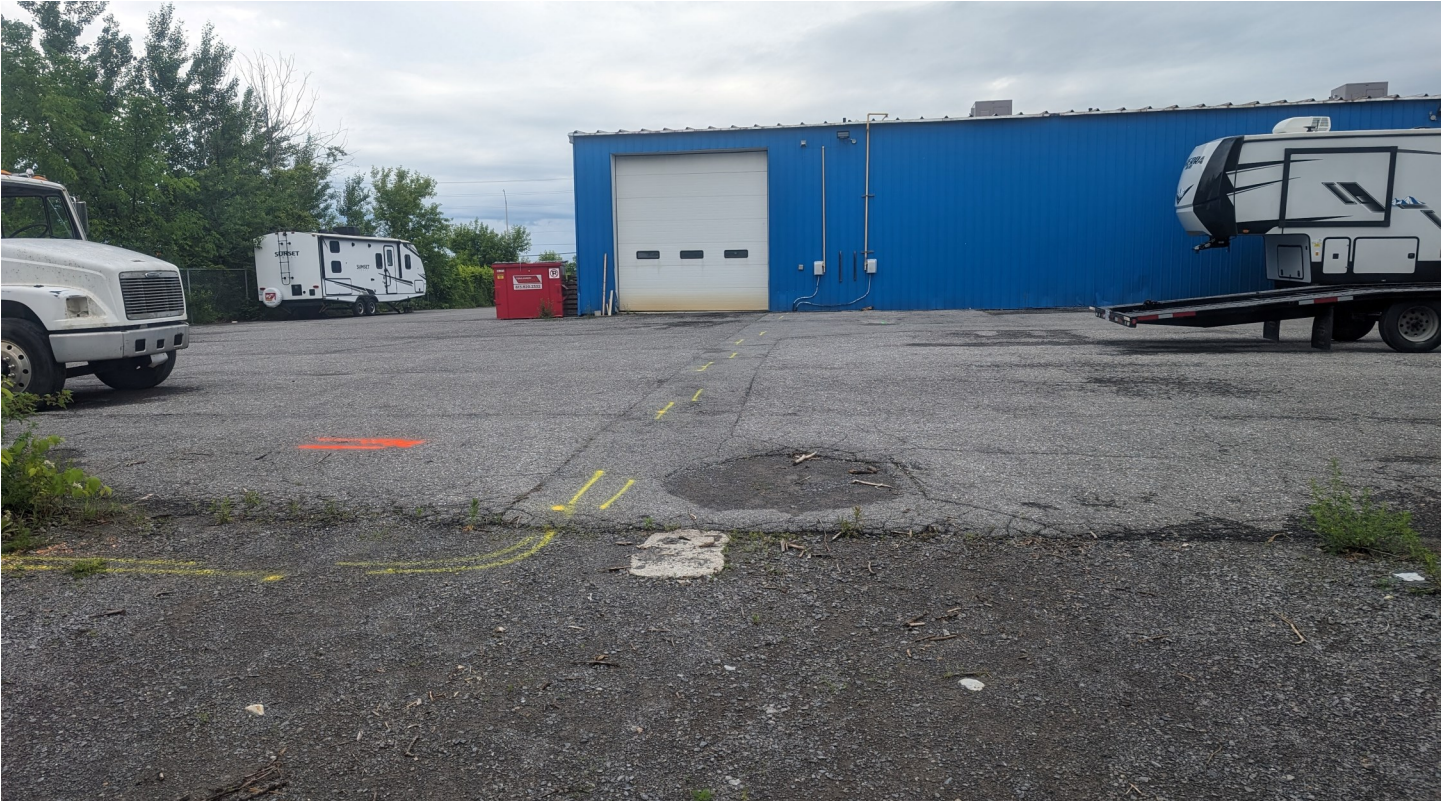
Photo K3 - Looking north towards the south building line of the on-Site structure. Abandoned gas lines were noted from the location of ASTs (noted as part of the review of aerial photographs between 2005 and 2022).

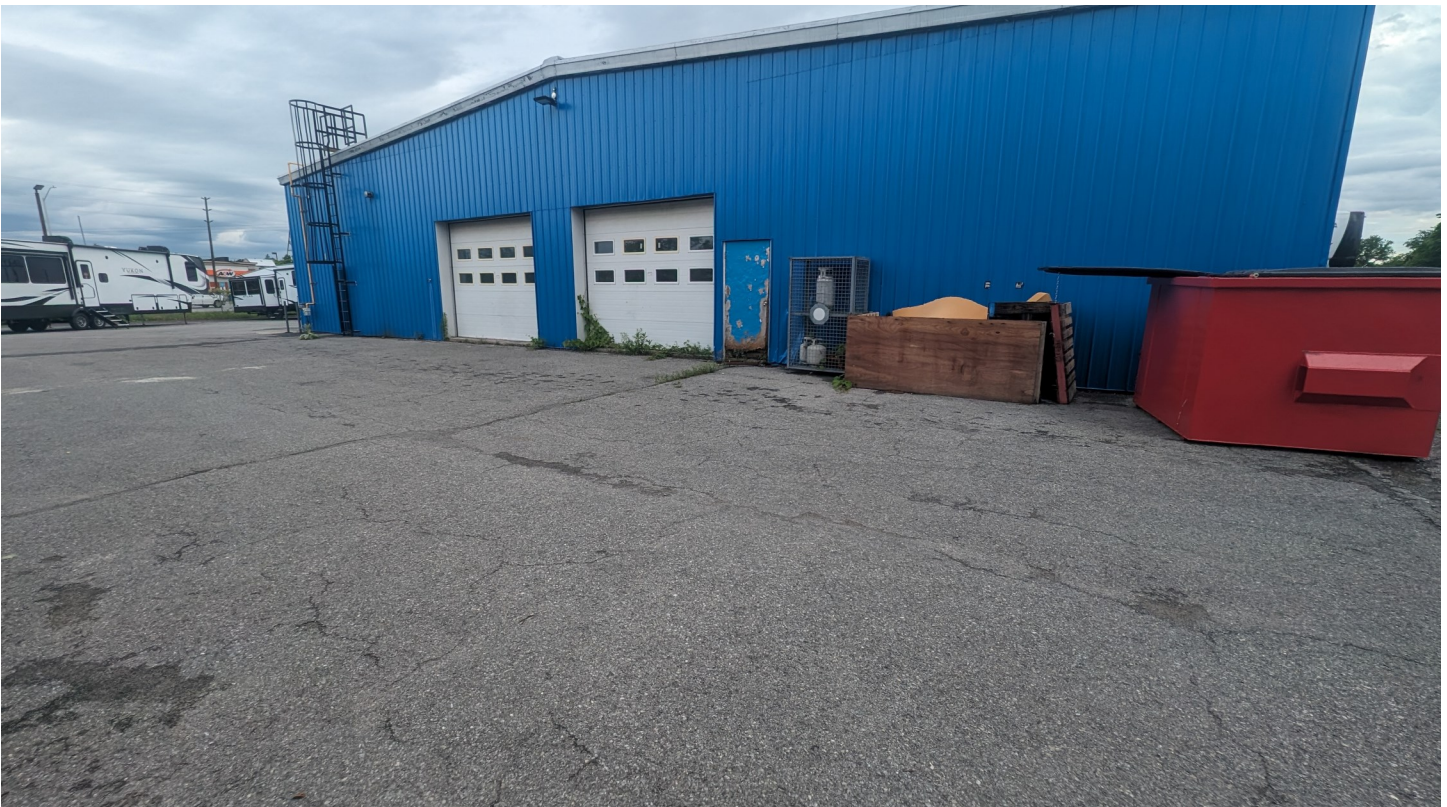
Photo K4 - Looking east towards the west building line of the on-Site structure. Gas meter can be seen to the left. Two bay doors were centrally located along the building line and propane cylinder storage.

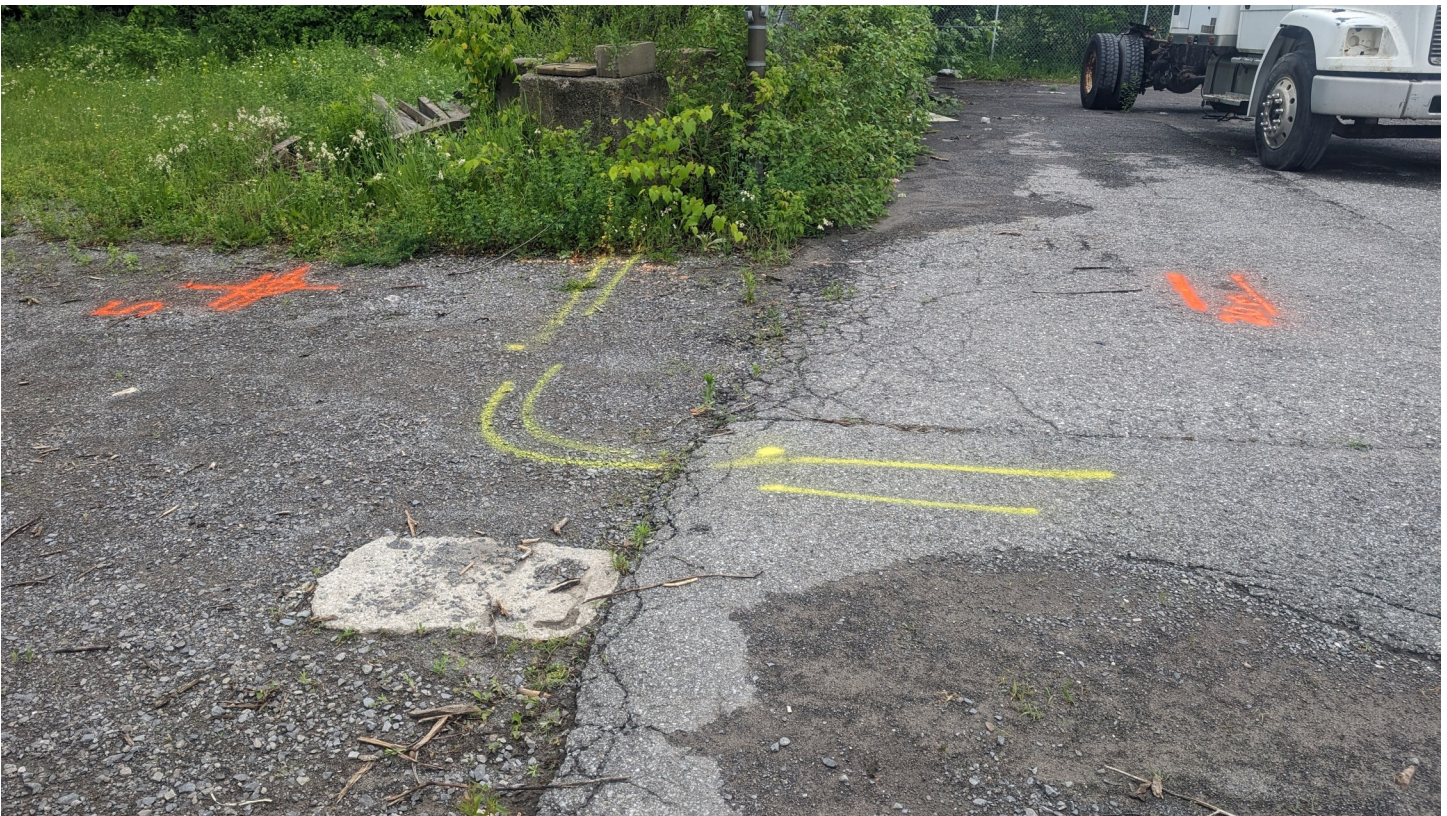
Through the review of aerial photographs, two ASTs were noted at the Site in the southwestern portion of the Site between 2005 and 2022. Considering the observations made during the review of aerial photographs and during Site reconnaissance, these ASTs were used for propane storage for heating considering the abandoned propane lines running towards the south building line of the on-Site structure. However, uncertainty remains with respect to the ASTs before GEMTEC's Phase I ESA in 2023. The COPCs are PHC F1-F4, VOCs, and PAHs in soil and groundwater.

Photo K6 - Looking west towards the approximate location of the AST (identified as part of the review of aerial photograph between 2005 and 2022). Abandoned gas lines were noted from the location of AST.

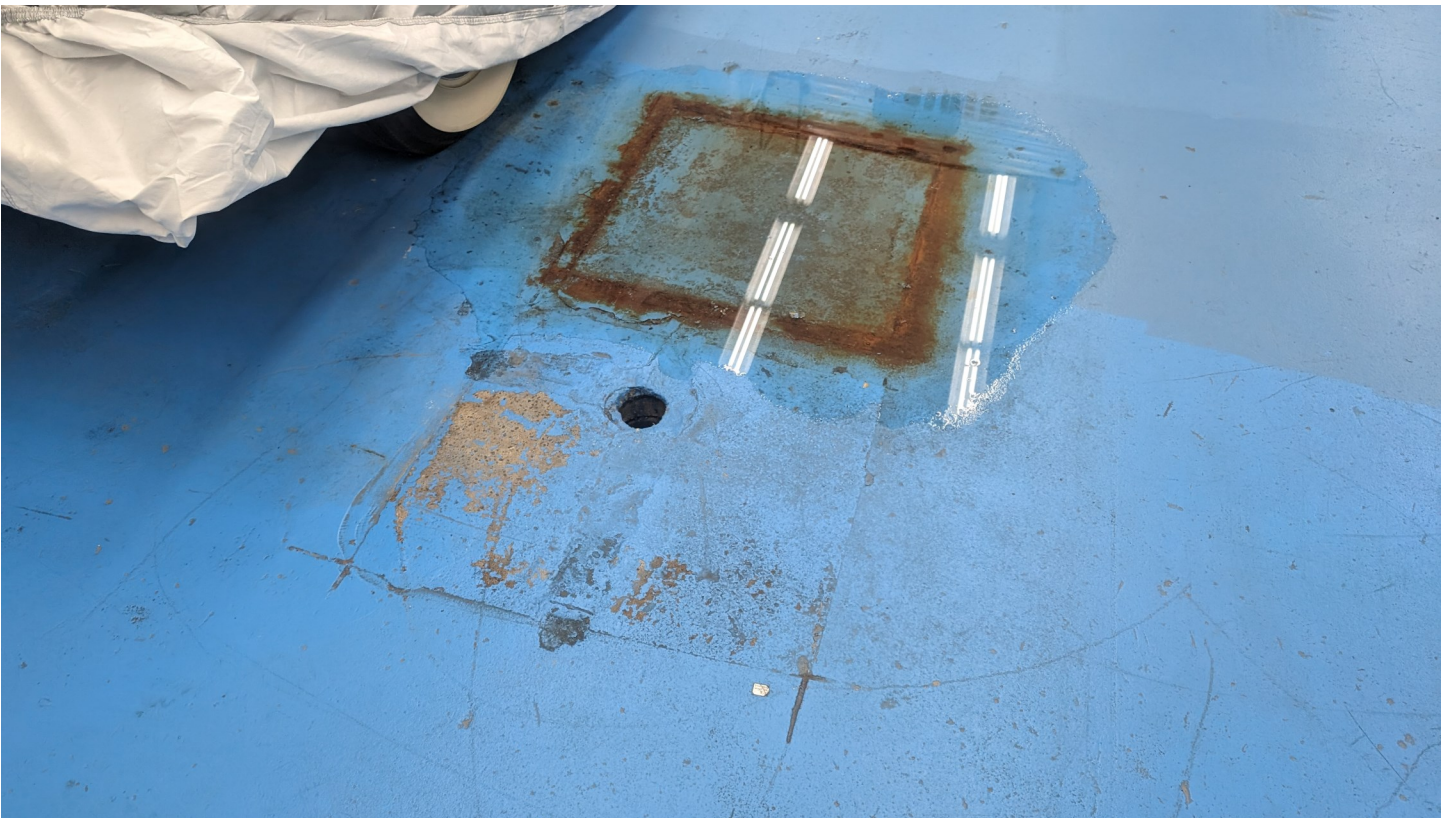
During the Site reconnaissance, GEMTEC noted a concrete filled pit, potentially related to an oil/water separator. The COPCs are PHC F1-F4, and VOCs in soil and groundwater.

Photo K8 - A cut out (potential location of the former oil water separator ) was noted in the floor of the building.

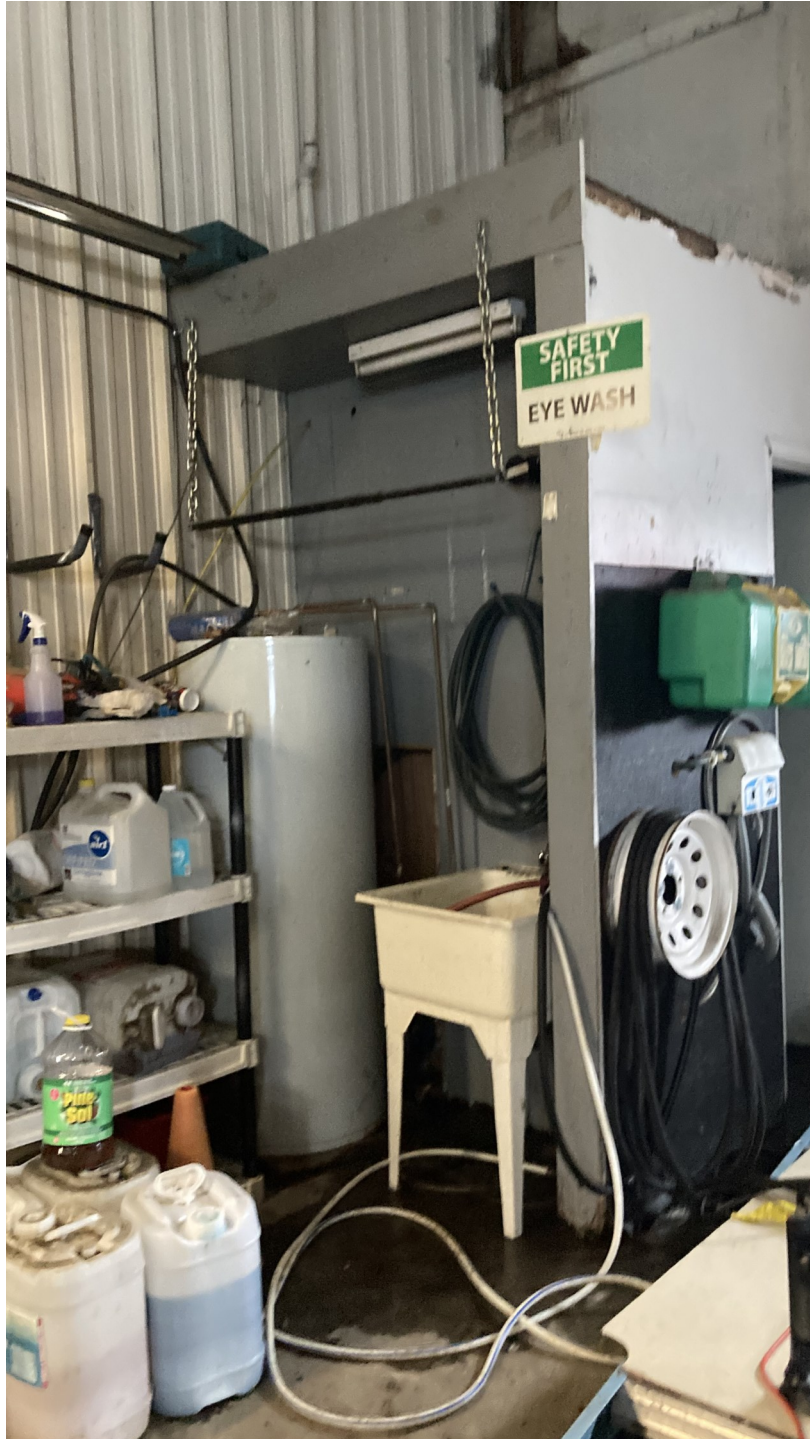
Photo K10 - Chemicals (basic repair shop products and general cleaning products) were stored on shelves and some water spillage was noted at the Site.

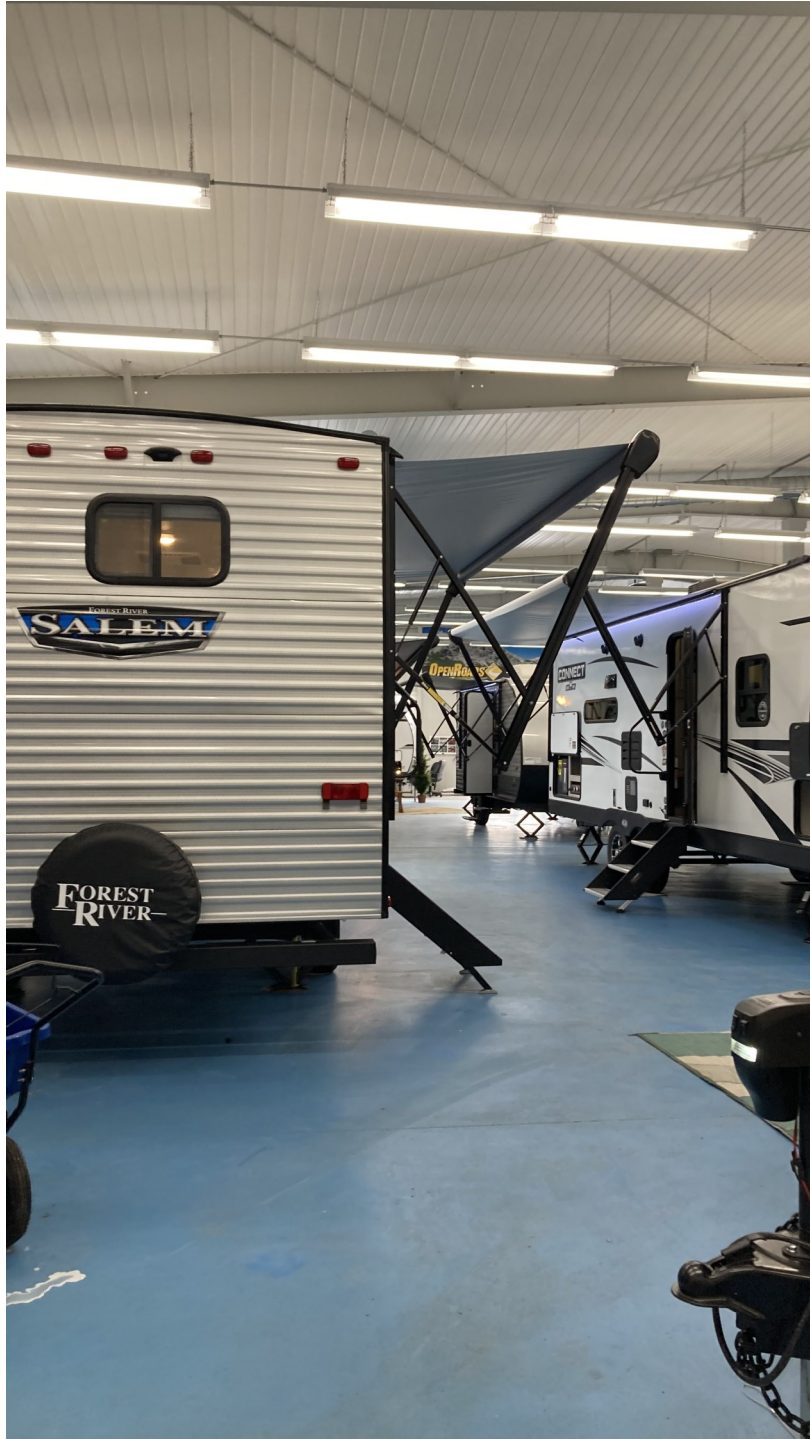
Photo K11 - The concrete floor was in a good condition with minimal cracking.

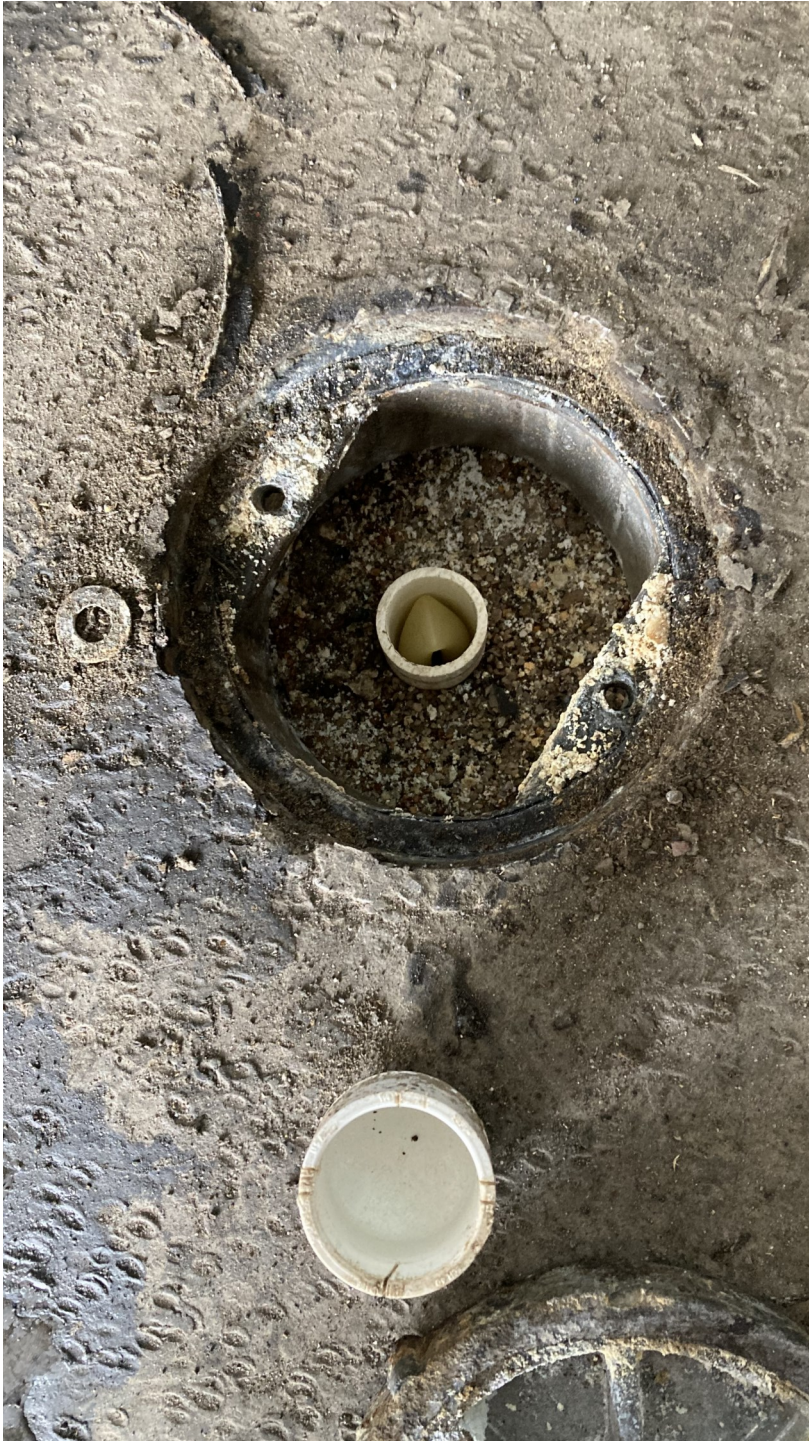
Photo K13 - A monitoring well installed during prior environmental investigations was noted at the Site.
