## Phase One Environmental Site Assessment 6659 Franktown Road, Ottawa, Ontario

Phase One Environmental Site Assessment

OTT-00243705-B0

August 9, 2023

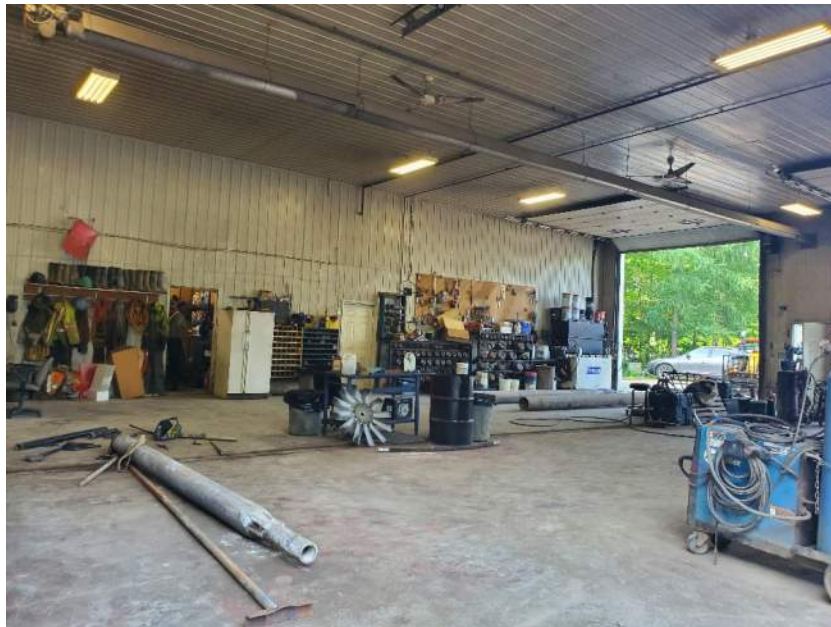
**Photograph No. 3**

View of the workshop interior

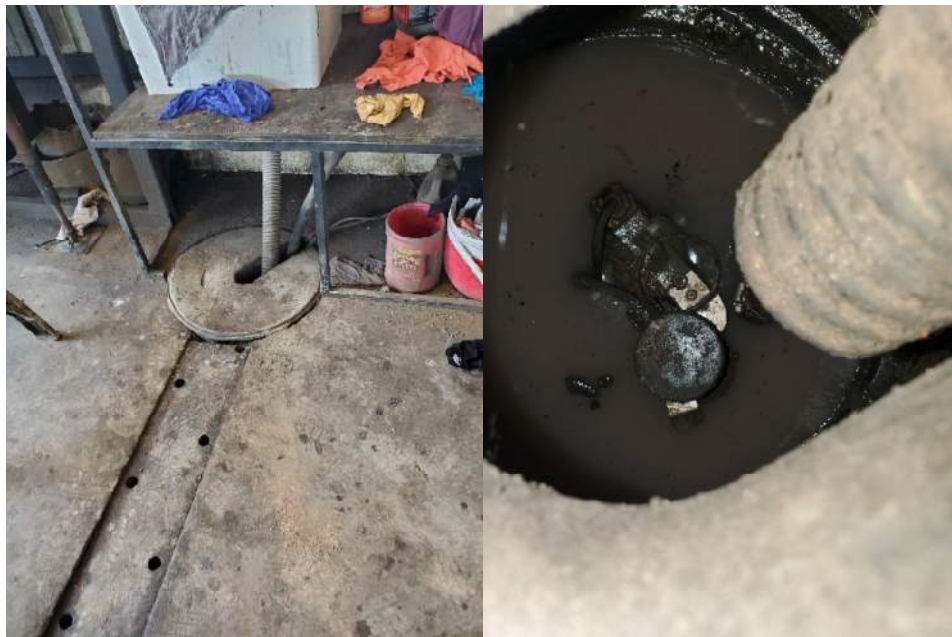
**Photograph No. 6**

View of the workshop sump pump (APEC-1)

The workshop present at the Phase One property is currently used for vehicle and equipment maintenance. The floor within the workshop was observed to be concrete with limited staining. The floor was observed to be installed with a trench drain which discharges into the sump pit located within the workshop. The sump discharges to the ground outside the workshop after being filtered, it represents an APEC (APEC 1).

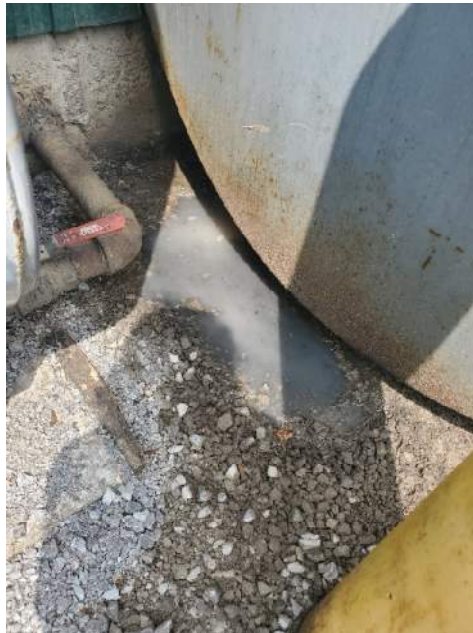
**Photograph No. 7**

View of workshop sump discharge (APEC 1)

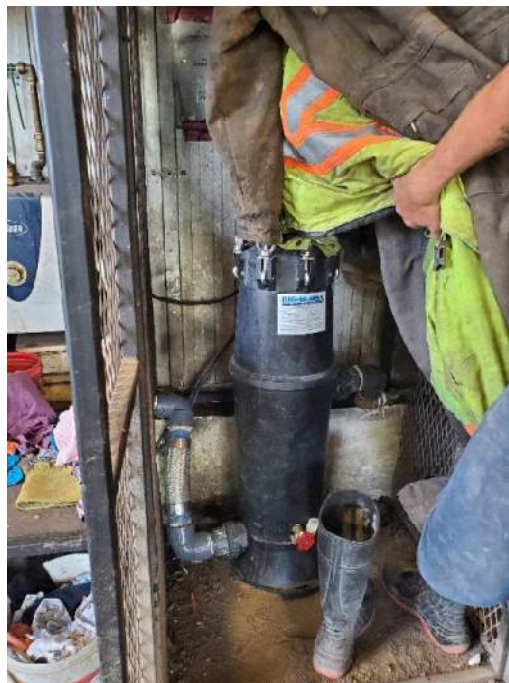
**Photograph No. 8**

View of workshop sump filter

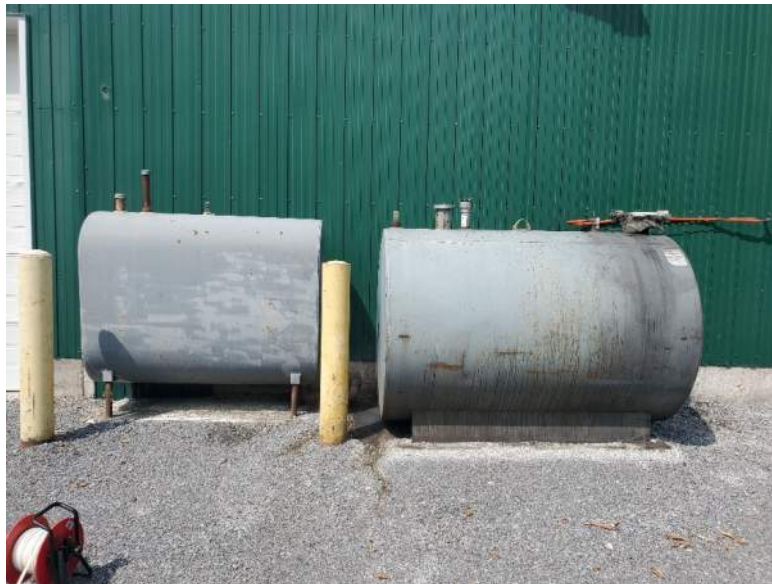
**Photograph No. 9**

View of the AST 1-2

- ASTs 1 and 2: These tanks were observed to be installed on undersized concrete pads with gravel, which were observed to be in good condition with no evident staining. However, the small nature of the concrete pads and the lack of secondary containment pose an APEC (APEC 2)

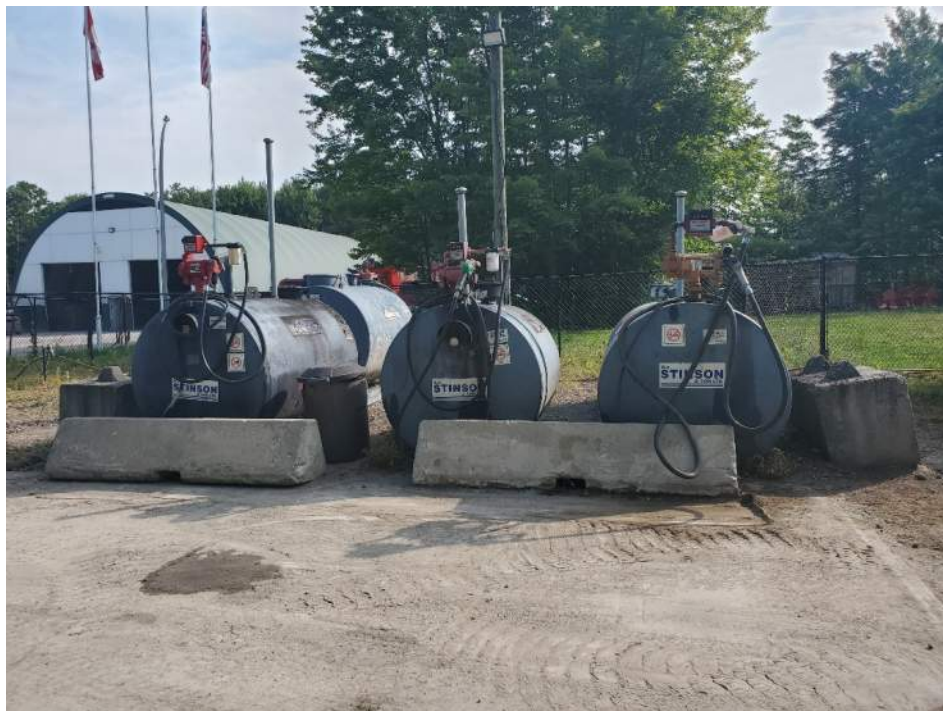
**Photograph No. 10**

View of AST 3-6

- AST-3 to AST-6: These tanks were observed to be installed on the west side of the access road on gravel. However, the fueling area (where vehicles would park during refuelling) was observed to be a concrete pad that was in good condition with minor staining observed. During the site visit, evidence of minor diesel spills was observed on some of the ASTs. Based on the observed staining combined with the eighteen year operation of the ASTs with a lack of proper secondary containment, results in these ASTs being considered APECs (APEC 3, AST-3 to AST-6).

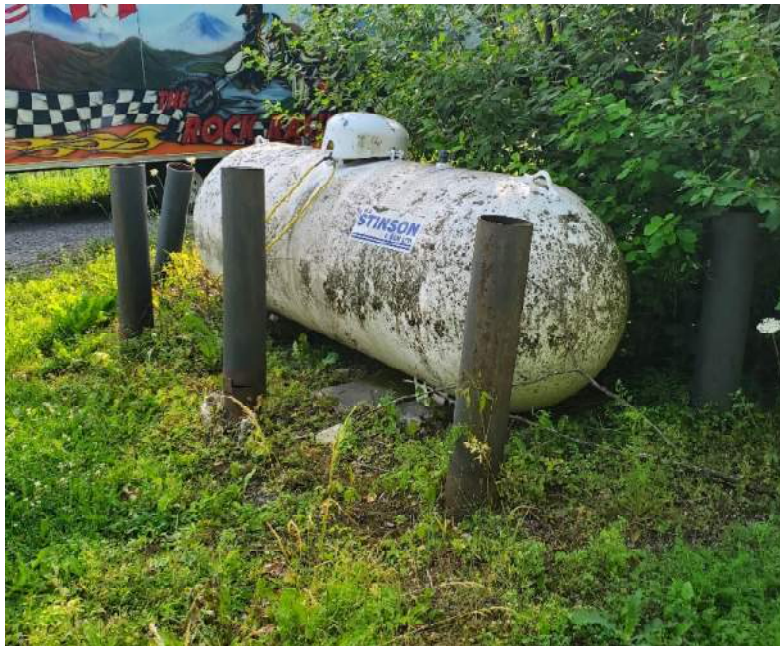
**Photograph No. 11**

View of abandoned AST

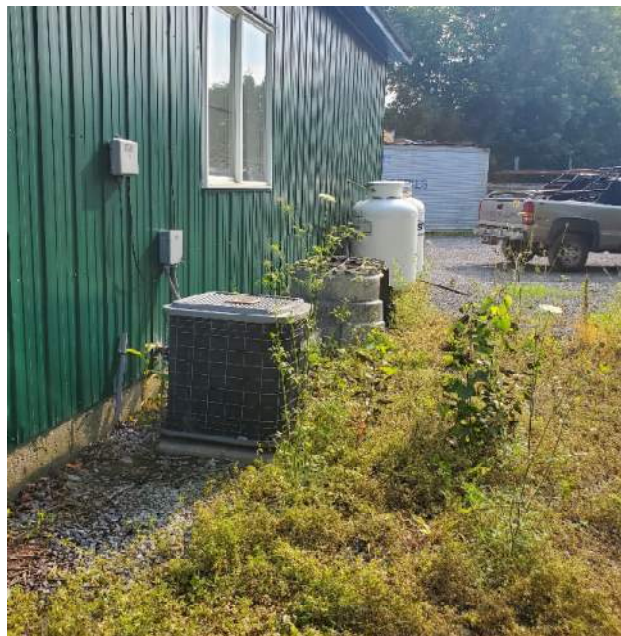
**Photograph No. 12**

View of A/C unit and propane tanks outside (SE) of workshop and office building

Heating within the residence is provided by geothermal heating and cooling is provided by a central air conditioning unit. The workshop area was observed to be heated with a waste oil heater, the office area was found to be heated by propane. The office portion of the building was also observed to be cooled by a central air conditioning unit. Heating or cooling sources were not observed within the Quonset building, the building is ventilated by passive vent openings on either end.
