**Phase One Environmental Site Assessment  
Proposed Chicken Processing Plant  
3043 Dunning Road  
Ottawa, Ontario**

June 20, 2024  
Project: 100117.056

**Re: Phase One Environmental Site Assessment  
Proposed Chicken Processing Plant  
3043 Dunning Road  
Ottawa, Ontario**

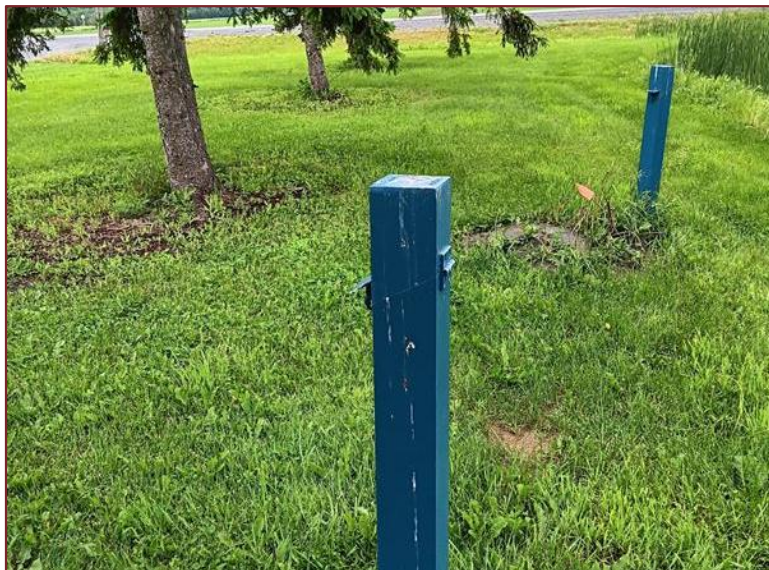
Photograph L1 – Looking west along the Dunning Road. View of two monitoring wells and a small ditch along Dunning Road..

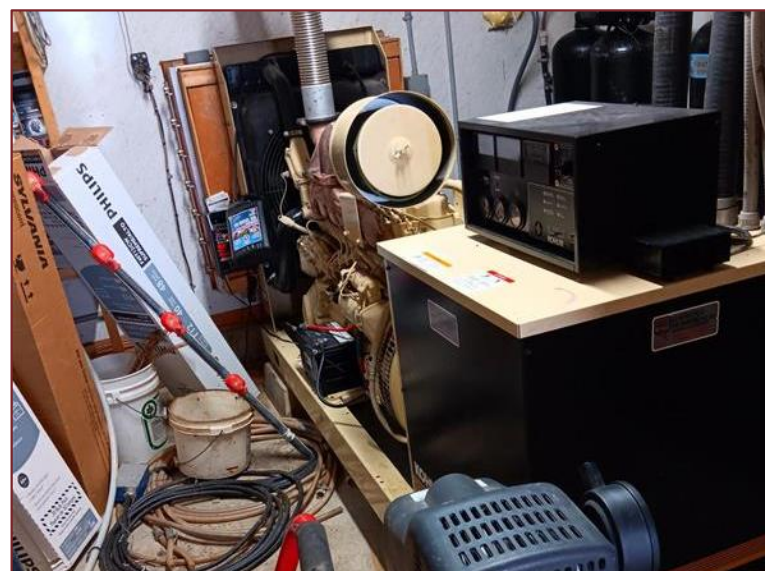
Photograph L4 – Generator used on site property. Stored within barn

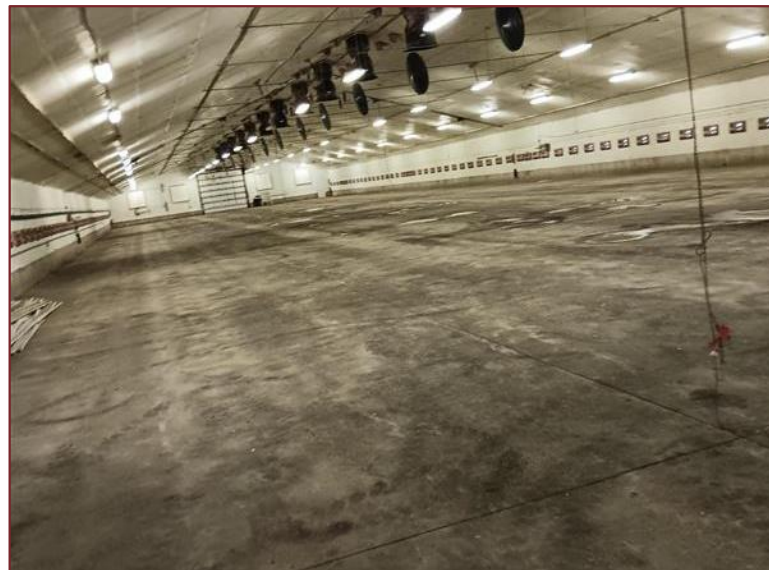
| Photo Number | Compass Orientation | Description |
|---|---|---|
| 6 | East | Looking west inside the barn. Slab floor on grade. Venting overhead and vent windows along wall. Some staining from agricultural practices. |

Photograph L6– Looking west inside the barn. Slab floor on grade. Venting overhead and vent windows along wall. Some staining from agricultural practices.

inside flooring was concrete with staining (likely from chickens and general operations) and minimal cracking. There are drains located the edges of the barn that lead outdoors (Mr. Robert Laplante stated that they are clogged and not in use).

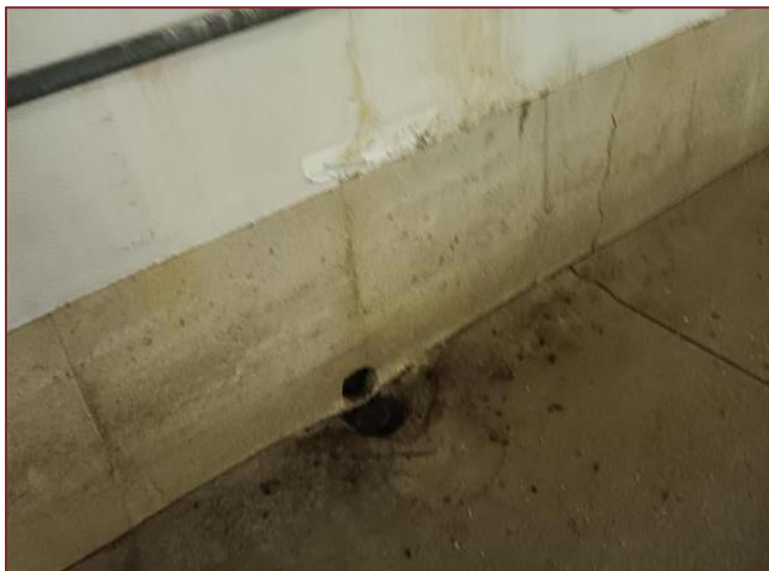
Photograph L7 – Looking north inside the bar. A drain located at the intersection of wall and floor. Multiple drains are within the barn. Piping for water above drain and below venting window.

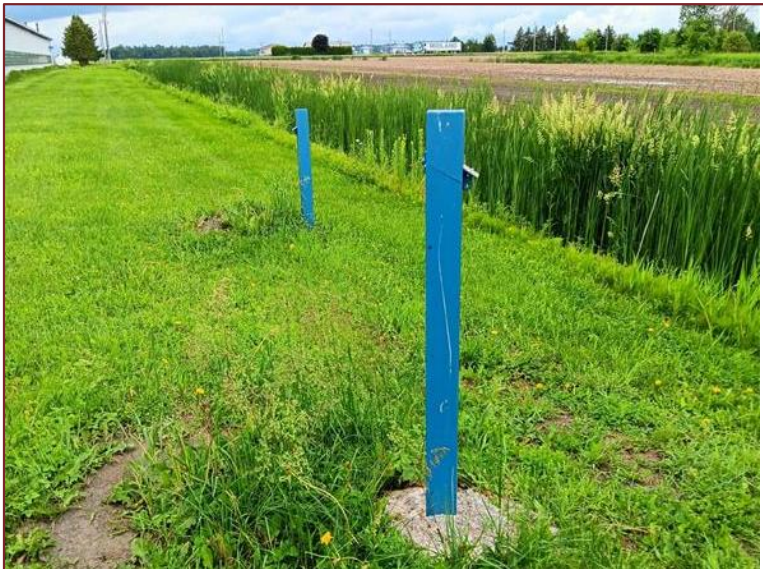
Photograph L9 – Looking west along the Dunning Road. View of a monitoring well and a small ditch along Dunning Road

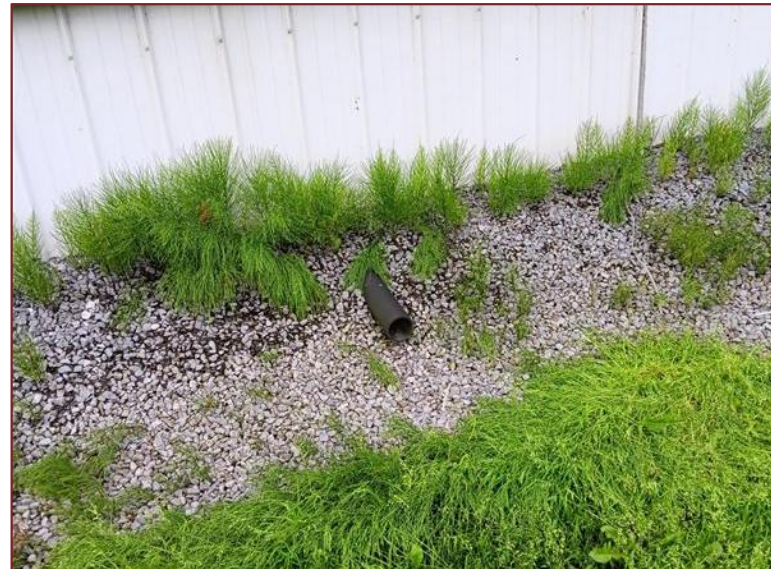
Photograph L10 – Looking south at the barn. Drain exit from the inside of the barn

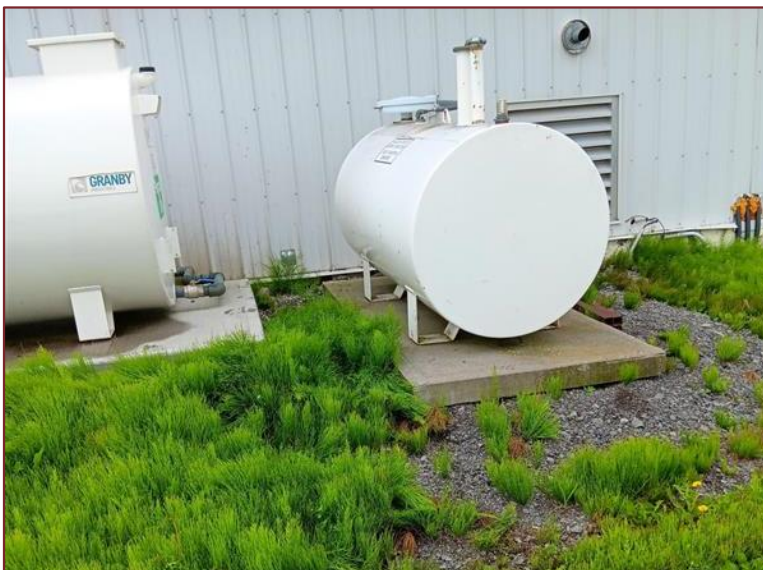
Photograph L11 – Looking south towards the diesel storage tank on concrete slab.

Adjacent to the barn (north) are two aboveground storage tank (ASTs). A 4,550 liter (L) storage tank with furnace oil and a 1,360 L storage tank for diesel. Both were on concrete slab on grade which has minimal to no cracking and no staining from the tank contents were noted.

Through the review of information (aerial photographs, Site reconnaissance, and Interview), the Site has two ASTs. No evidence of staining, spills or odours were noted at the time of the Site reconnaissance. The COPCs are PHC F1-F4, BTEX, Metals, and PAHs in soil and groundwater.

Adjacent to the barn (north) are two ASTs. A 4,550 L storage tank with furnace oil and a 1,360 L storage tank for diesel. Both were on concrete slab on grade which has minimal to no cracking and no staining from the tank contents were noted.

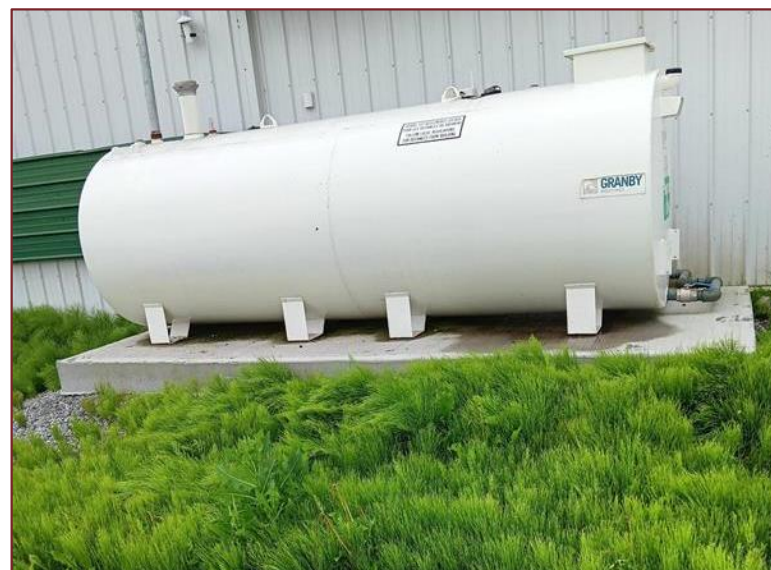
Photograph L12 – Looking south towards the furnace oil storage tank on concrete slab.

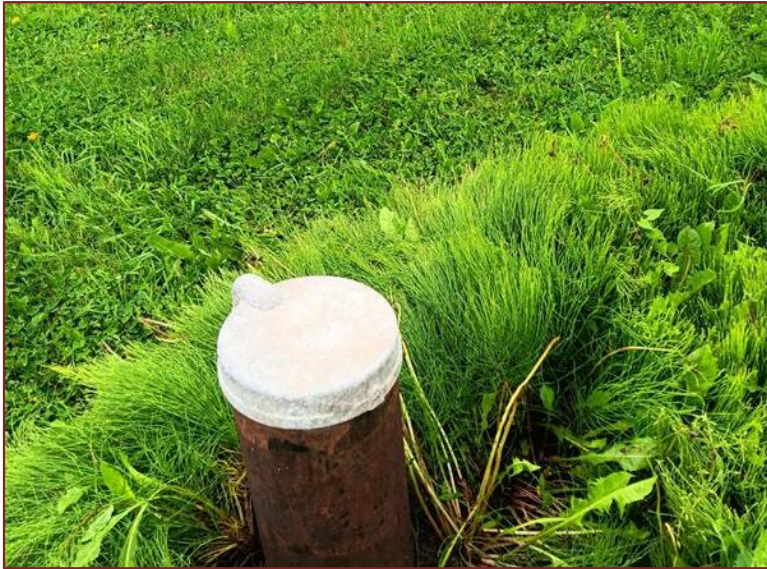
Photograph L13 -Looking south towards the two storage tank with an old well. .

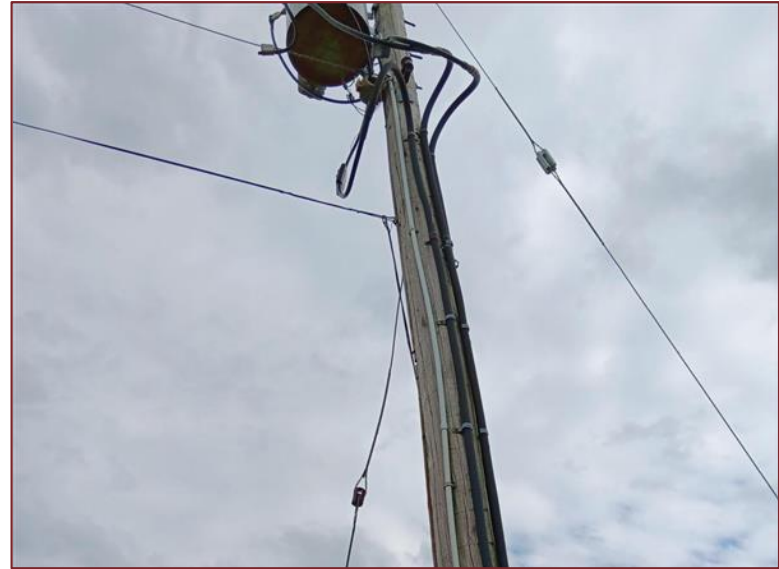
| Photo Number | Compass Orientation | Description |
|---|---|---|
| 14 | North | Looking north, up the pole. An electrical transformer on the pole with no staining seen on the wood below it. |

Photograph L14 – Looking north, up the pole. An electrical transformer on the pole with no staining seen on the wood below it..

Through the review of information (Site reconnaissance), there is a pole mounted transformer on the north of the border. No evidence of staining on the pole below the transformer or stressed vegetation in the area. The COPCs are polychlorinated biphenyls (PCBs).

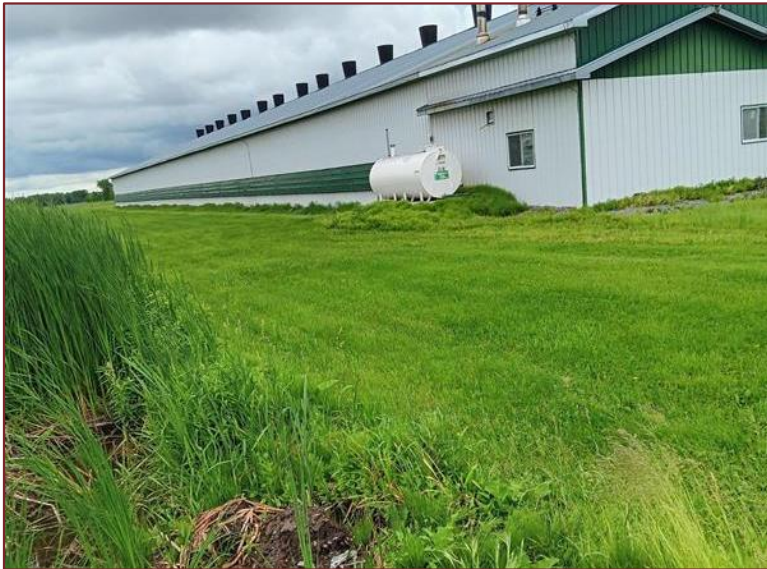
Photograph L15 – Looking south at the adjacent barn's furnace oil tank.  
Parcels of land are separated by a small ditch.
