Report

Trail Road Battery Energy Storage System (BESS)  
Fluvial Geomorphology Assessment

H375035-0000-2B0-066-0001

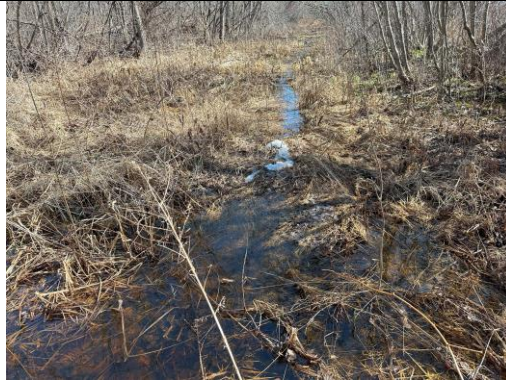
**Photo 20:** View looking east at the south site boundary from location S9, showing the head of a secondary reach of the creek that initiates on-site and flows eastward on April 7, 2025.
