# Phase One Environmental Site Assessment

8599 & 8600  
Jeanne D'Arc  
Boulevard  
Ottawa, Ontario

Prepared for:  
3223701 Canada Inc.

LOP22-024A

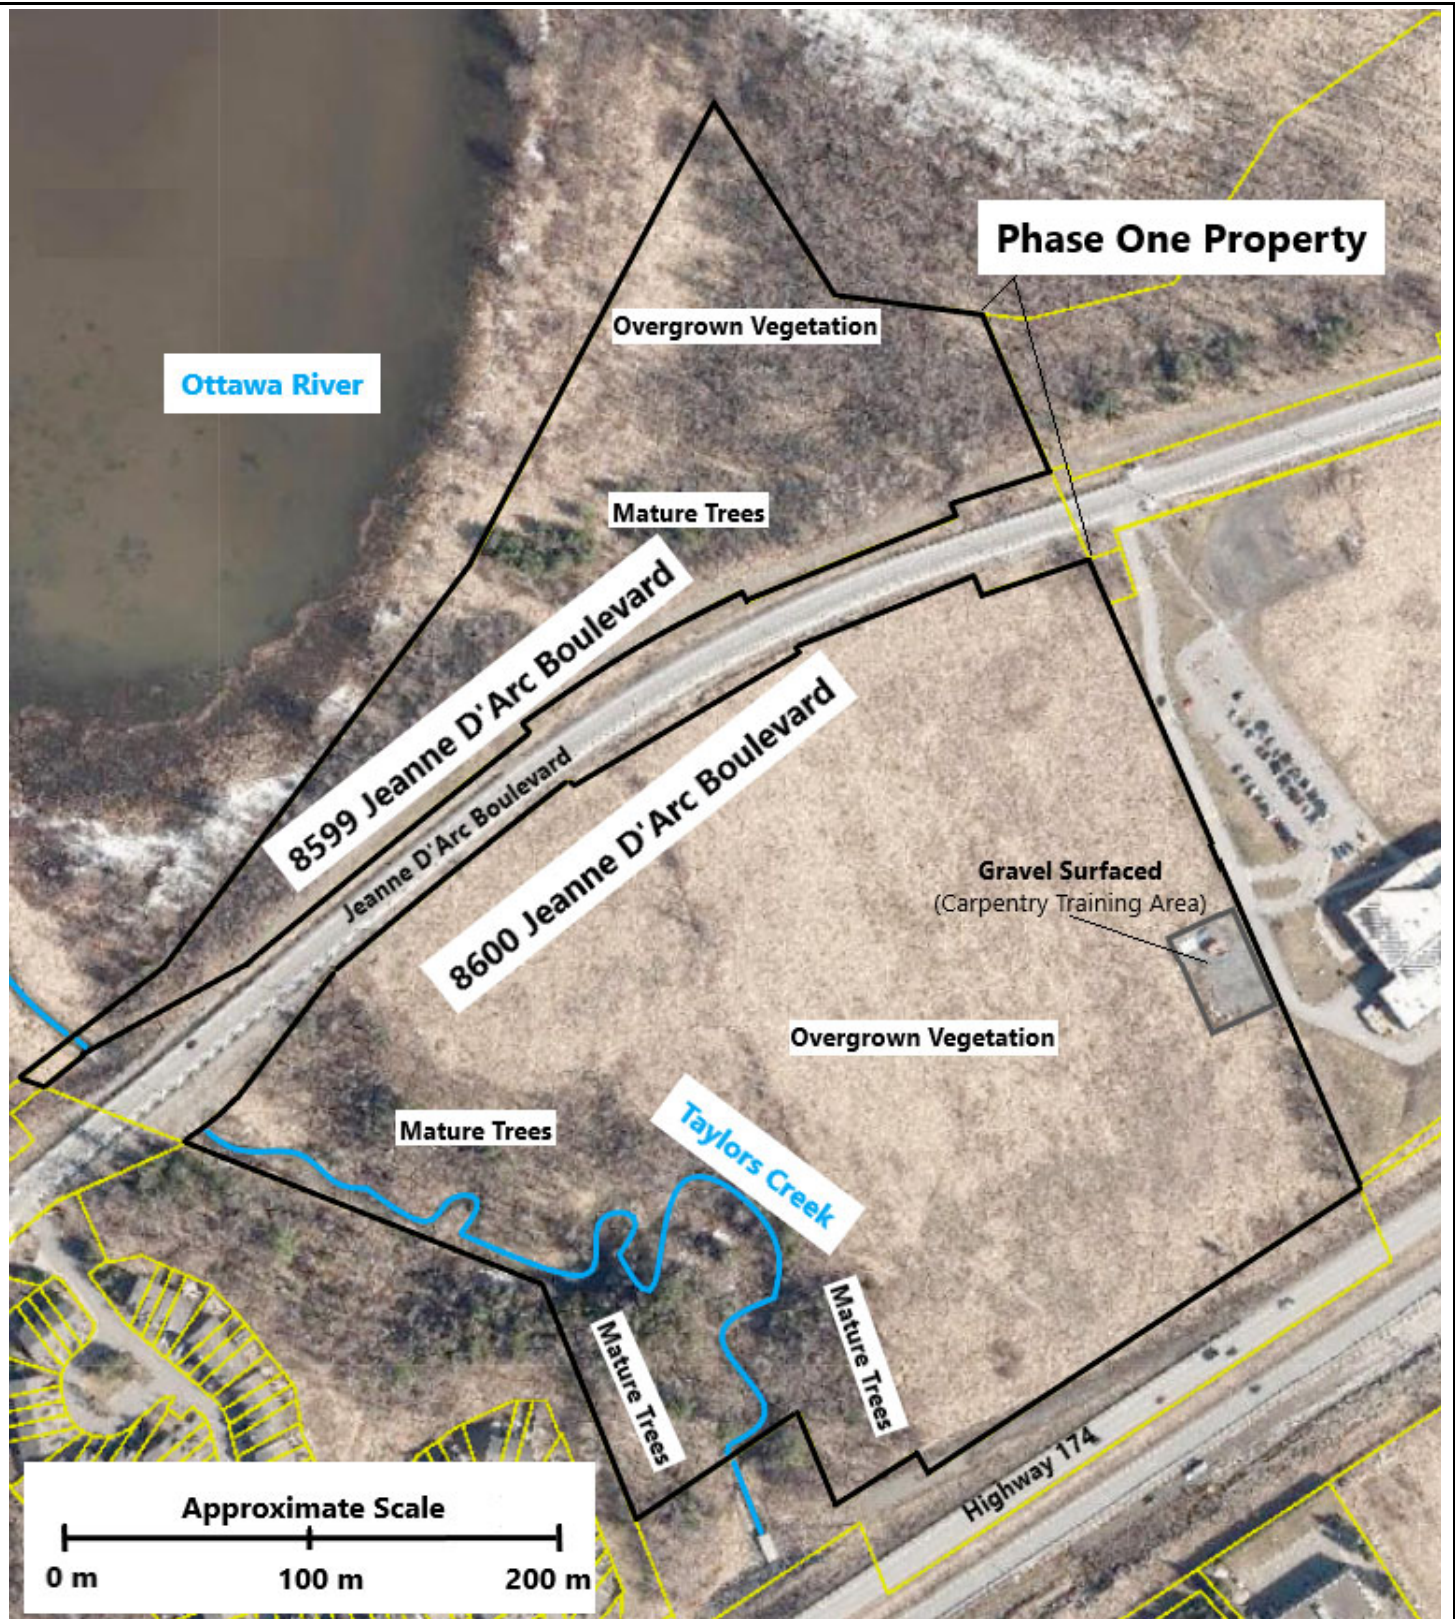
**Figure 2: Site Plan**  
Phase One Environmental Site Assessment  
8599 & 8600 Jeanne D'Arc Boulevard, Ottawa, Ontario  
3223701 Canada Inc.

Three Figures are provided to visually depict the Conceptual Site Model. Figure 1: Key Plan shows the location of the Phase One Property within the City of Ottawa. Figure 2: Site Plan depicts the current general conditions and environmentally significant features at the Phase One Property. Figure 3: Surrounding Land Use shows the current uses of properties in the Phase One Study Area, and the location of PCAs.

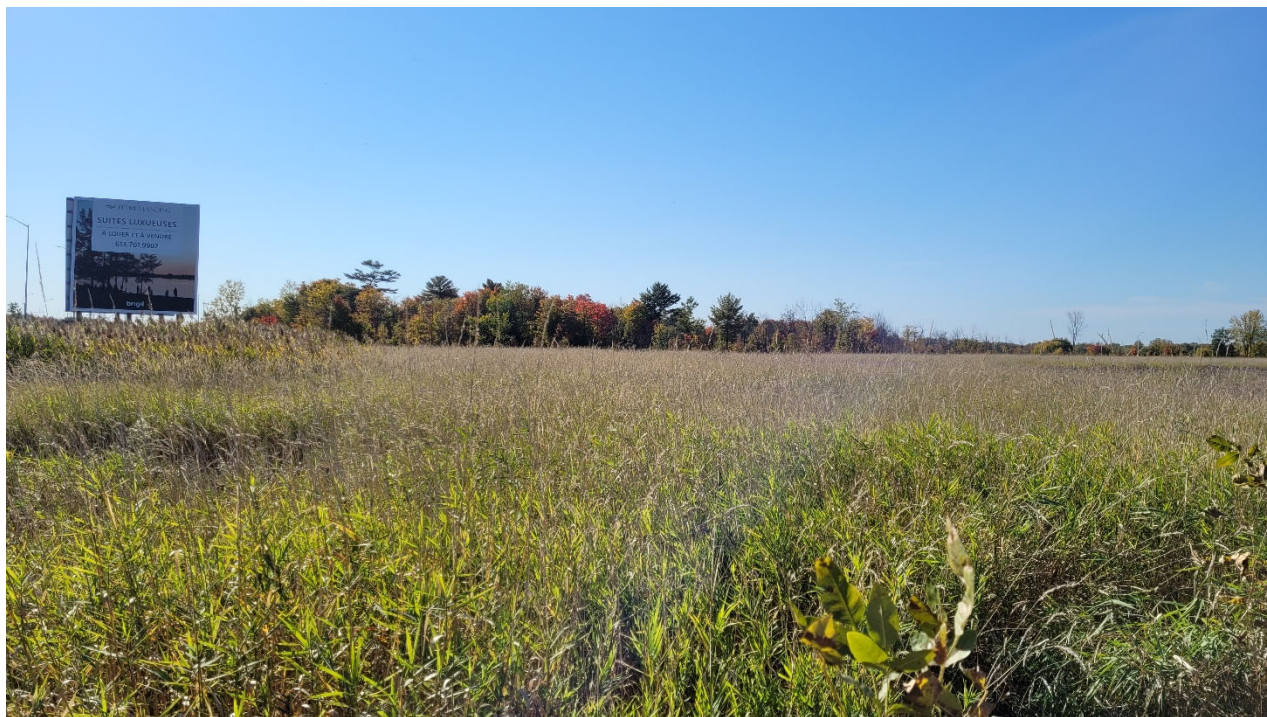
Photograph 1: View of the south portion of the Phase One Property looking west. View shows the Phase One Property to be overgrown with vegetation.

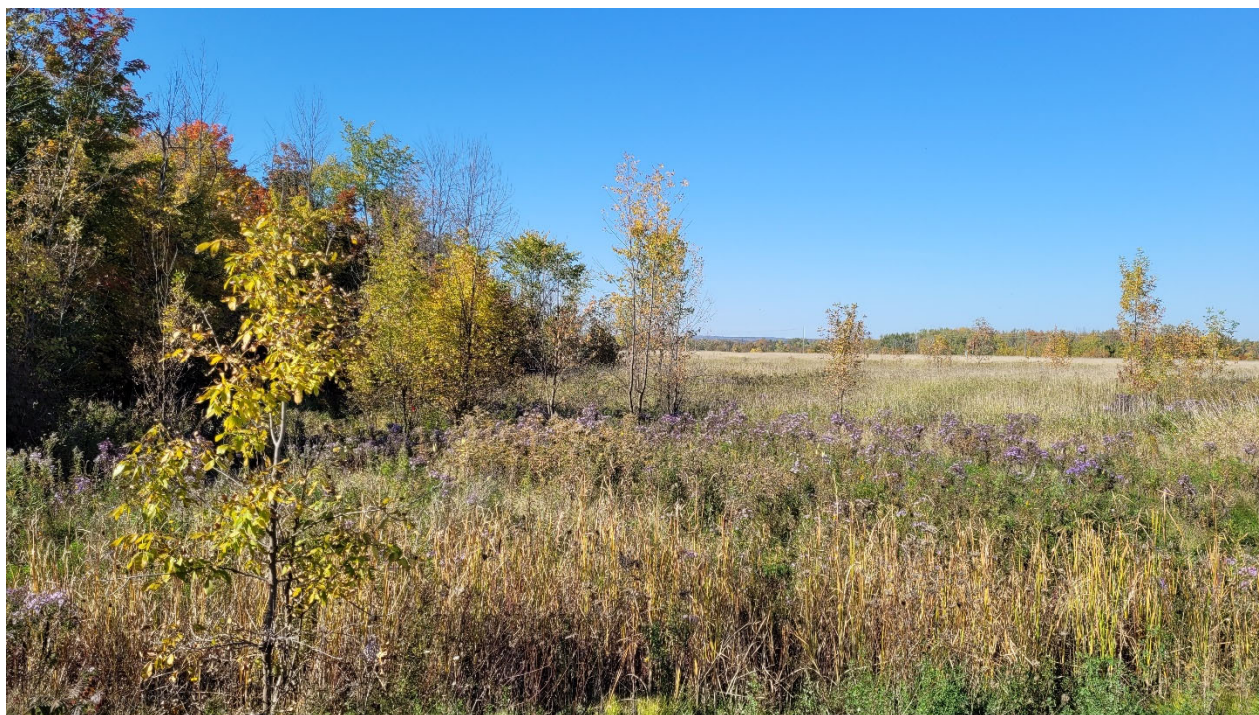
Photograph 2: View of the west side of the Phase One Property looking north. Mature trees can be observed on the left side of the photograph, which is the top of an embankment leading to Taylors Creek.

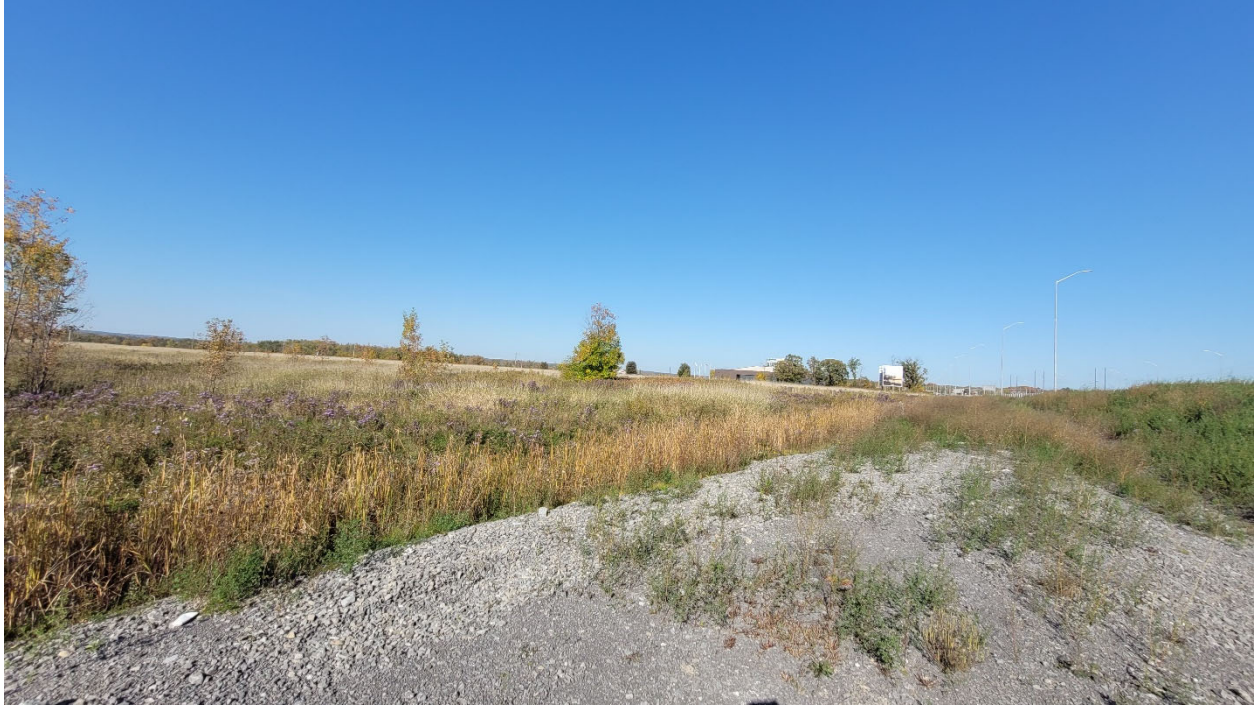
Photograph 3: View of the south side of the Phase One Property, looking east. La Cite Collegial can be seen in the distance; La Cite borders the east Property limits.

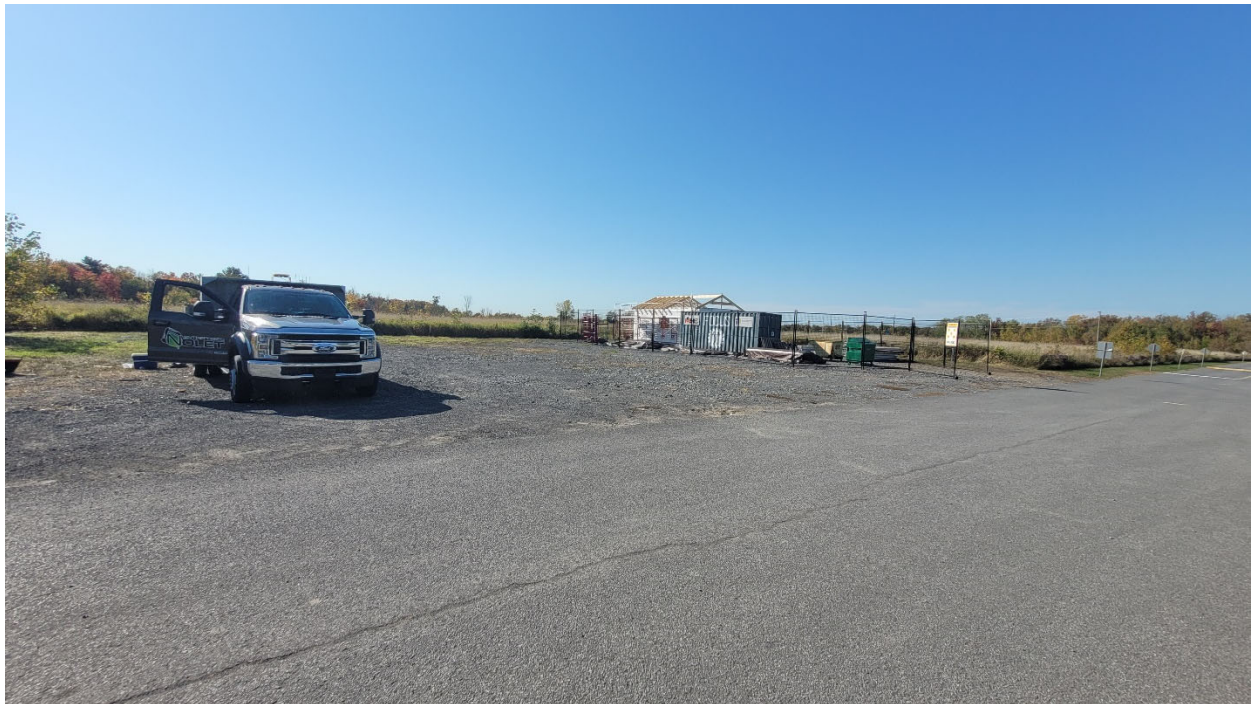
Photograph 4: View of a gravel pad and carpentry training area for La Cite Collegial on the east portion of the Phase One Property.

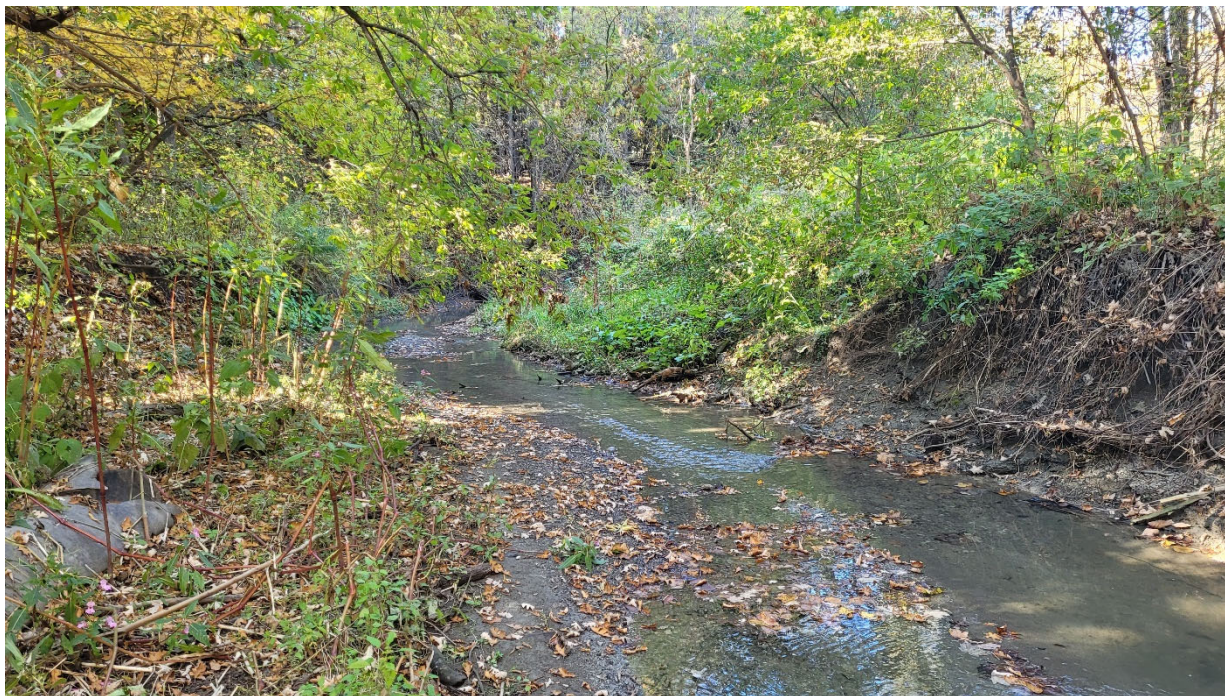
Photograph 5: View of Taylors Creek on the west portion of 8600 Jeanne D'Arc Boulevard; view is looking north.

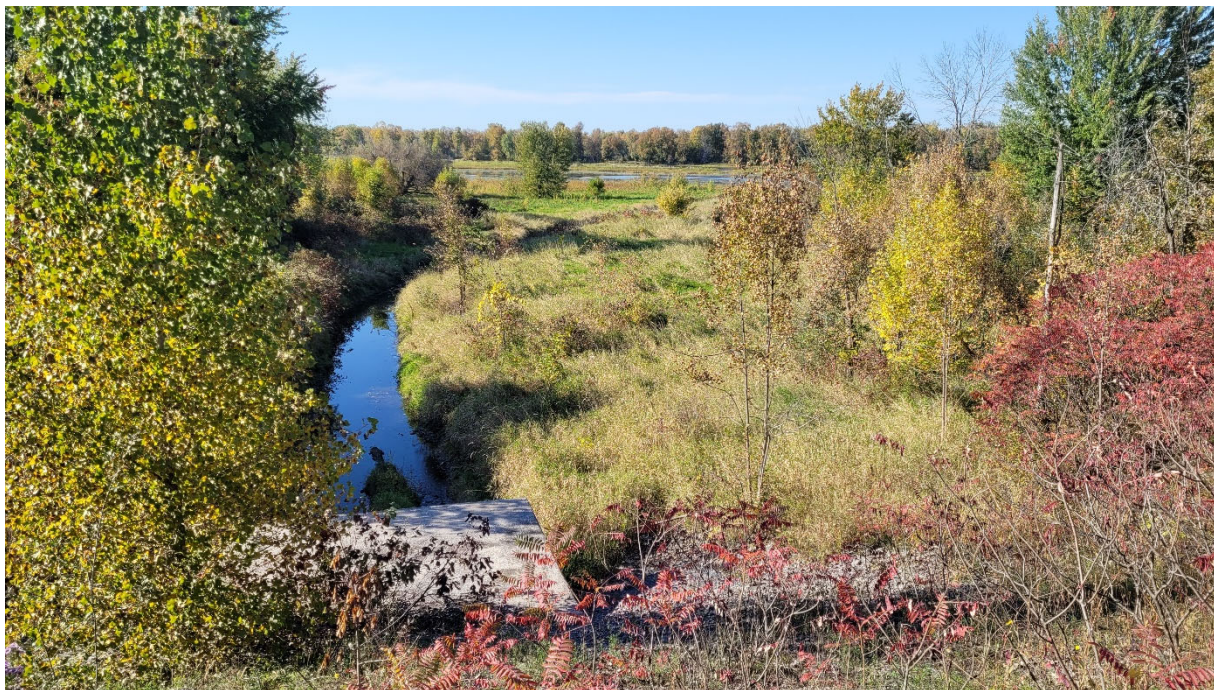
Photograph 6: View of Taylors Creek on the west portion of 8599 Jeanne D'Arc Boulevard; view is looking north towards the Ottawa River.

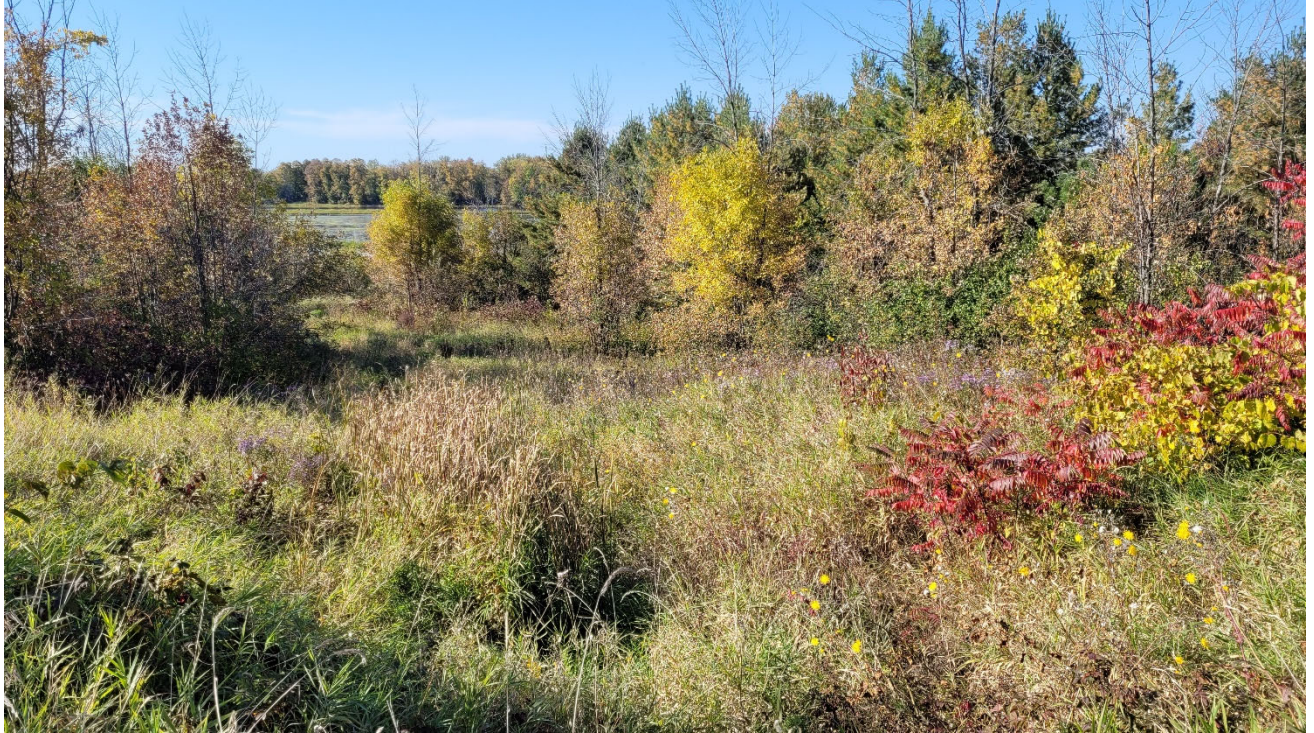
Photograph 7: View of the north portion of the Phase One Property (8599 Jeanne D’Arc), looking north. The Ottawa River can be seen further north of the Property.

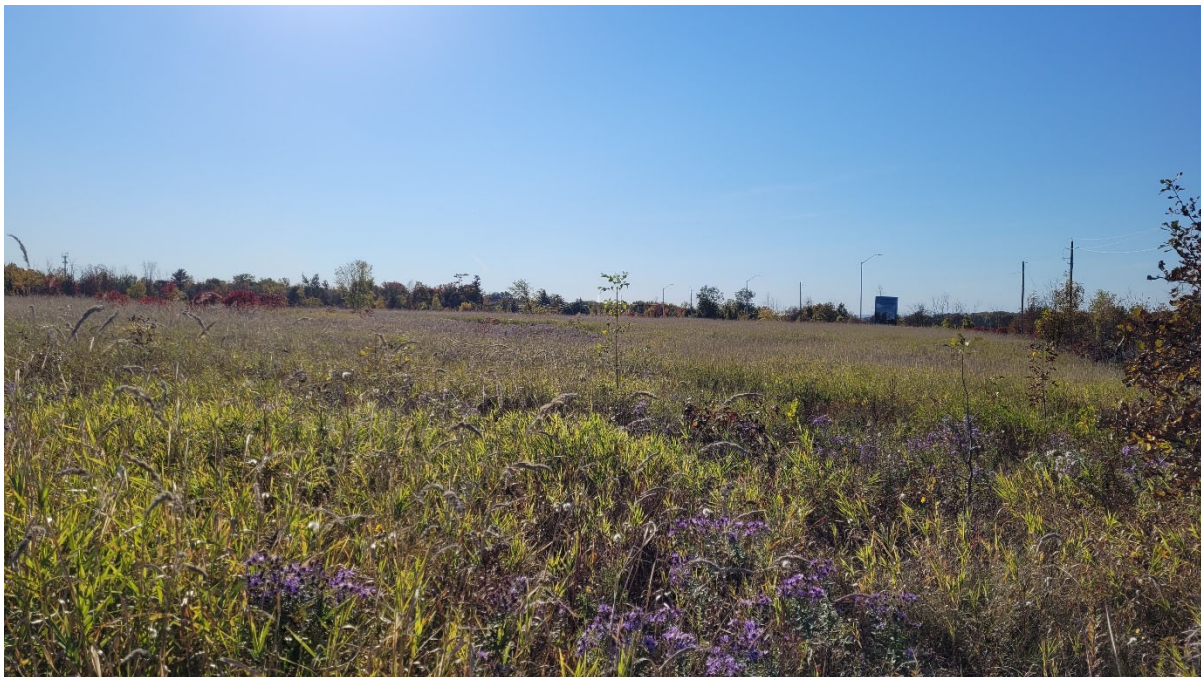
Photograph 8: View of the north portion of 8600 Jeanne D’Arc looking west. Jeanne D’Arc Boulevard is present on the left side of the photograph.
