# VUZE Construction

1015 Tweddle Road

## TREE CONSERVATION REPORT

CIMA+ file number: Z0018492  
18 November 2025 - Review 002

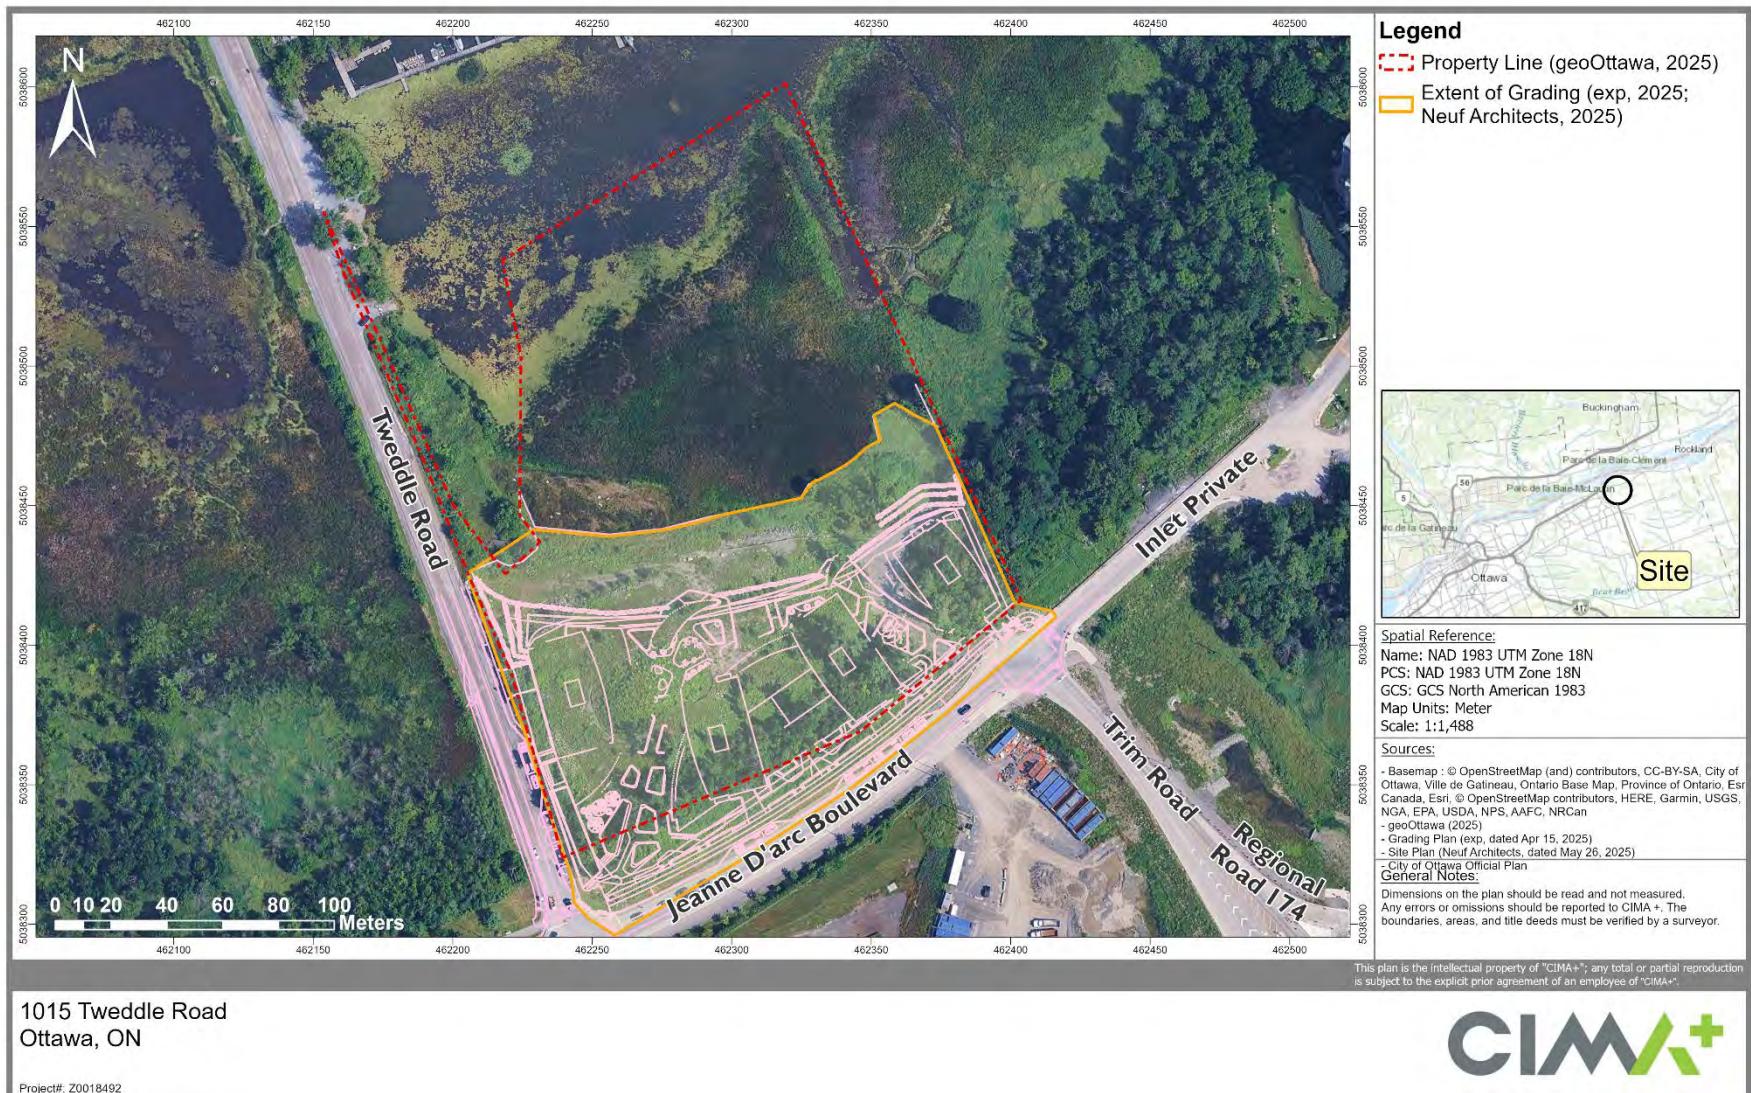
Figure 1: Property Location and Proposed Works

VUZE Construction, hereafter referred to as the proponent, intends to develop the property at 1015 Tweddle Road (the “Property”), situated at the northeast corner of the intersection at Tweddle Road and Jeanne d’Arc Boulevard North. As of 2022, Bowfin merged its services with CIMA+ who has taken over the mandate of updating this Tree Conservation Report (TCR) as per the City of Ottawa’s Tree Conservation Report Guidelines (2021).

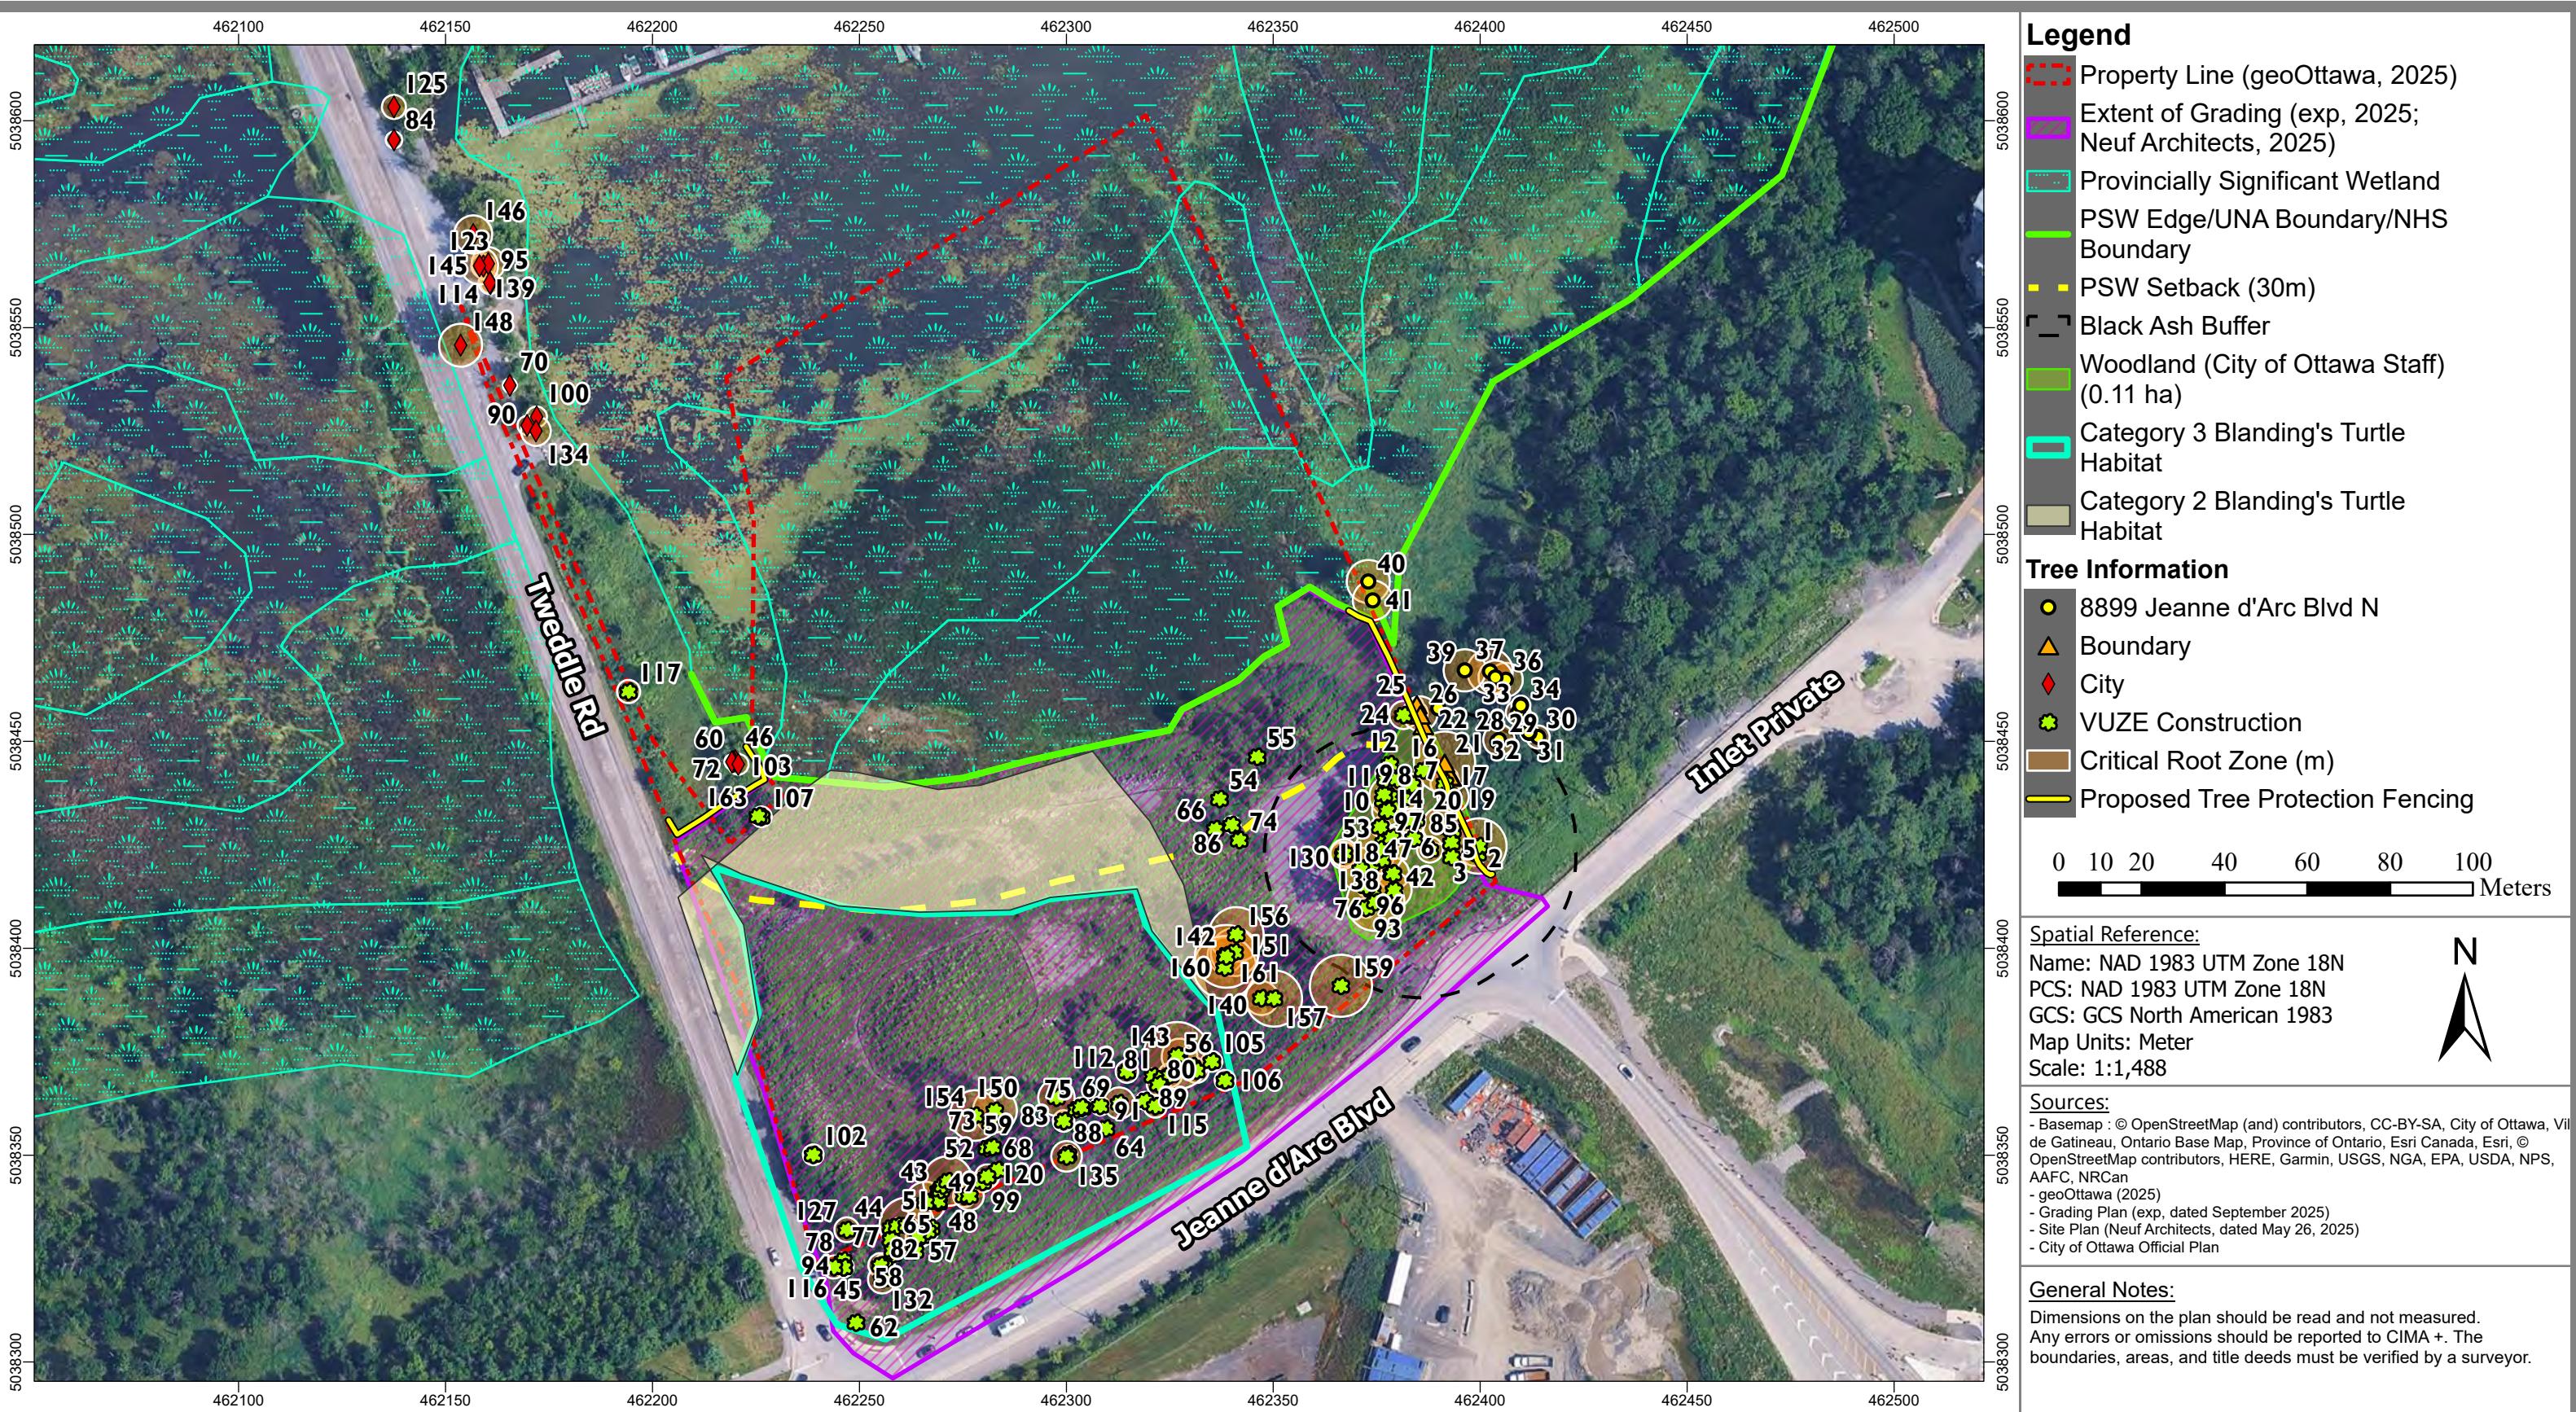
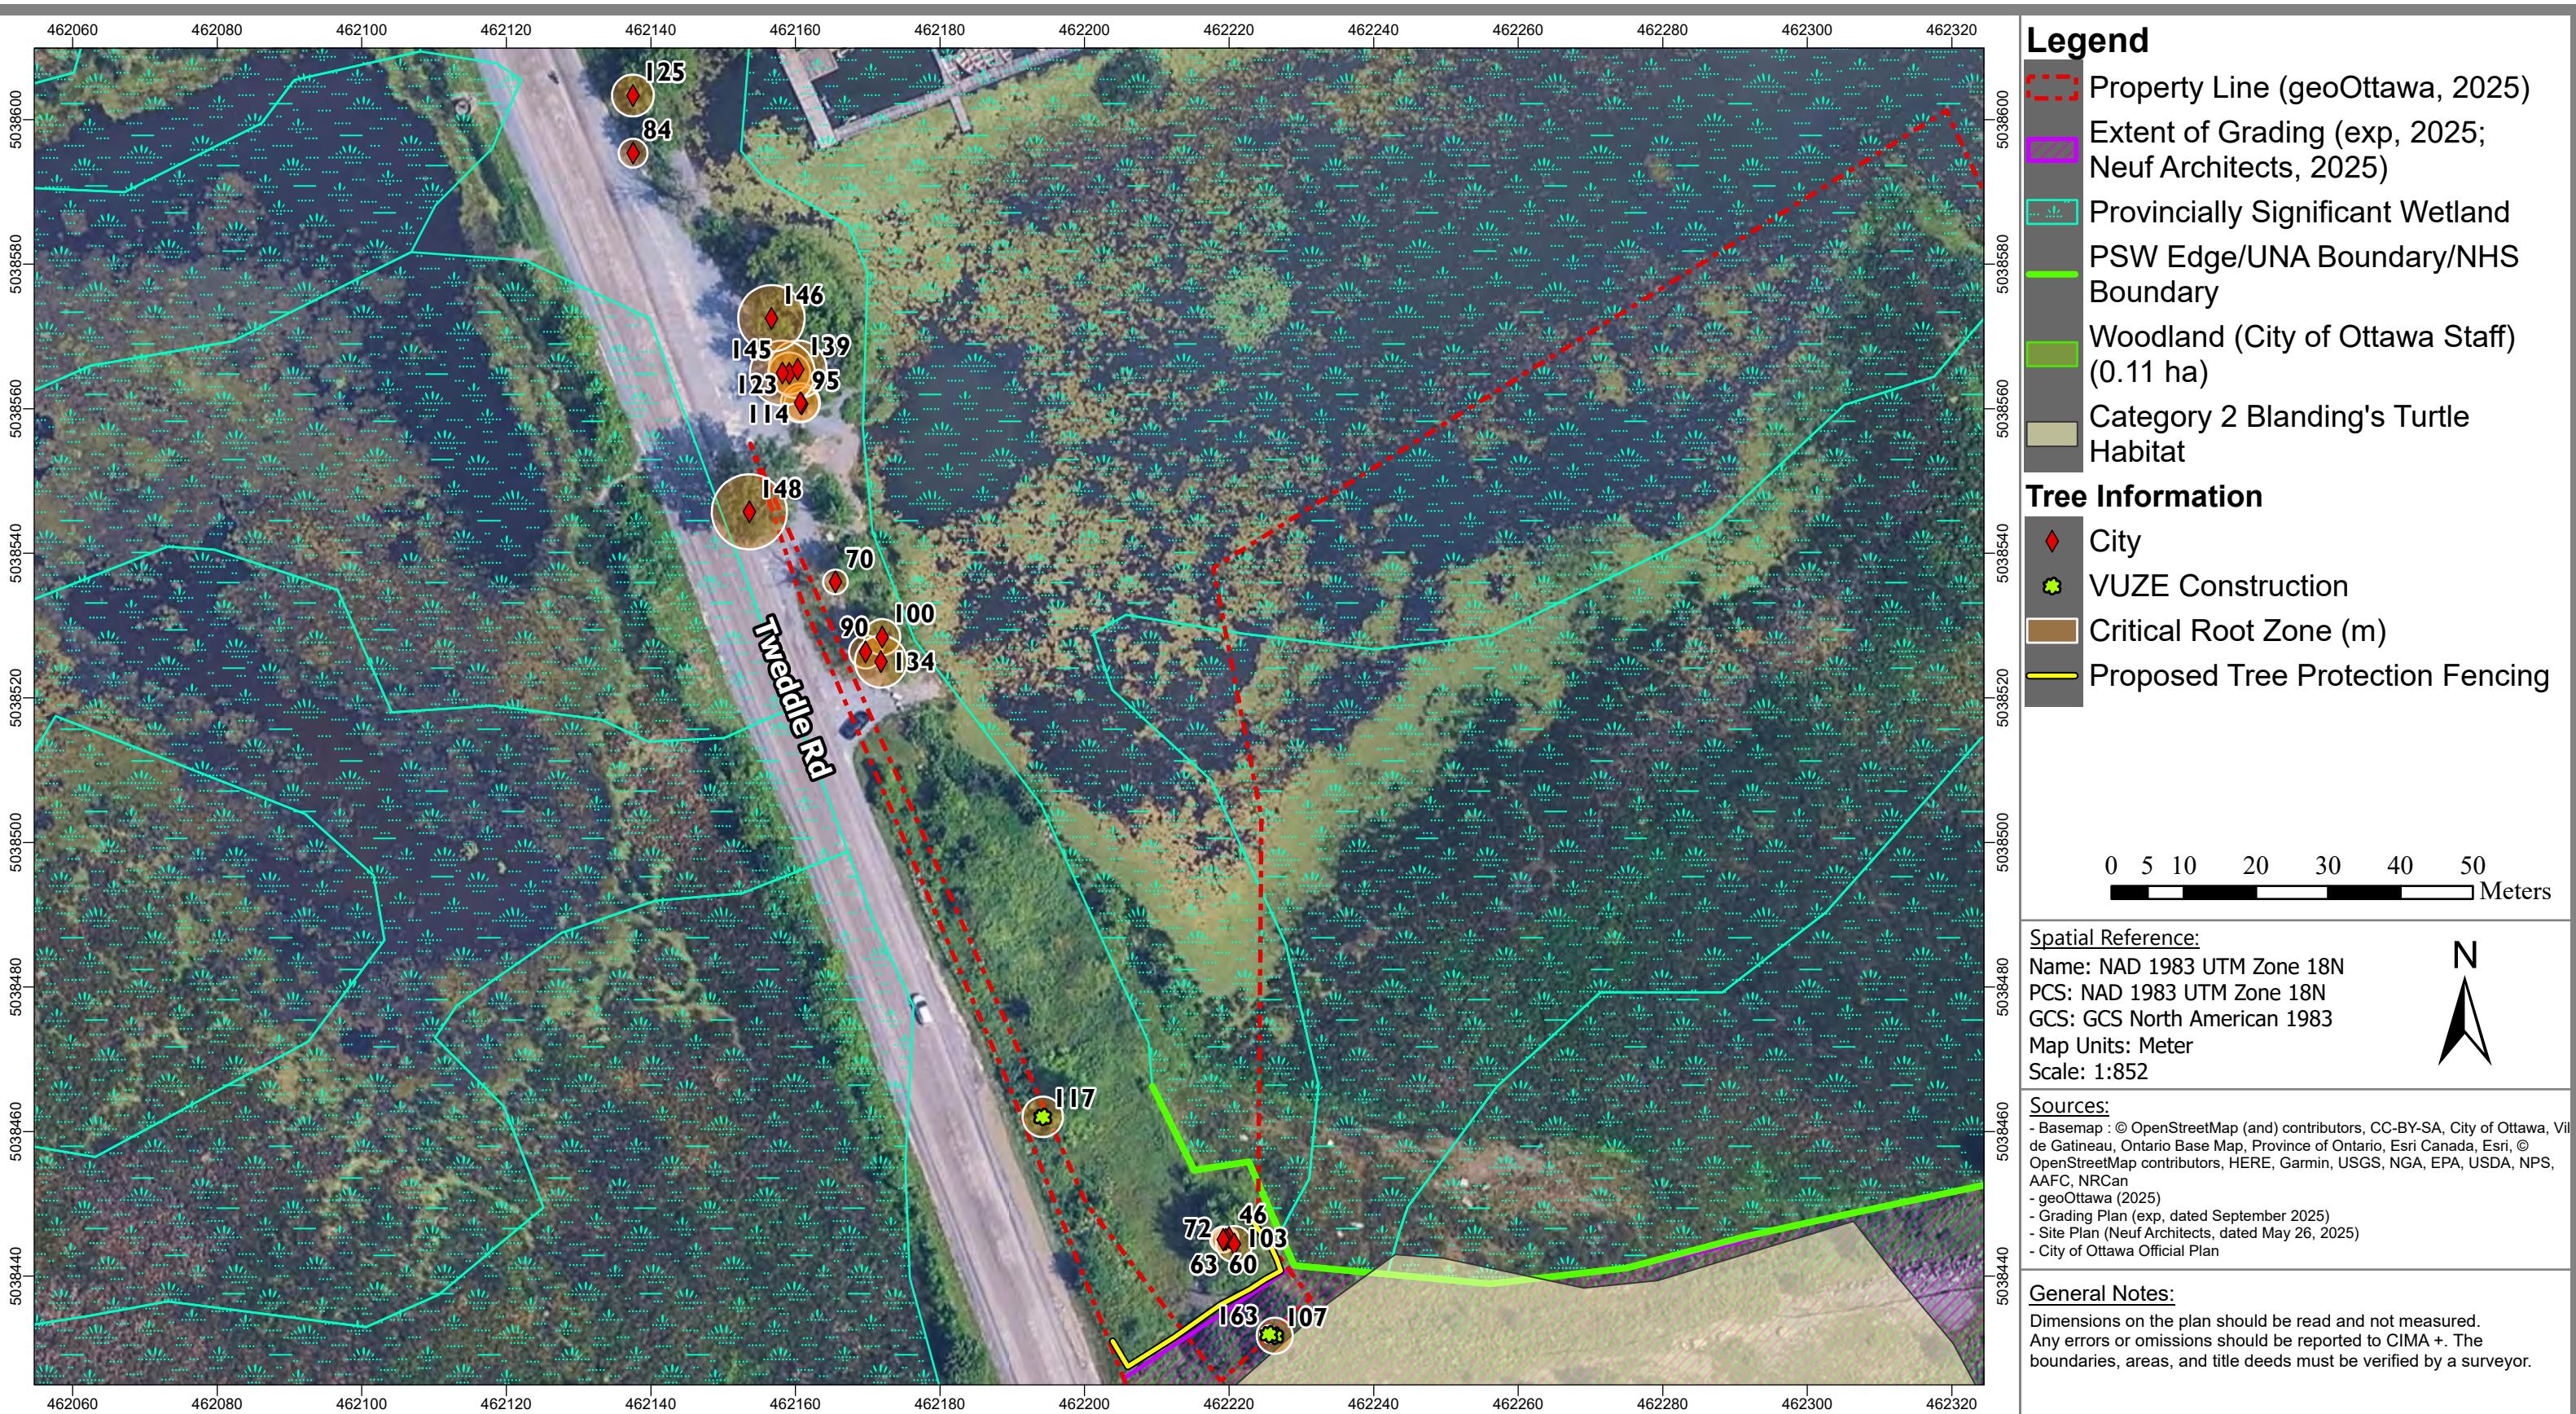
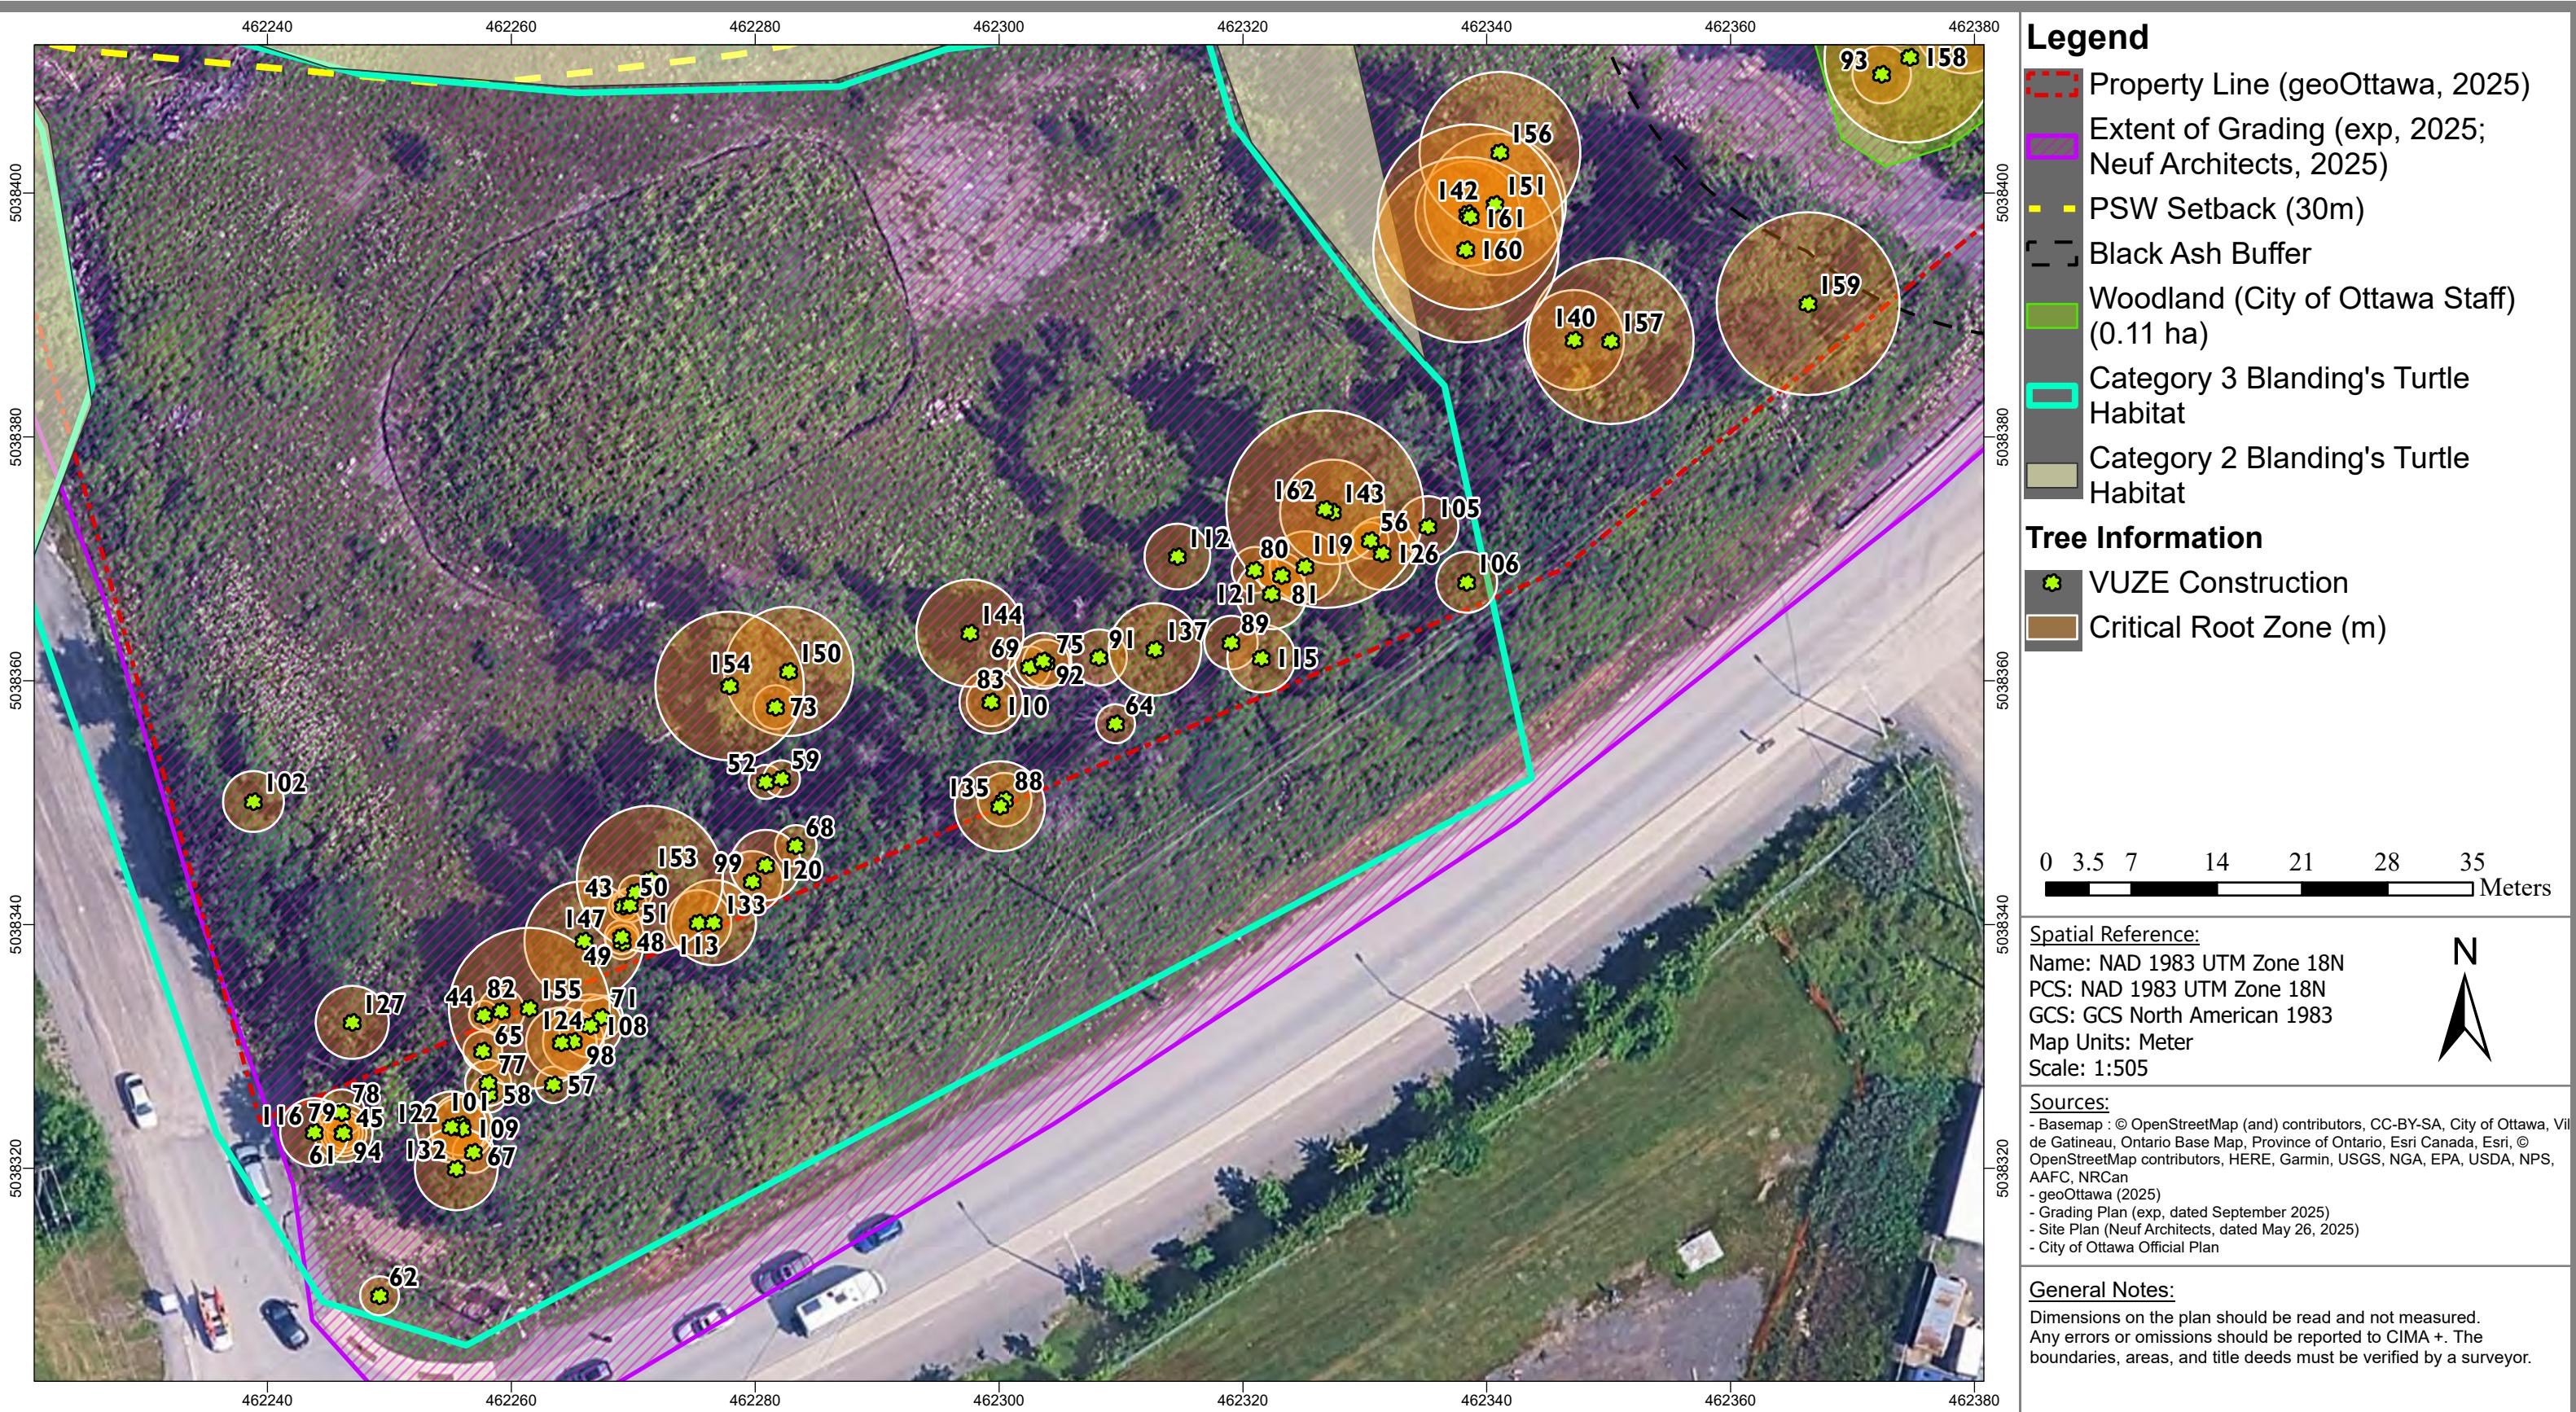
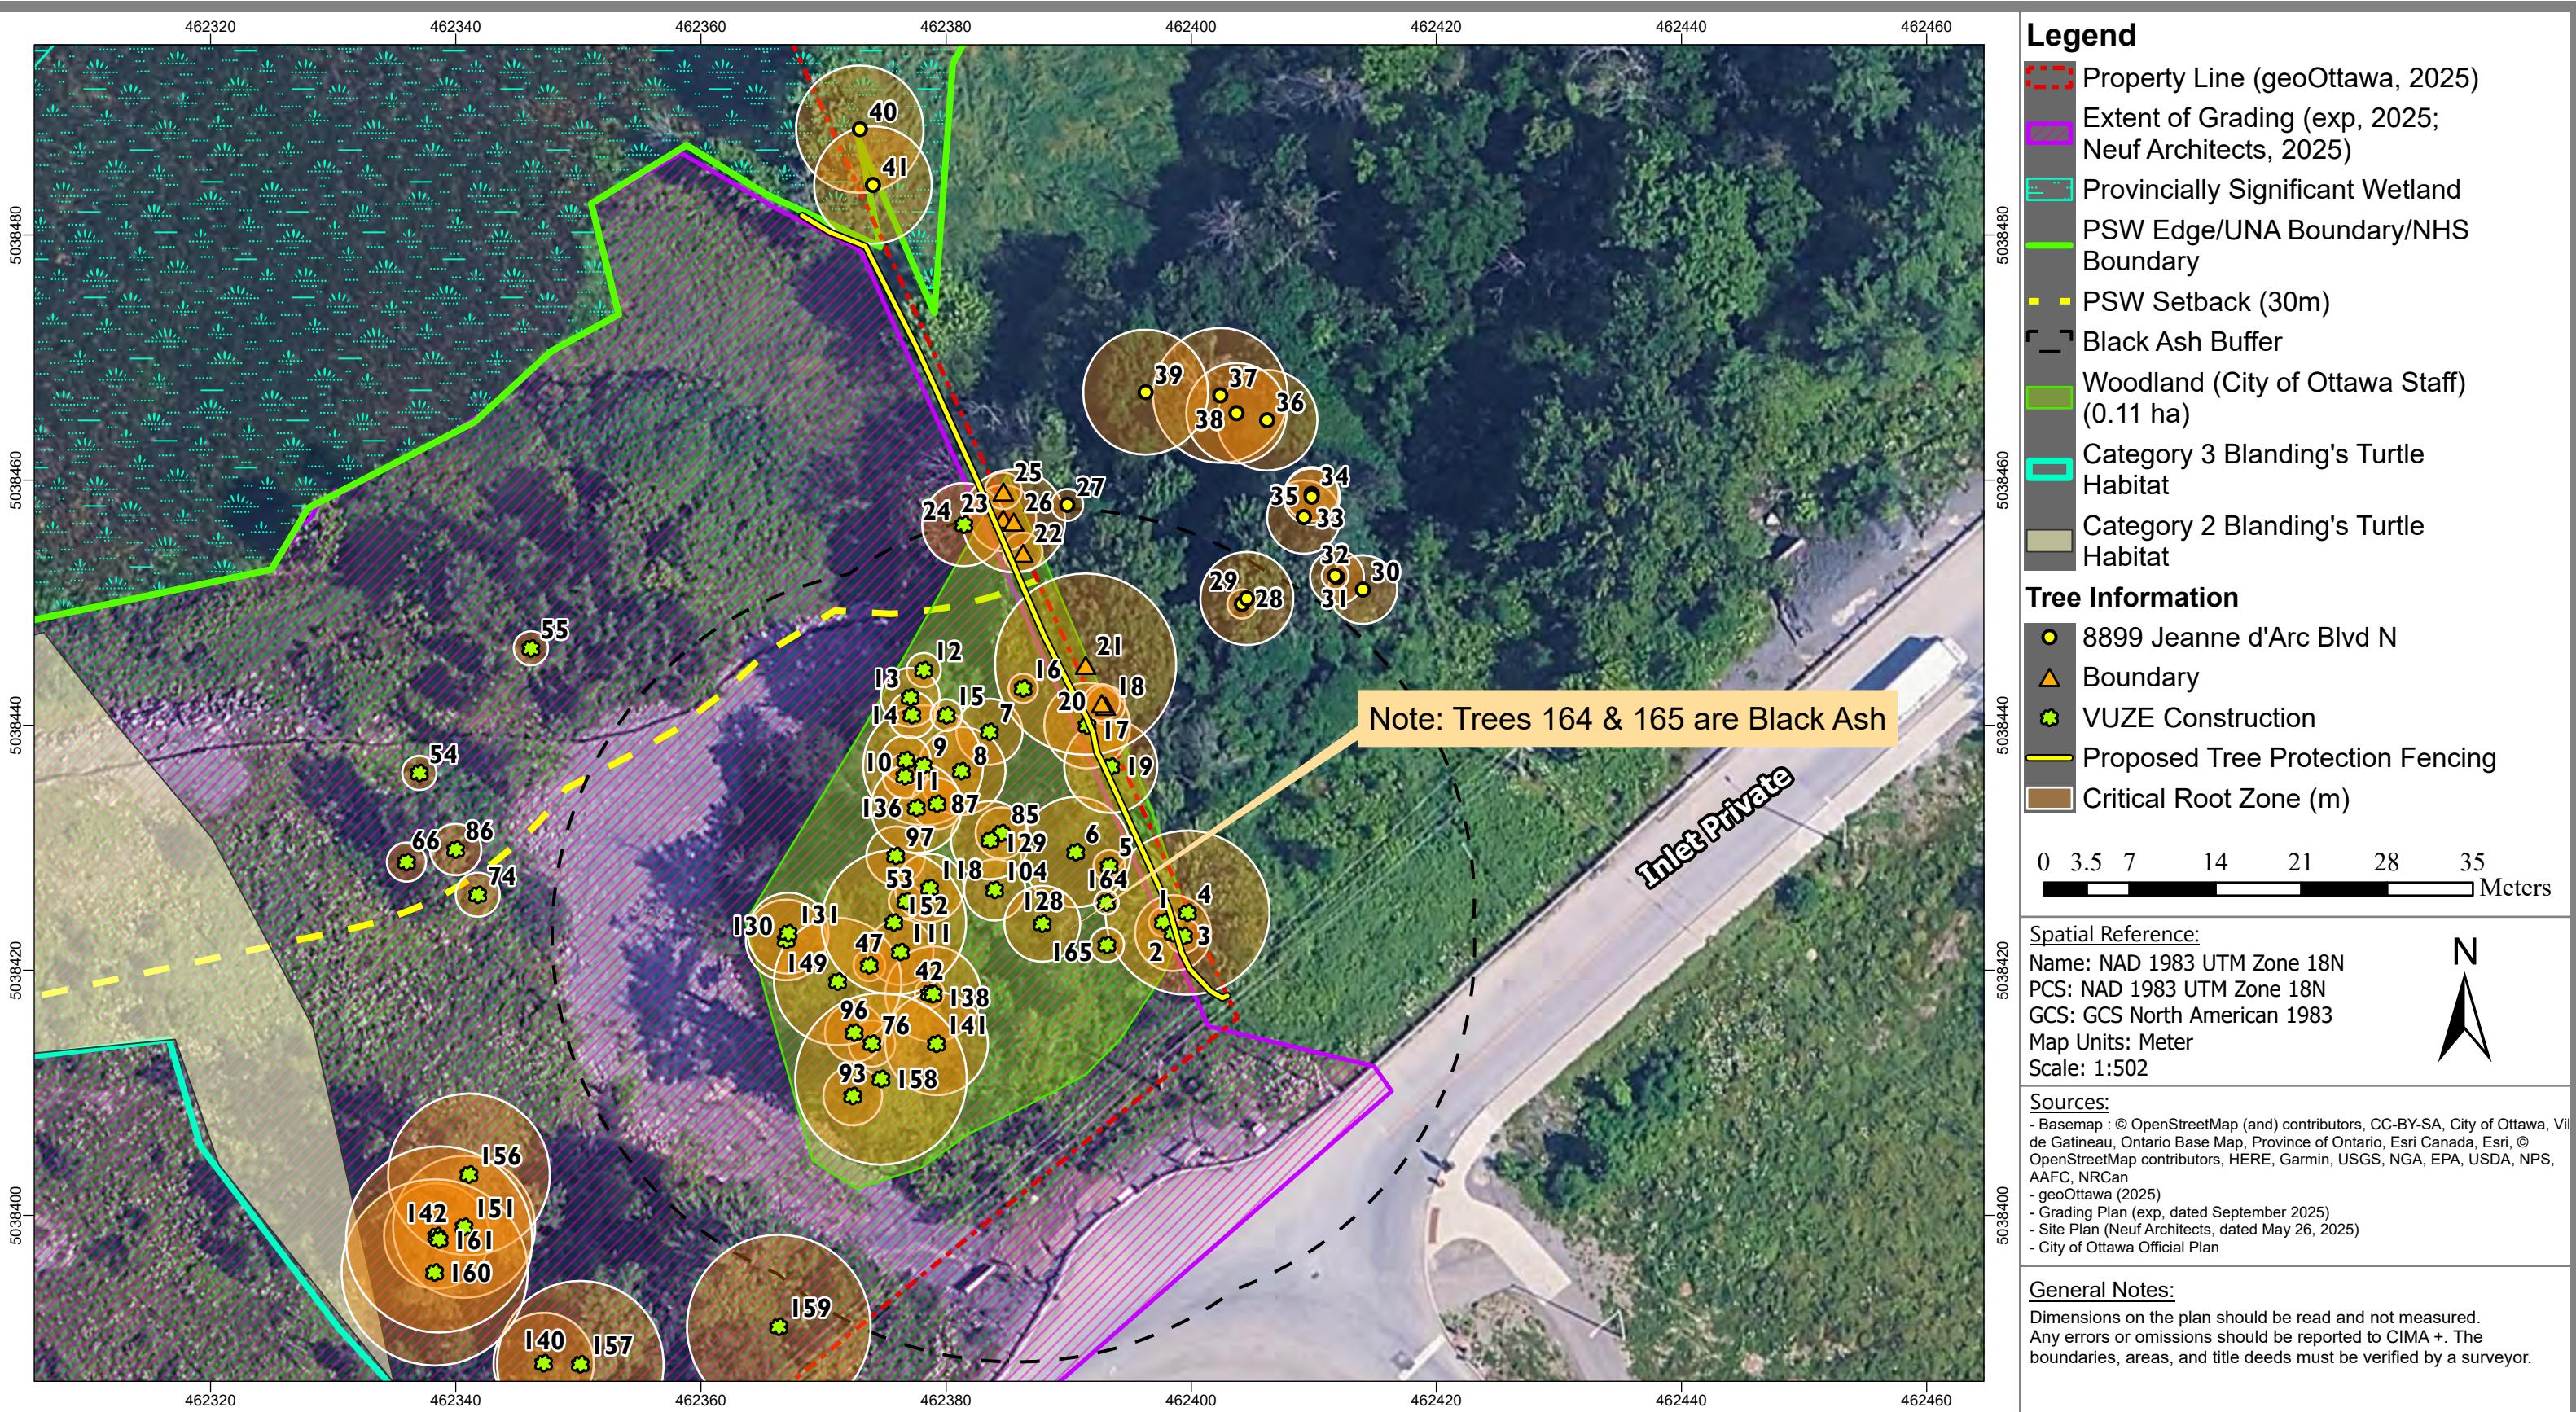
## Appendix A Map 1

The location of individual trees are depicted on Map 1 and Map 2 (Appendix A, Appendix B).

- Provincially significant wetland on the north side of the Property
- Habitat of endangered and threatened species
  - Two (2) SAR Black Ash trees were found (Trees 164, 165) with dbh of 10 and 14 cm. These were located on the southeast corner of the Property.

- Trees to be Retained:
  - 1 tree (Tree 117) to be retained is owned by VUZE Construction. This tree, and its CRZ, is situated along Tweddle Road, north of the area to be graded.

- 19 trees to be retained are City-owned trees situated north along Tweddle Road or Ottawa River. None of these individuals have their CRZs extending into the grading or construction limits.

- 15 trees to be retained are owned by the adjacent landowner to the east (8899 Jeanne d'Arc Blvd N). None of these 15 trees have their CRZs extending into the grading or construction limits.

- 7 trees to be retained are of shared ownership on the property line between the Property and the adjacent landowner to the east (8899 Jeanne d'Arc Blvd N).

- 3 of these trees have CRZs extending into the grading limits – Trees 21, 23, 26.

- Trees 21, 23 and 26 fall near the property line and are of shared ownership with the property owner to the east. These are recommended for retention and pruning, as grading will occur within their CRZs.
  - Tree 21 is a Bur Oak with dbh 74 cm
  - Tree 23 is an American Elm with dbh 23 cm.
  - Tree 26 is a Bur Oak with dbh 42 cm.

Three trees of shared ownership are proposed for retention and/or pruning as needed (Tree 21, 23, 26), as their minimum CRZ fall within the grading limits.
