# VUZE Construction

1015 Tweddle Road

## TREE CONSERVATION REPORT

CIMA+ file number: Z0018492  
18 November 2025 - Review 002

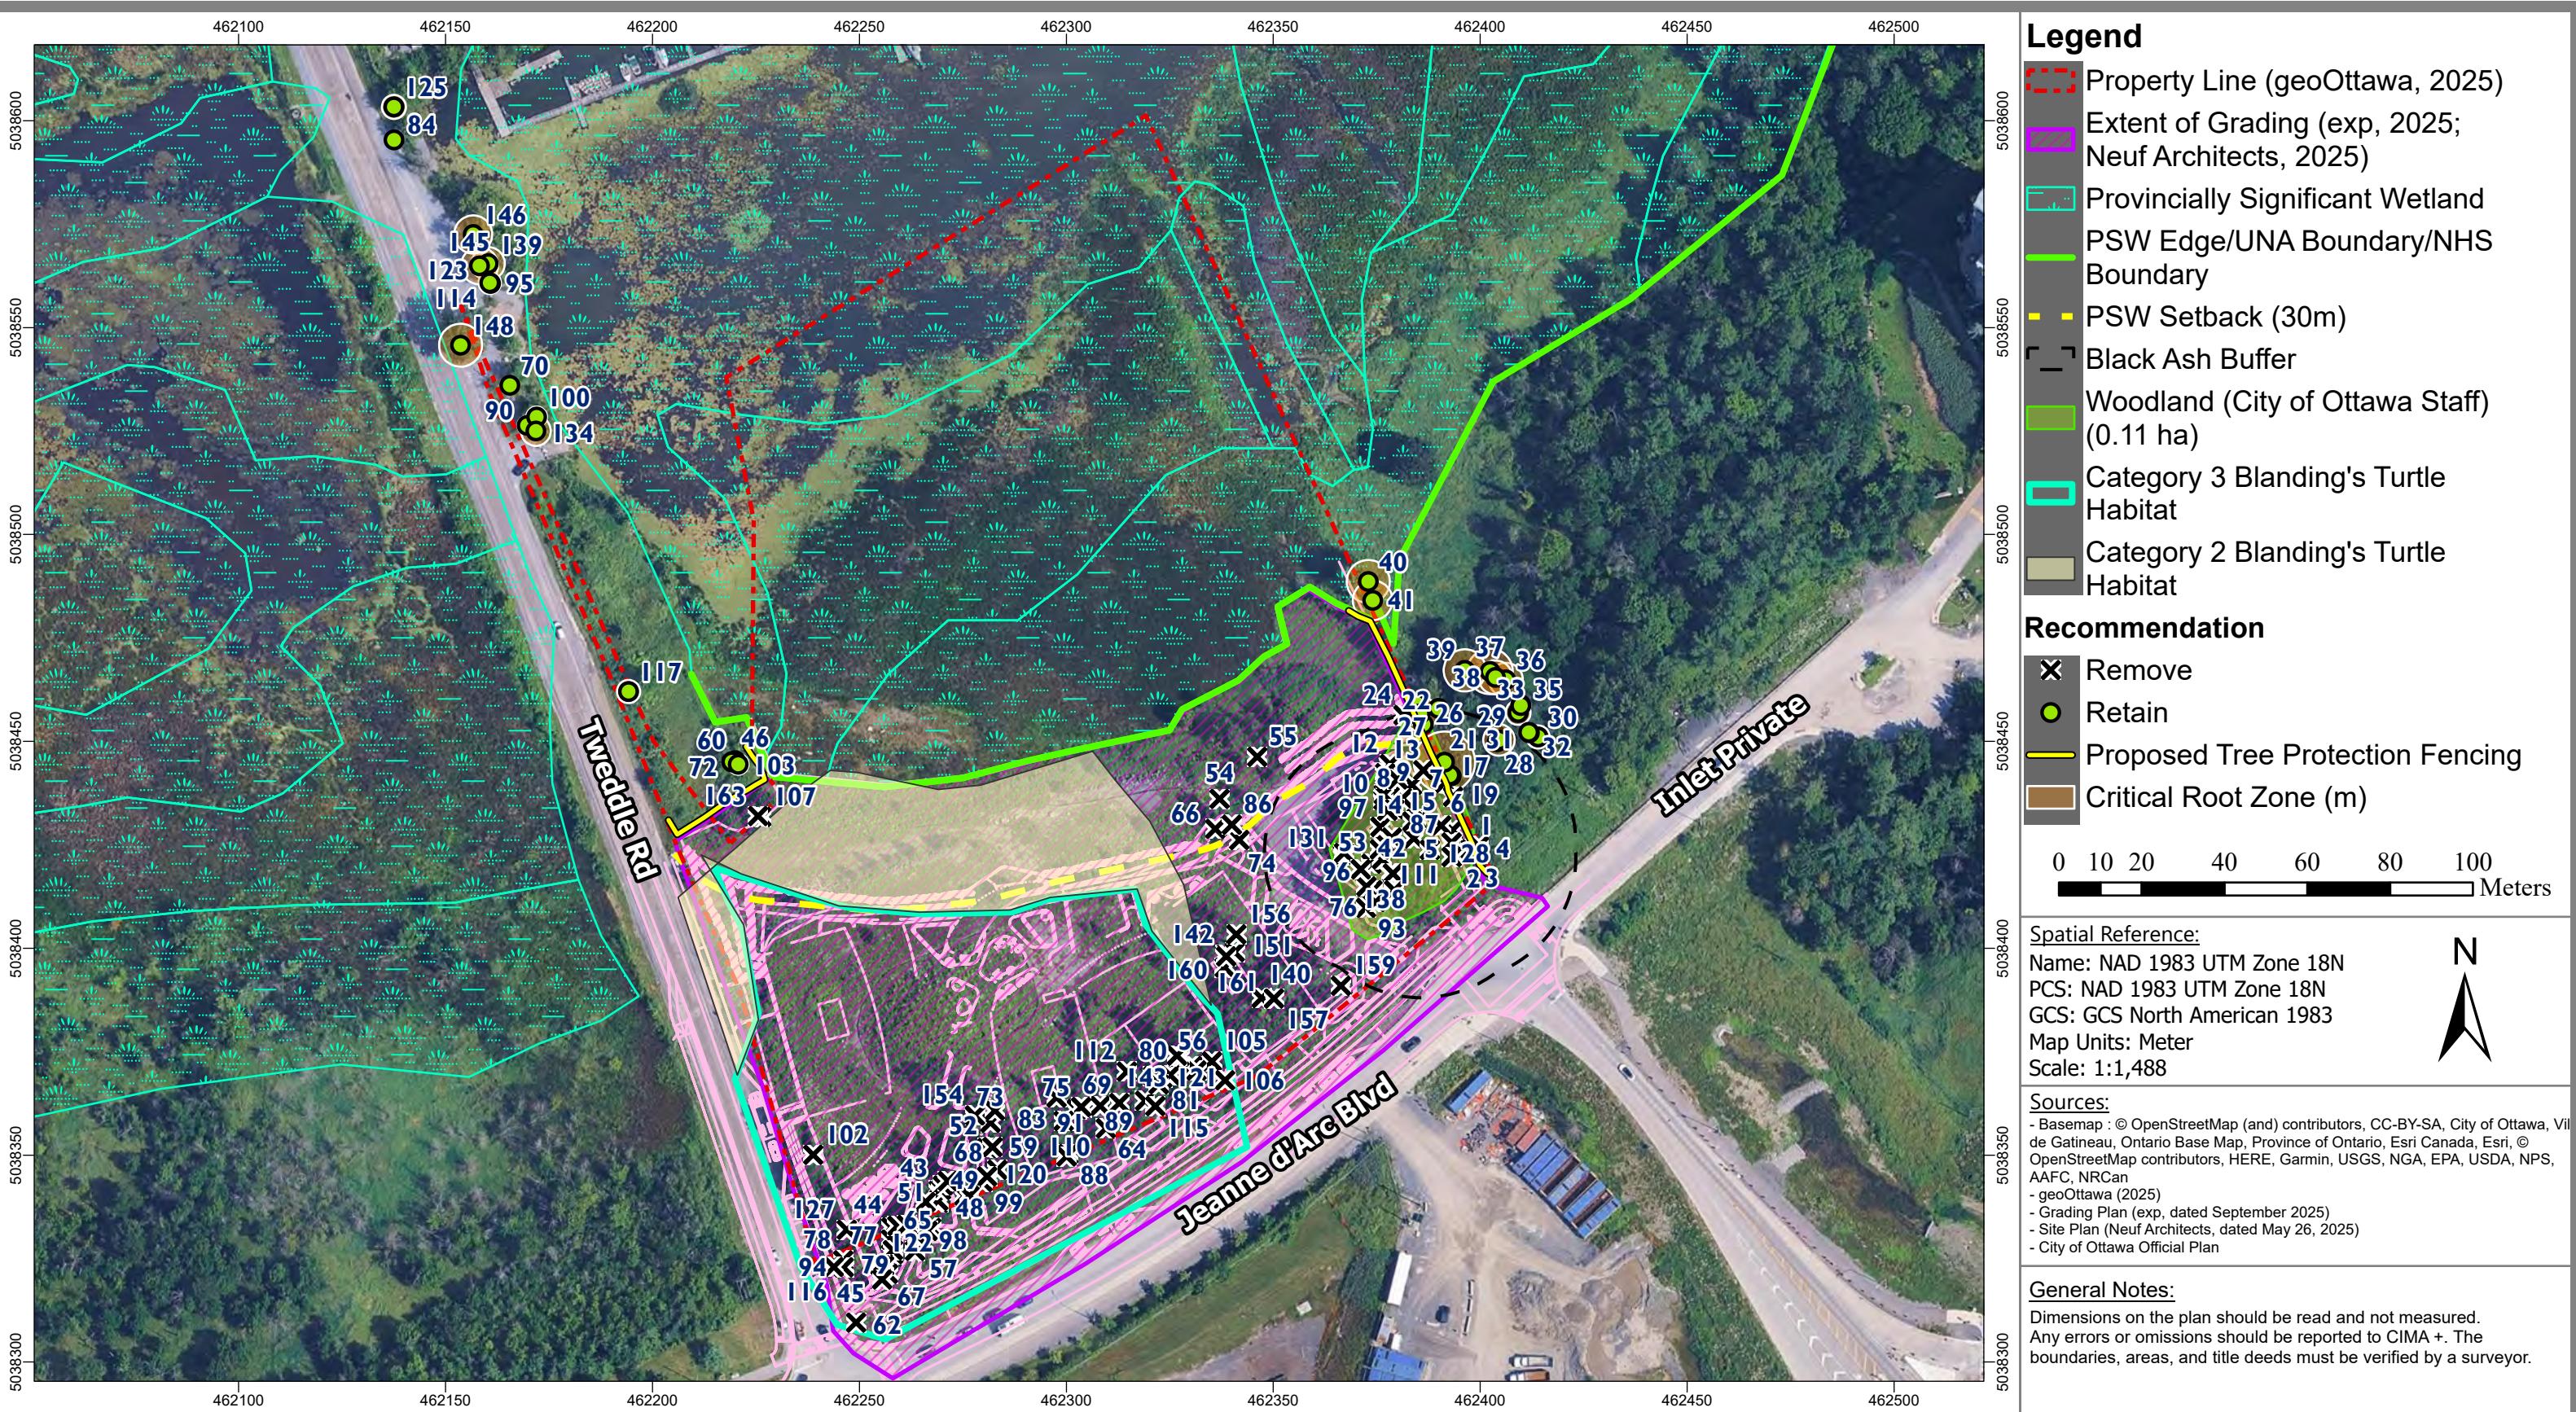
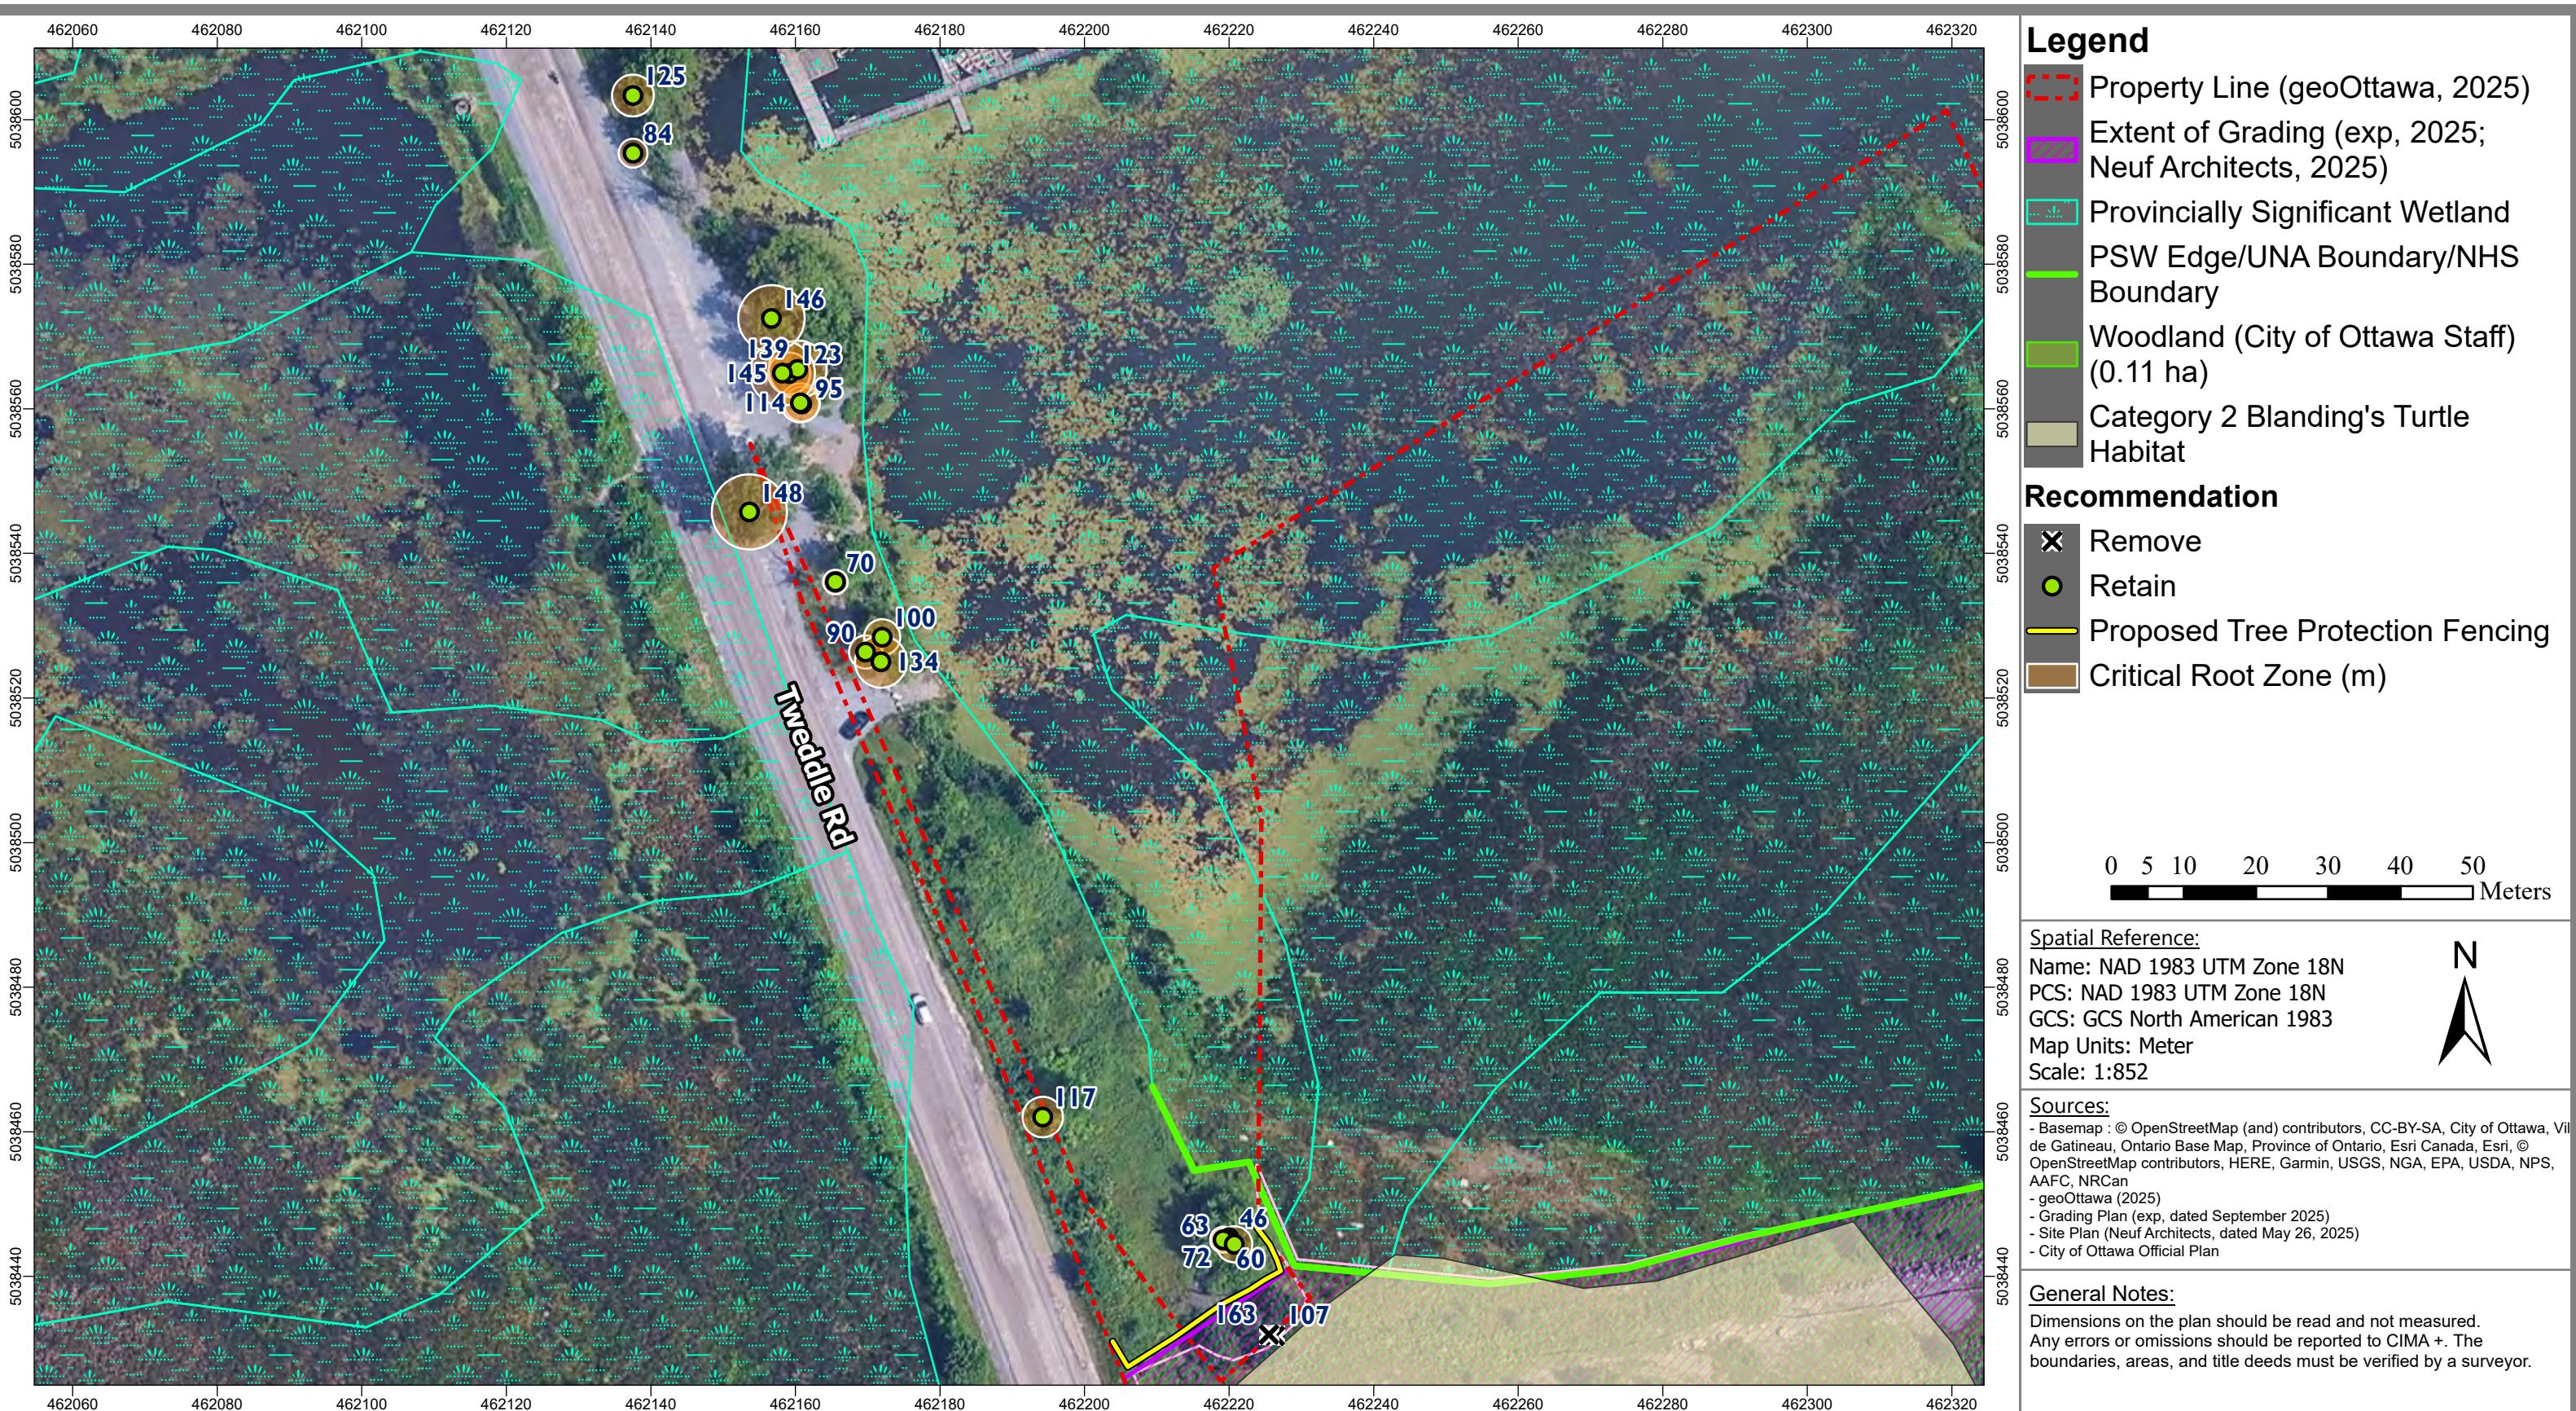
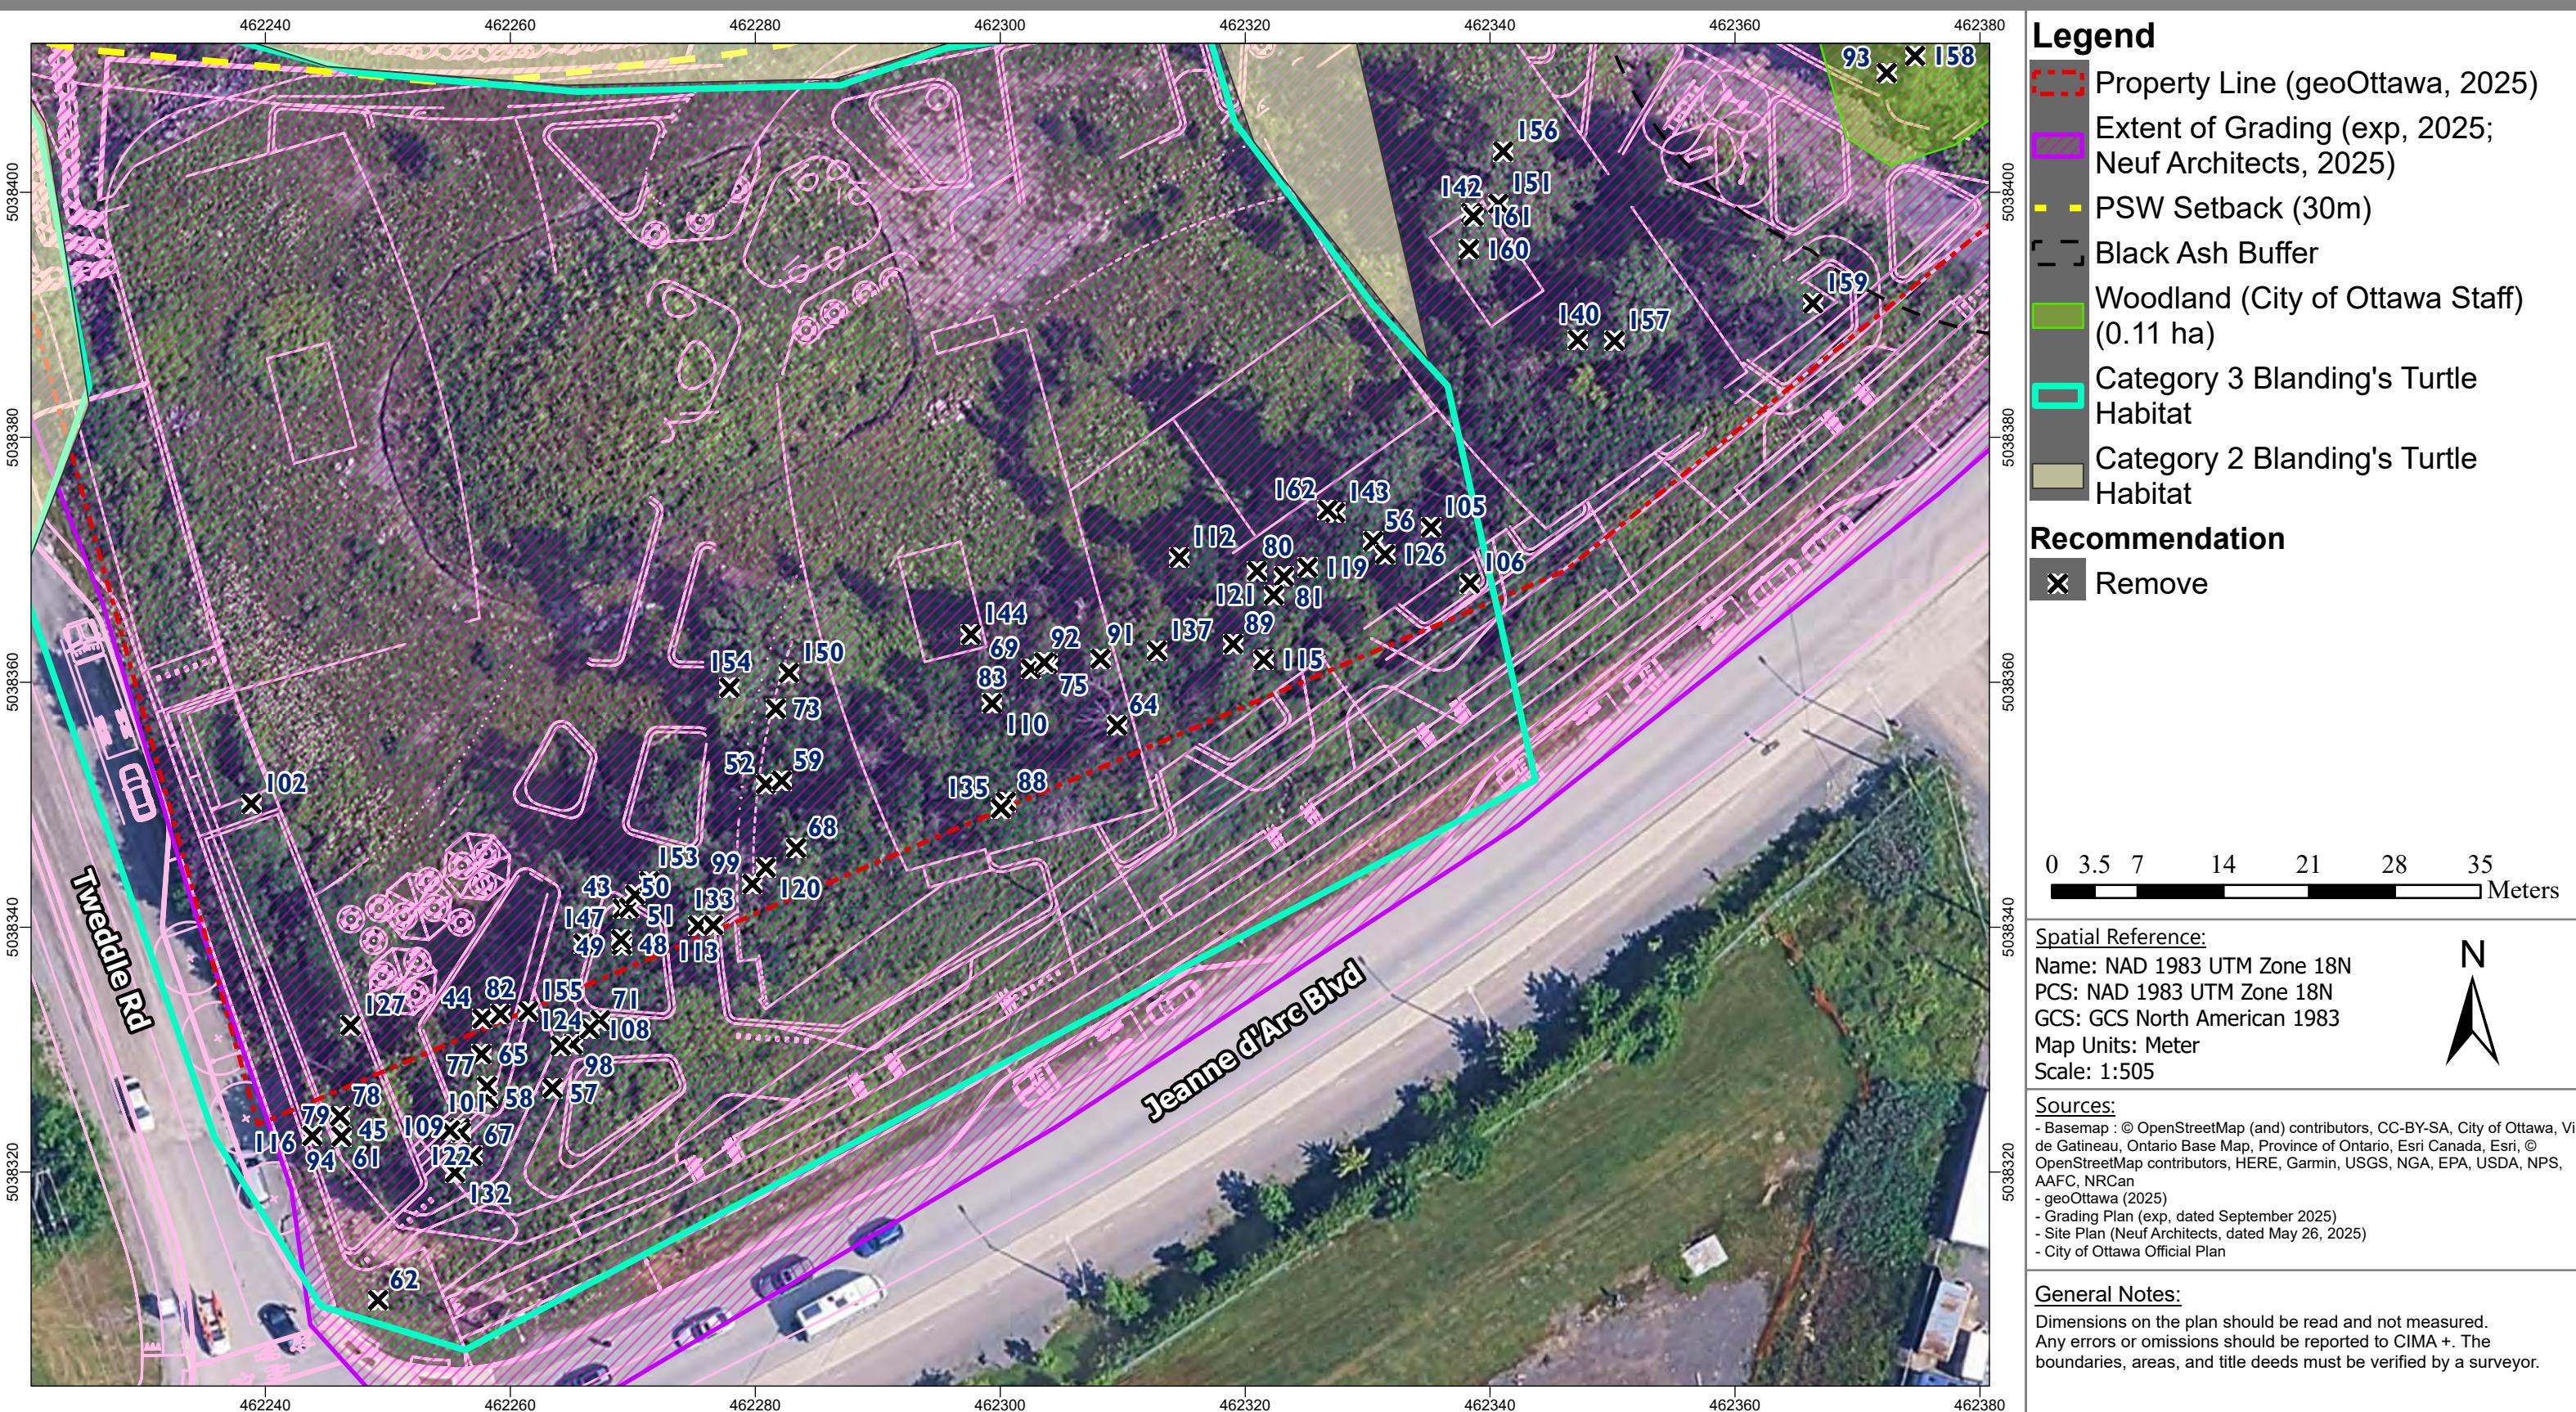
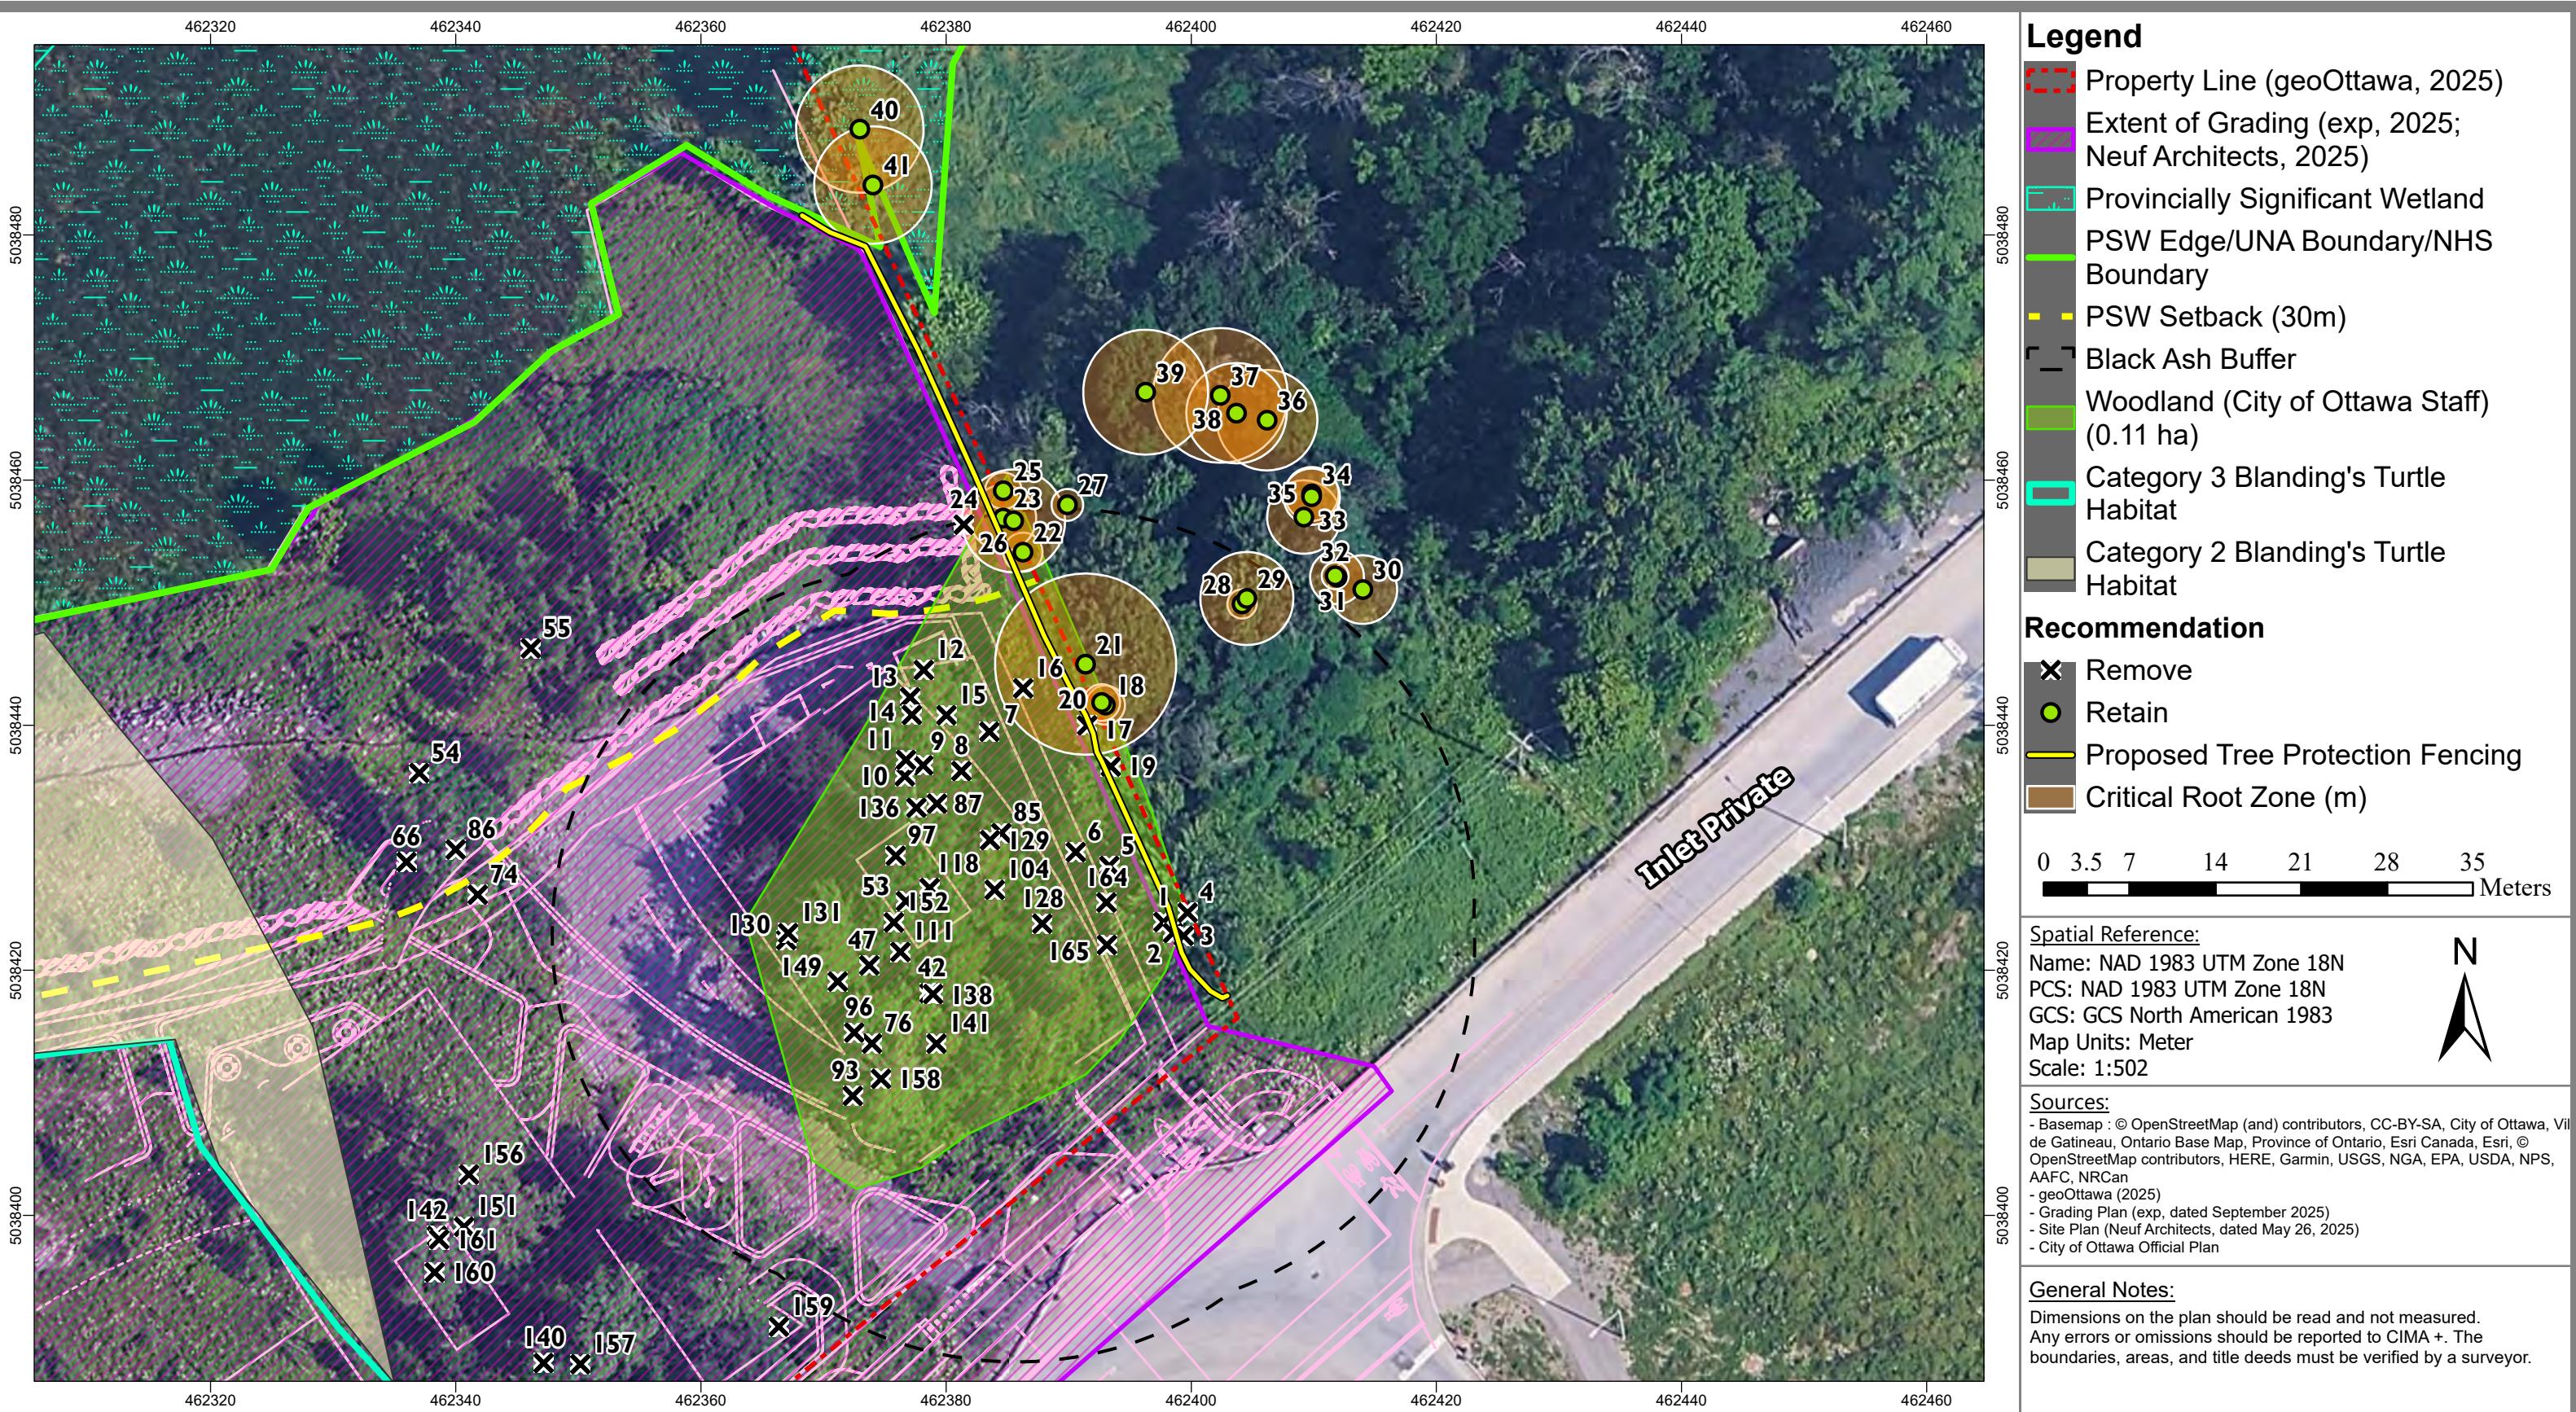
## Appendix B Map 2

In addition, this report will help determine the proposed work’s potential impacts and provide general recommendations to avoid and/or mitigate tree loss and injury. Note that these avoidance and mitigation measures are also provided in the accompanying updated Environmental Impact Study (EIS) (CIMA+, 2025). Note that the natural heritage constraints (i.e., Provincially Significant Wetland (PSW), Fish Habitat, Species at Risk (SAR) Fauna, any Significant Wildlife Habitat or Areas of Natural and Scientific Interest (ANSIs)) are all detailed in the EIS (CIMA+, 2025). The Wooded Areas and any SAR Trees are identified on Map 1 and Map 2 of this TCR.

The location of individual trees are depicted on Map 1 and Map 2 (Appendix A, Appendix B).
