Subject: **Slope Stability Review and Landslide Risk Assessment
Proposed Multi-Storey Building Complex
1009 Trim Road - Ottawa**

**1015 TWEDDLE ROAD, OTTAWA, ONTARIO
LANDSLIDE HAZARD ASSESSMENT
ADDENDUM**

1009 TRIM ROAD OTTAWA, ONTARIO LANDSLIDE HAZARD ASSESSMENT

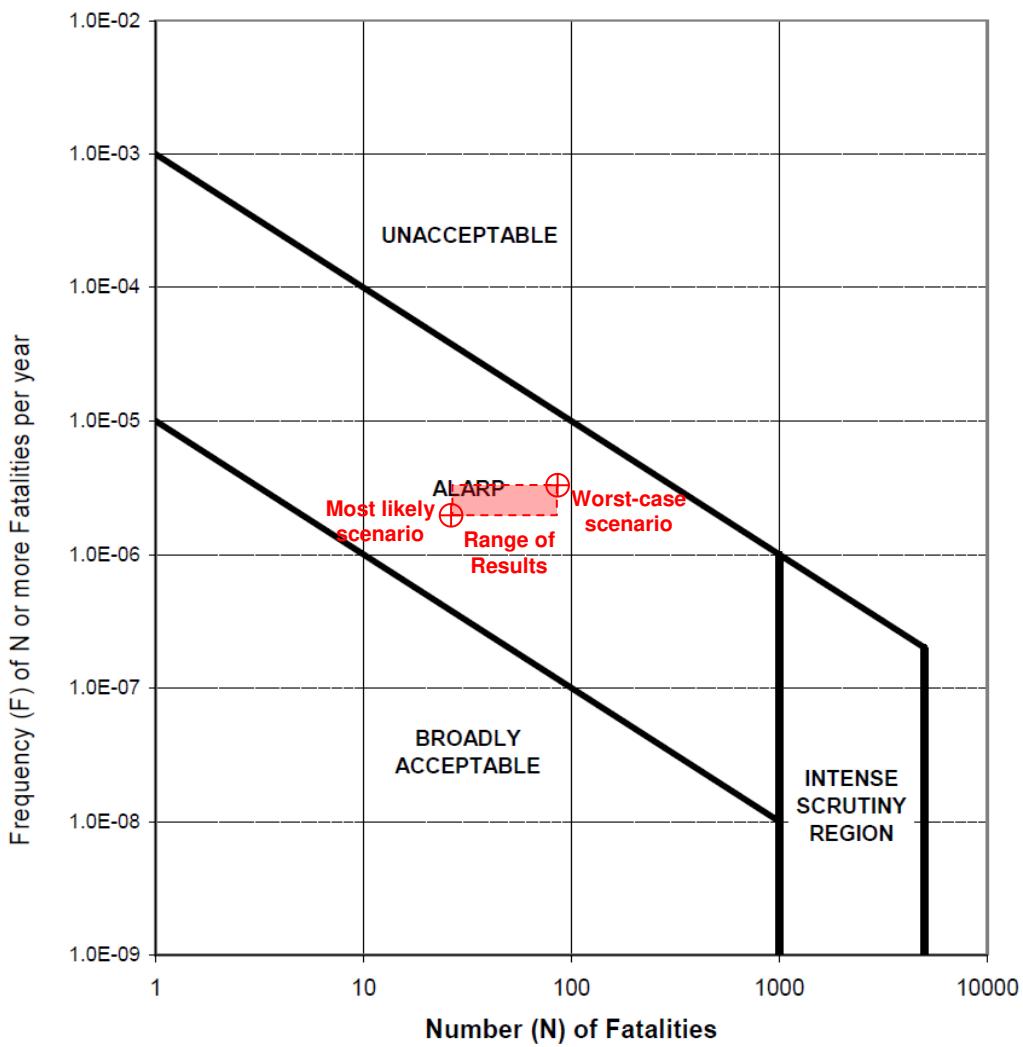
Figure 1: Societal Risk Frequency of Landslide vs Number of Fatalities

Both of these points are plotted on the F-N graph on Figure 1. Despite the vastly different estimates on probability and number of deaths, the two points still plot in the middle of the ALARP zone, which demonstrates the broad range of risks represented by this zone.

Societal risk estimates are based on F-N curves that plot the estimated number of fatalities versus the probability of landslide occurrence. When multiple landslide scenarios exist, each is plotted individually to create a series of points. Different landslide scenarios could include different magnitudes of landslides or different structures where the probability of spatial interaction or the vulnerability differ. However, in this situation, only one landslide hazard was considered and all of the occupants of the four towers were considered to be equally exposed.

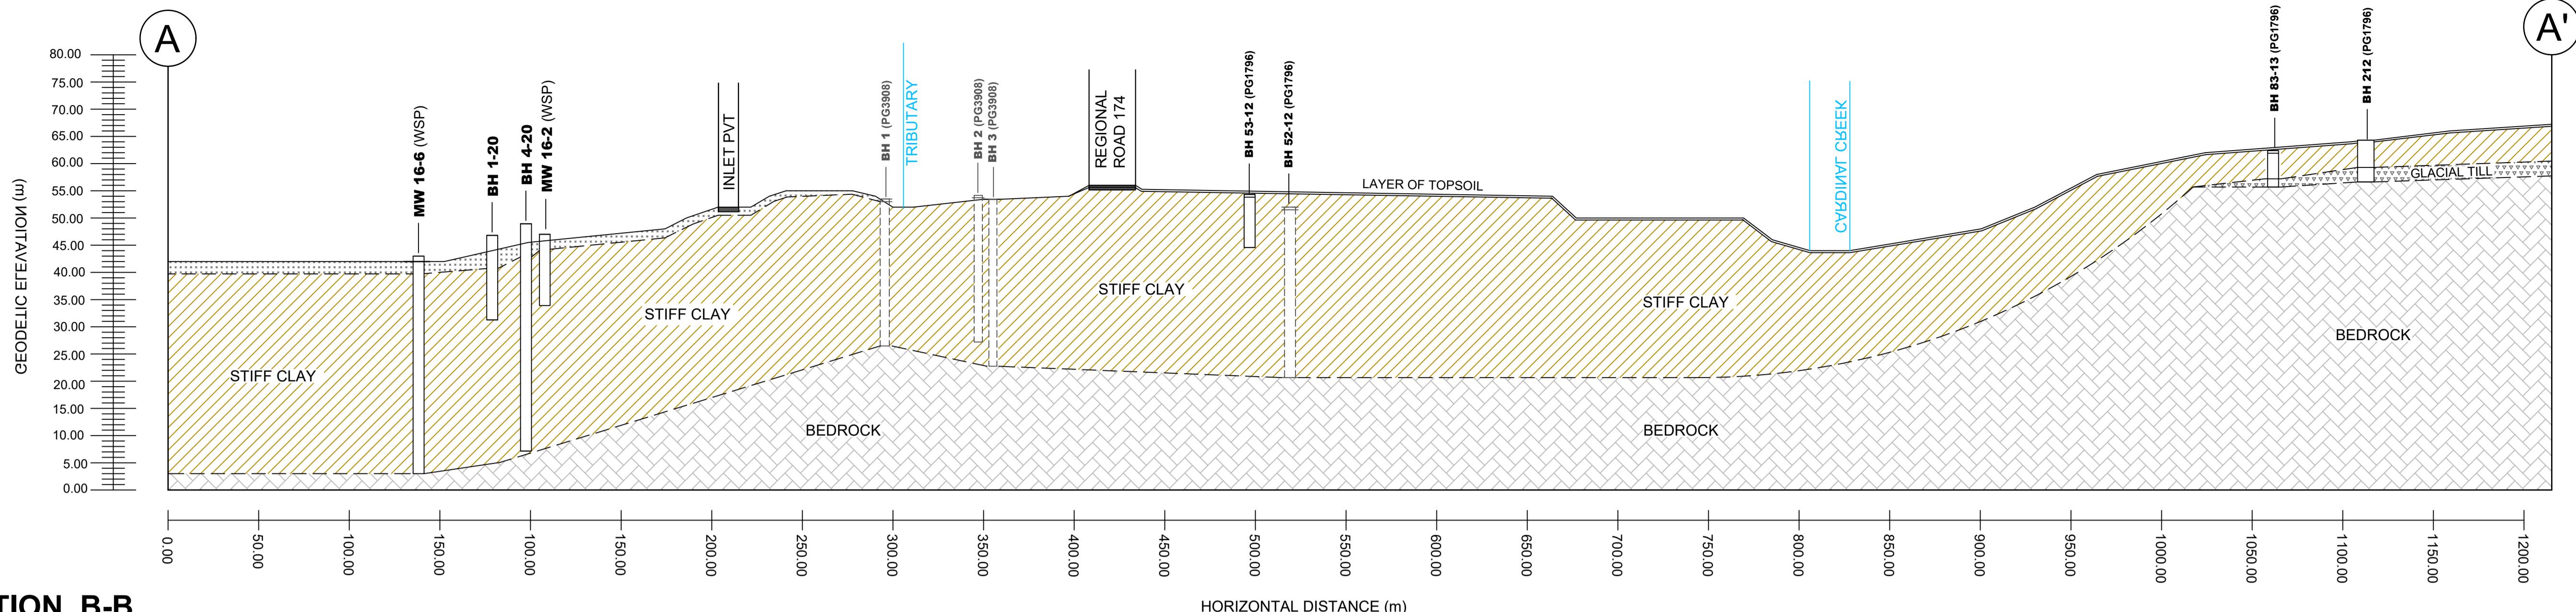
SECTION B-B

SCALE - H1:2000 , V : AS SHOWN

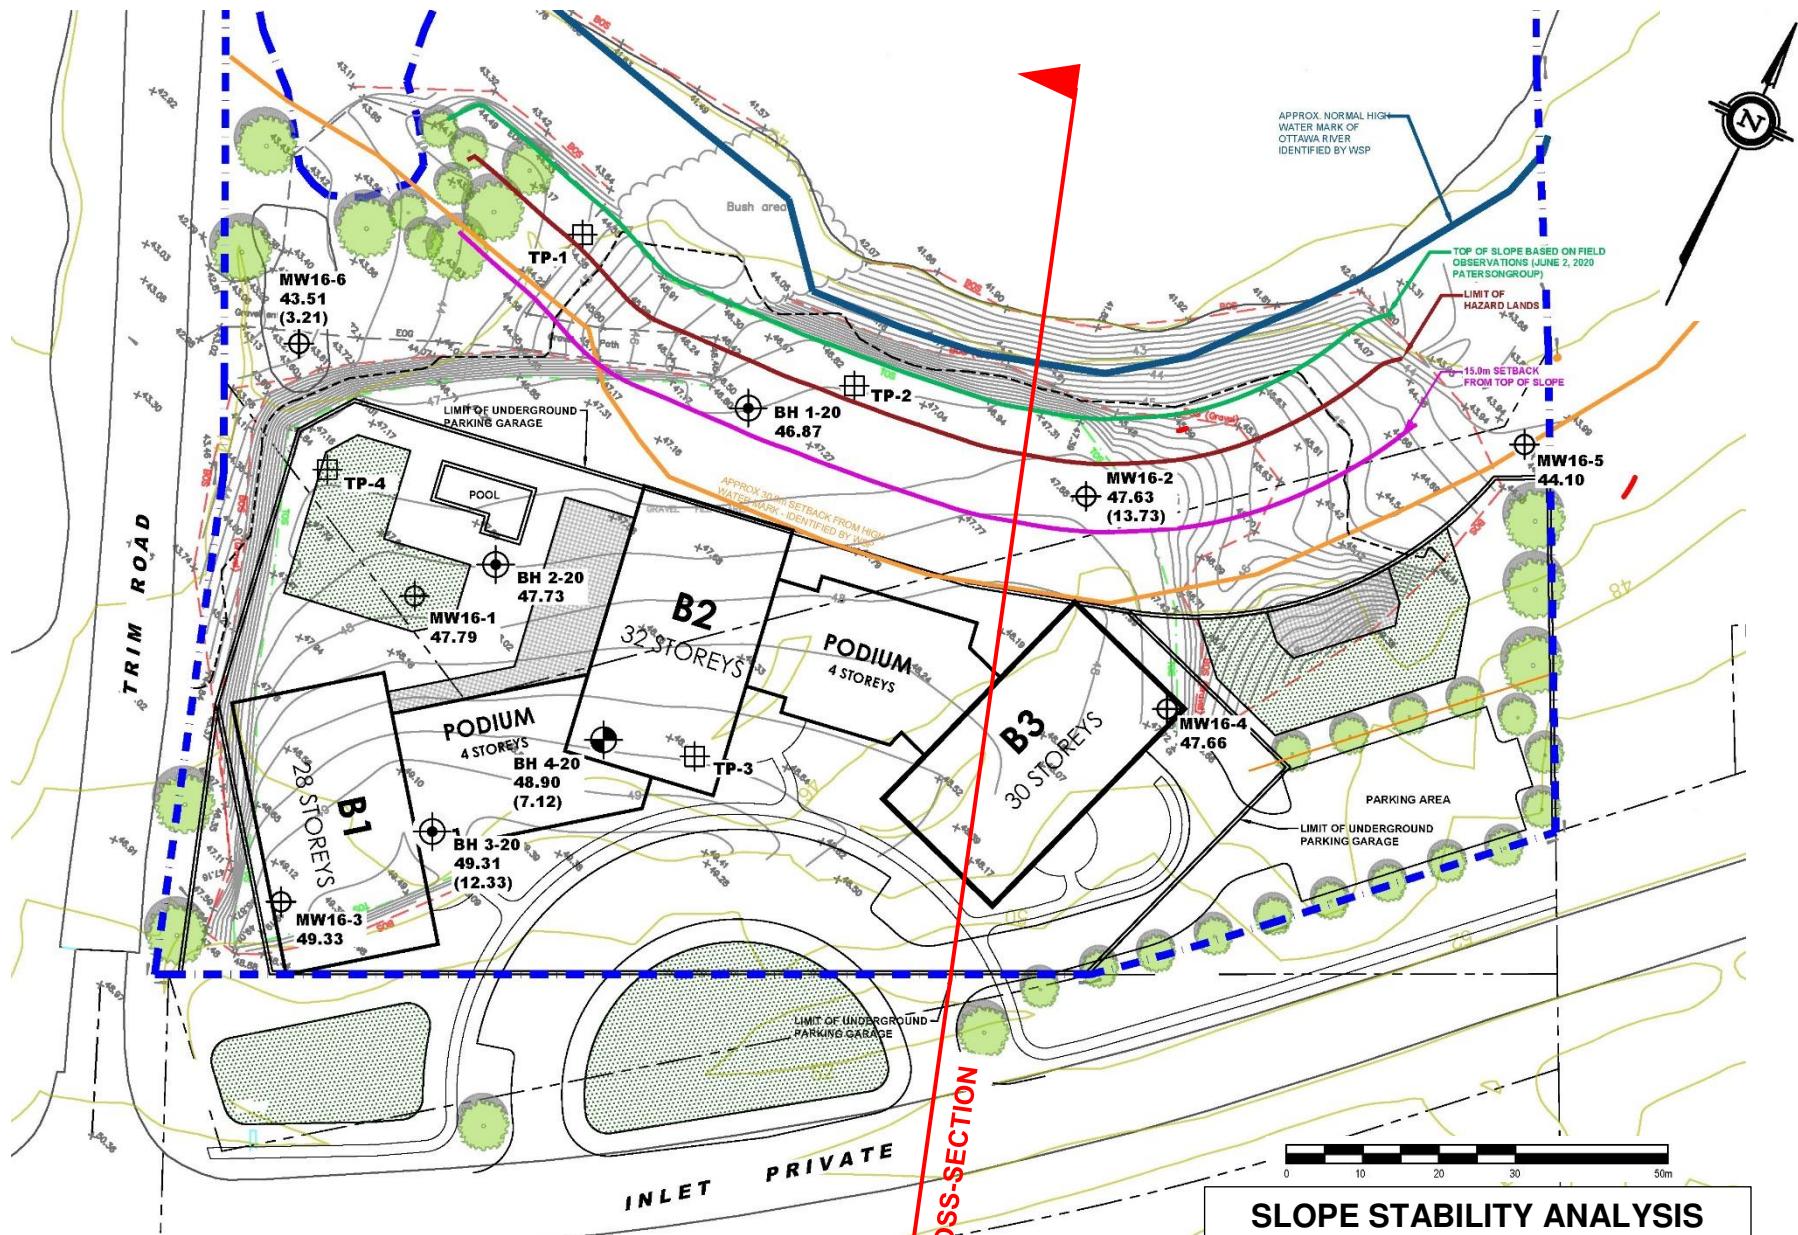
CROSS-SECTION LOCATION PLAN

From Test Hole Location Plan prepared by Paterson Group (2020b).

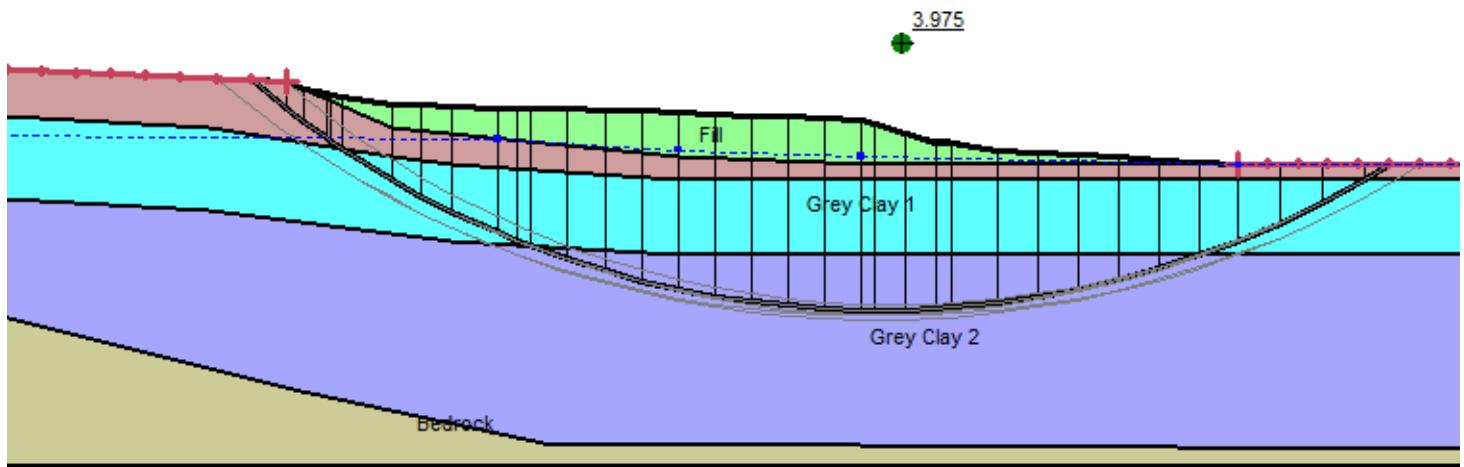
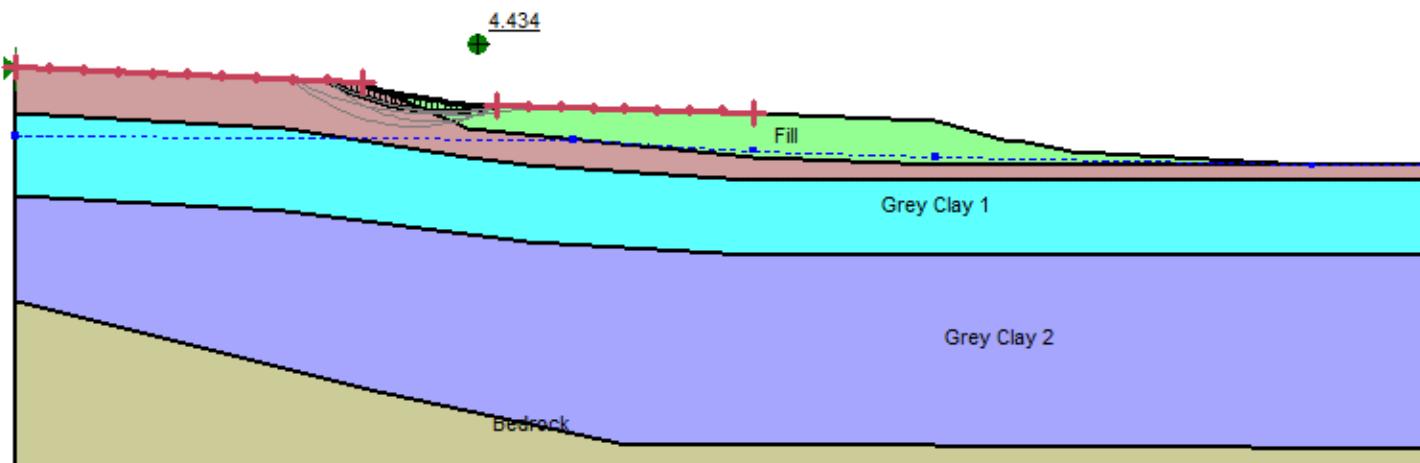
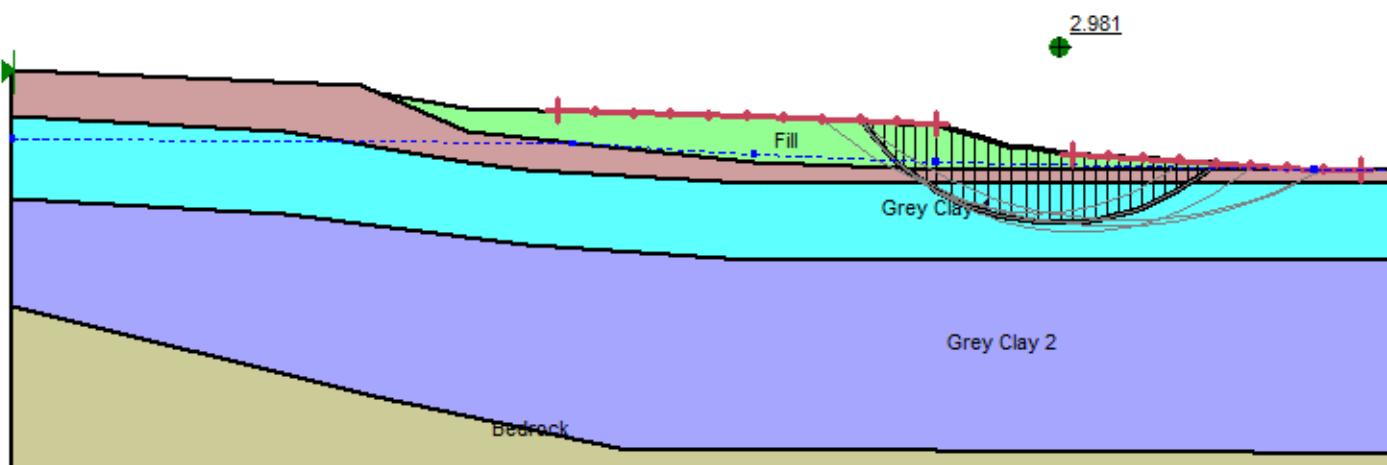
SLOPE STABILITY RESULTS

EXISTING CONDITIONS

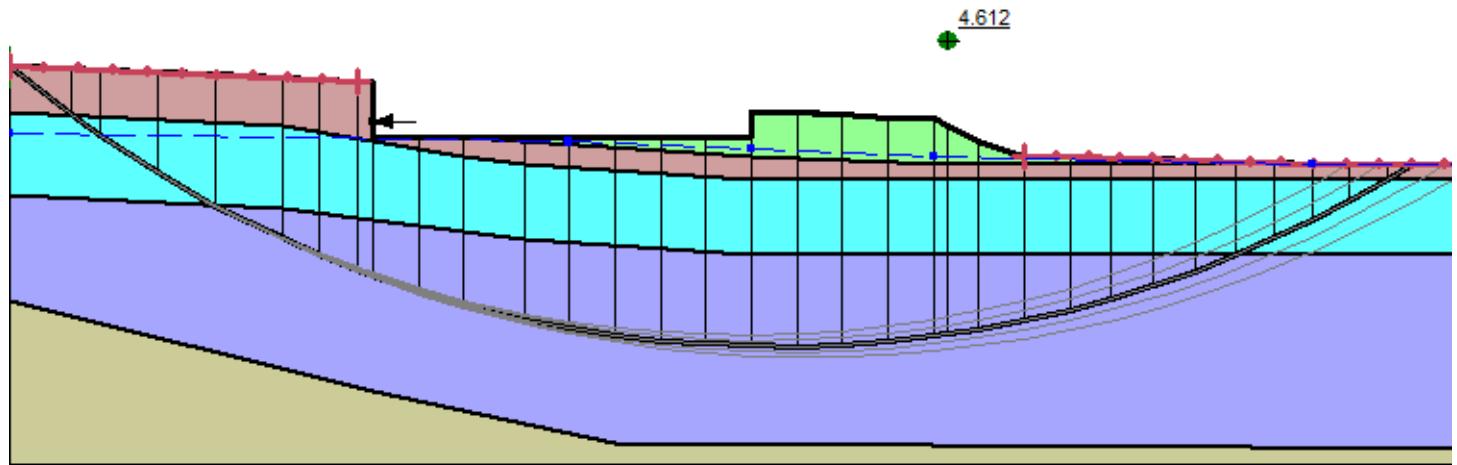
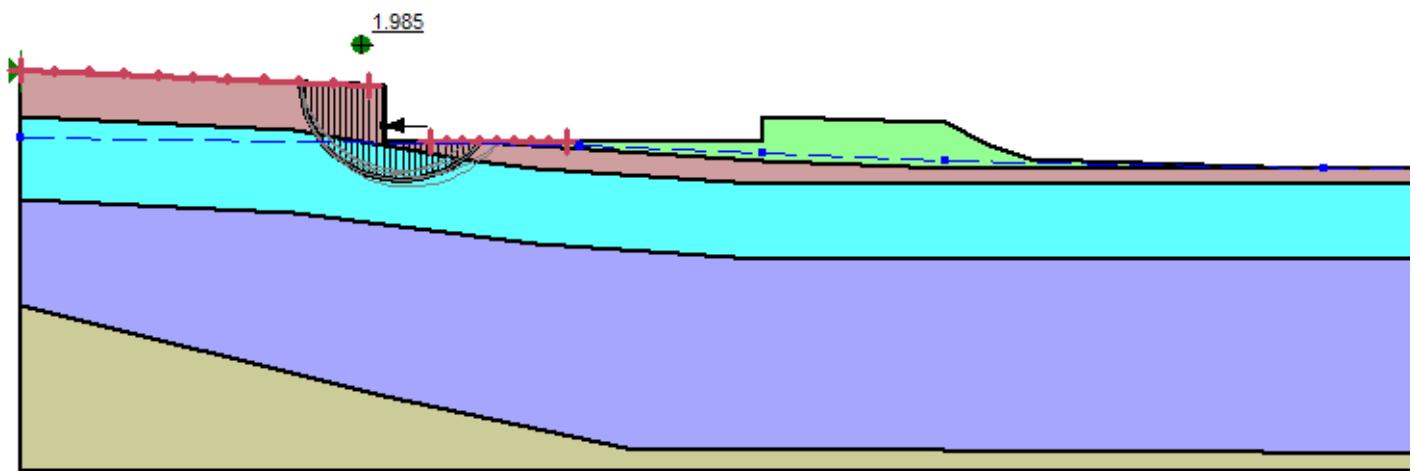
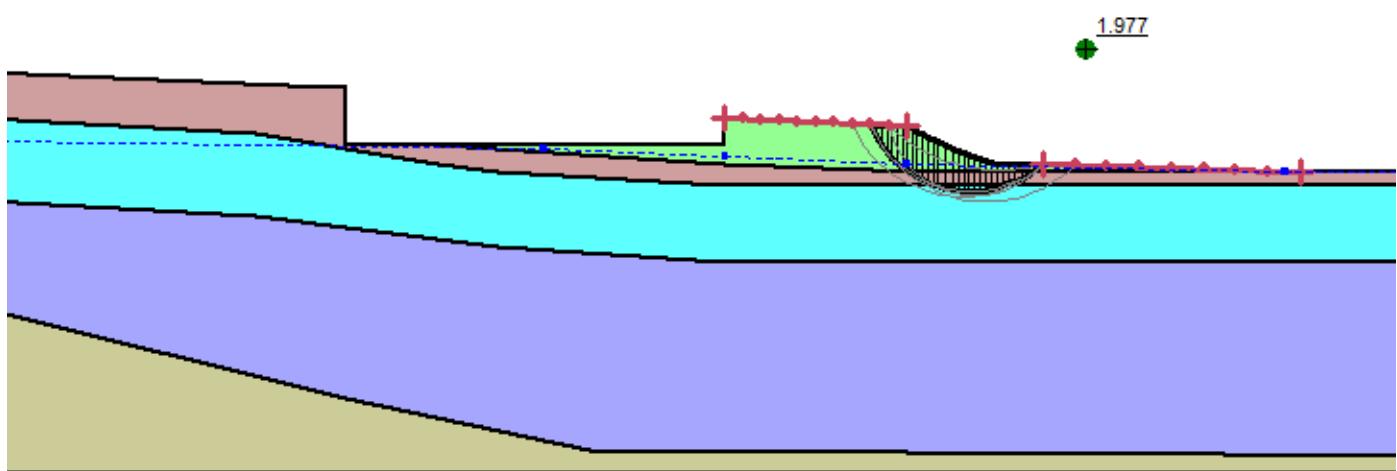
**SLOPE STABILITY RESULTS
FINAL CONDITIONS**

Scale 1:1,000 (Approximately)

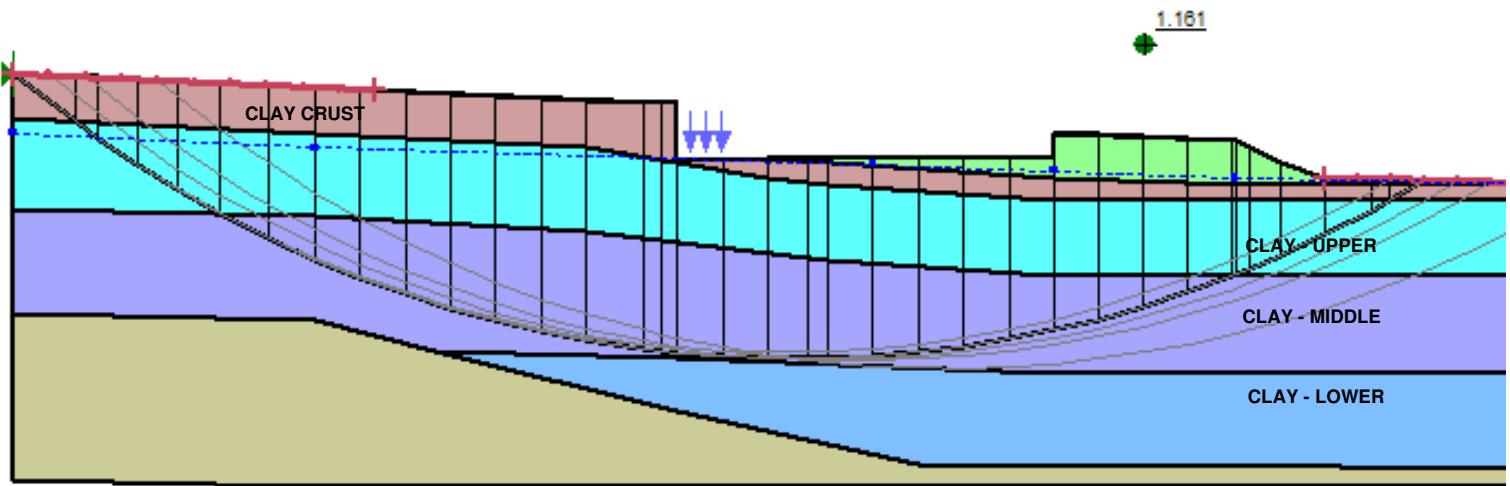
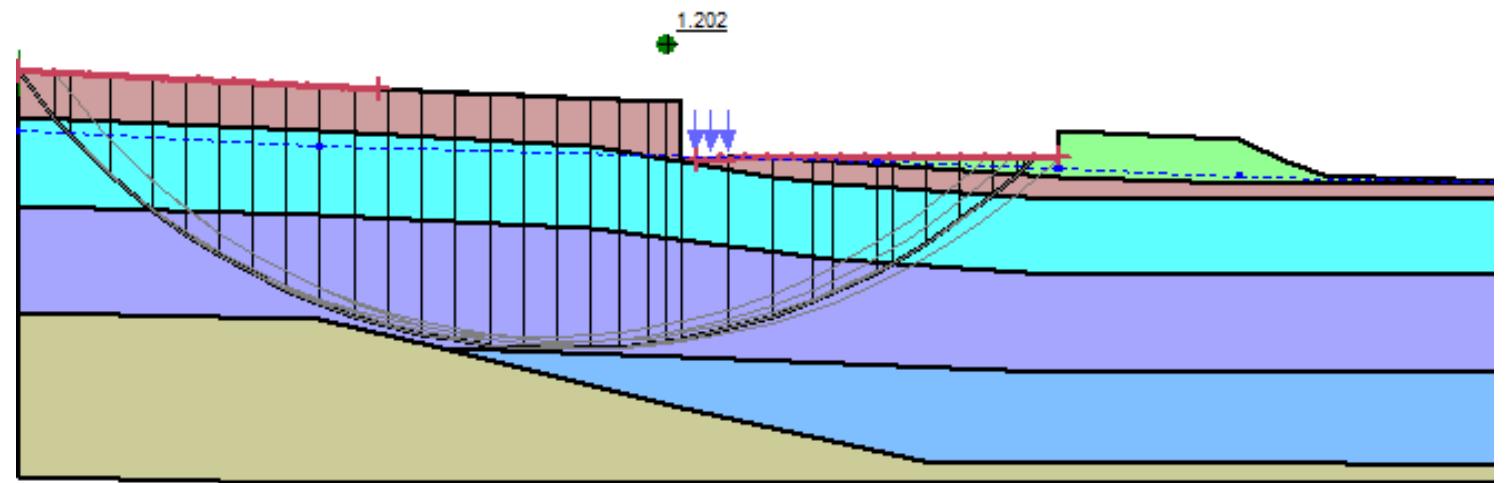
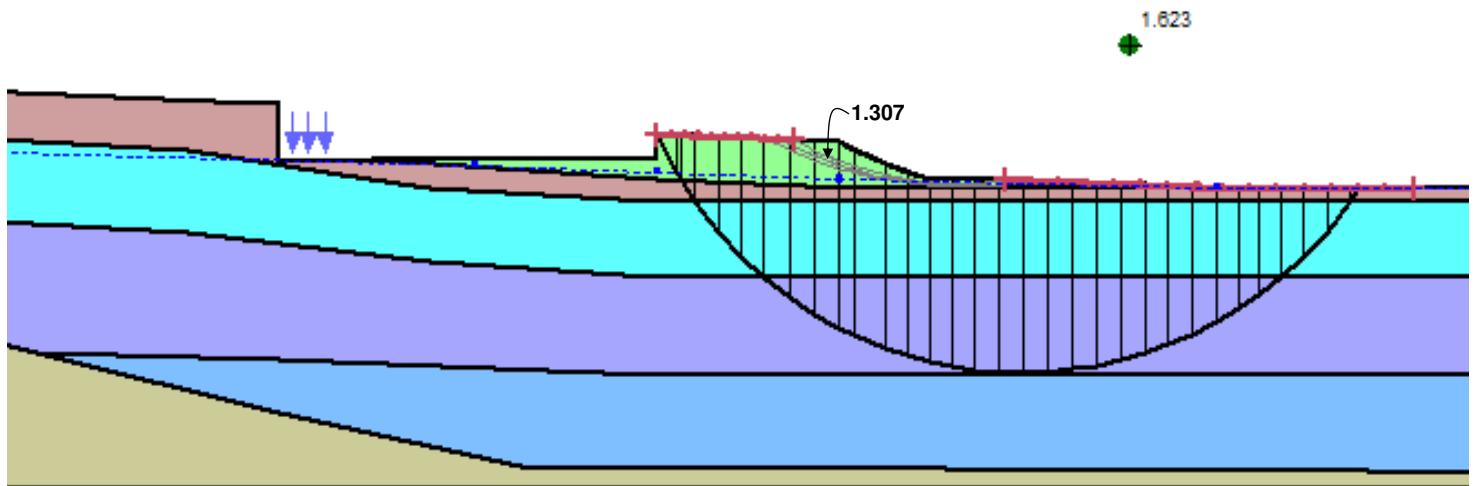
SLOPE STABILITY RESULTS

SEISMIC CONDITIONS

At Tweddle Road, the pseudo-static slope stability analysis determined the factor of safety under seismic conditions to be greater than 1.1 when subject to the 1:2,475 year earthquake. The application of limit equilibrium analysis to landslides in sensitive clay has been questioned by some researchers; however, it is still often used to analyze the initiating failure that triggers an earth flow. The stable factor of safety is consistent with both the terrain and soil conditions described above. Even under seismic conditions, the landslide probability should be less than the base probability.

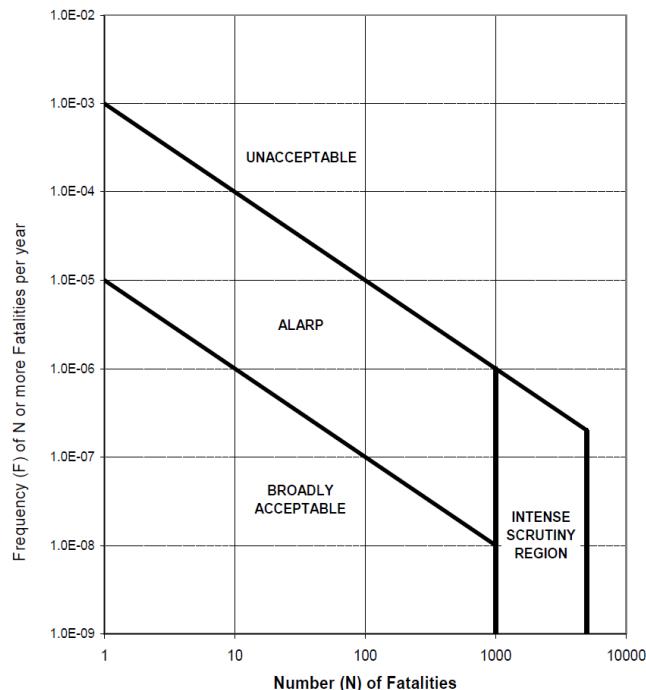
The example F-N curve in GSC OF7312 is shown in the figure to the right.
