# VUZE Construction

1015 Tweddle Road

## TREE CONSERVATION REPORT

CIMA+ file number: Z0018492  
22 August 2025 - Review 000

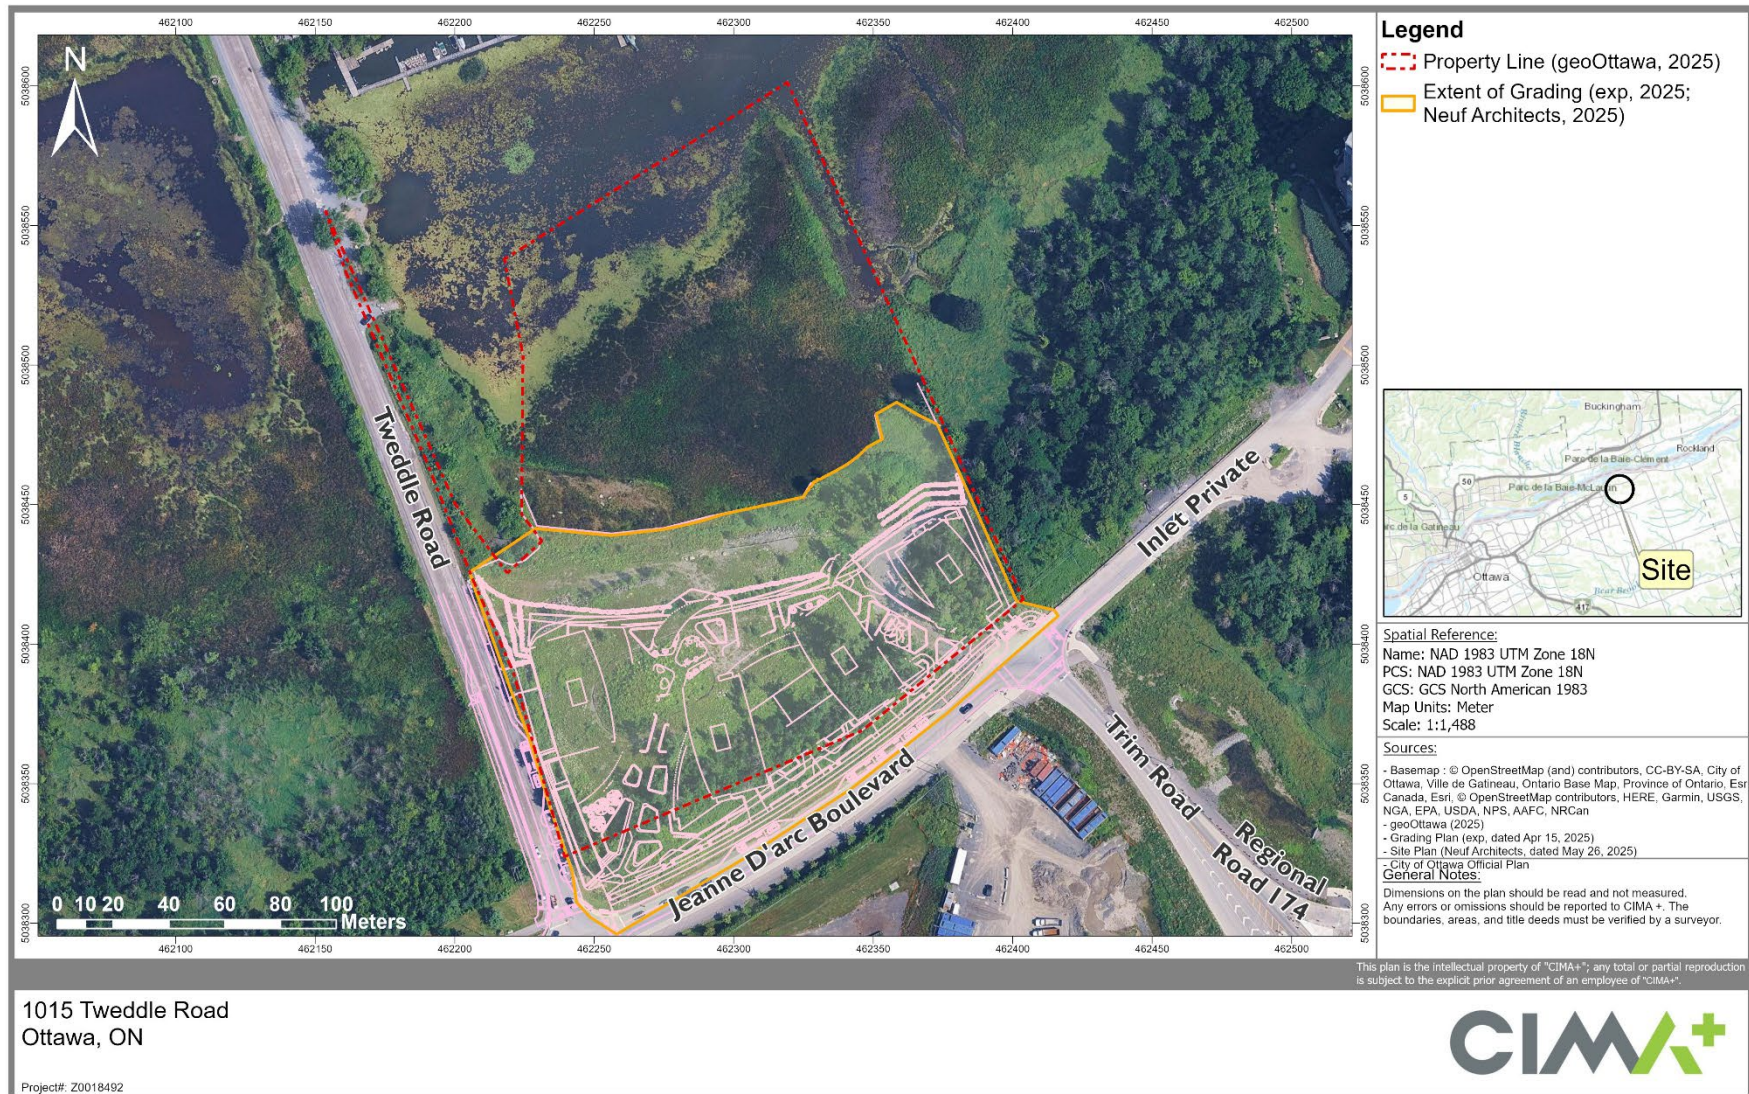
Figure 1: Property Location and Proposed Works

VUZE Construction, hereafter referred to as the proponent, intends to develop the property at 1015 Tweddle Road (the “Property”), situated at the northeast corner of the intersection at Tweddle Road and Jeanne d’Arc Boulevard North. As of 2022, Bowfin merged its services with CIMA+ who has taken over the mandate of updating this Tree Conservation Report (TCR) as per the City of Ottawa’s Tree Conservation Report Guidelines (2021).

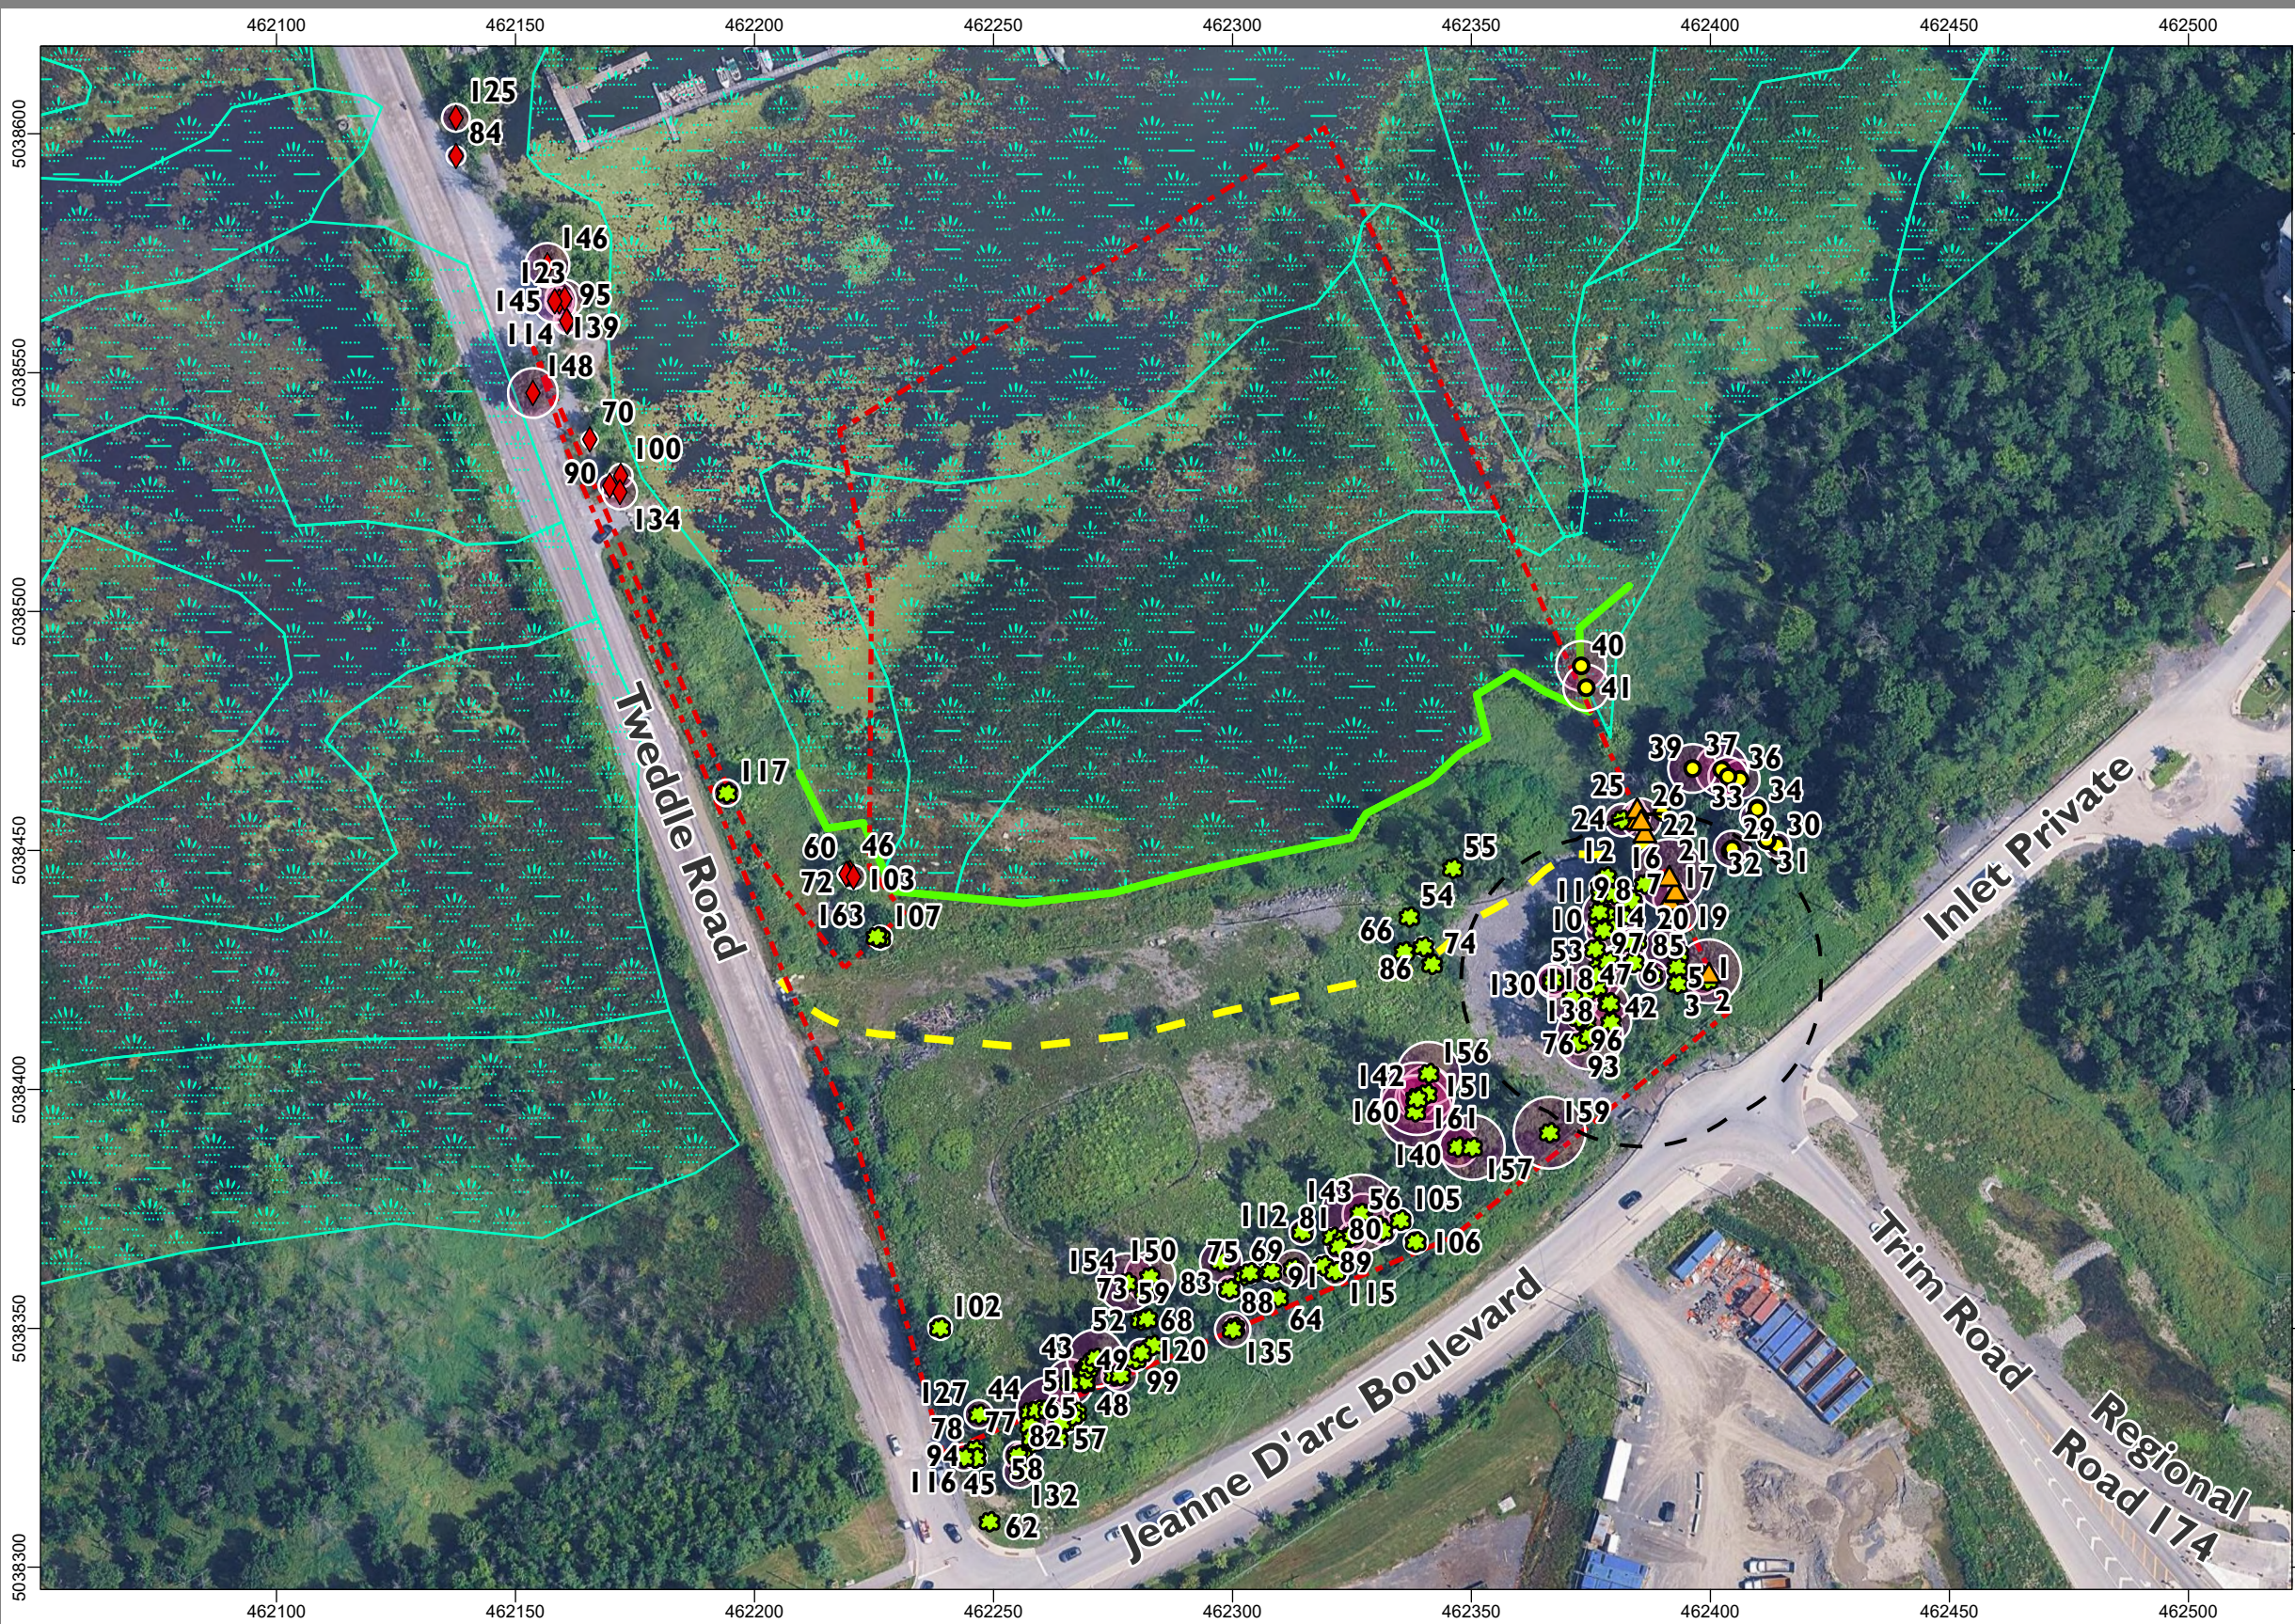
## Appendix A Map 1

The location of individual trees are depicted on Map 1 and Map 2 (Appendix A, Appendix B).

- Provincially significant wetland on the north side of the Property
- Habitat of endangered and threatened species
  - Two (2) SAR Black Ash trees were found (Trees 164, 165) with dbh of 10 and 14 cm. These were located on the southeast corner of the Property.
