Stittsville South W4 Future Neighbourhood Area – Eder Block: Environmental Impact Study for the Draft Plan of Subdivision

Final Report

Project Number: CAIV 1300.4

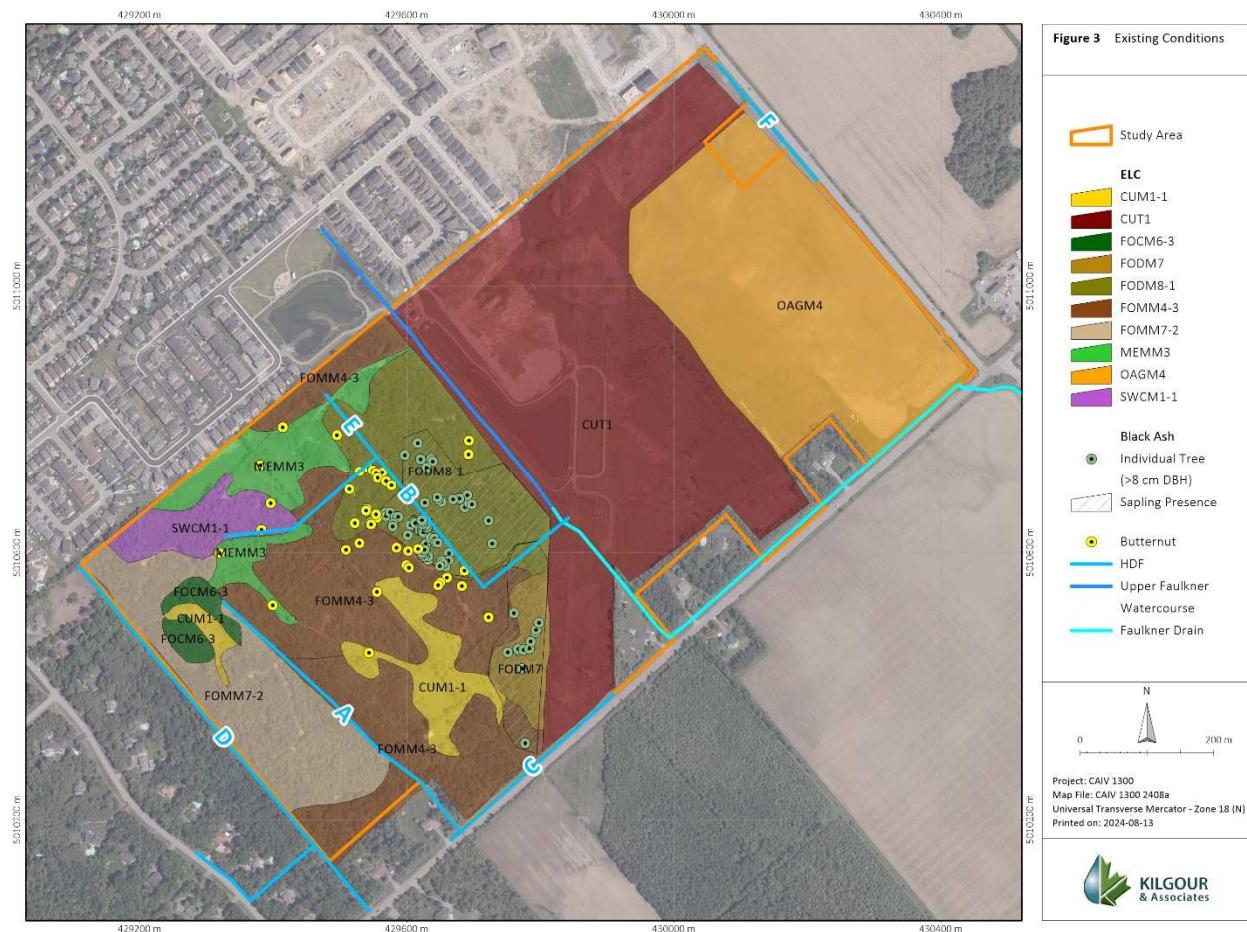
Figure 3. Existing Conditions

A total of ten distinct landcovers or ELC units were delineated on the Site (Figure 3). The majority of the western portion of the Site is a mixed Eastern White Cedar forest, a Poplar dominant deciduous forest, and meadow areas, with smaller areas of Scots Pine plantation and an Eastern White Cedar Swamp. The eastern portion of the Site is dominated by a thicket community and open agricultural lands. KAL Biologists were not permitted direct access to the small, residential parcels along Flewellyn Road as they are privately-owned. Road-side and aerial image reviews, however, indicate land cover on the small parcels (other than of the manicured spaces directly associated with houses and lawns) to correspond with the adjacent landcover of the Site. For each ELC unit identified, the dominant species observed, and any SAR plant species (highlighted in the descriptions below with an asterisk) are discussed in the following sections. An exhaustive list of all plant species observed in each ELC unit as well as tree sizes (DBH), where applicable is included in Appendix E.

Anuran surveys were performed on April 20th, May 23rd, and June 30th, 2023, at eight stations distributed across the Site to capture spatial and habitat variability. A total of five frog species were observed on the Site via evening Frog surveys and incidental observations. A summary of the weather conditions during the anuran survey is provided in Table 6. Frog species and their respective stations and calling codes are summarized in Table 7. Station locations are shown in Figure 3.

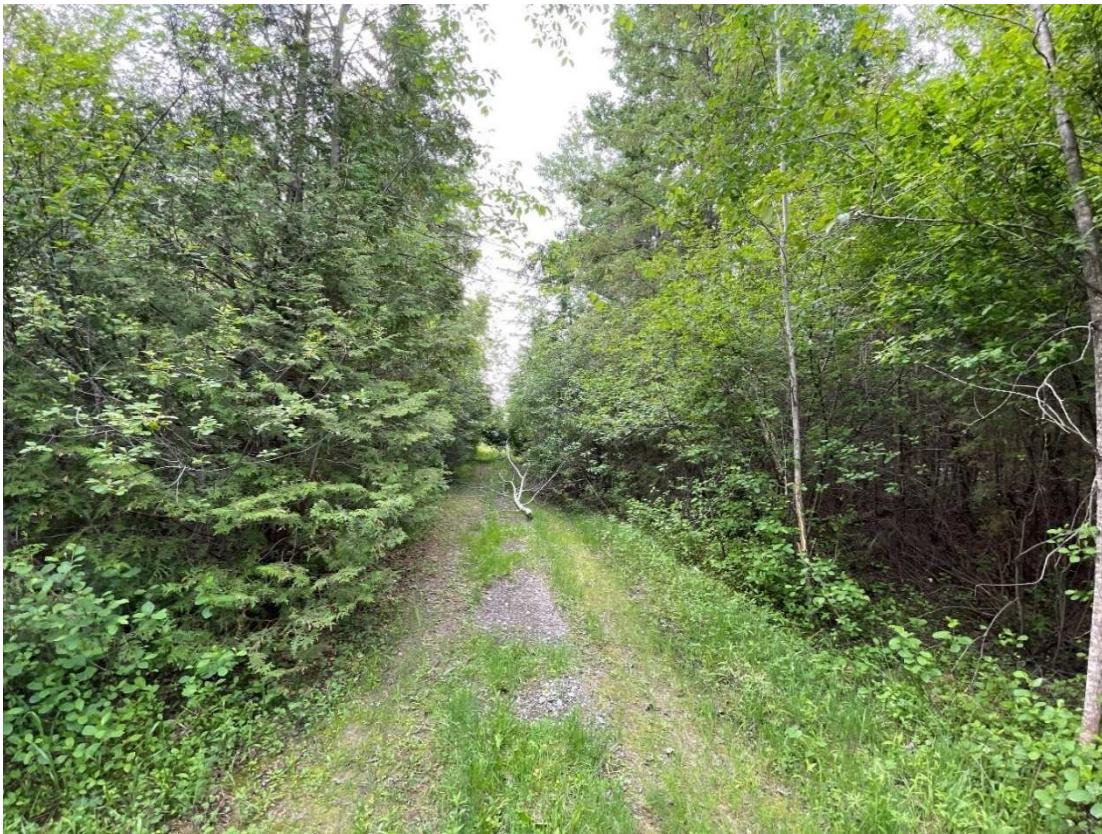
Figure 4. Dry - Fresh White Cedar – Hardwood Mixed Forest Type (FOMM4-3)

A broad swath of the western portion of the Site is characterized as a Dry - Fresh White Cedar – Hardwood Mixed Forest Type (FOMM4-3) community (Figure 4). It is dominated by Eastern White Cedar (*Thuja occidentalis*; 10-20 cm DBH), Trembling Aspen (*Populus tremuloides*; 10-20 cm DBH), Green Ash (*Fraxinus pennsylvanica*; 10-15 cm DBH), Large tooth Aspen (*Populus grandidentata*; ~15 cm DBH), White Spruce (*Picea glauca*; 30 cm DBH), White Pine (*Pinus strobus*; 25 cm DBH), Larch/Tamarack (*Larix laricina*; 15-20 cm DBH), American Beech (*Fagus grandifolia*; 10-15 cm DBH), and American Elm (*Ulmus americana*). Butternut* (*Juglans cinerea*; 20-50 cm DBH) were observed scattered throughout this community.

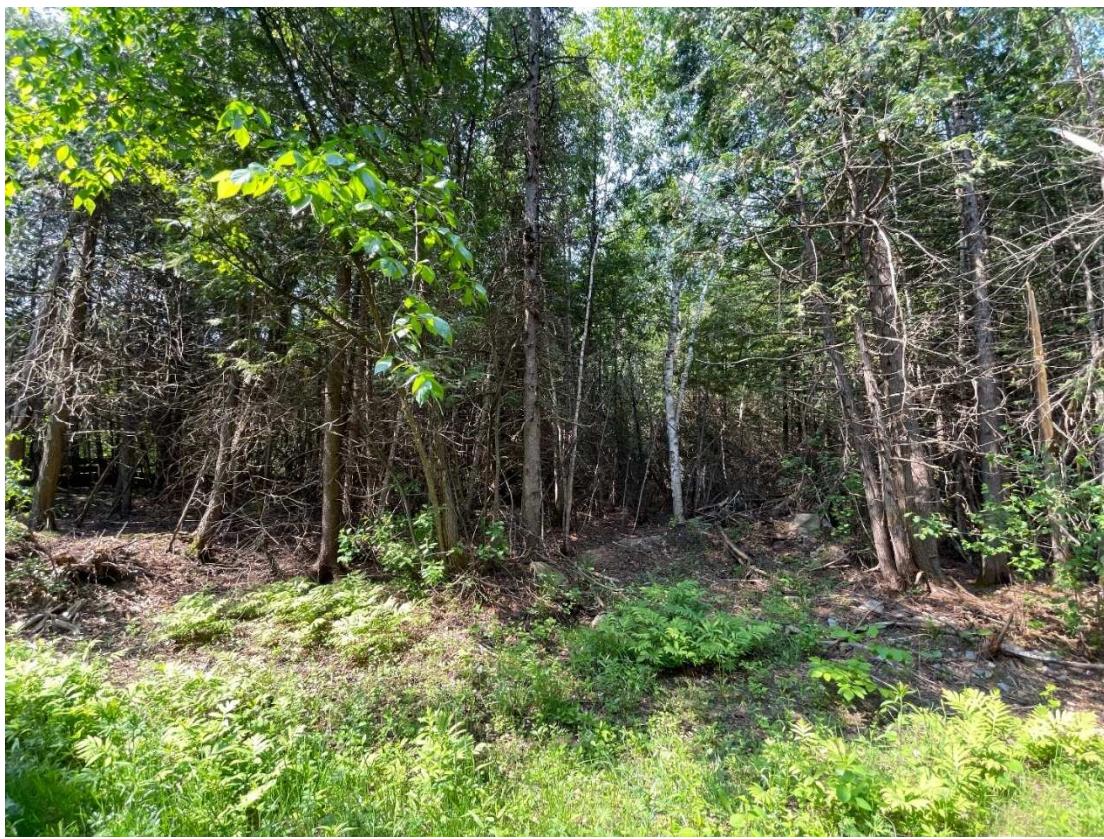
Figure 5. Fresh - Moist White Cedar - Hardwood Mixed Forest Type (FOMM7-2)

The western-most extent of the Site is characterized as a Fresh - Moist White Cedar - Hardwood Mixed Forest Type (FOMM7-2) community (Figure 5). It is dominated by Eastern White Cedar (*Thuja occidentalis*; 5-15 cm DBH), White Birch (*Betula papyrifera*; 10-20 cm DBH), Trembling Aspen (*Populus tremuloides*; 10-35 cm DBH), White Ash (*Fraxinus americana*; 5-8 cm DBH), White Spruce (*Picea glauca*; ~10 cm DBH), and Balsam Fir (*Abies Balsamea*) tree species.

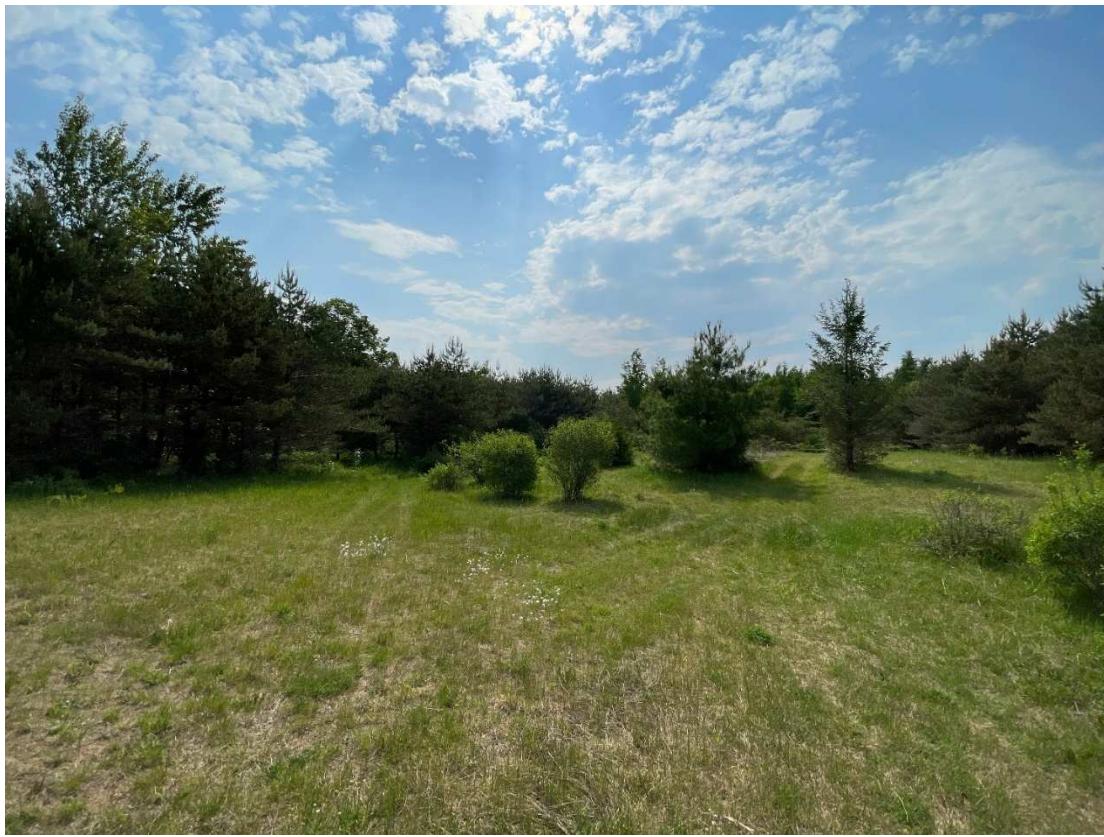
Figure 6. Dry – Moist Old Field Meadow Type (CUM1-1)

A Dry – Moist Old Field Meadow Type (CUM1-1; Figure 6) is located centrally on the Site. This area is characteristic of previous disturbance with scattered tree species including Large tooth Aspen (*Populus grandidentata*; ~5 cm DBH), Trembling Aspen (*Populus tremuloides*; 10-25 cm DBH), Eastern White Cedar (*Thuja occidentalis*; ~10 cm DBH), Scots Pine (*Pinus sylvestris*; 5-10 cm DBH), American Beech (*Fagus grandifolia*; ~10 cm DBH), Apple Spp. (*Malus*; 8-10 cm DBH), White Spruce (*Picea glauca*; 20-25 cm DBH), Larch/Tamarack (*Larix laricina*; ~5-10 cm DBH), Green Ash (*Fraxinus pennsylvanica*; <5 cm DBH). Dominant shrub and groundcover species included Common Juniper (*Juniperus communis*), Trembling Aspen (*Populus tremuloides*) saplings, Orchard Grass (*Dactylis glomerata*), Wild Strawberry (*Fragaria vesca*), Canada Goldenrod (*Solidago canadensis*), Poison Ivy (*Toxicodendron radicans*), Red Raspberry (*Rubus idaeus*), Alder Buckthorn (*Rhamnus frangula*), and Common Blackberry (*Rubus allegheniensis*).

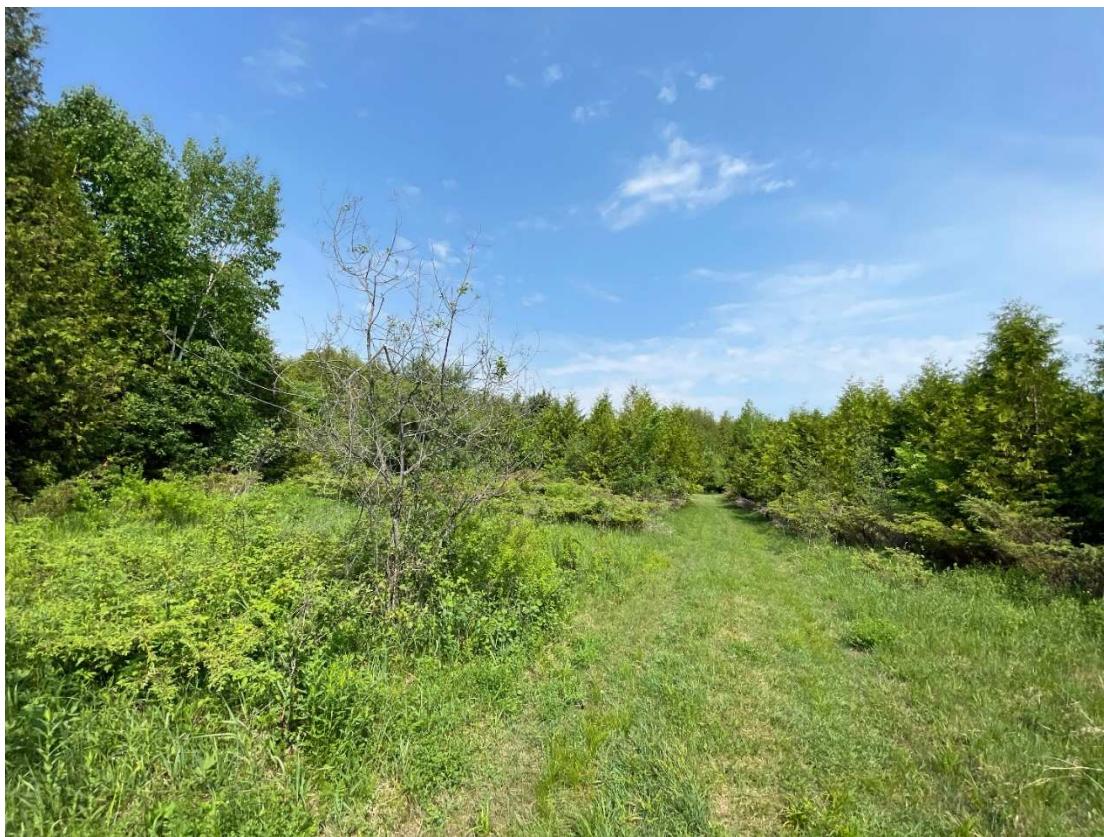
Figure 7. Dry – Fresh Mixed Meadow Ecosite (MEMM3)

A Dry – Fresh Mixed Meadow Ecosite (MEMM3) is located in the northwest corner of the Site (Figure 7). This area is mainly characterized by Eastern White Cedar (*Thuja occidentalis*), Scots Pine (*Pinus sylvestris*; ~10-20 DBH), Larch/Tamarack (*Larix laricina*; ~10 DBH), and scattered Butternut* (*Juglans cinerea*; ~10-20 DBH) trees. Dominant shrub and groundcover species included Common Juniper (*Juniperus communis*), Orchard grass (*Dactylis glomerata*), Wild strawberry (*Fragaria vesca*), Canada Goldenrod (*Solidago canadensis*), Alder Buckthorn (*Rhamnus frangula*), and Common Blackberry (*Rubus allegheniensis*).

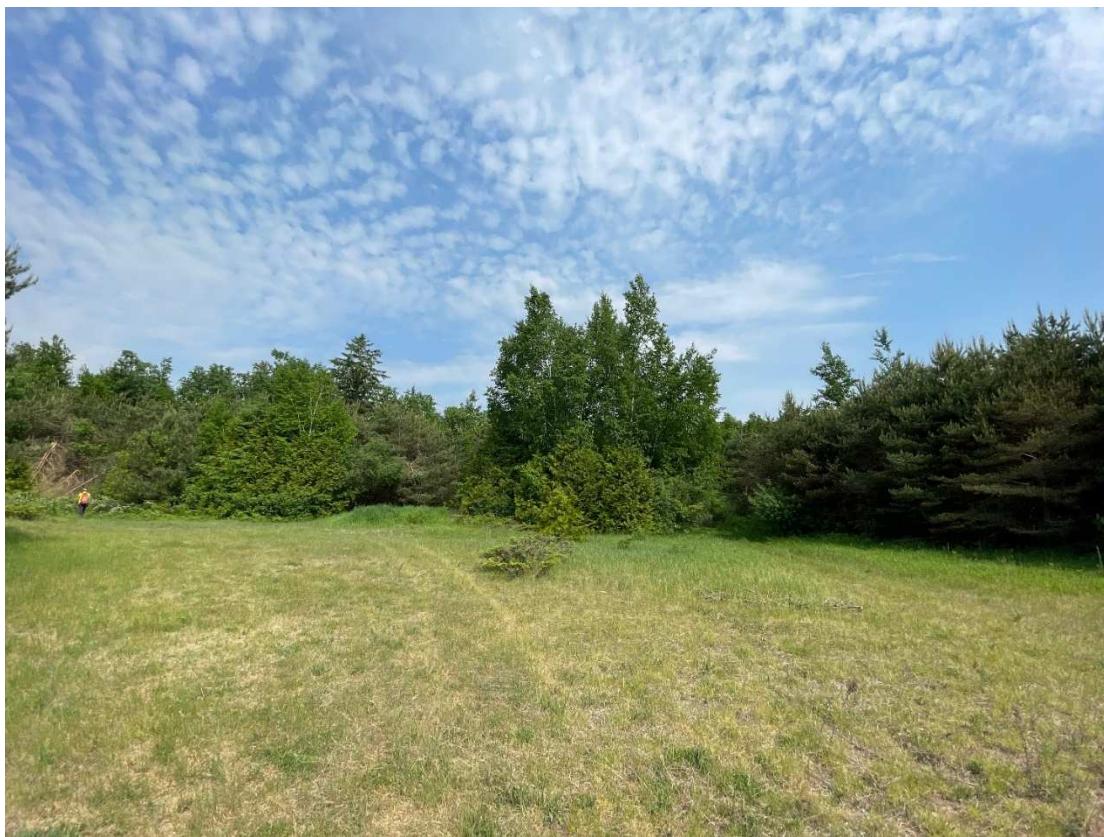
Figure 8. Dry – Fresh Scots Pine Naturalized Coniferous Plantation Type (FOCM6-3)

A Fresh Scots Pine Naturalized Coniferous Plantation Type (FOCM6-3) is located in the northwest corner of the Site (Figure 8). It is mainly dominated by Scots Pine (*Pinus sylvestris*; ~10-20 cm DBH), Jack Pine (*Pinus banksiana*; ~15 cm DBH), Eastern White Cedar (*Thuja occidentalis*), White Pine (*Pinus strobus*; ~20 cm DBH), White Birch (*Betula papyrifera*; 10-20 cm DBH), Butternut* (*Juglans cinerea*), American Beech (*Fagus grandifolia*), and Green Ash (*Fraxinus pennsylvanica*; 10-15 cm DBH).

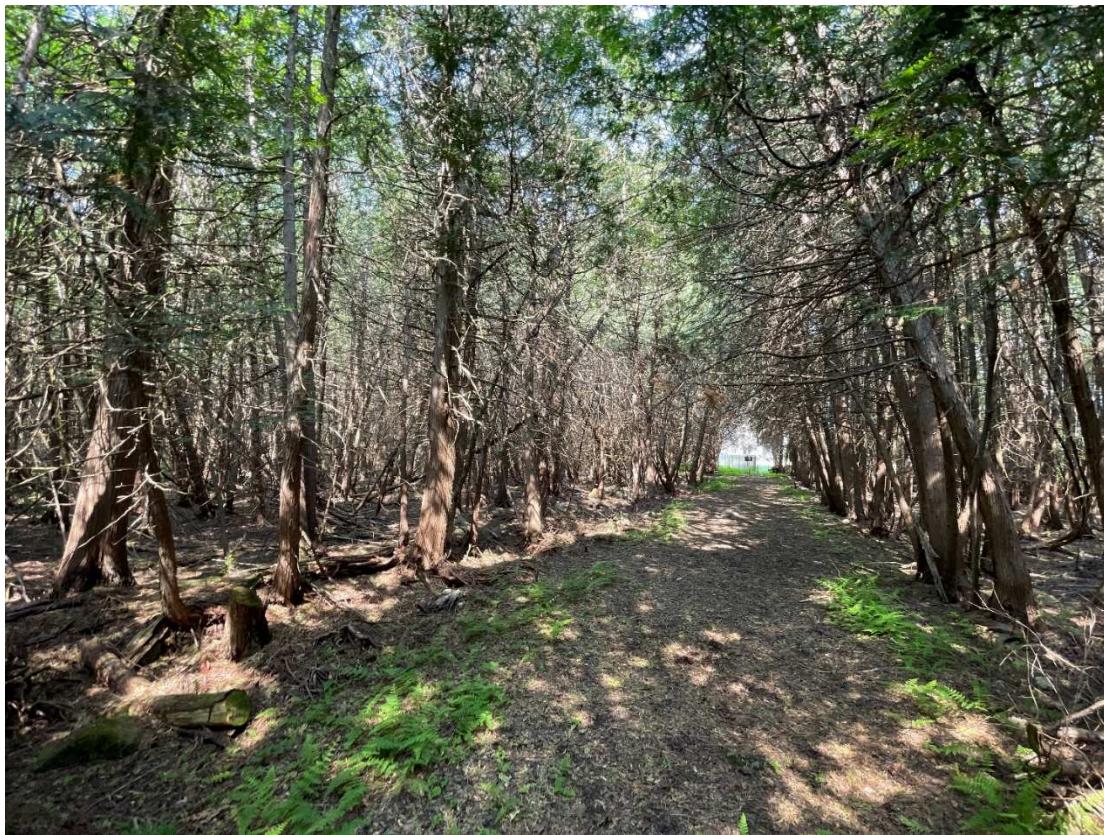
Figure 9. White Cedar Mineral Coniferous Swamp (SWCM1-1)

A White Cedar Mineral Coniferous Swamp (SWCM1-1) is located on Site (Figure 9). It is dominated by Eastern White Cedar (*Thuja occidentalis*) and has ground cover consisting of Bulblet Bladder Fern (*Cystopteris bulbifera*), Alder Buckthorn (*Rhamnus frangula*), Interrupted Fern (*Osmunda claytoniana*), Sensitive Fern (*Onoclea sensibilis*), and Poison Ivy (*Toxicodendron radicans*).

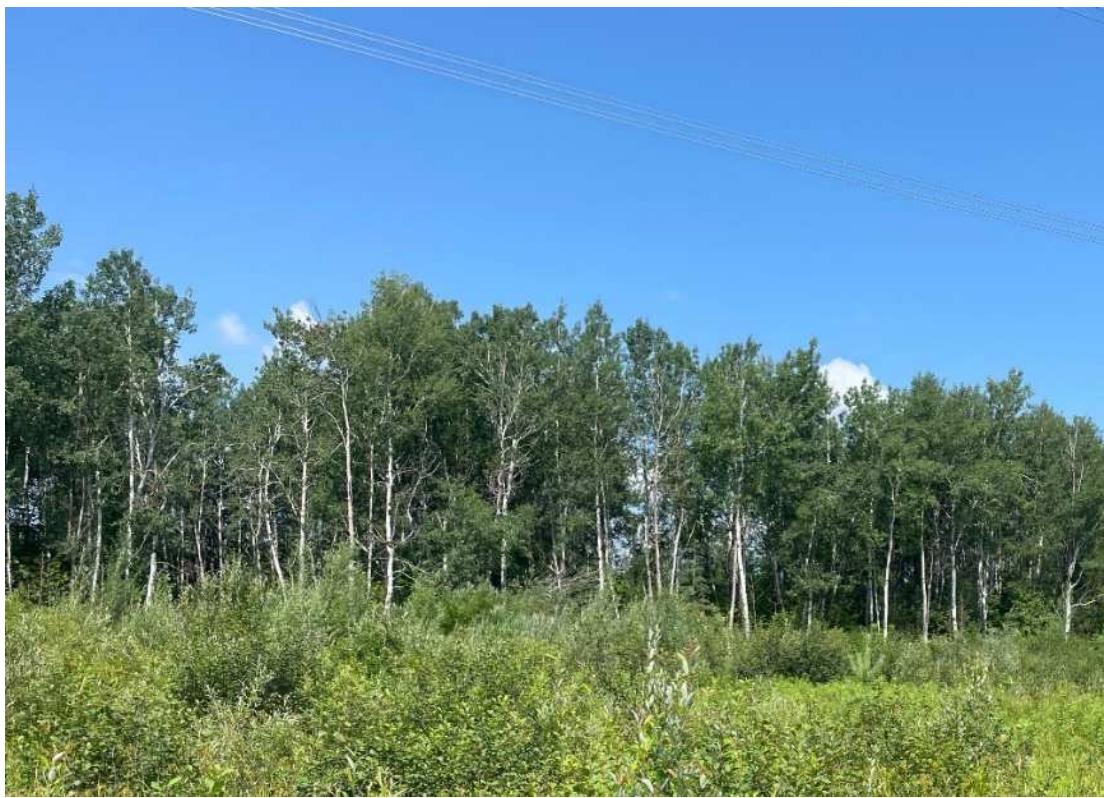
Figure 10. Fresh – Moist Lowland Deciduous Forest Ecosite (FODM7)

A Fresh-Moist Lowland Deciduous Forest Ecosite (FODM7) is located in the center of the Site (Figure 10). It is dominated by Trembling Aspen (*Populus tremuloides*) Eastern White Cedar (*Thuja occidentalis*), Butternut* (*Juglans cinerea*), Black Ash* (*Fraxinus nigra*), and Balsam Poplar (*Populus balsamifera*). Its ground cover consists of Common Buckthorn (*Rhamnus cathartica*), Poison Ivy (*Toxicodendron radicans*), White Panicle Aster (*Symphyotrichum lanceolatum*), Riverbank Grape (*Vitis riparia*), Common Ragweed (*Ambrosia artemisiifolia*), and Yellow Sweet Clover (*Melilotus officinalis*).

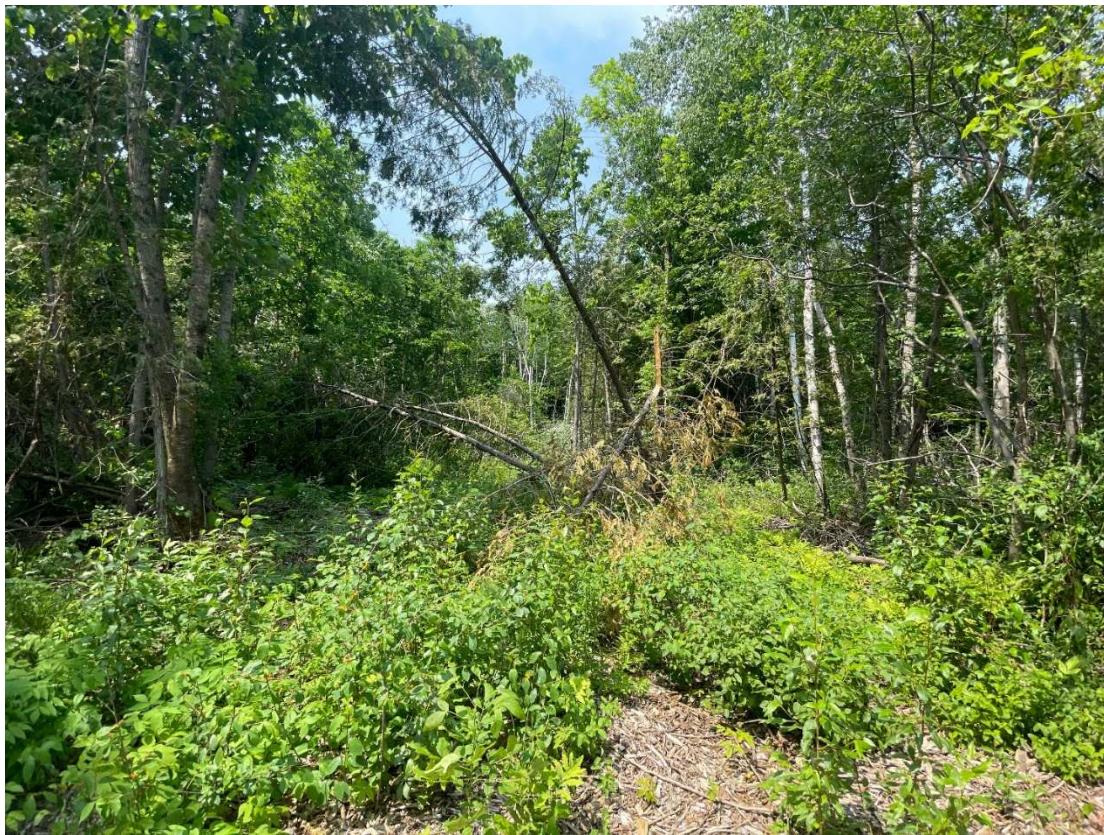
Figure 11. Fresh – Moist Poplar Deciduous Forest Type (FODM8-1)

A Fresh – Moist Poplar Deciduous Forest Type (FODM8-1; Figure 11) is located on Site and is dominated by Trembling Aspen (*Populus tremuloides*; 10-20 cm DBH), White Birch (*Betula papyrifera*; 10-20 cm DBH), Balsam Poplar (*Populus balsamifera*; 10-25 cm DBH), Butternut* (*Juglans cinerea*; 10-20 cm DBH), Eastern White Cedar (*Thuja occidentalis*; 10-20 cm DBH), Basswood (*Tilia americana*; ~30 cm DBH), Red Maple (*Acer rubrum*; ~27 cm DBH), American Elm (*Ulmus americana*; 10-20 cm DBH), and Black Ash* (*Fraxinus nigra*). Its dominant ground cover consists of Common Juniper (*Juniperus communis*), Trembling Aspen saplings (*Populus tremuloides*), Sensitive Fern (*Onoclea sensibilis*), Ostrich Fern (*Matteuccia struthiopteris*), Interrupted Fern (*Osmunda claytoniana*), Canada Goldenrod (*Solidago canadensis*), Poison Ivy (*Toxicodendron radicans*), Alder Buckthorn (*Rhamnus frangula*), Bloodroot (*Sanguinaria*), and Meadow Horsetail (*Equisetum pratense*).

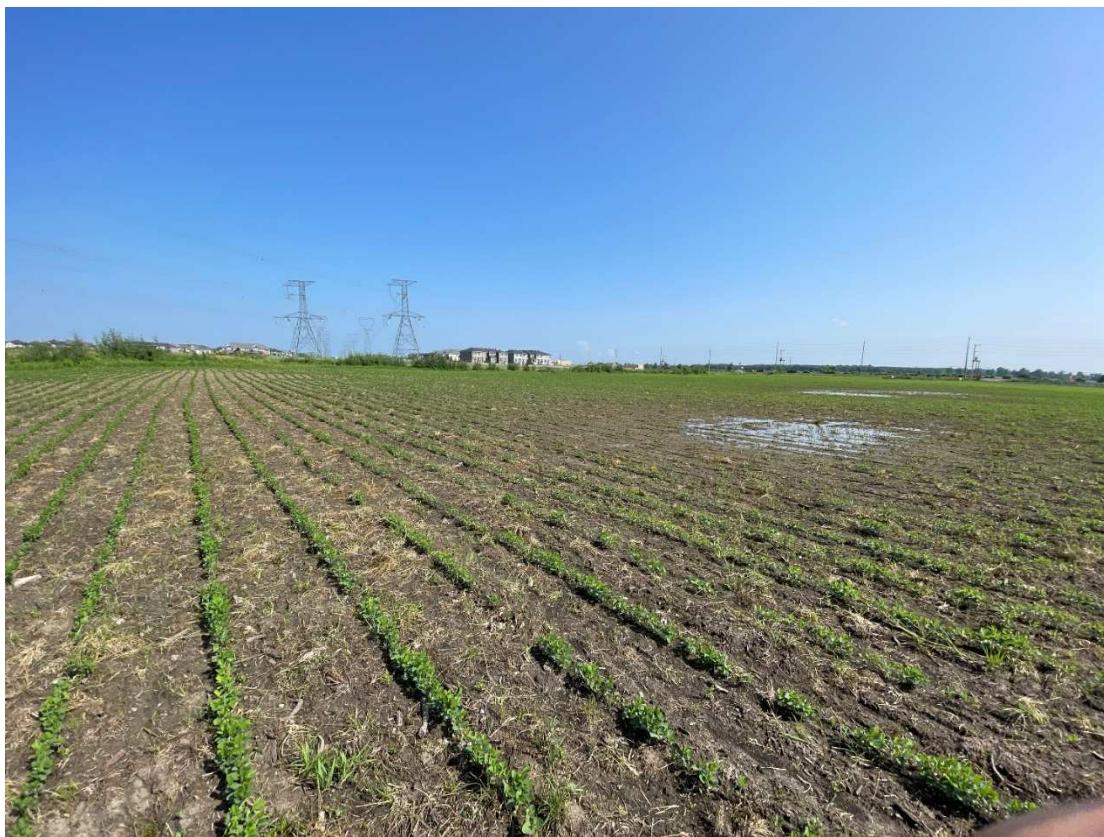
Figure 12. Medium Mineral Open Pasture Type (OAGM4)

A Medium Mineral Open Pasture Type (OAGM4) on Site (Figure 12) is dominated by planted crop cultivar and scattered shrub community species such as Canada Goldenrod (*Solidago canadensis*), Meadow Horsetail (*Equisetum pratense*), Purple Aster (*Sympphyotrichum patens*), Common Mullein (*Verbascum thapsus*), Meadow Buttercup (*Ranunculus acris*), Wild Strawberry (*Fragaria vesca*), and Common Dandelion (*Taraxacum officinale*).

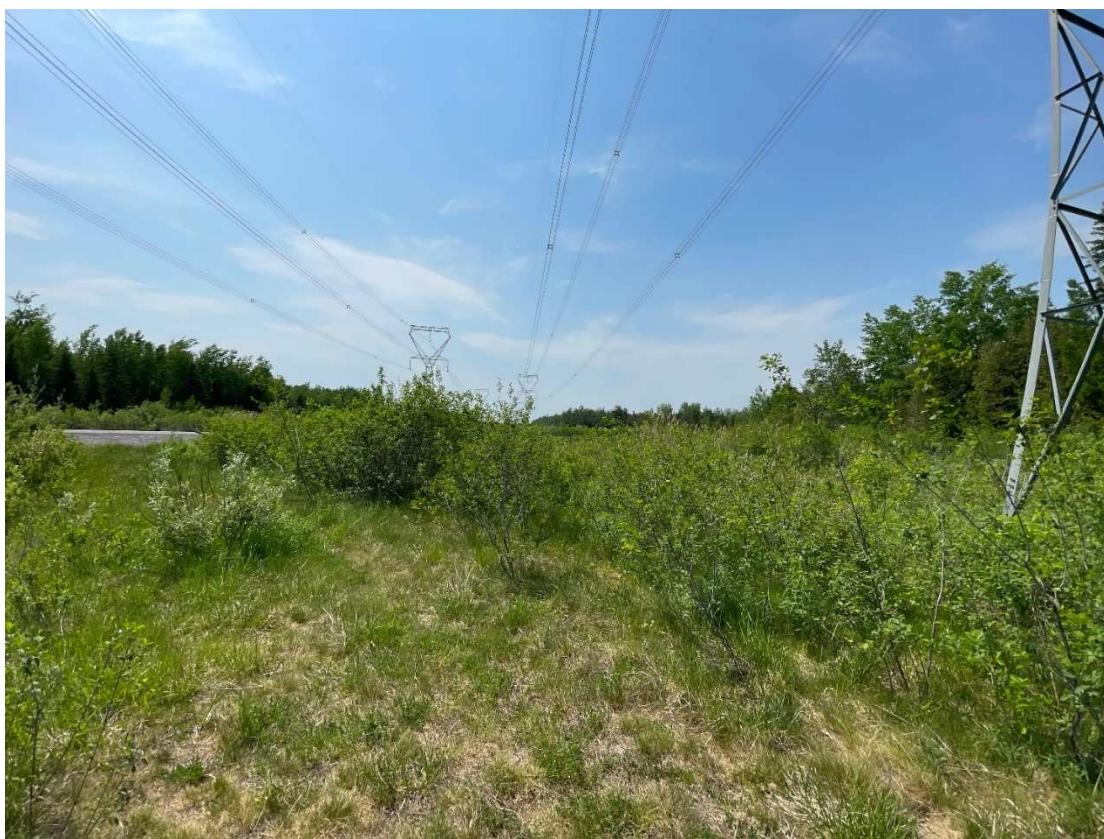
Figure 13. Cultural Thicket Ecosite (CUT1)

A Cultural Thicket Ecosite (CUT1; Figure 13) on Site is dominated by Bebb's Willow (*Salix bebbiana*), Alder Buckthorn (*Rhamnus frangula*), Trembling Aspen Saplings (*Populus tremuloides*), White Willow (*Salix alba*), White Meadowsweet (*Spiraea alba*), and Common Milkweed (*Asclepias syriaca*).

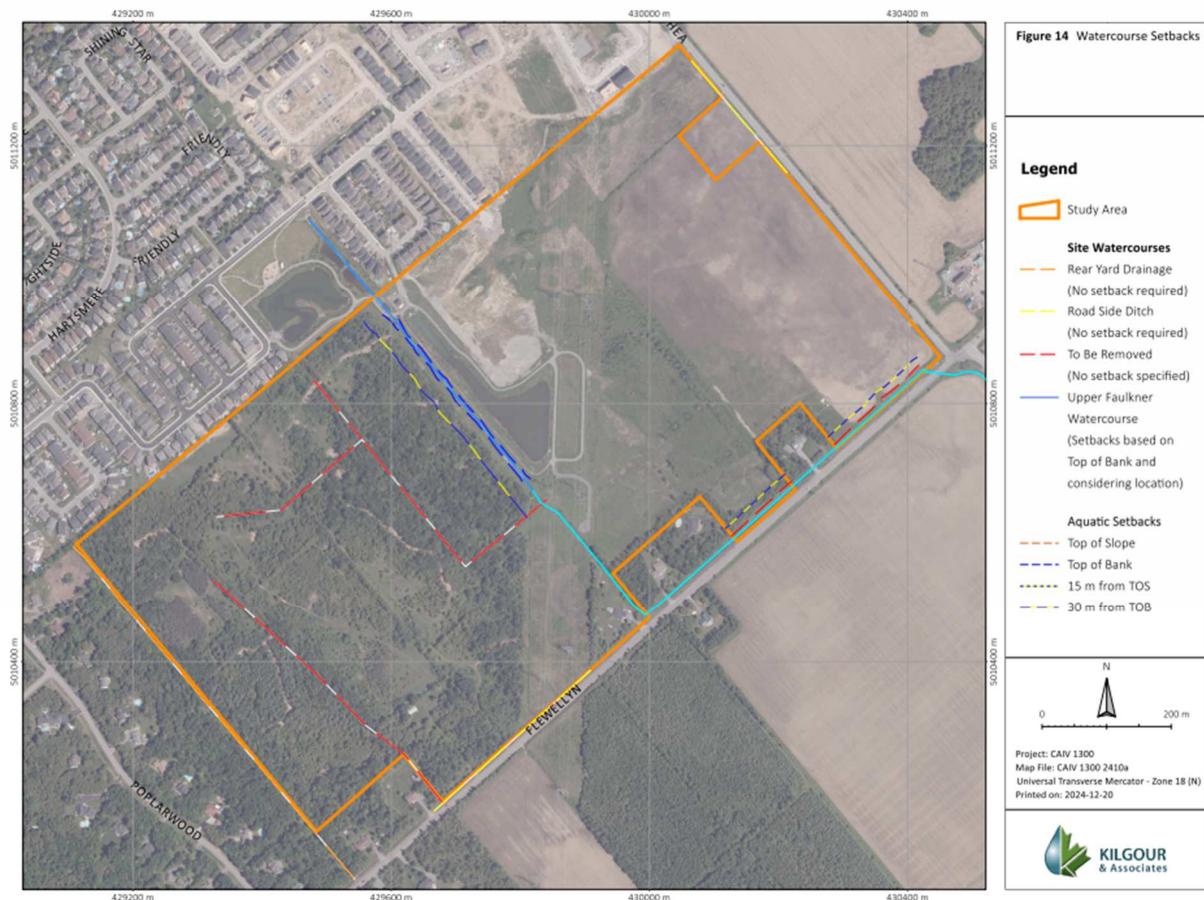
Figure 14 Watercourse Setbacks

- Site grading is designed to ensure all adjacent overland flow is directed to a SWM system for quality and quantity control before release (i.e., to otherwise prevent direct, unfiltered/unmitigated surface flow) to the drain; and
- The buffer space includes vegetation suitable for the provision of soil stability, allochthonous input to drain, and (to the extent feasible from the north side bank) shading over water to improve existing drain condition and fish habitat.

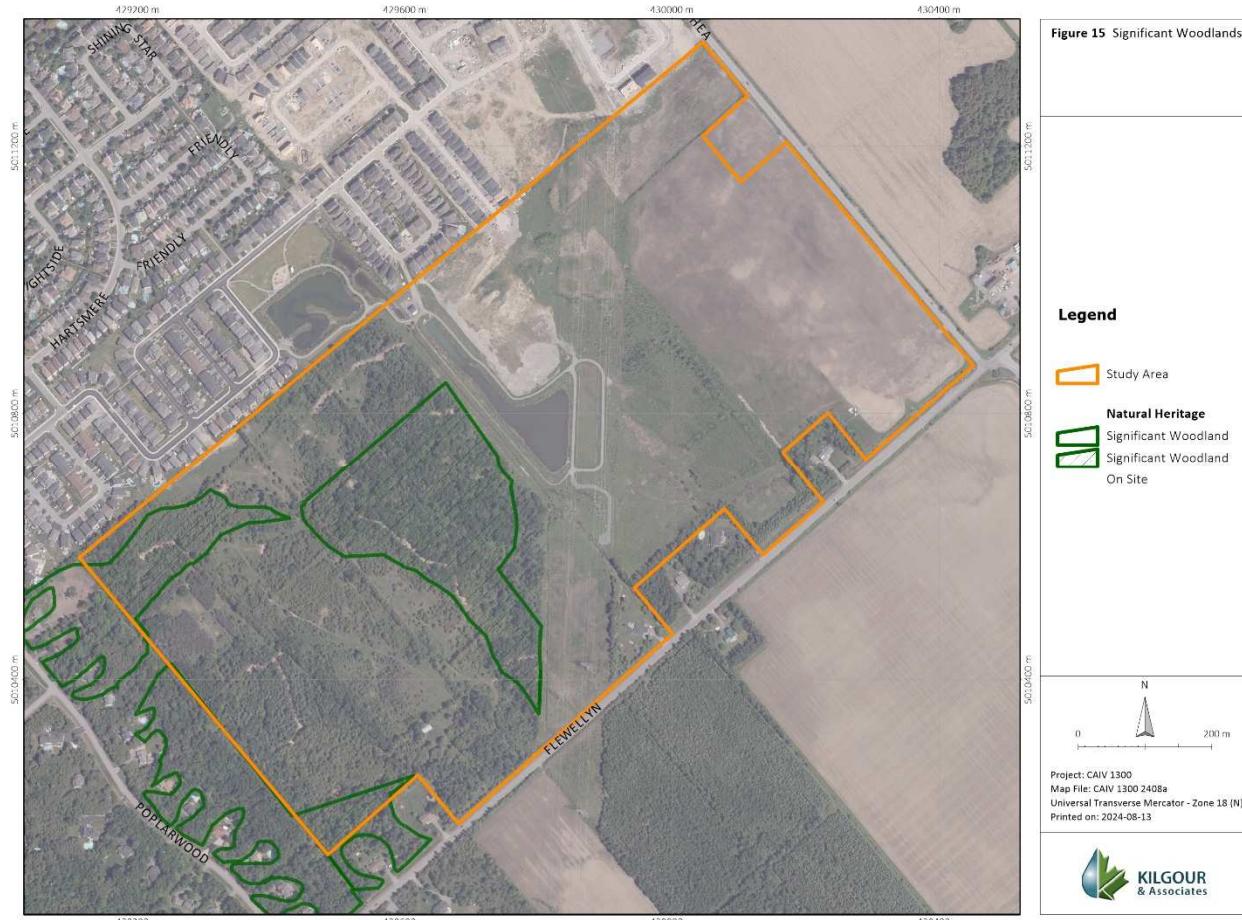
Figure 15. Significant Woodlands

Specialized habitat	Limited. There are no uncommon community types or rare species within the wooded areas. Many of the largest trees on the Site (primarily poplar species) were blown down in the 2022 derecho event (including the largest historically present Butternuts). The current forest mix consists of trees neither especially large nor uncharacteristically old for the broader area. The Significant Woodlands do contain remaining Butternuts (i.e., those not blown down) and some small clusters of Black Ash, which are both listed as SAR.

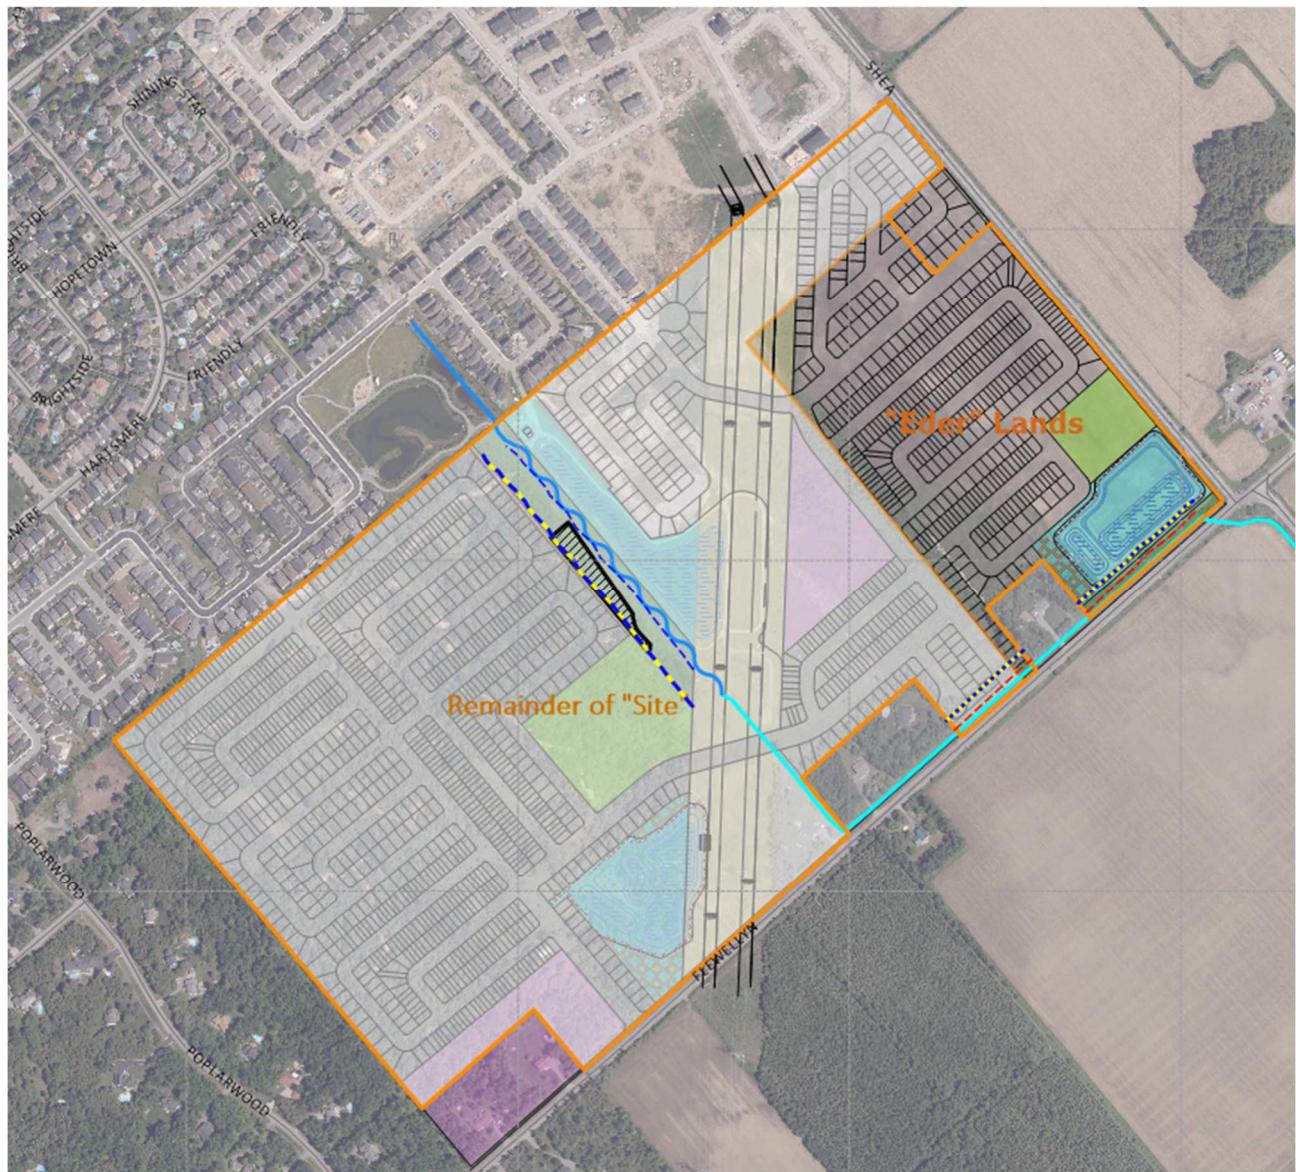
Figure 16. Proposed Draft Plan of Subdivision

naturalize that area as further public greenspace for the community. Employing low-height canopy enhancements through the planting of thickets can be expected to further increase the Site canopy cover. Canopy coverage is based on average expected mature diameter of ~12.5m, area of 138m² (combination of medium and large sized trees). Calculation accounts for canopy overlap between trees and excludes canopy overlap to non-residential lands (NAK Design Strategies, 2025).

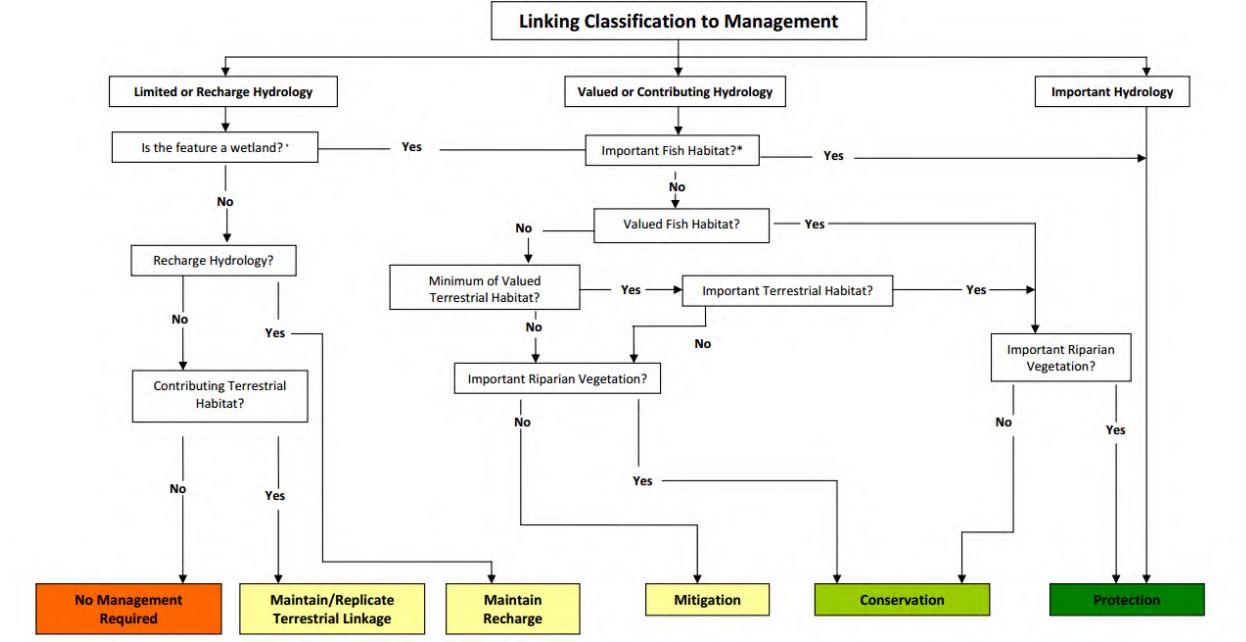
The classification categories identified in Section 2 provide the basis of the management recommendations provided here. The following flow chart (Figure 2) combines and translates the classification results to management recommendations.

Figure 2 Headwater Drainage Feature Assessment (HDFA) flow chart providing direction on management options

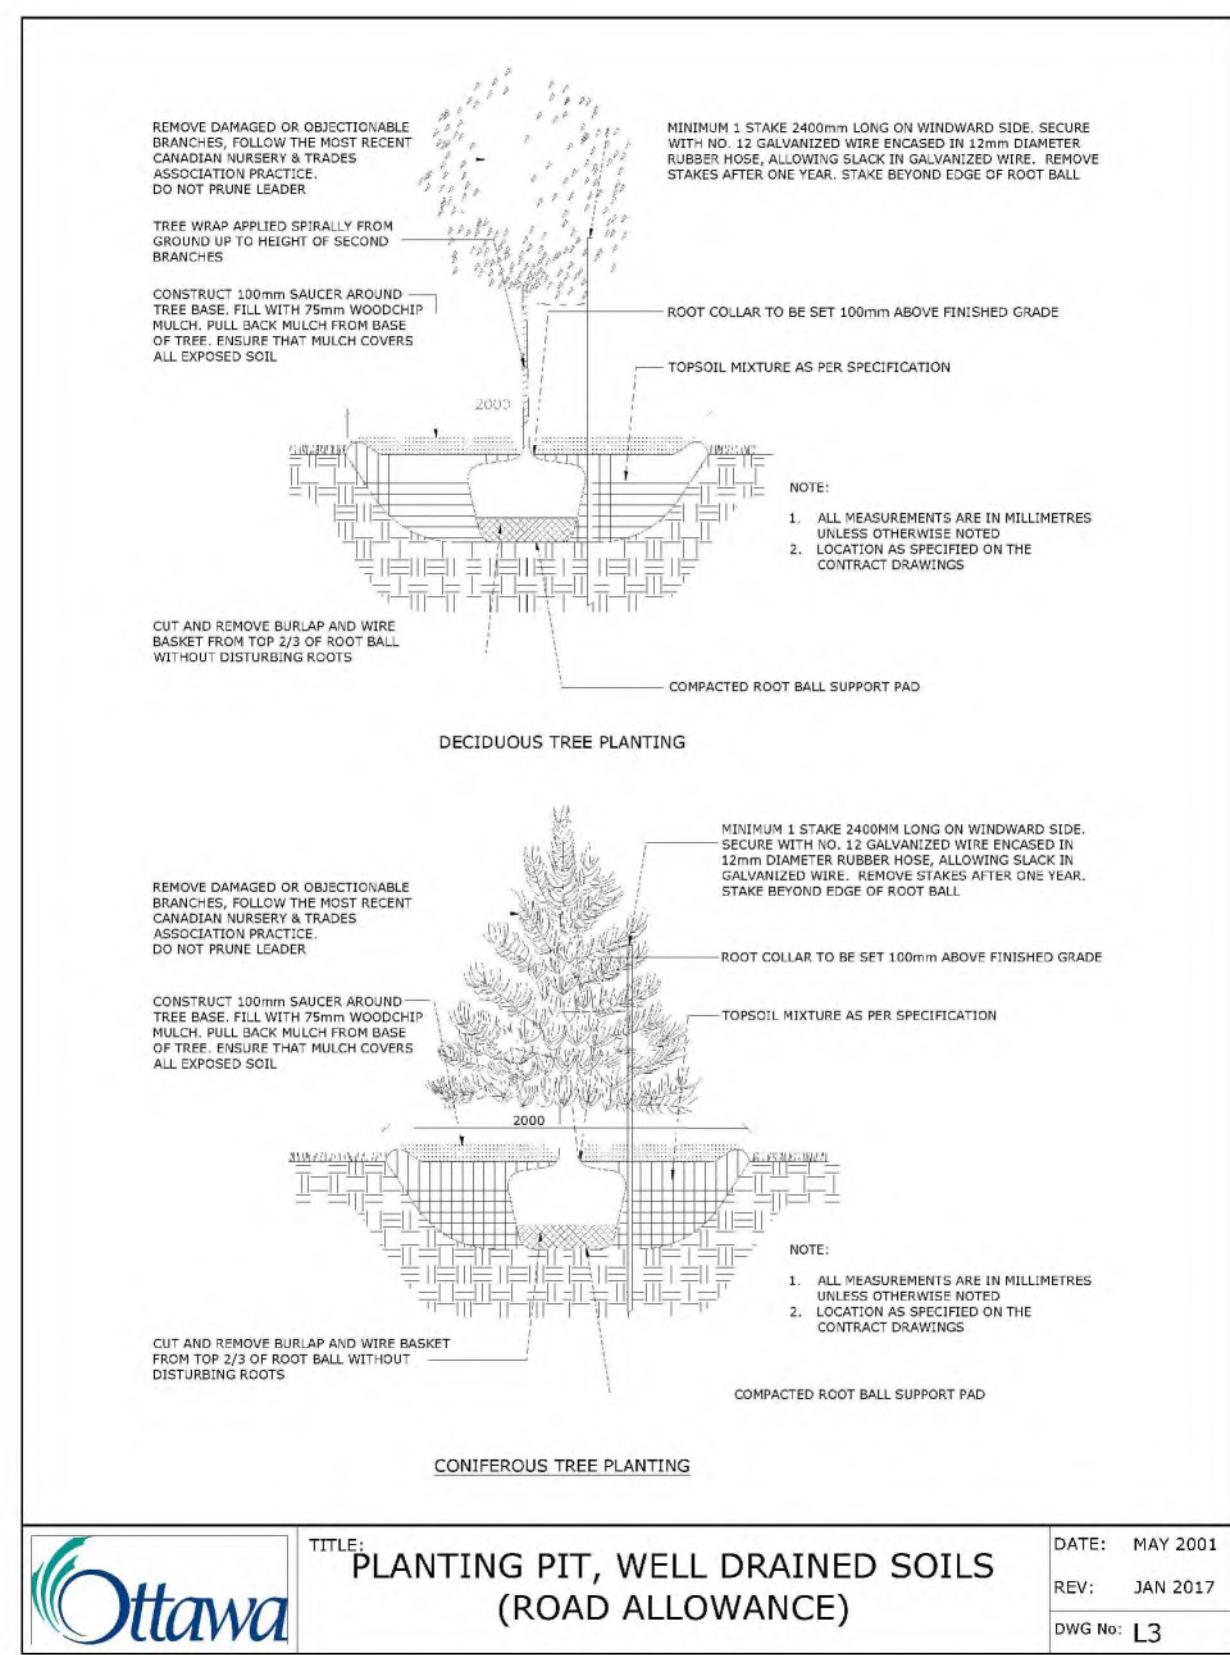
TITLE: PLANTING PIT, WELL DRAINED SOILS (ROAD ALLOWANCE)
REV: JAN 2017
DWG No: L3

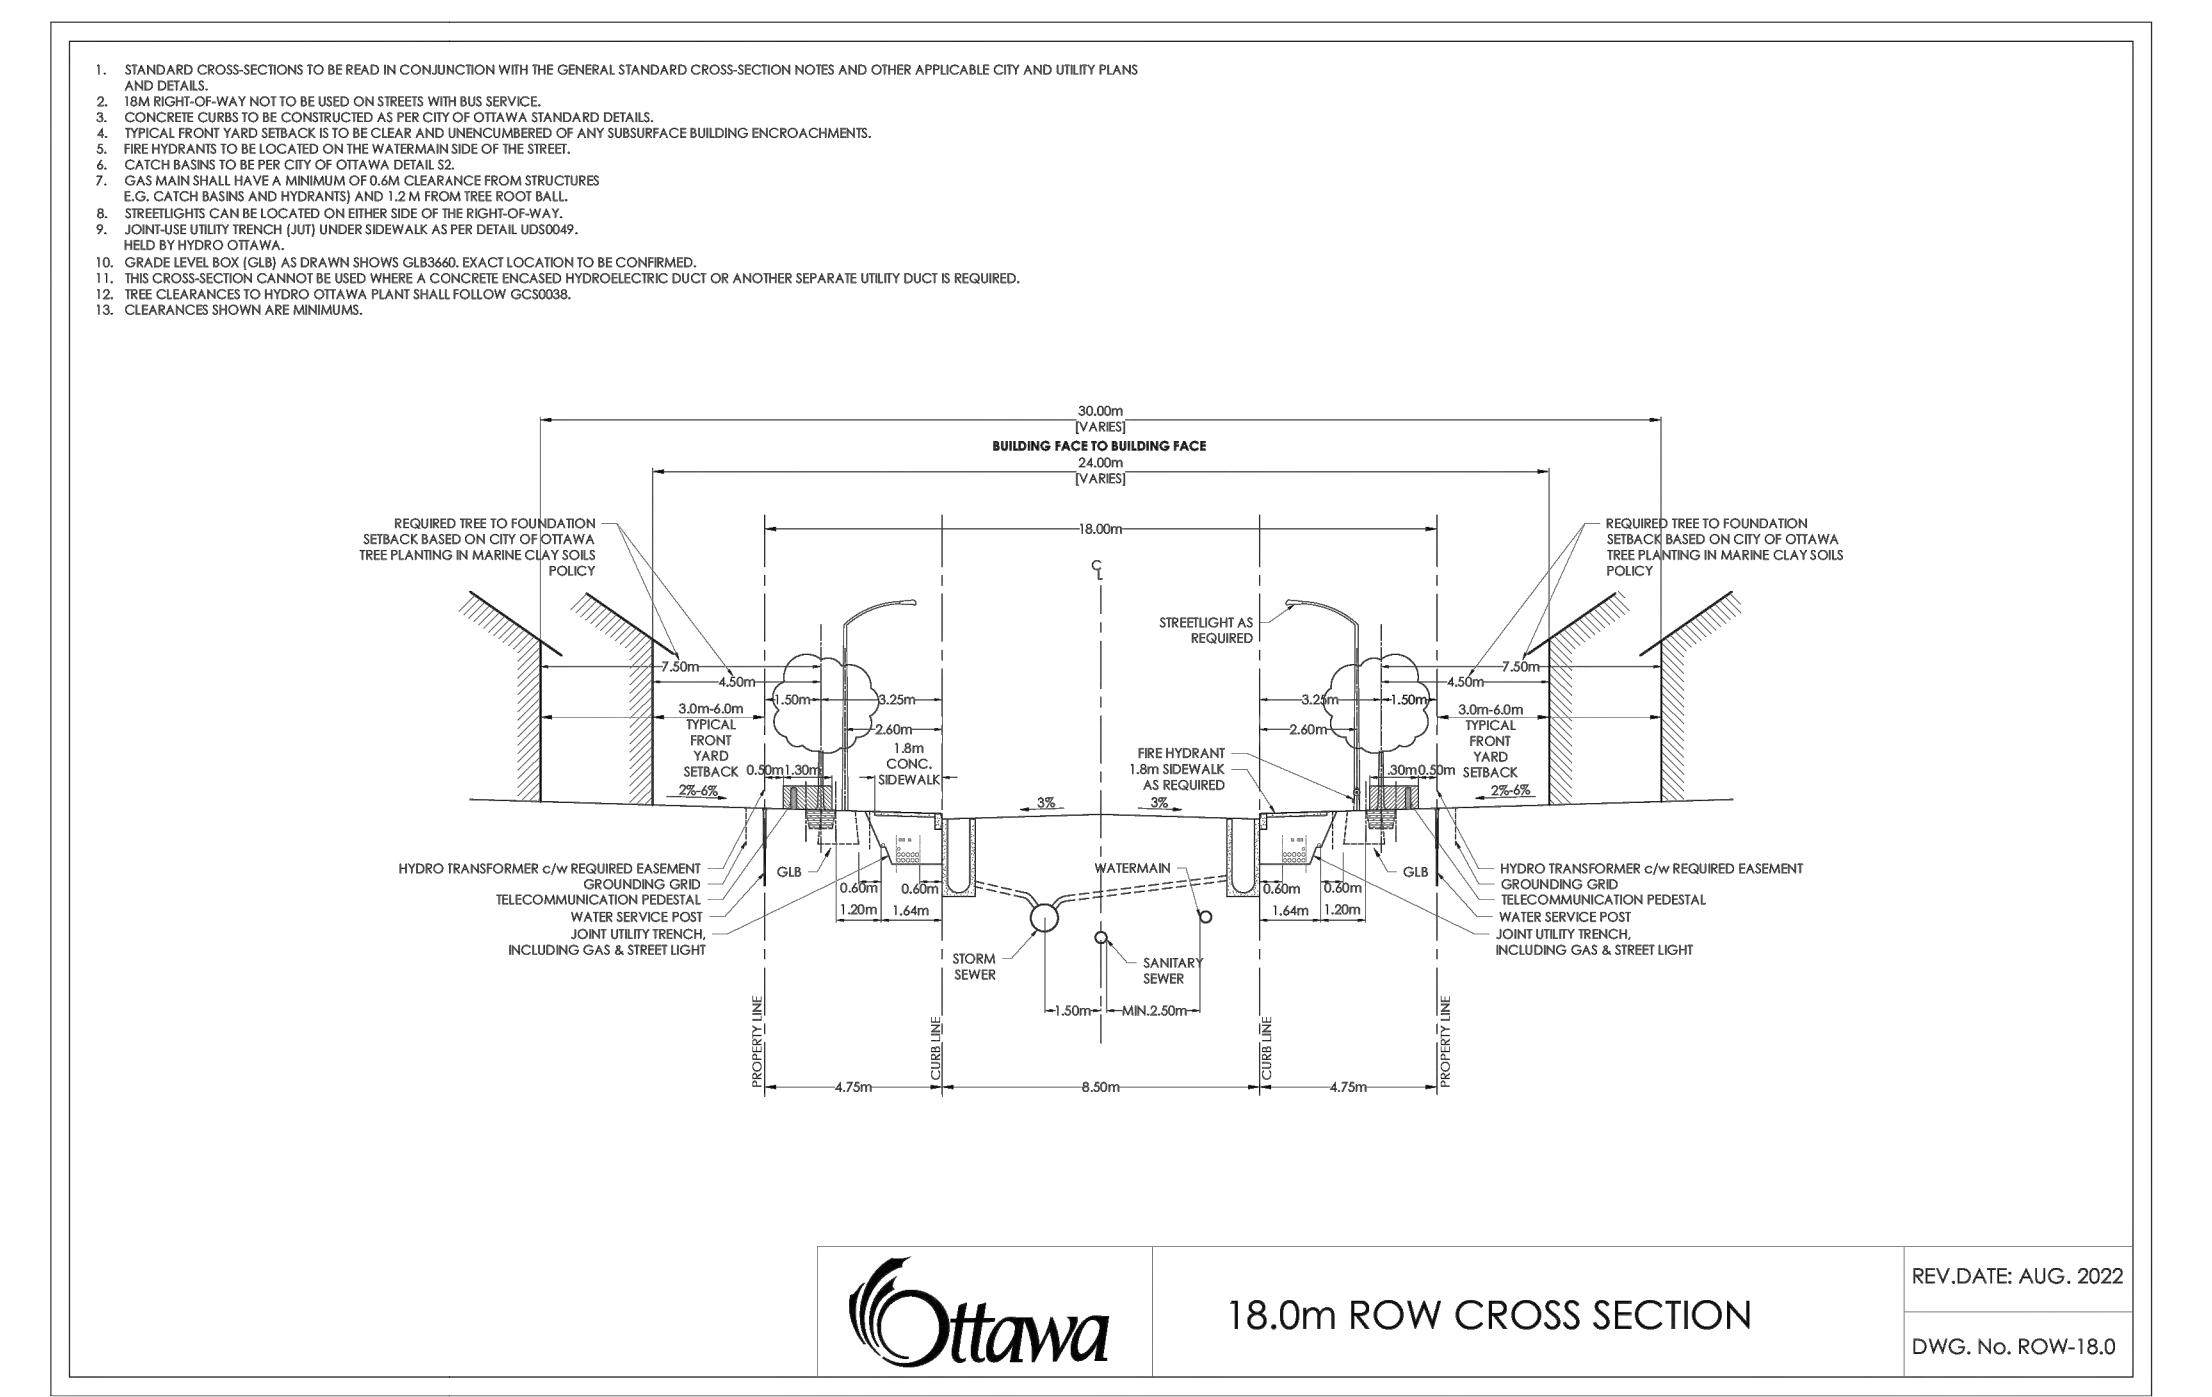
18.0m ROW CROSS SECTION

REV.DATE: AUG. 2022
DWG. No. ROW-18.0
