Stittsville South W4 Future Neighbourhood Area – Eder Block: Environmental Impact Study for the Draft Plan of Subdivision

Final Report

Project Number: CAIV 1300.4

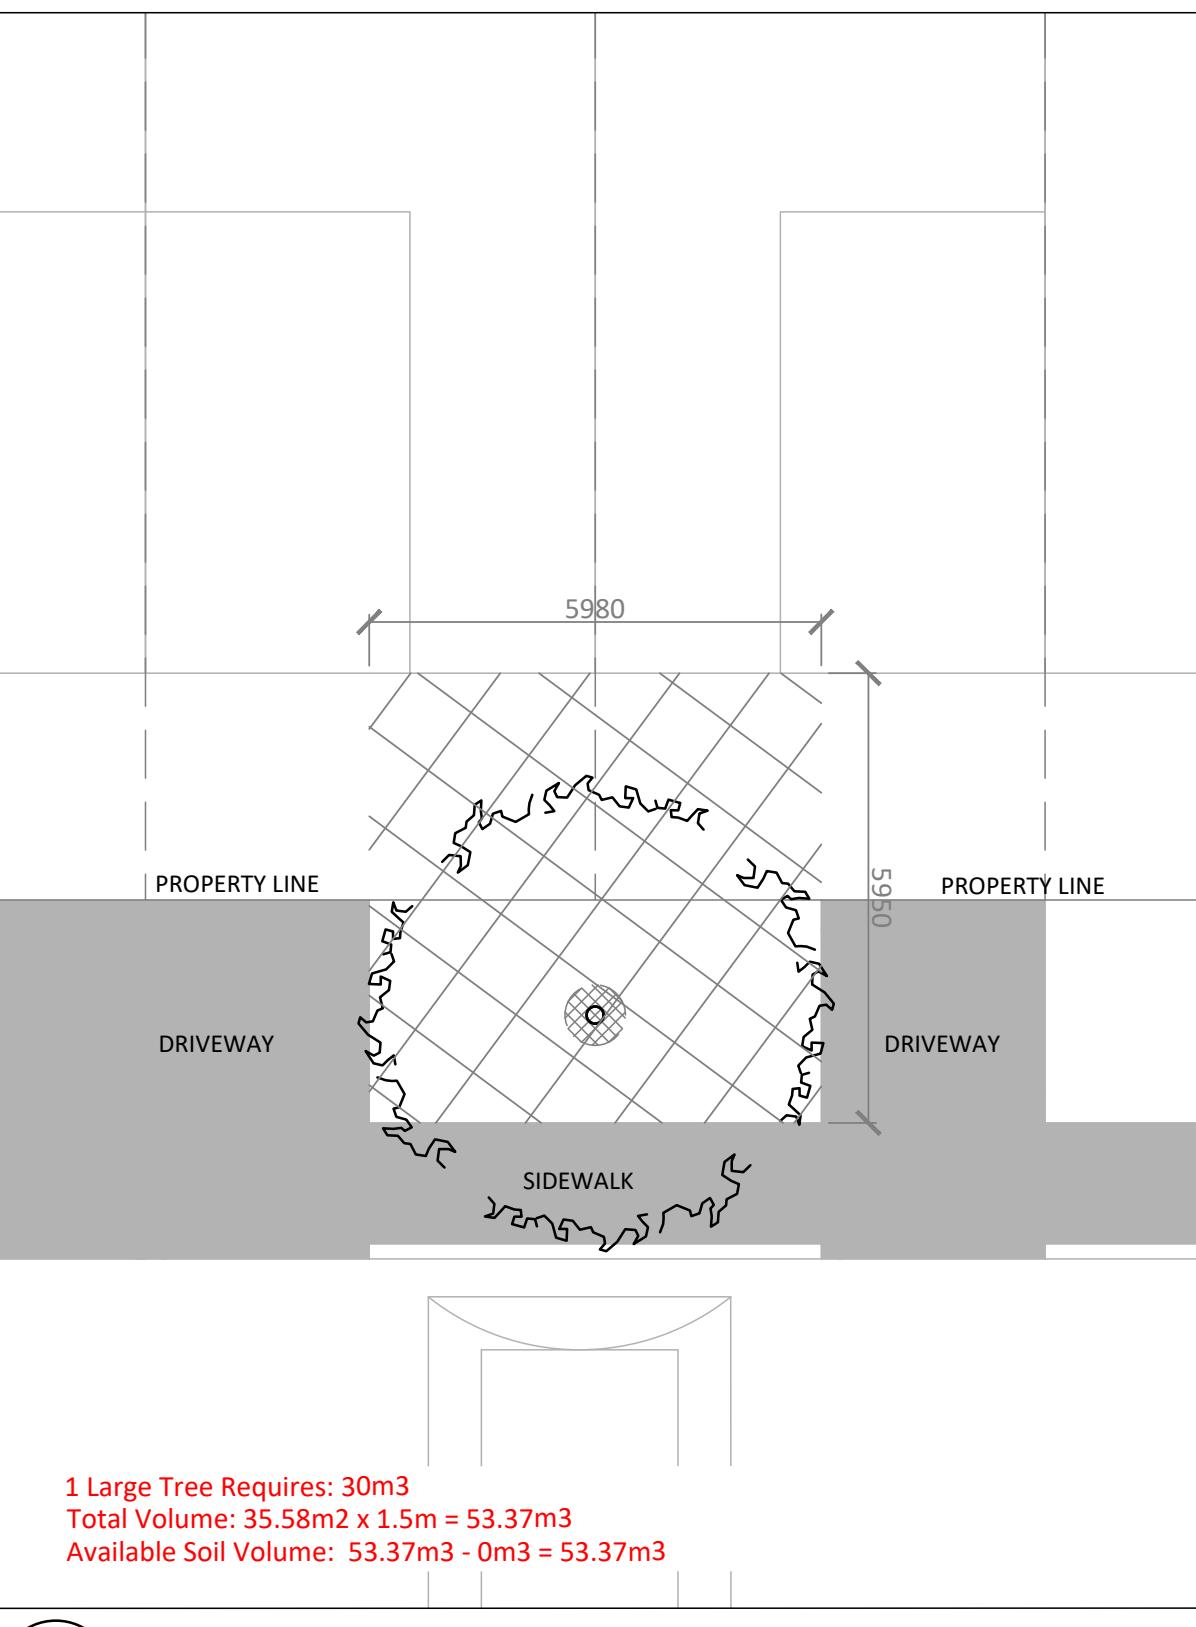
3 SOIL VOLUME CALCULATION (SCALE 1:100)
18M ROW - STREET 1

TREE SOIL VOLUMES		
TREE TYPE/SIZE	SINGLE TREE SOIL VOLUME	MULTIPLE TREE SOIL VOLUME (m ³ /TREE)
ORNAMENTAL	15	9
COLUMNAR	15	9
SMALL	20	12
MEDIUM	25	15
LARGE	30	18
CONIFER	25	15

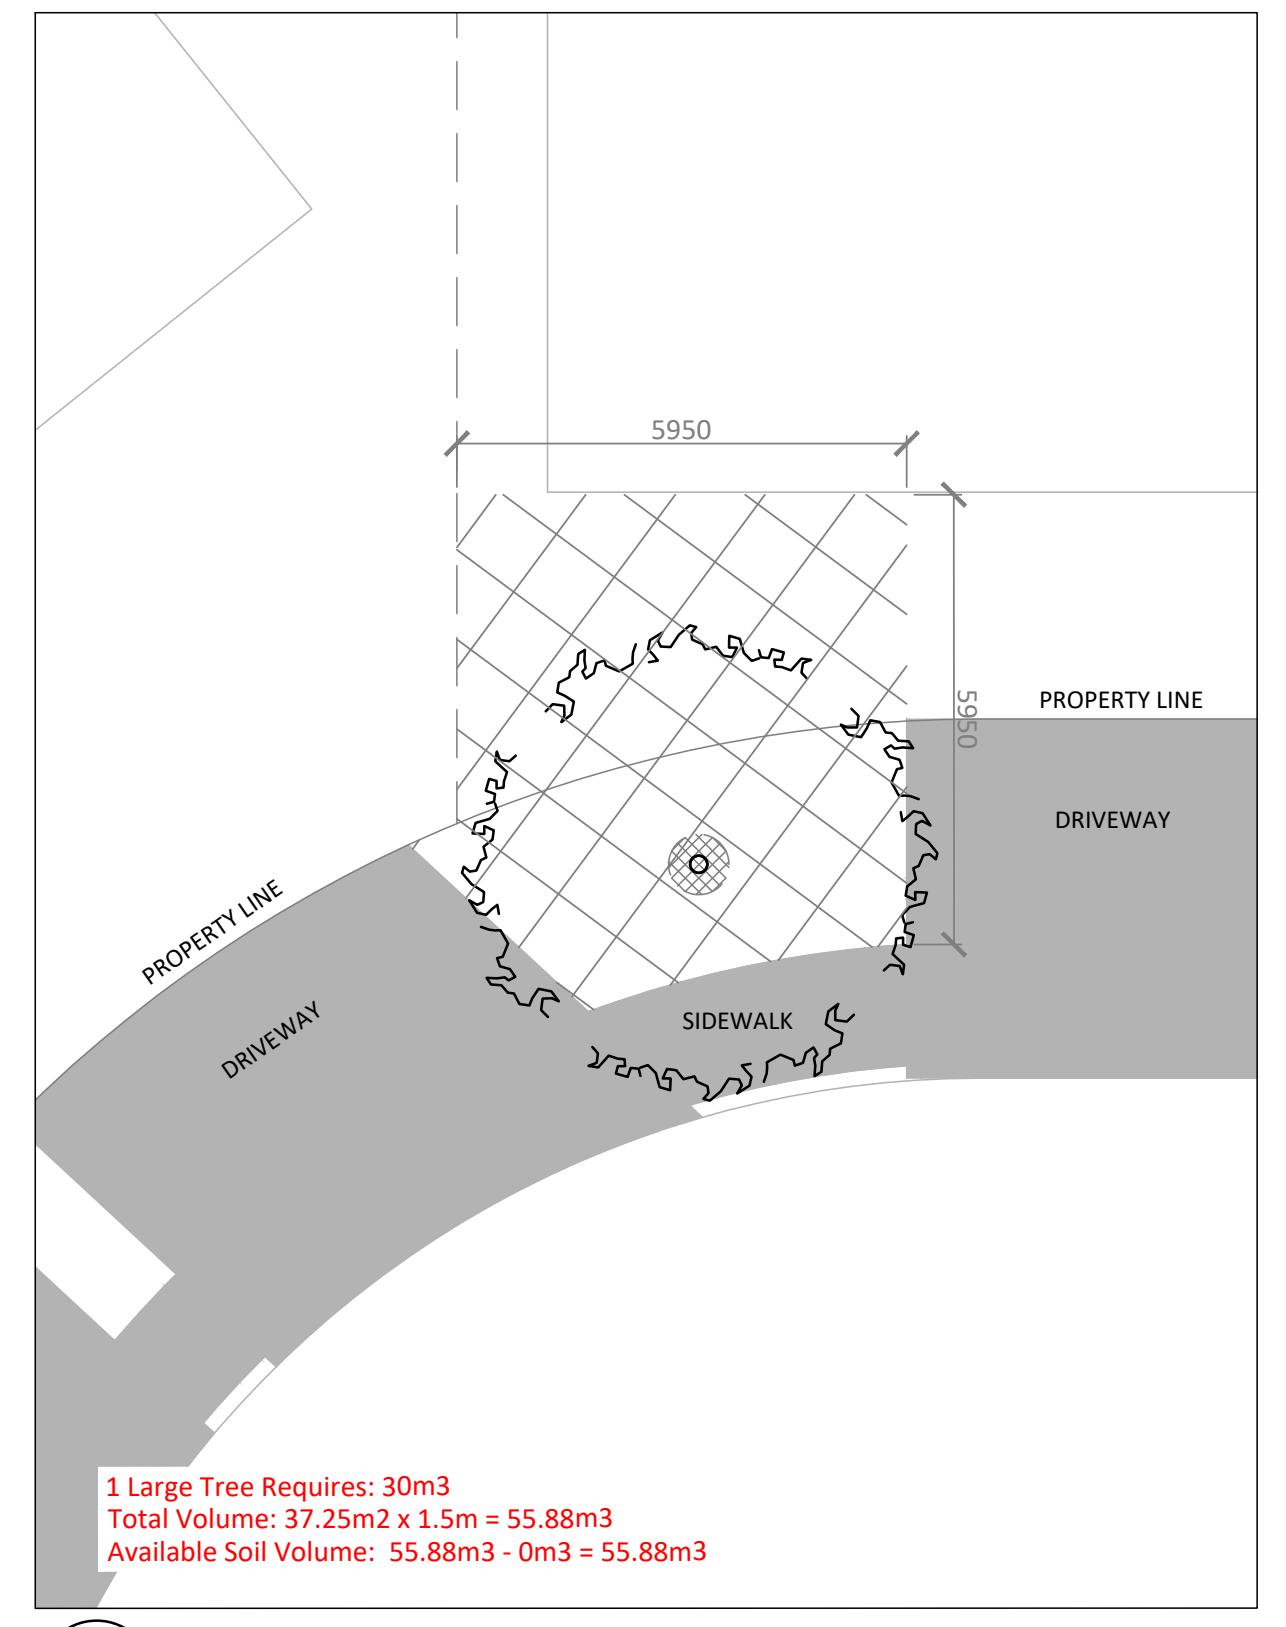
4 SOIL VOLUME CALCULATION (SCALE 1:100)
18M ROW - STREET 1

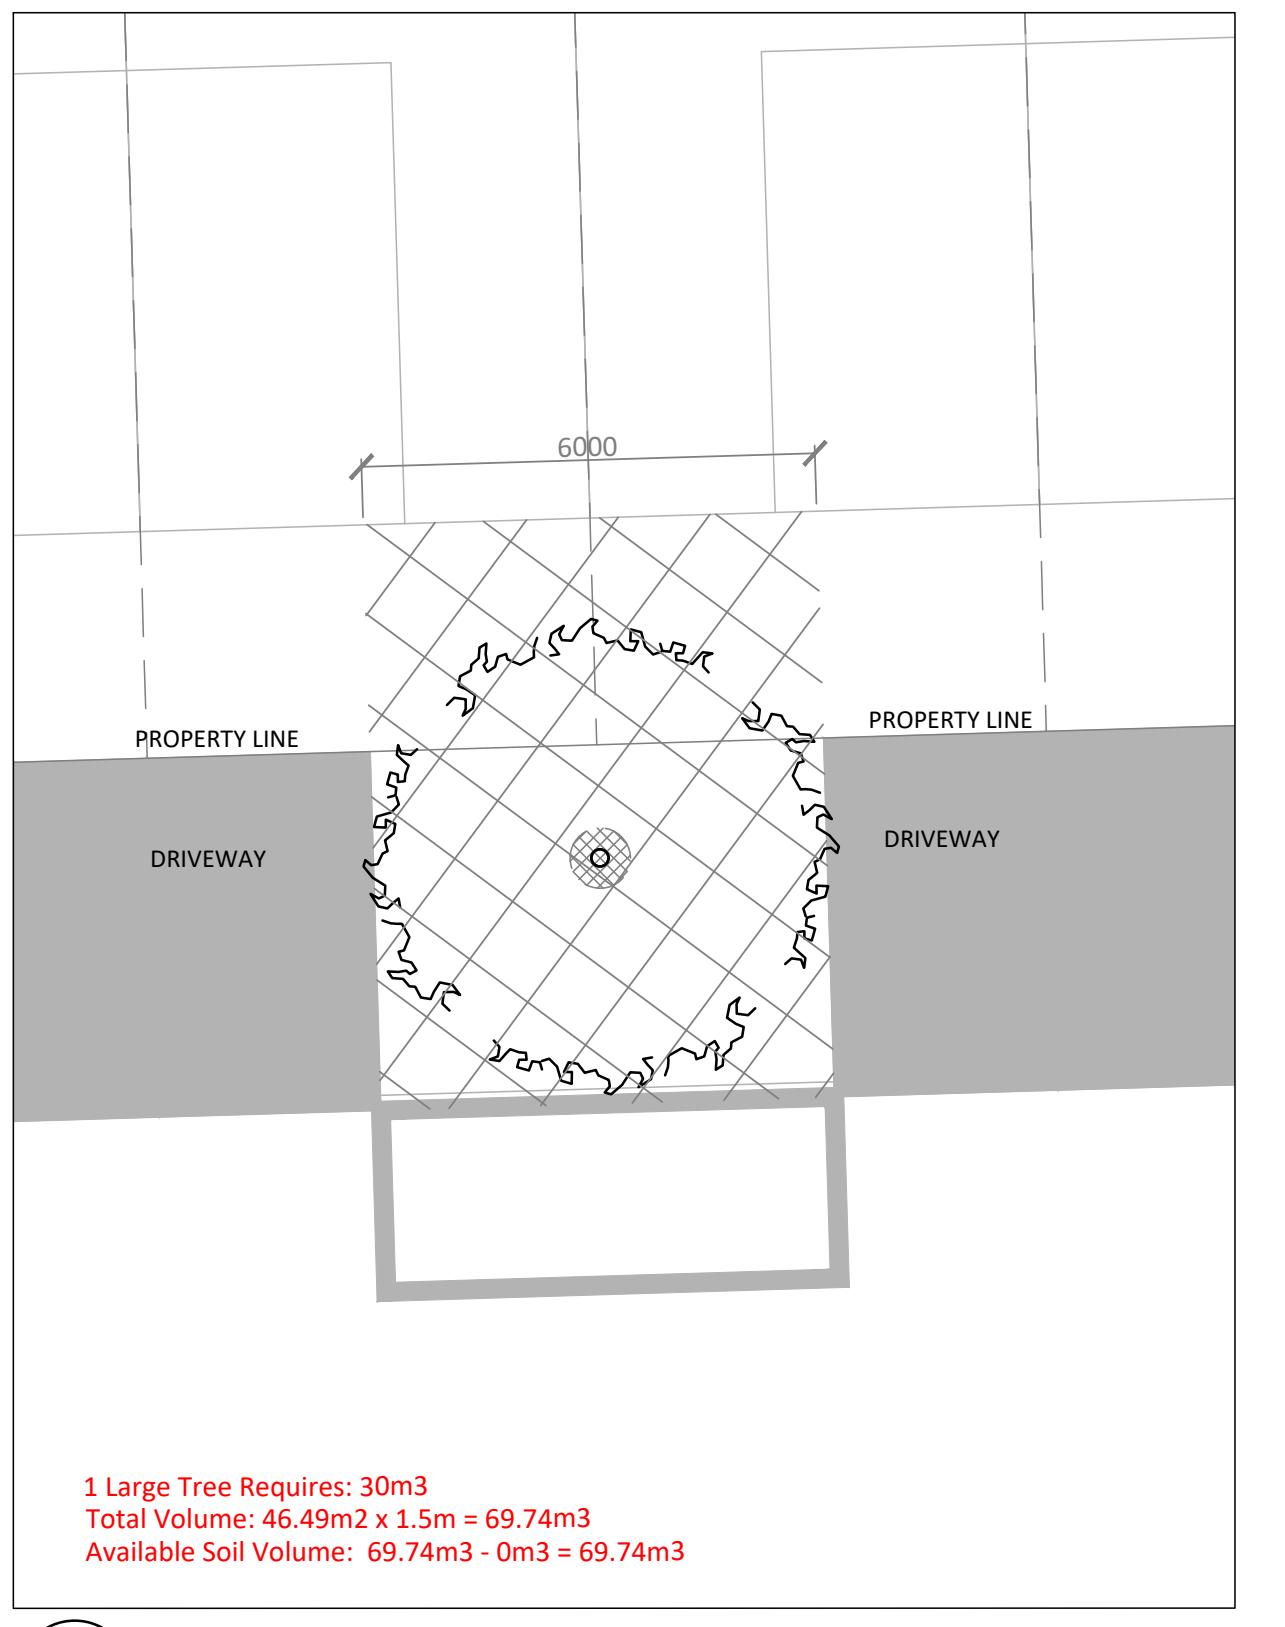
5 SOIL VOLUME CALCULATION (SCALE 1:100)
18M ROW - STREET 20

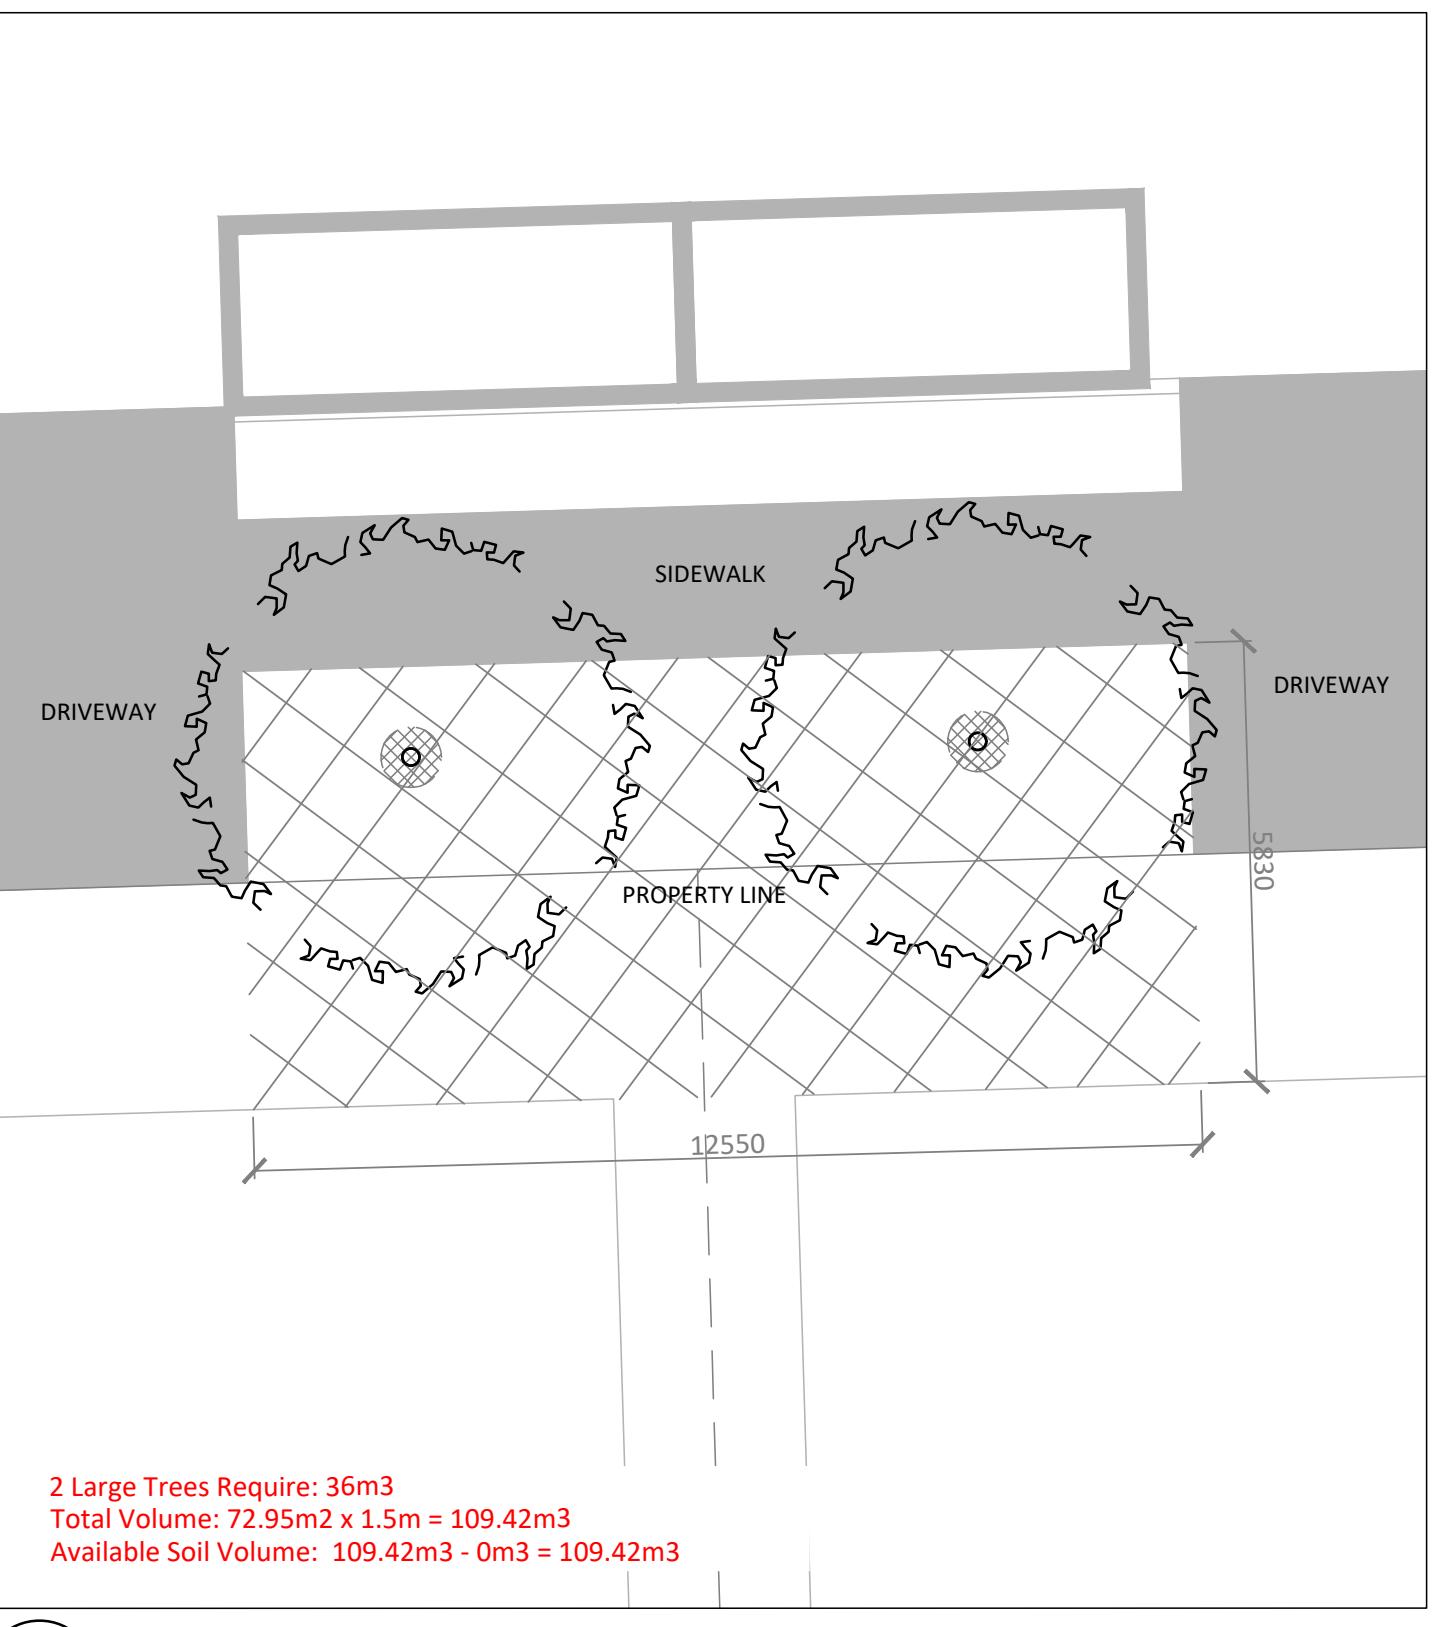
6 SOIL VOLUME CALCULATION (SCALE 1:100)
24M ROW - STREET 13

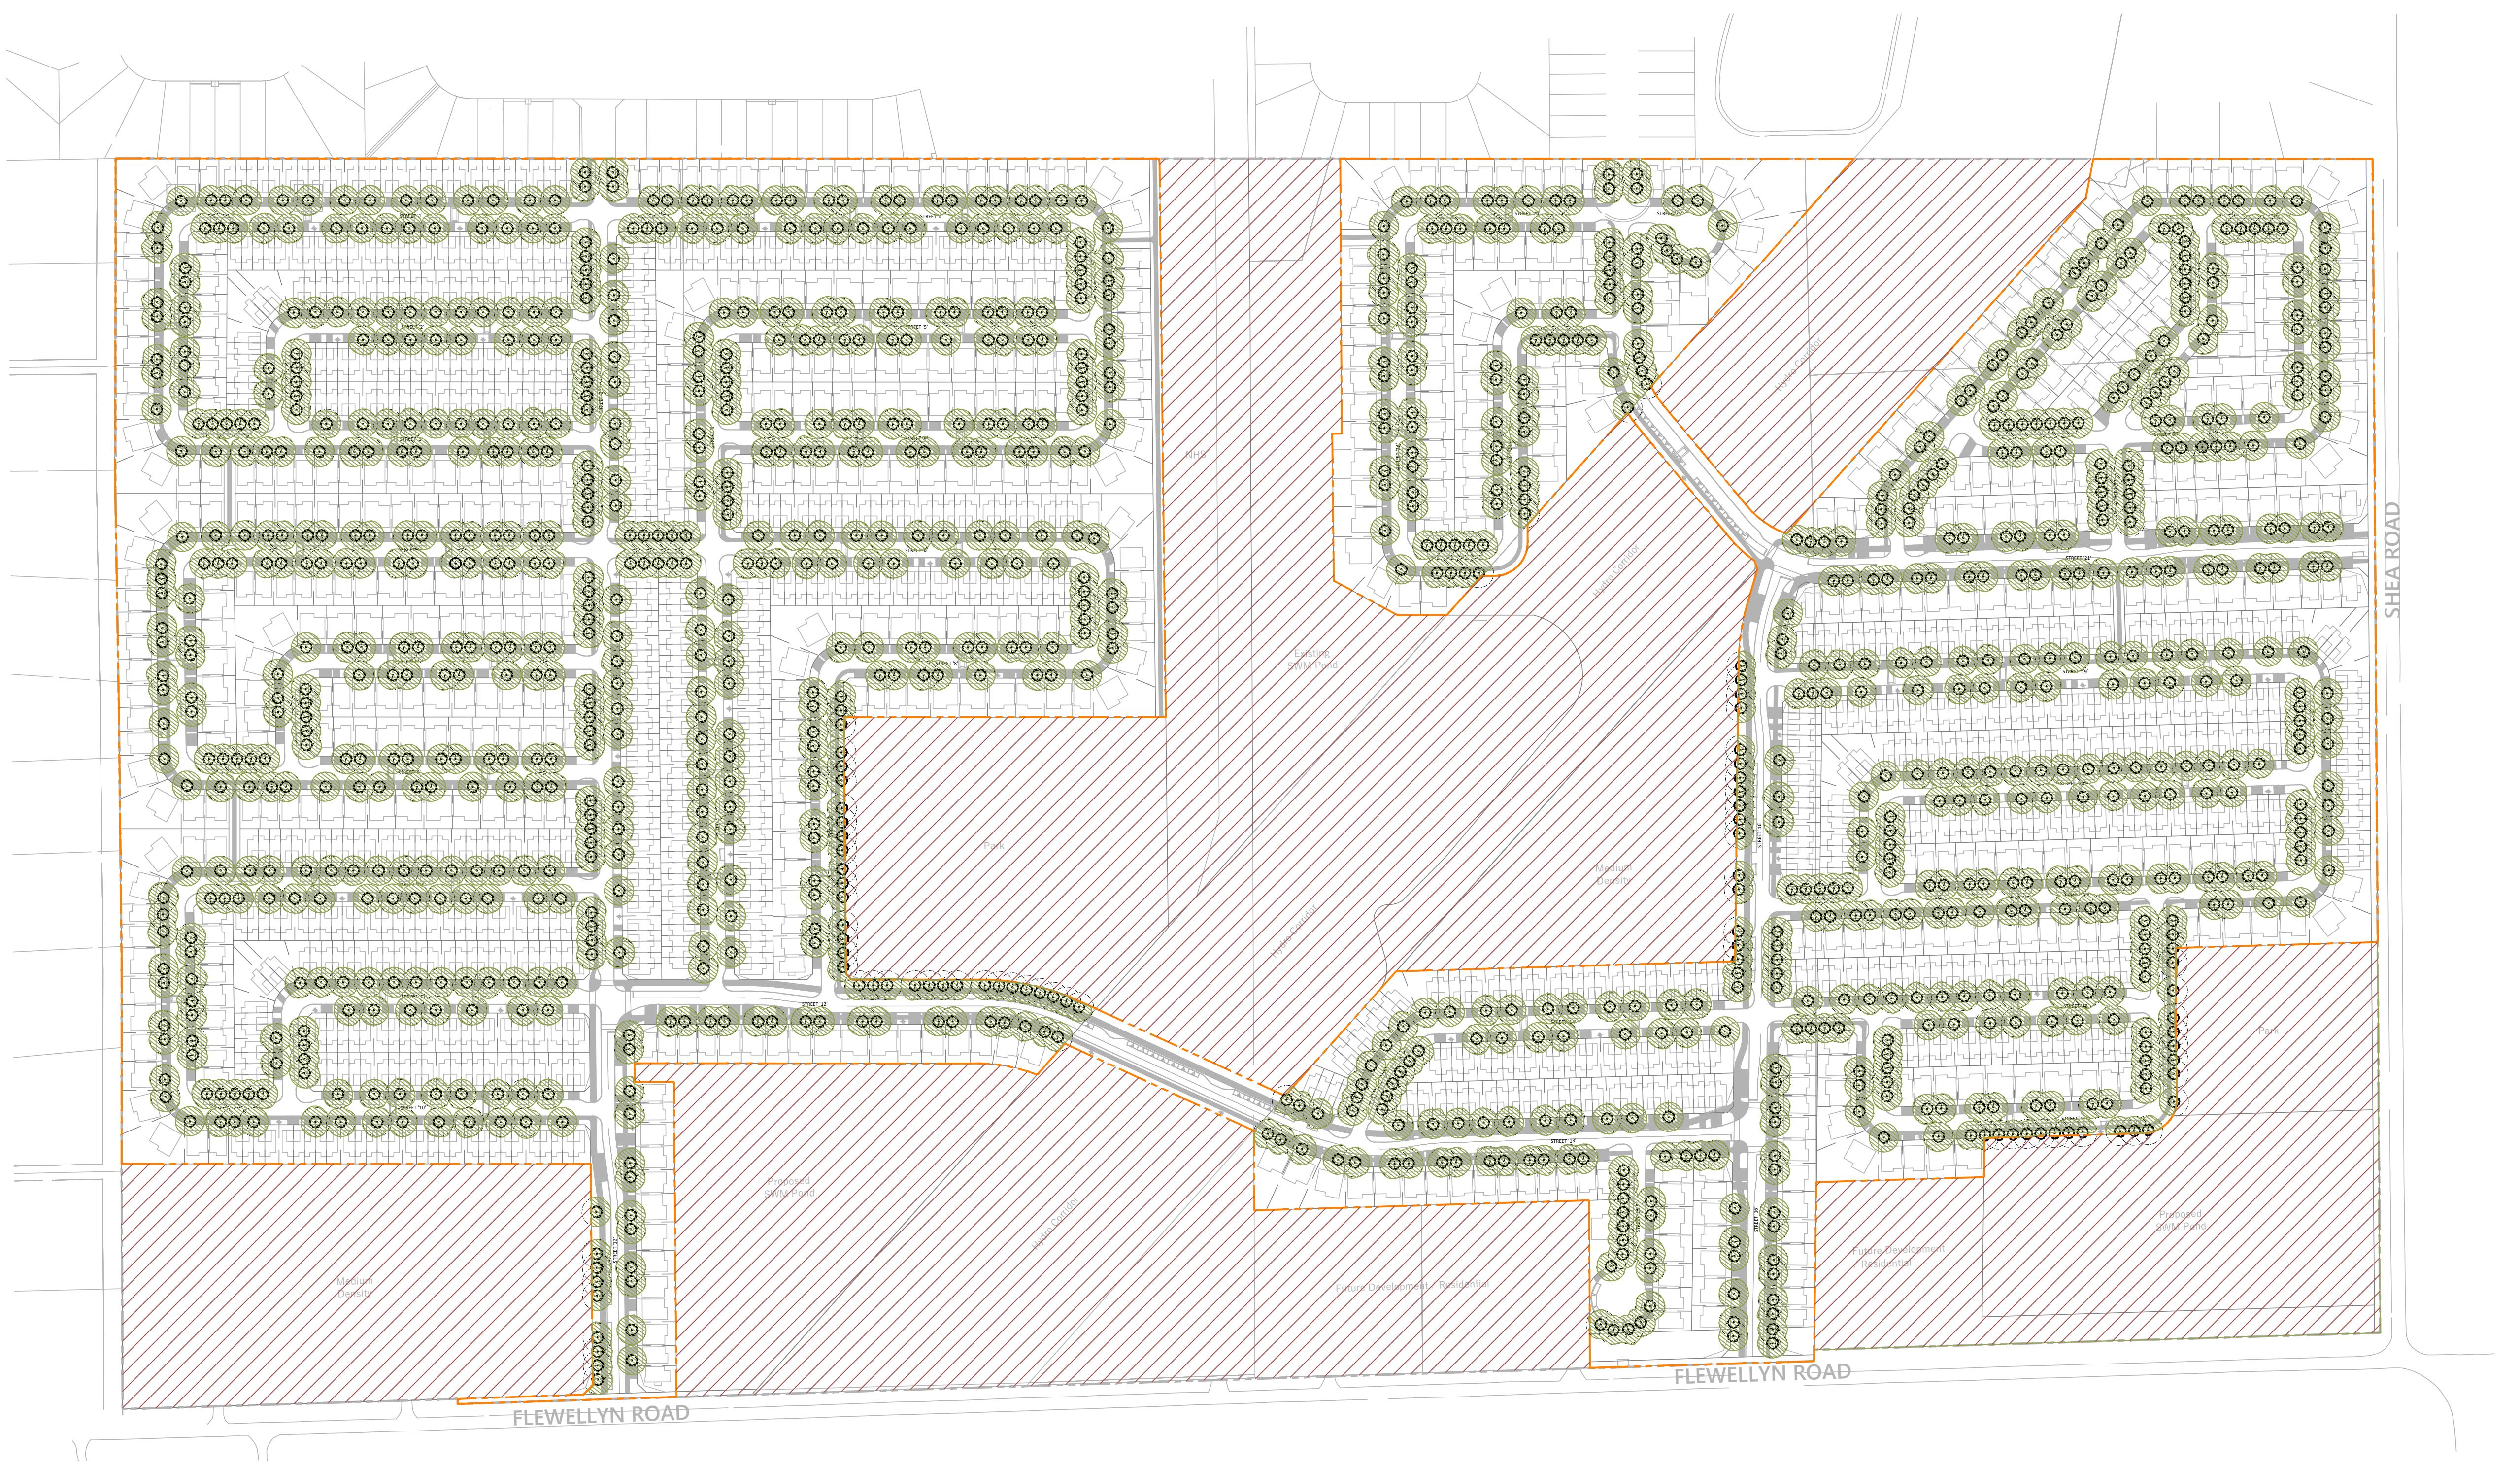
PROPOSED TREE CANOPY PROJECTIONS

TREE TYPE/SIZE	CROWN AREA PER TREE STANDARD RANGE (m ²)	CROWN AREA PER TREE USED FOR CALC. (m ²)	SITE CANOPY COVER
MEDIUM/LARGE (1229)	35-250*	±138	***CANOPY (W. OVERLAP): 162,886m ²
