Report

South March Battery Energy Storage System (BESS)  
Fluvial Geomorphology Assessment

H375142-0000-2B0-066-0001

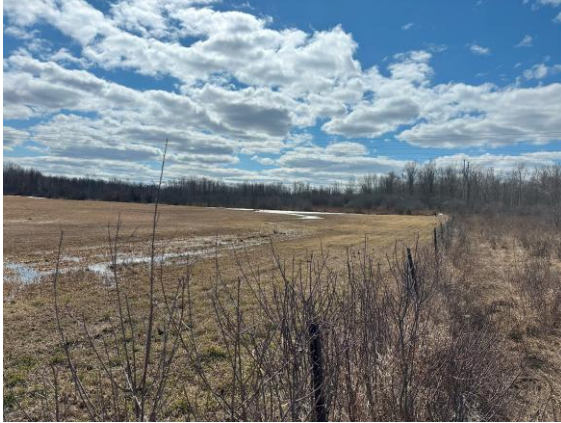
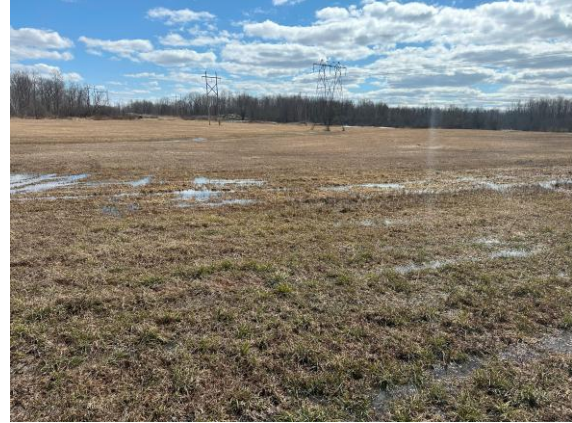
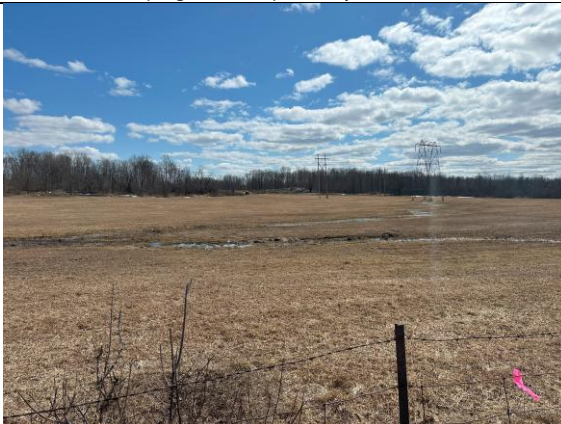
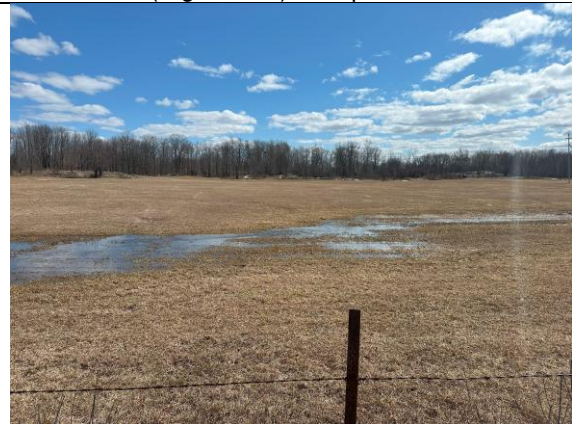
At the southeast boundary of the Project site, stagnant water was observed within two upstream branches of the creek, as shown in Photos 1 to 4 (Appendix B) from locations S1 and S2. The presence of standing water outside the defined channel zone may suggest backwater effects during wet periods, although no well-defined channel was visible in this area. These observations are consistent with the high groundwater table identified in the borehole data from the geotechnical investigation (Hatch, 2025). The lack of defined banks suggests low channel confinement, with water dispersing laterally across the adjacent field. These conditions are characteristic of weak channelization and reduced hydraulic capacity, with potential for overland flow contributions during high-flow events.

**Photo 1:** View looking south (Upstream) at location S1 (Figure 3-1) on April 7, 2025.

**Photo 2:** View looking southeast (Upstream) at location S1 (Figure 3-1) on April 7, 2025.

**Photo 3:** View looking southeast (Upstream) at location S2 (Figure 3-1) on April 7, 2025.

**Photo 4:** View looking southeast (Upstream) at location S3 (Figure 3-1) on April 7, 2025.

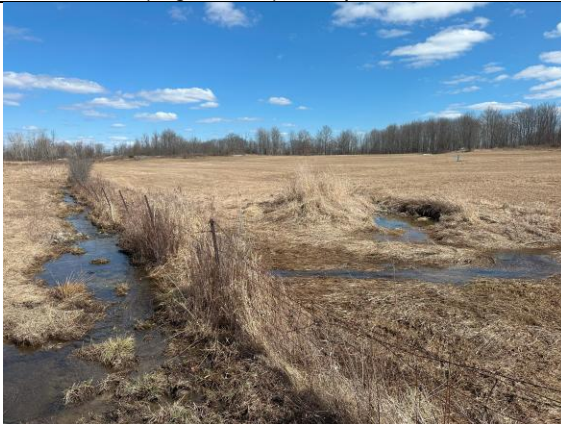
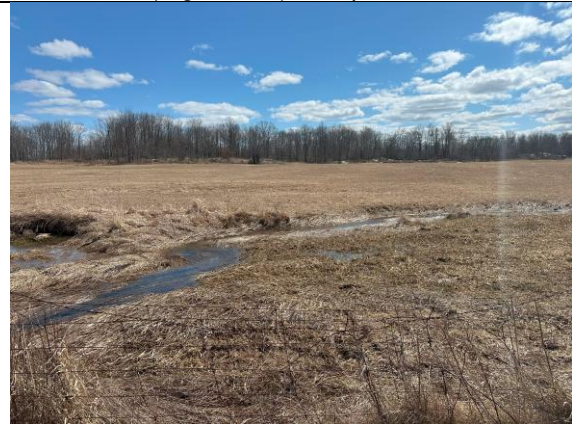
From location S4, the watercourse flows through a vegetated corridor with yellowing grasses and mild side slopes (approximately 3:1). The channel bed consists primarily of fine sediments, organic debris, and high grass. Riparian vegetation includes shrubs, saplings, and deadfall along both banks. No signs of bank slumping or undercutting were observed, and no erosion control measures (e.g., riprap or engineered stabilization) were noted. These conditions support classifying this section of the creek as a stable, shallow, confined system, with minimal erosion activity and limited potential for channel migration under current hydrologic conditions.

**Photo 5:** View looking northeast (Downstream) at location S4 (Figure 3-1) on April 7, 2025.

**Photo 6:** View looking south (Upstream) at location S4 (Figure 3-1) on April 7, 2025.

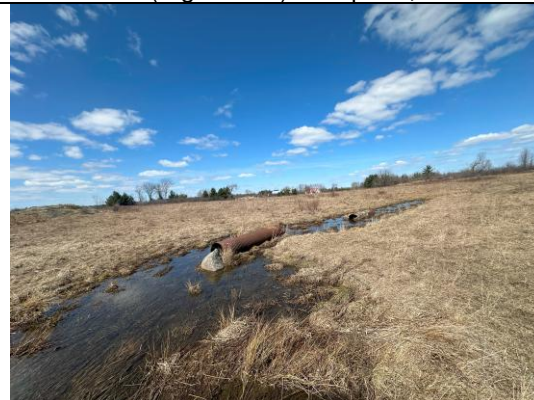
Two culverts installed in series, each is 80 cm in diameter and 3.5 m in length (Photo 12 in Appendix B) were observed along the creek corridor. These culverts convey flow into a large wet pond located along the northern portion of the Creek, shown in Photo 13 (Appendix B).

**Photo 12:** View looking northeast (downstream) at location S9 (Figure 3-1) on April 7, 2025.

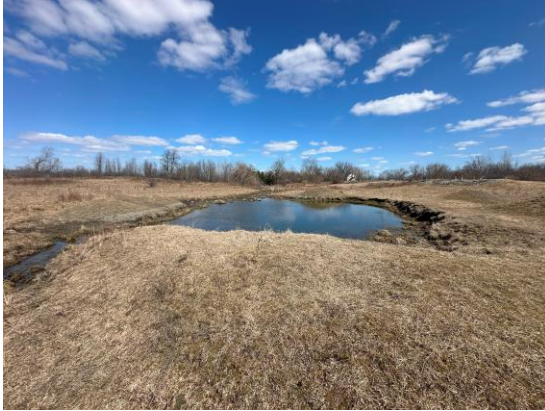
**Photo 13:** View looking northeast (Downstream) at location S10 (wet pond) (Figure 3-1) (minor sinuosity) on April 7, 2025.

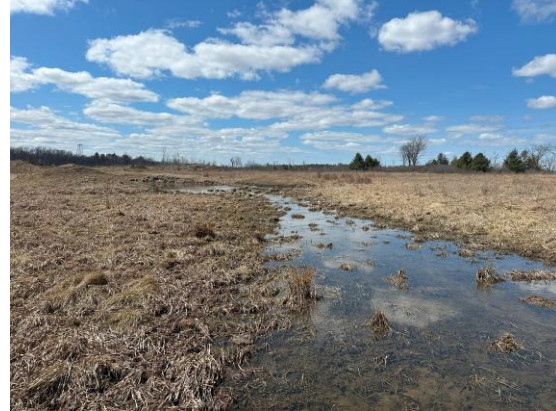
Evidence of localized channel widening was noted in two areas within the confined portion of the creek at locations S5, S11, and S12 (Appendix B). Instances of channel adjustment and planform variability were also observed. At location S14, the creek exhibits minor sinuosity, with lateral deflections in the low-flow path suggesting limited but active fluvial processes. These changes in flow alignment are likely the result of small-scale bank erosion and scour along the outer edges of developing meander features. Such features may indicate the early formation of a meander belt within this reach of the channel.

**Photo 14:** View looking west (Upstream) at location S11 (Figure 3-1) (minor sinuosity) on April 7, 2025.

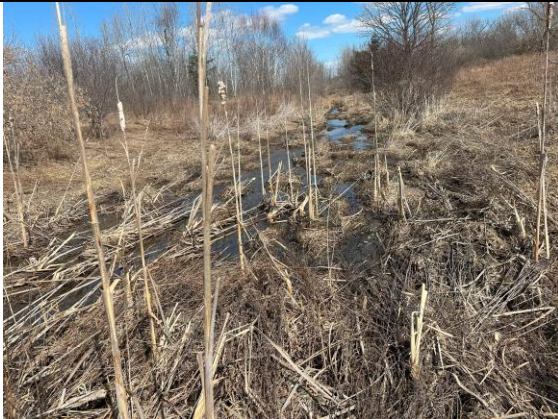
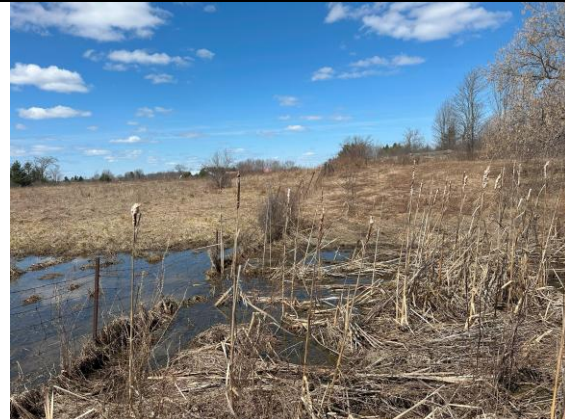
**Photo 15:** View looking northeast (downstream) at location S12 (Figure 3-1) on April 7, 2025.

**Photo 16:** Side view at location S12 (Figure 3-1) on April 7, 2025.

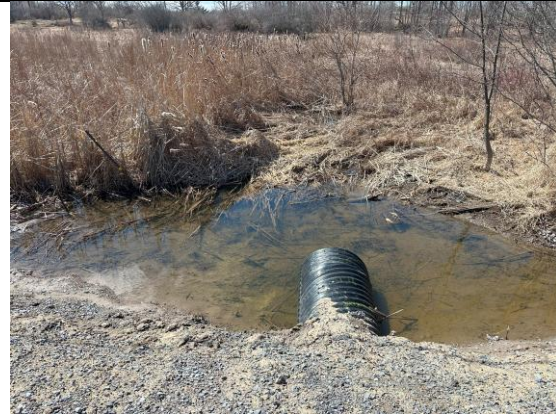
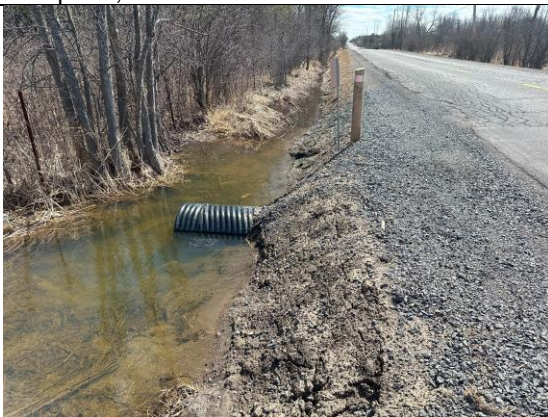
Active flow was observed during the site visit, with ponded water present within the upstream ponded/spreading water section, and continuous flow through the downstream channelized reach. At the northeast property boundary, the Creek drains through a 70 cm diameter culvert crossing Marchurst Road, discharging to the northeast (Photos 26 and 27 in Appendix B).

**Photo 26:** View looking southwest (Upstream) at location S18 (Figure 3-1) on April 7, 2025.

**Photo 27:** Side view at location S18 (Figure 3-1) on April 7, 2025.
