# S-4 Leitrim Urban Expansion Area

## Serviceability Report

2025-08-08

Arcadis Professional Services (Canada) Inc.  
333 Preston Street, Suite 500  
Ottawa, Ontario  
K1S 5N4

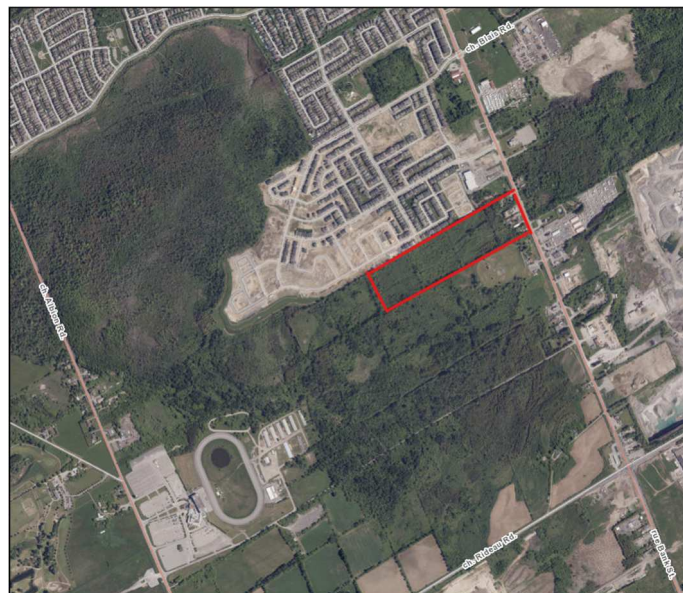
The S-4 Leitrim Expansion Land covers approximately 13.7 ha of heavily vegetated land located west of Bank Street at the southern limit of the existing Leitrim Development Area. It is bounded to the north by an existing residential community, to the east by Bank Street and undeveloped lands to the south and west. The location of the future Earl Armstrong extension is planned to encroach over the southern property line of the subject lands. A municipal class environmental assessment has already been completed for the Earl Armstrong extension. The Leitrim Wetlands and Rideau Carleton Raceway and Casino are located to the west of the property. An aerial photo of the subject site location is provided below;

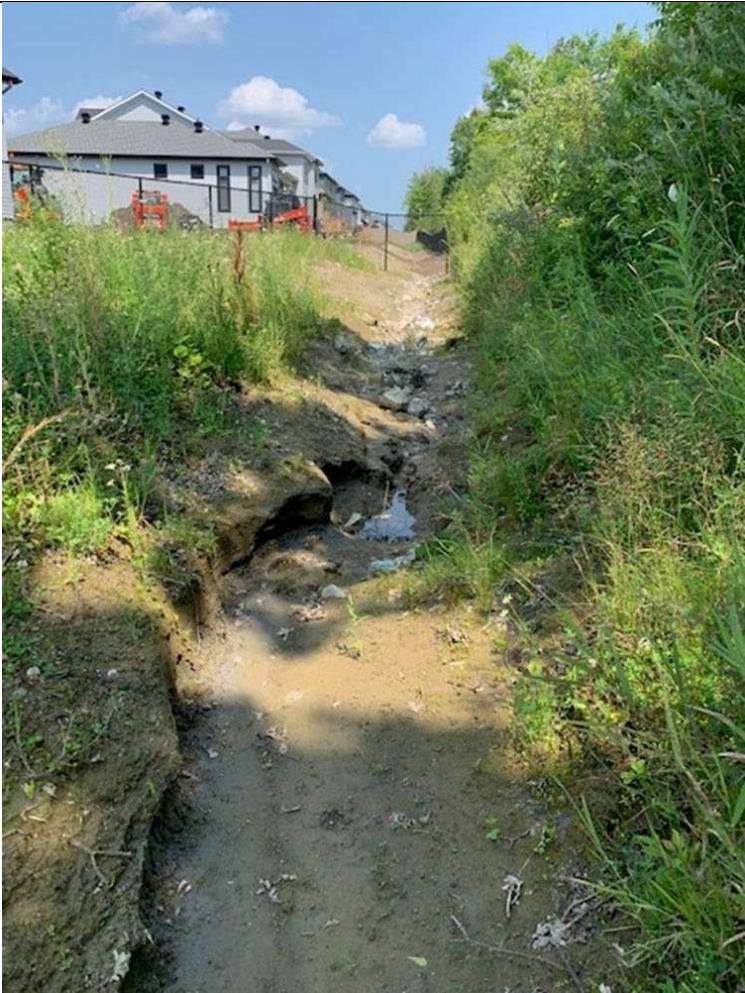
| Constructed Channel Plan Fig. 6-2 EMP Reference Location | Notes/Observations | Aerial Photo Location | Corresponding Site Photos | |
|---|---|---|---|---|
| LOCATION A<br><br>INT-3<br>Watercourse and<br><br>Watercourse outlet and start of Conveyance Channel and end of Scratch Ditch/rear yard swale on adjacent development | <p><b>Observations</b></p> <ul style="list-style-type: none"><li>- not apparent where the INT-3 HDFA watercourse enters into the channel, outlet now obstructed with rock weir and not functioning – needs maintenance/removal</li><li>- Rear Yard double swale/ Scratch Ditch entirely on private properties – As Built location of Scratch Ditch different than Remer Site Serviceability Plan</li><li>- double swale design to service subdivision and catch overland flows</li><li>- erosion where scratch ditch enters constructed channel</li><li>-conveyance area was moist after rain but essentially with no vegetation in this area</li><li>- Tire tracks of a vehicle in dry mud</li></ul> <p><b>INT-3</b><br/>Intermittent watercourse 3 (INT-3) enters the southwest part of the Site from the southeast. INT-3</p> | | | |

| | <p>appears to convey surface flow from the upstream rural lands to the south of the Site into WC-B. INT-3 conveys major flows during spring freshet and high water events, however north of the Idone property boundary the channel is more defined.</p> <p><b>Action:</b><br/>S4 Servicability Update for the Leitrim Development Area, corresponding to the As-Built for the Scratch Ditch/rear yard swale contained within the adjacent development in property owner’s backyards.</p> <p>Discuss if this feature will be redundant and if a permanent swale will be placed to the south of the S4 lands to intercept surface sheet flow south to northwest.</p> | | | |

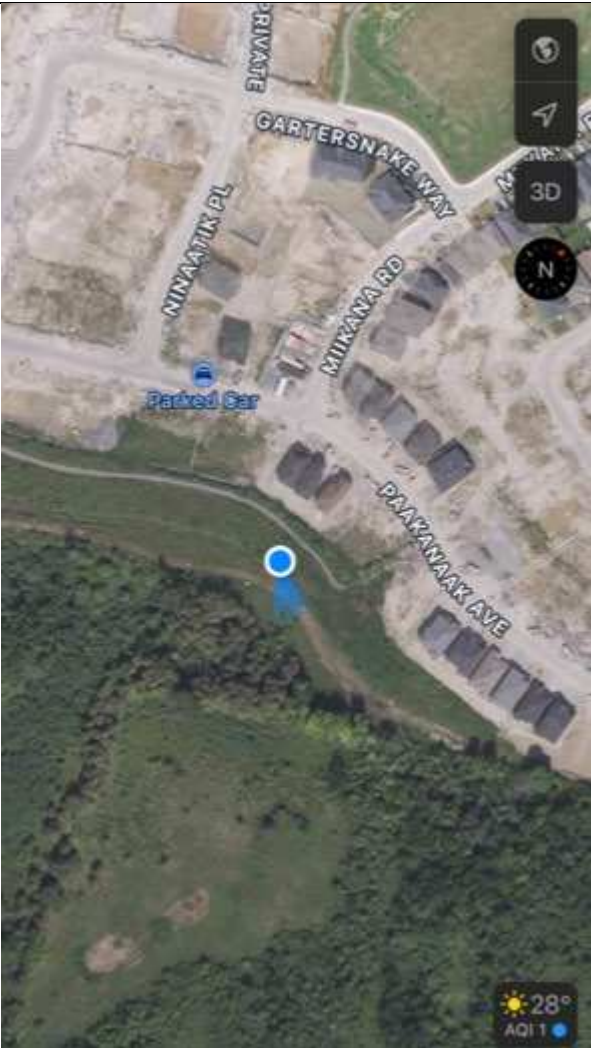
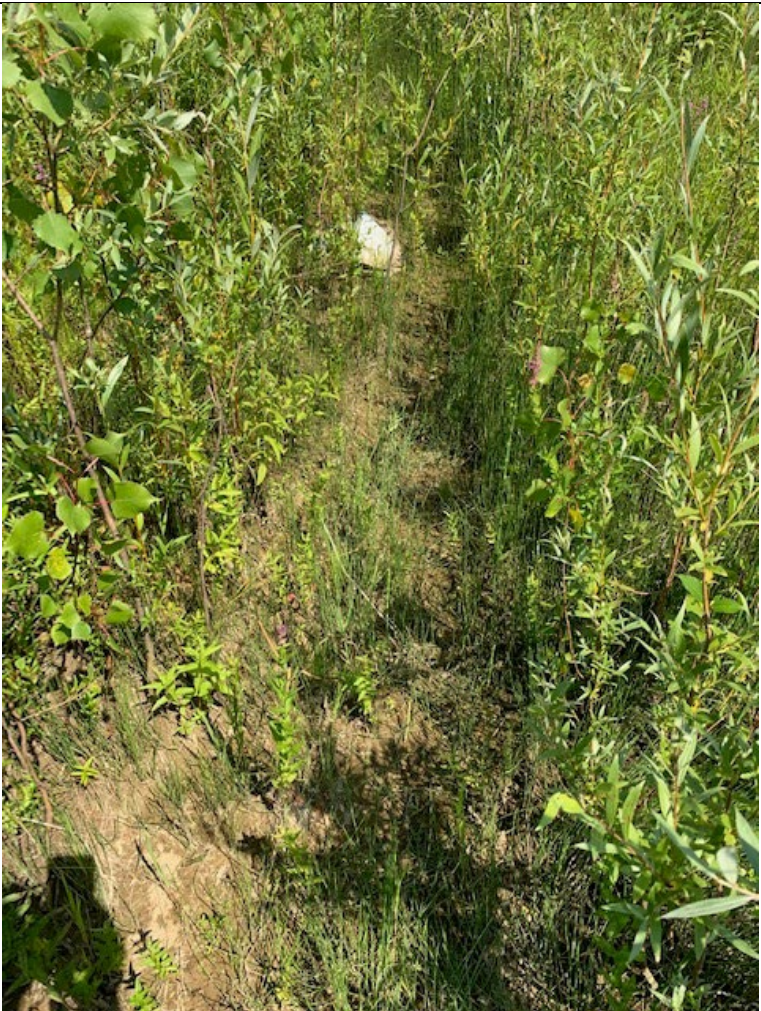
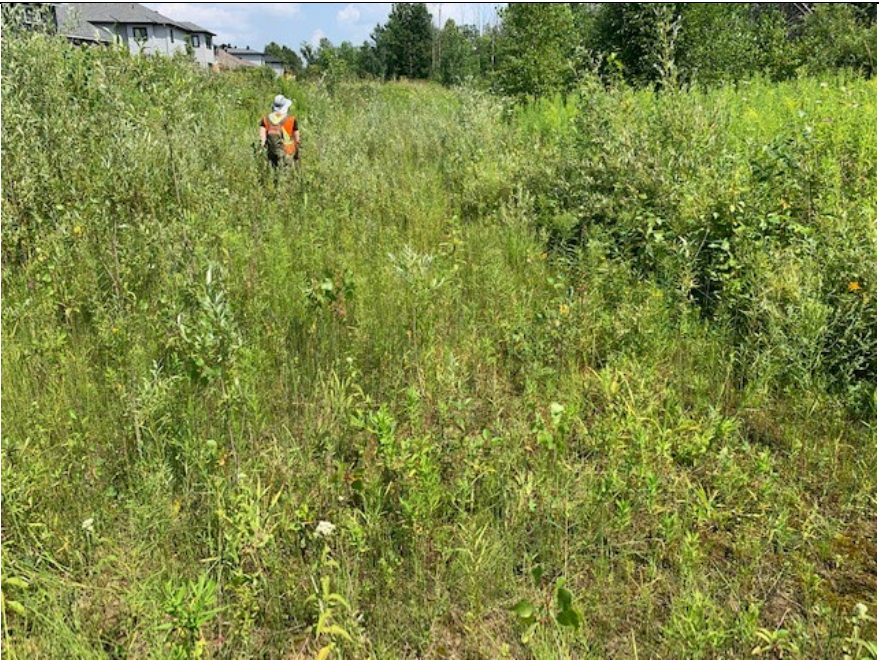
**LOCATION C**  
**Mid-section**  
**conveyance**  
**channel**

Observed wetland vegetation with some small pools of standing surface water. Well established buffer zones with mature plantings. Area functioning as per design.

The constructed conveyance channel requires that a linkage be maintained between the Casino Wetland and the Leitrim Core Wetland through maintenance of a natural area within the proposed development area.
