**PATERSON
GROUP**

PH5103-LET.01-REV.01

Subject: **Hydrogeological Assessment and Terrain Analysis
Re-zoning Application
2966-2978 Carp Road
Ottawa (Carp), Ontario**

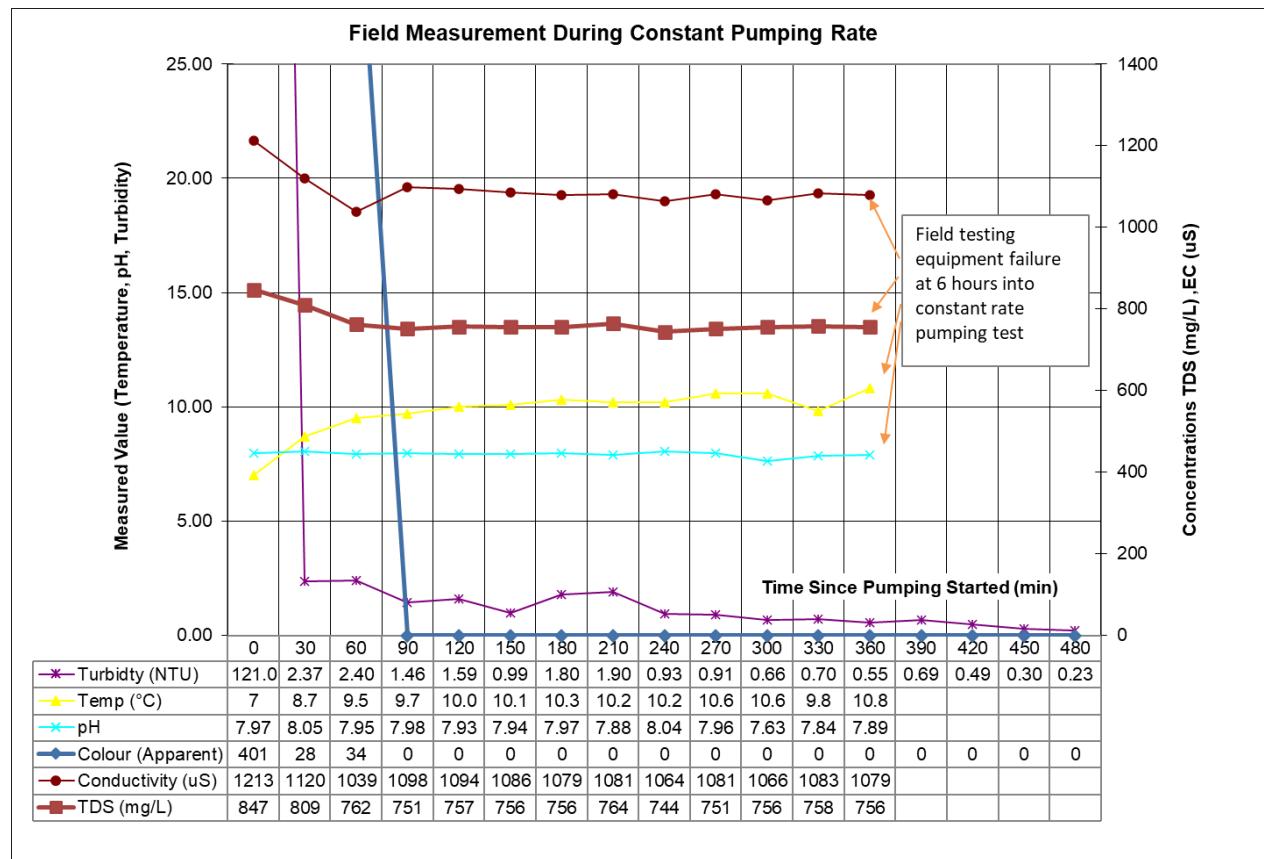
Turbidity, electrical conductivity, total dissolved solids (TDS), pH, true color and temperature were measured at the wellhead during the pumping test. The measurements and time intervals for each of these parameters are summarized on the graphical representation below. In addition, a HACH Pocket Colorimeter II chlorine reader was used to measure the free chlorine residual level. No chlorine residual was detected in the discharged water prior to the collection of the water samples. During the constant rate pumping test, the field-testing equipment which tests for pH, TDS, EC, and temperature malfunctioned at the 6-hour point. These parameters were noted to have stabilized prior to the malfunction of the equipment.

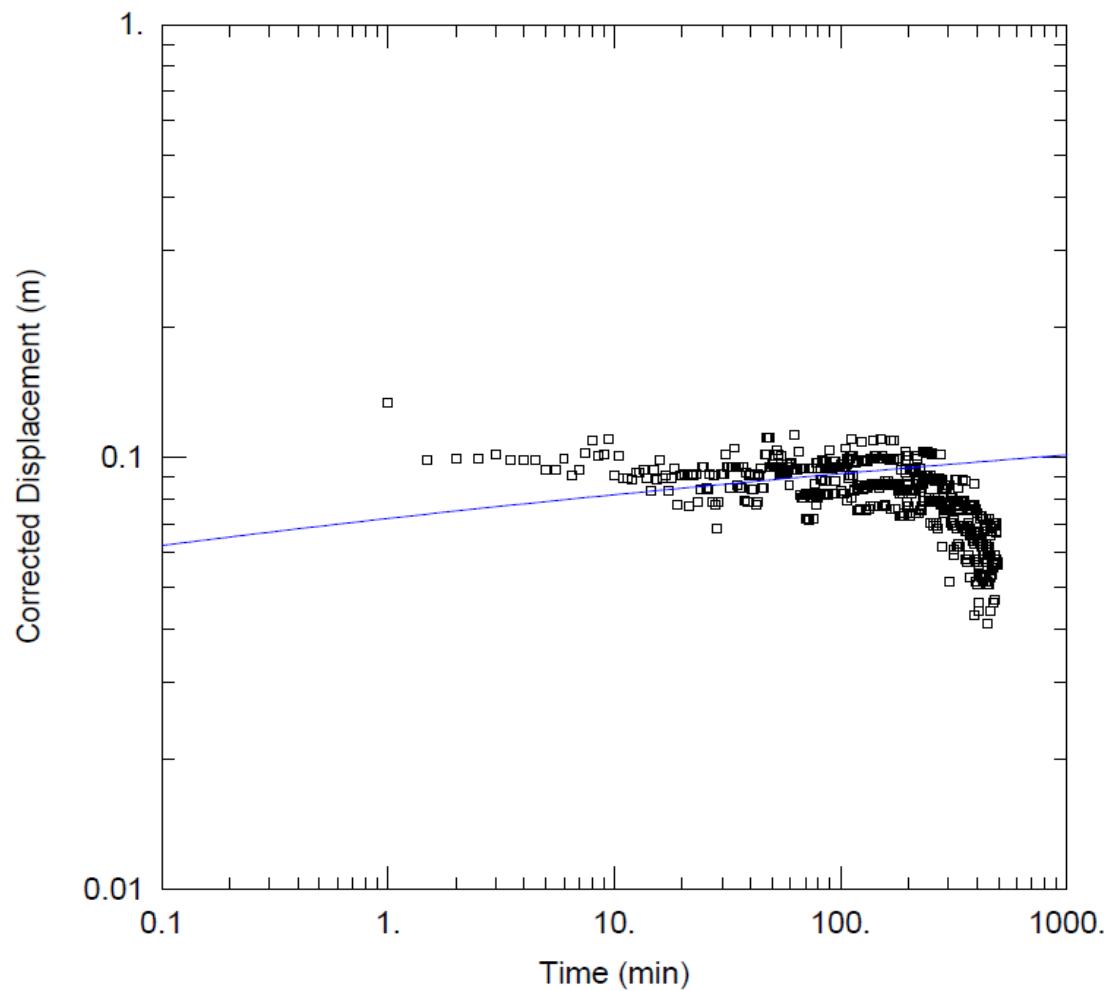
Pumping Test Analysis Report

| File No. | PH4484 | Well ID: | TW1 |
| Site Address: | 2966 Carp Road, Ottawa | Discharge Rate (L/min) | 45 |

The pumping test results show that TW1 has a high yield to support the water demands that may be required. Overall maximum drawdown at a constant pumping rate for a period of 8 hours was approximately 0.14 m (0.3% of the available drawdown), but only 0.06 m at the end of the test period. 95% recovery was achieved approximately one minute after the end of pumping. It should be noted that the water level was measured to be increasing throughout the 8-hour constant rate pumping test.

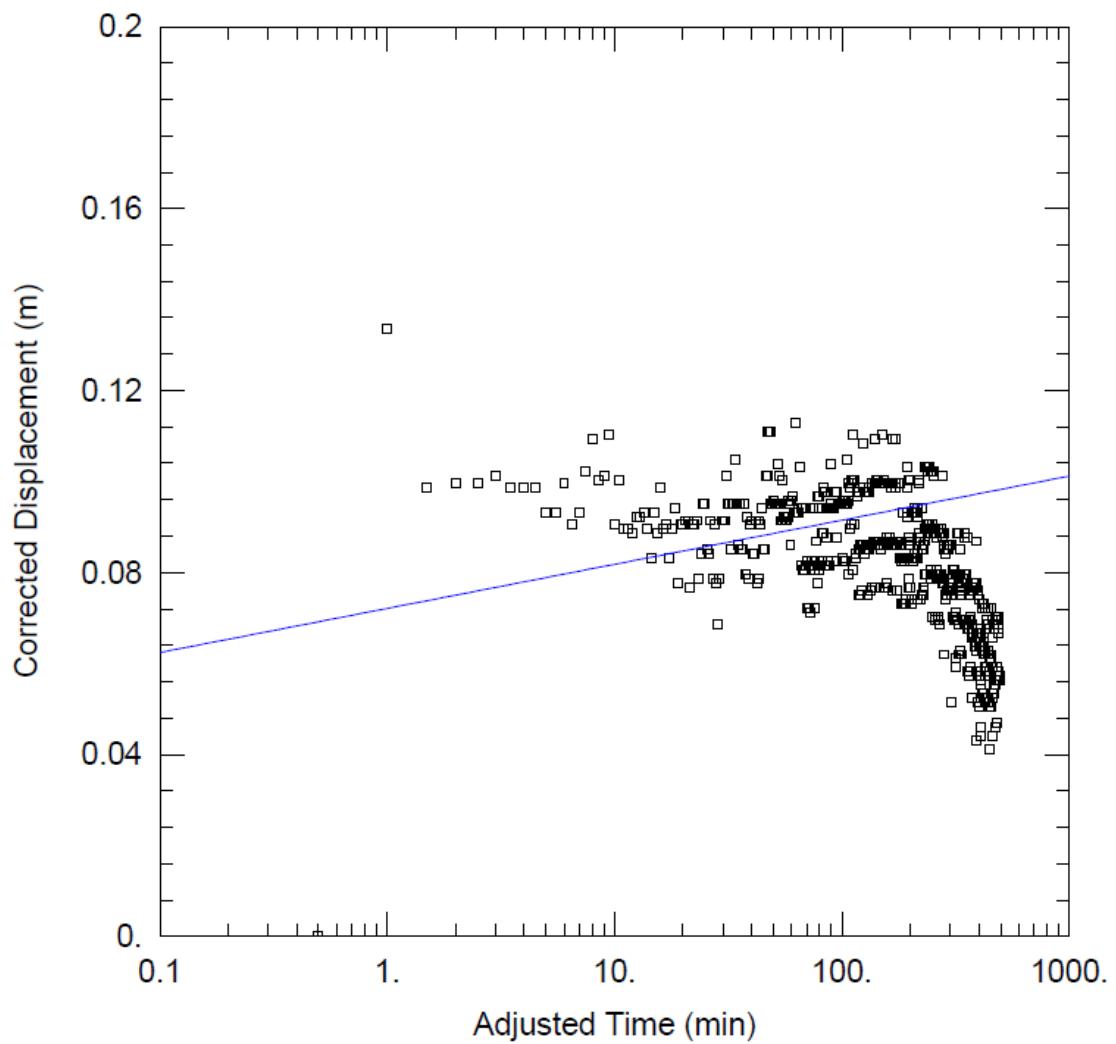
Pumping Test Analysis Report

| File No. | PH4484 | Well ID: | TW1 |
| Site Address: | 2966 Carp Road, Ottawa | Discharge Rate (L/min) | 45 |
