Re: **Phase One Environmental Site Assessment Update**
2966 and 2978 Carp Road, Ottawa, Ontario
Pinchin File: 361665

**Phase One Environmental Site Assessment Update**

2966 and 2978 Carp Road, Ottawa, Ontario

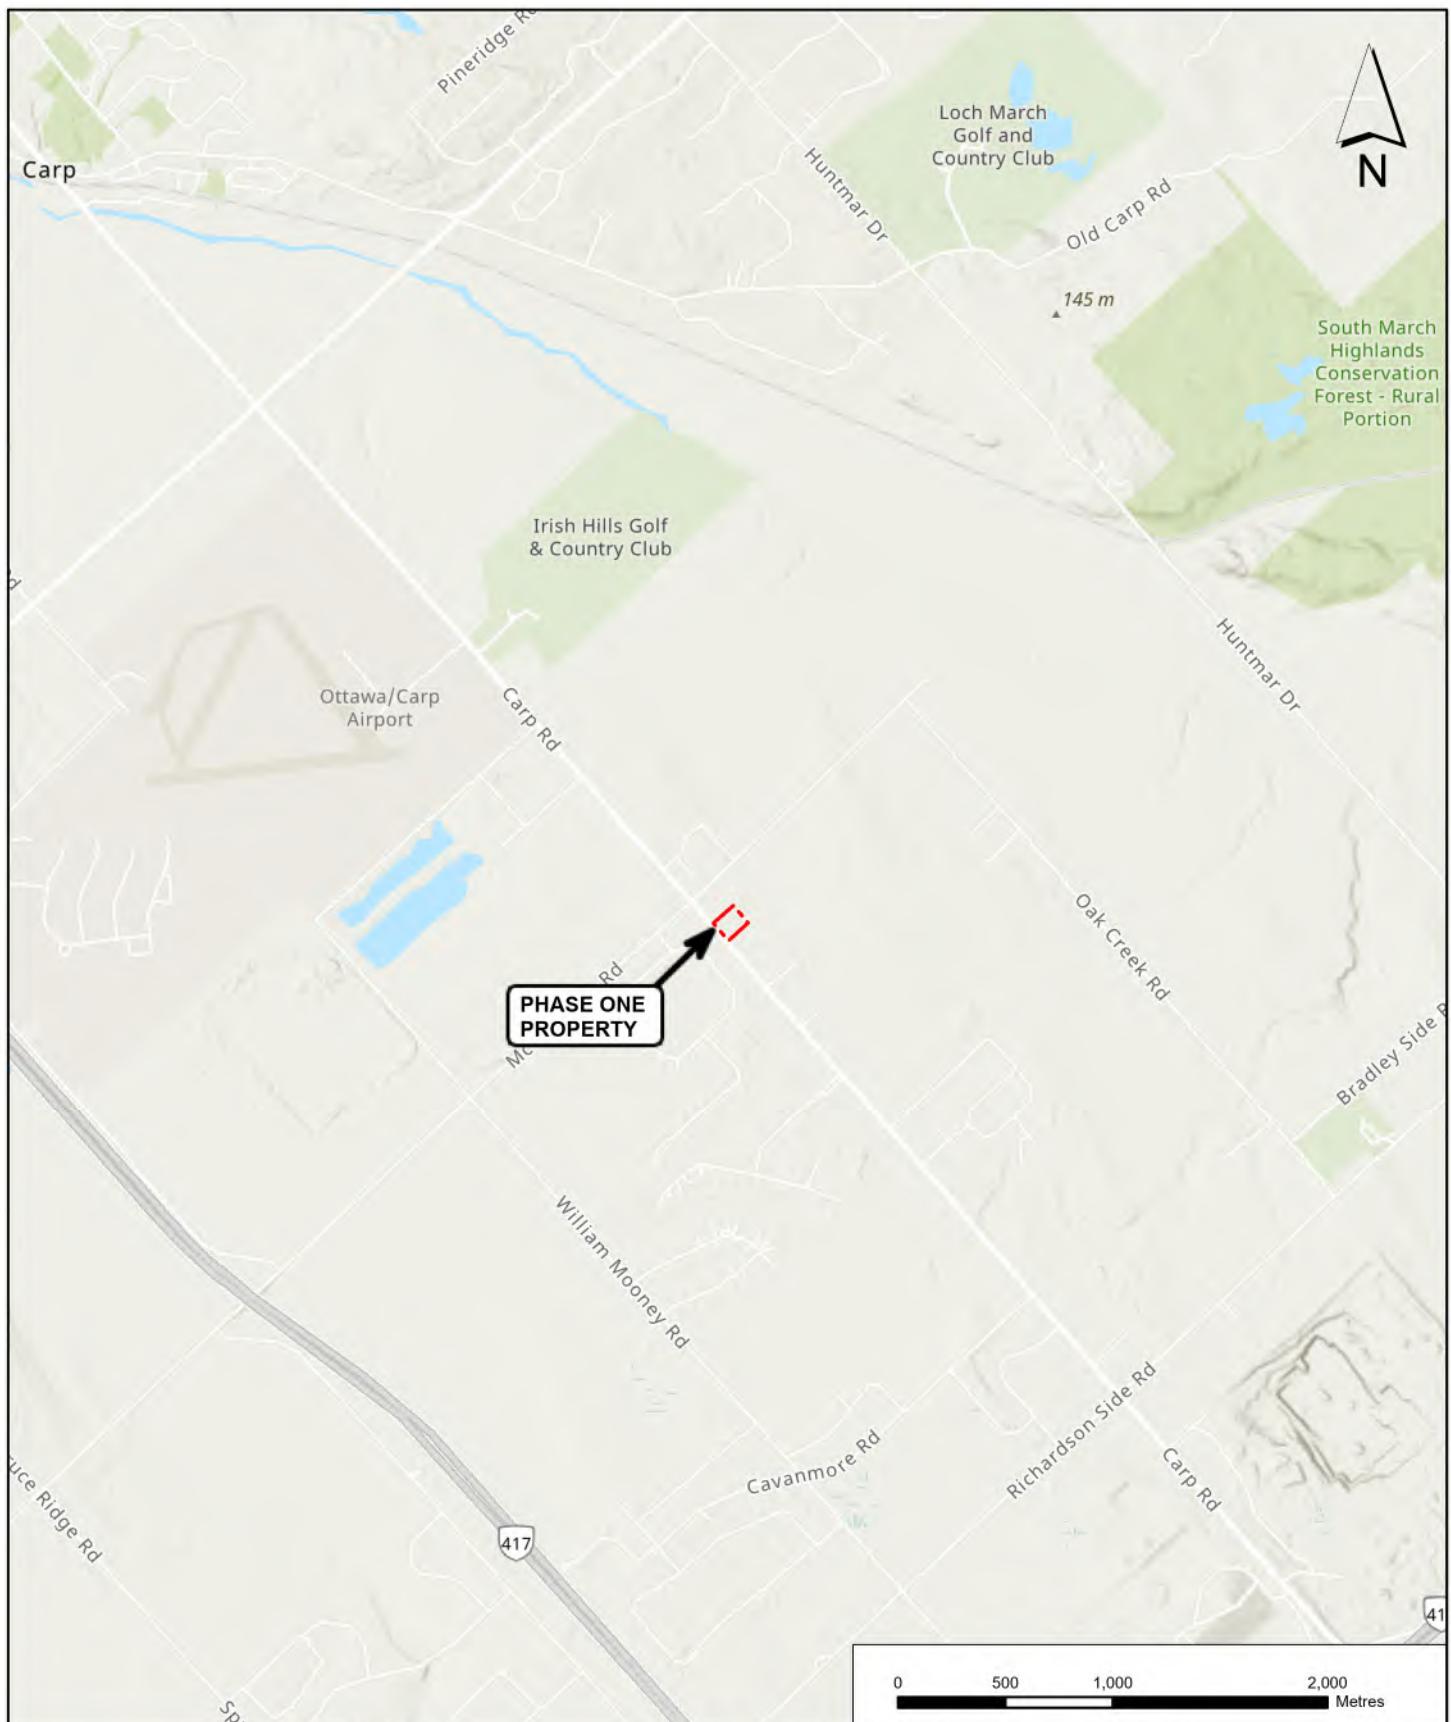
FIGURE NAME: KEY MAP FIGURE NUMBER

A conceptual site model (CSM) was created to provide a summary of the findings of the Update Phase One ESA. The Phase One CSM is summarized in Figures 1 through 3, which illustrate the following features within the Phase One Study Area, where present:

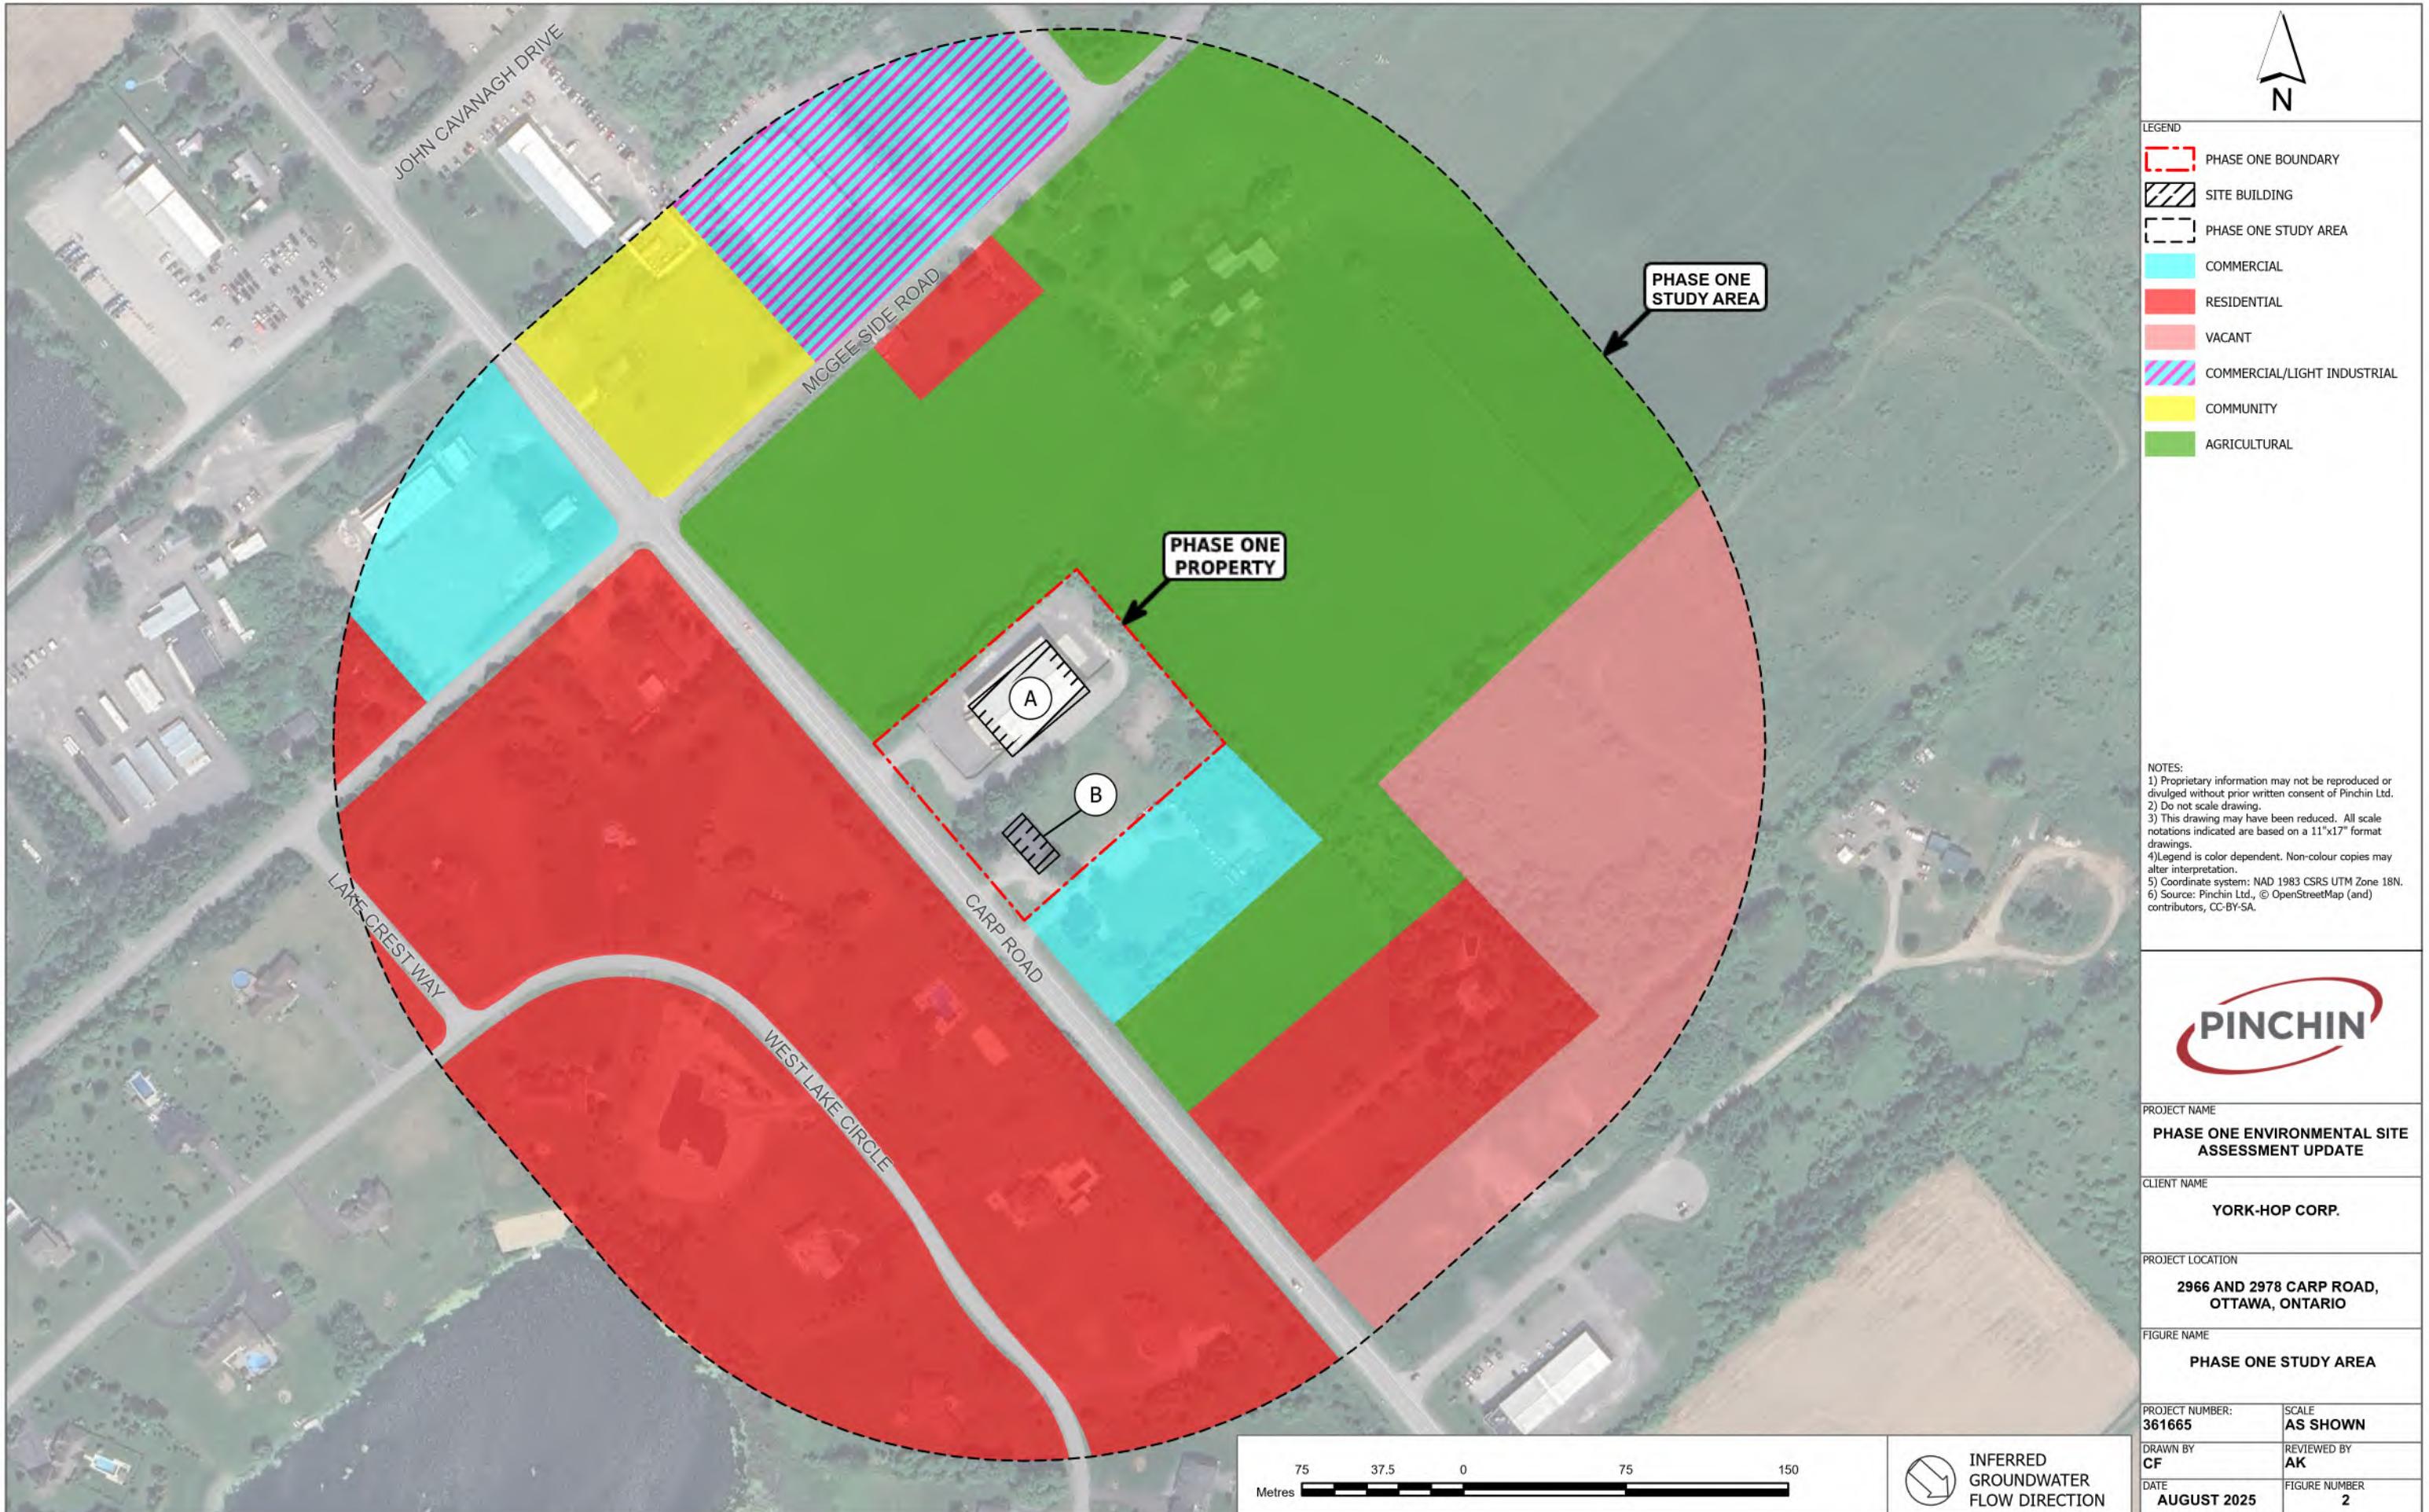
This Phase One ESA Update has been prepared by Pinchin for Client as an update to a Phase One ESA dated March 1, 2022 completed for the 2966 and 2978 Carp Road, Ottawa, Ontario. The Phase One Property and Phase One Study Area are shown on Figures 2 and 3 (all figures are provided in Appendix I).

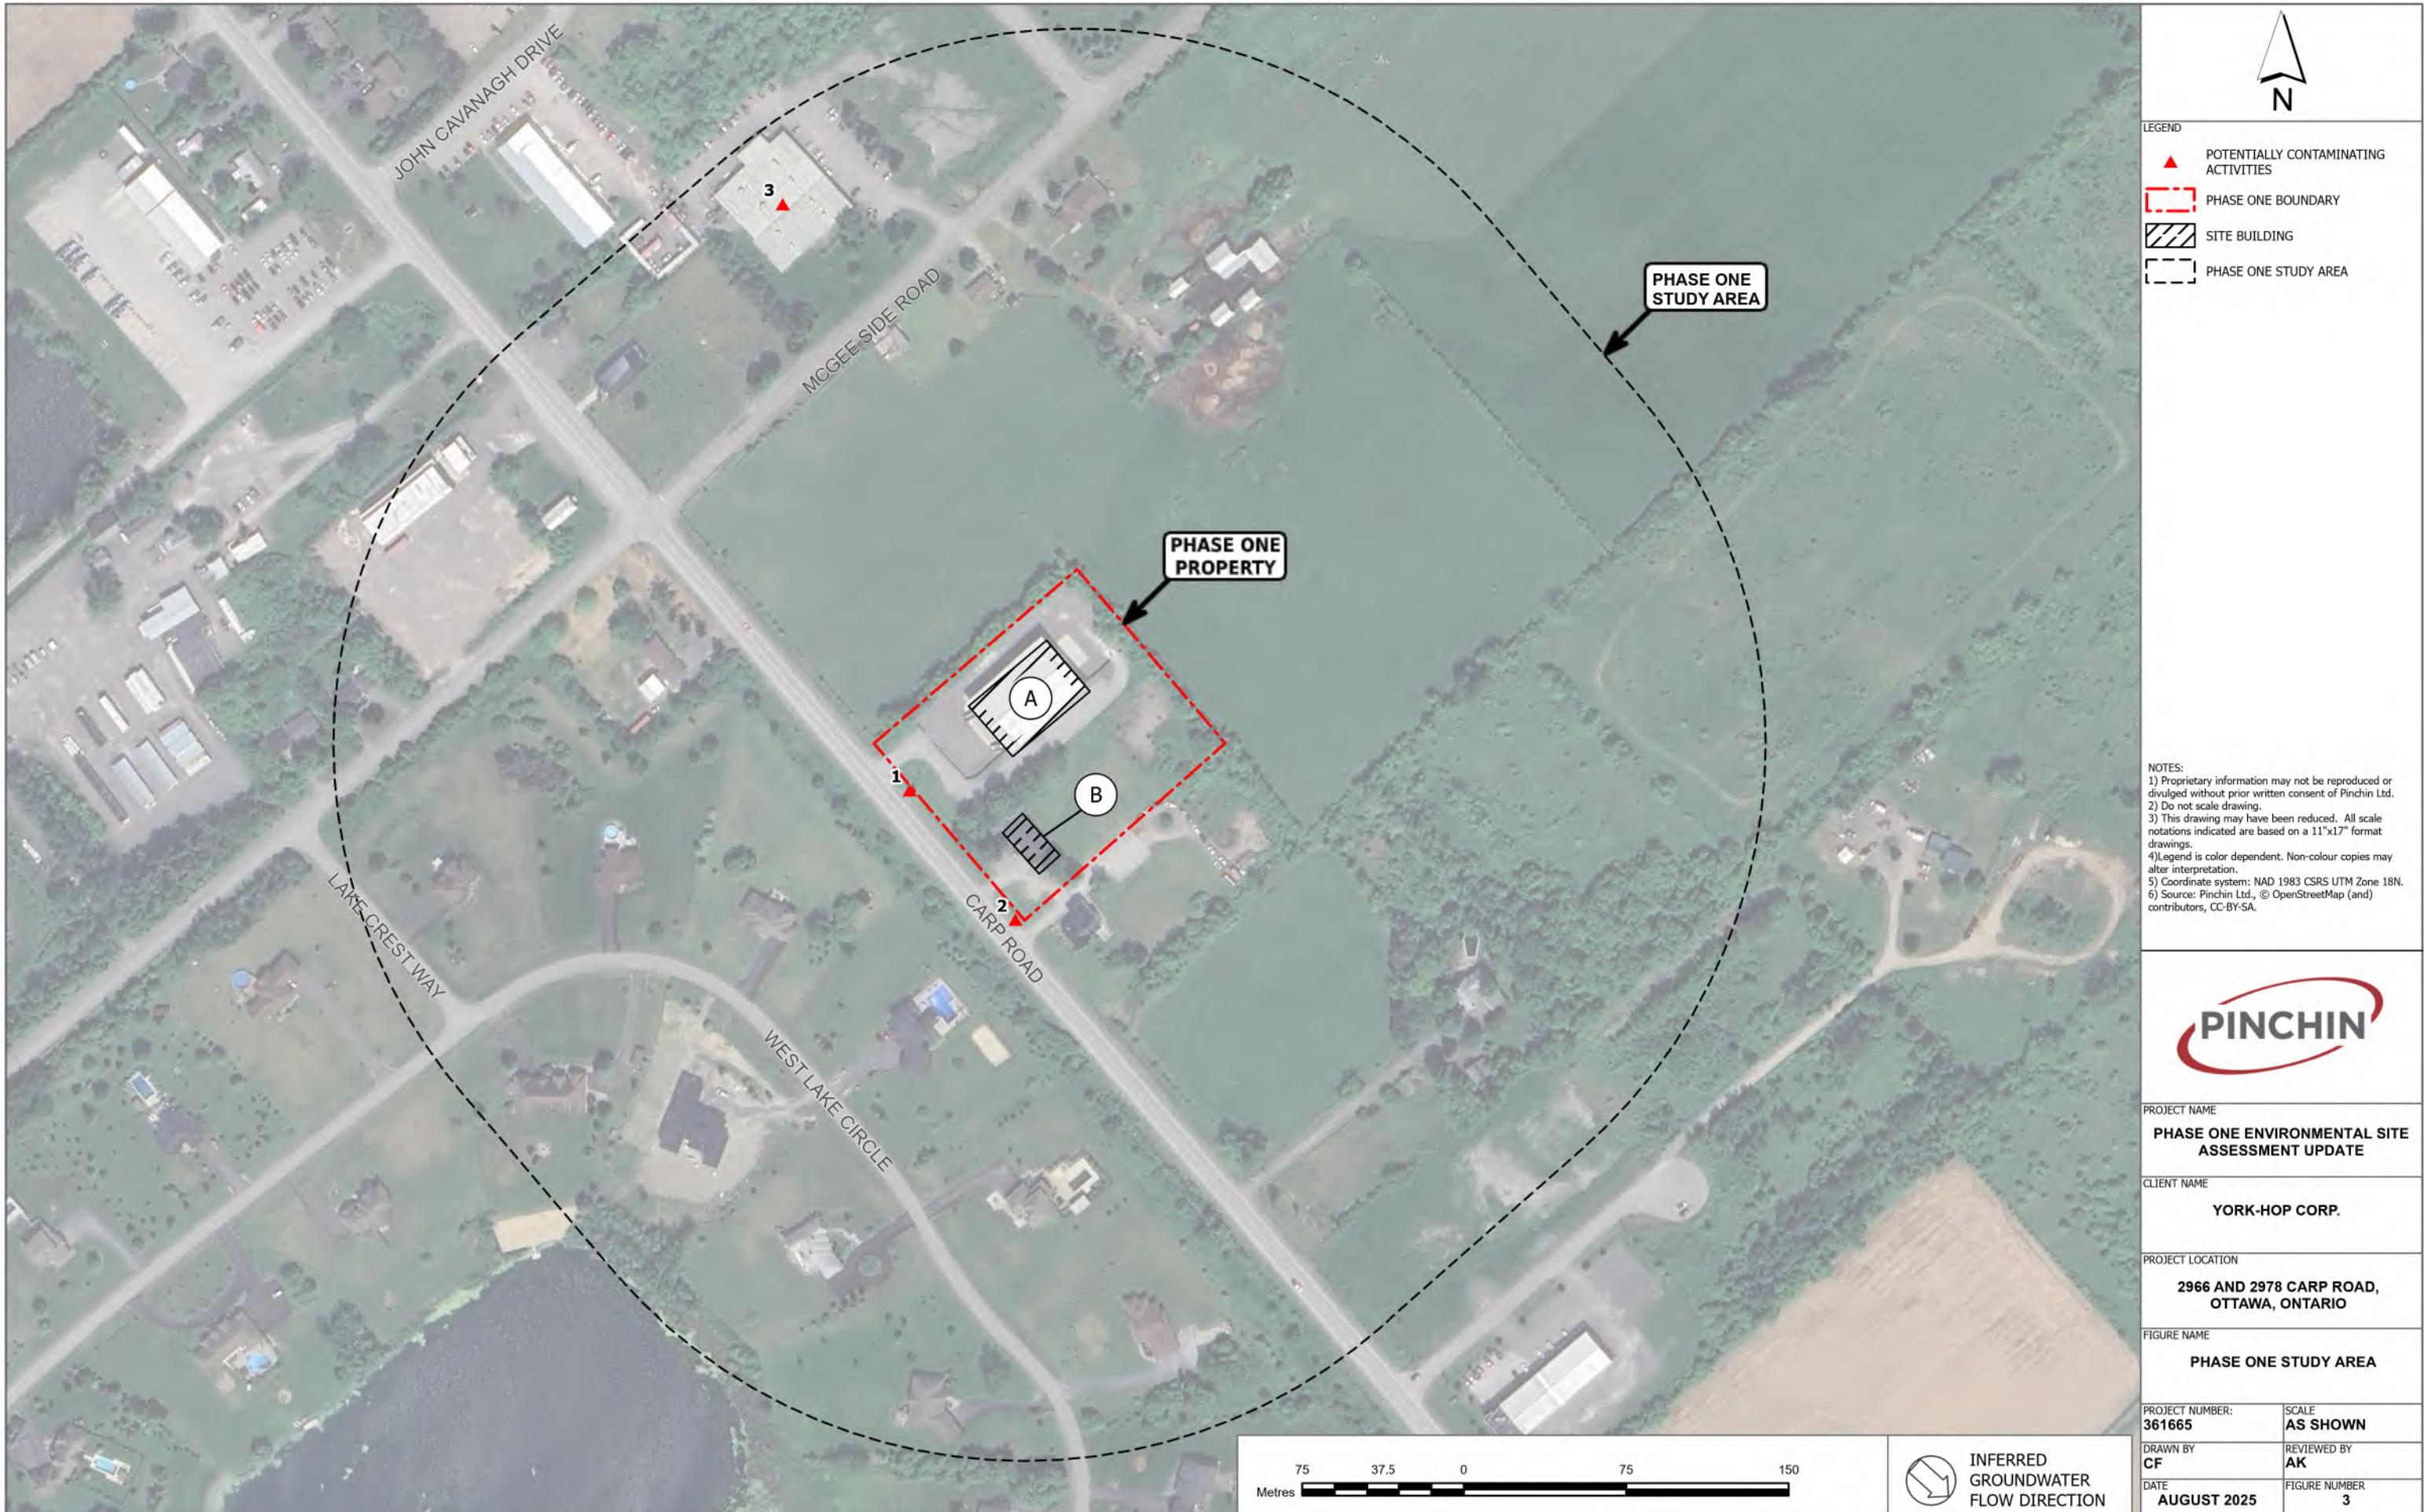
Pinchin formerly completed a Site inspection and a review of surrounding properties within the Phase One Study Area from publicly accessible locations on February 17, 2022 as part of the original Phase One ESA. The initial Site reconnaissance was completed by Pinchin personnel, under the supervision of Pinchin's Qualified Person (QP) overseeing this project. The Phase One Study Area is outlined on Figure 3.
